BOEING COMMERCIAL AIRPLANES

FLIGHT OPERATIONS TECHNICAL BULLETIN

NUMBER: 737-12-2
747-400-64
747-8-4
757-84
767-86
777-36
787-8

SUBJECT: Upset Recovery

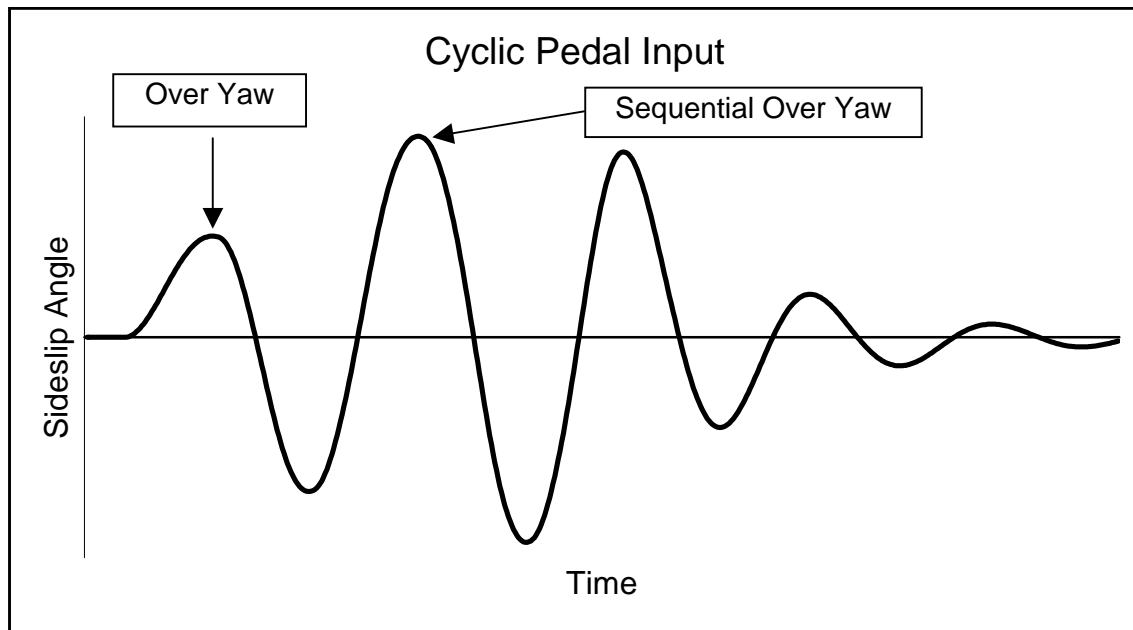
Figure 3 “Sideslip Response to Abrupt Cyclic Rudder Input”

Precise roll control using rudder is difficult and therefore not recommended. Because sideslip must build up to generate the roll, there is a time lag between the pilot making a rudder input and the pilot perceiving a roll rate. This lag has caused some pilots to be surprised by the abrupt roll onset and in some cases to interpret the rapid onset of roll as being caused by an outside element not related to their rudder pedal input. If the pilot reacts to this abrupt roll onset with another large rudder input in the opposite direction, large amplitude oscillations in roll and yaw can result. Cyclic rudder pedal inputs can result in very large amplitude sideslip oscillations (See Figure 3).

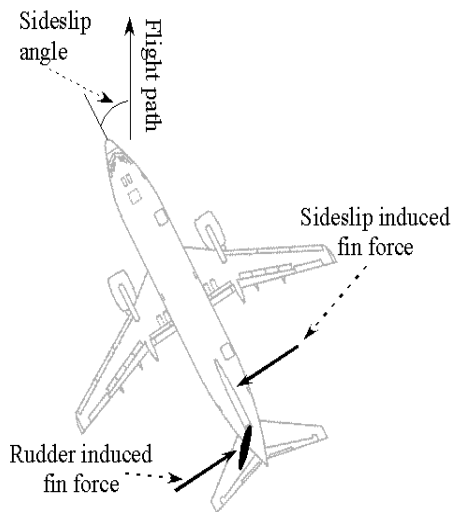
Figure 4 Rudder Induced Sideslip Forces

The sideslip angle that is momentarily reached with such “sequential over yaw” can be much larger than the over yaw associated with a single, abrupt rudder input (See Figure 2 & 3). When the rudder is reversed at this sequential over yaw/sideslip angle, the rudder induced fin force is added to the sideslip induced fin force (See Figure 4 & 5). The resulting structural loads can exceed the limit loads and possibly the ultimate loads, which can result in structural damage.

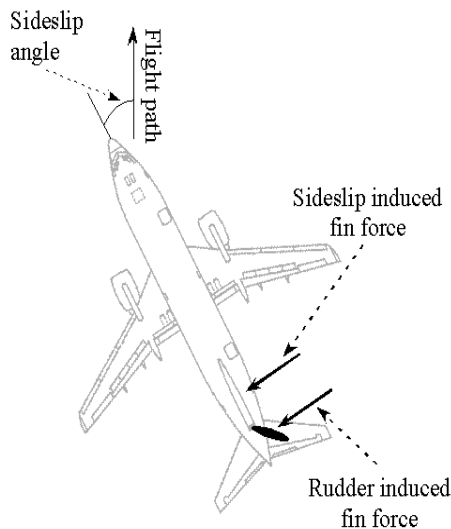
Figure 5 Rapid Rudder Reversal Forces

- If the pilot reacts to an abrupt roll onset with a large rudder input in the opposite direction, the pilot can induce large amplitude oscillations. These large amplitude oscillations can generate loads that exceed the limit loads and possibly the ultimate loads, which could result in structural damage.

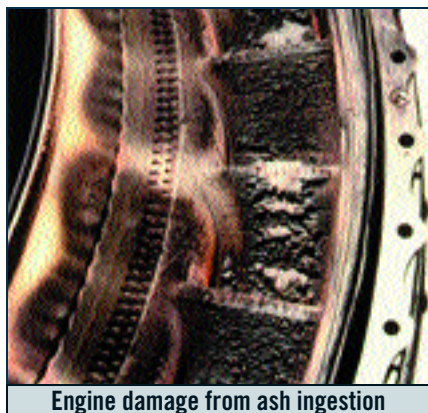
Engine damage from ash ingestion

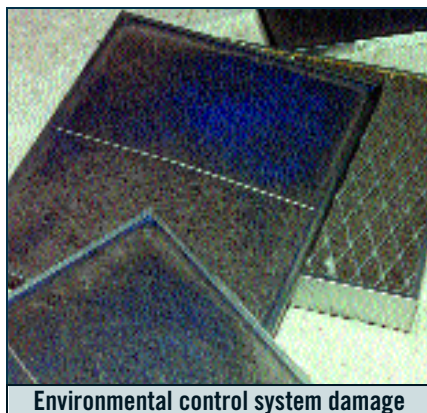
Environmental control system damage

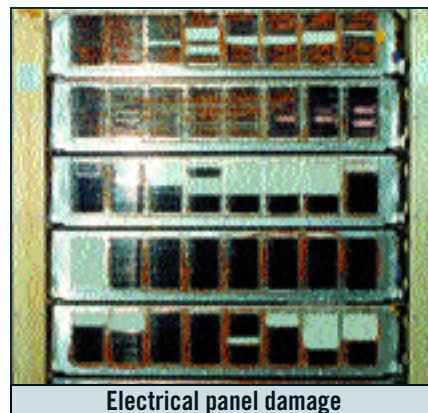
Electrical panel damage
