## Case Study: “V” Flow Lines

- Color ink screen printed on lamp panels to change the color of the EL light (“overprint”)
- Some panels get a defect in a “V” pattern that is usually not a functional defect, ***but customers do not like it***
- Panels with the V defect must be reworked by removing ink with solvent – time consuming and unsafe

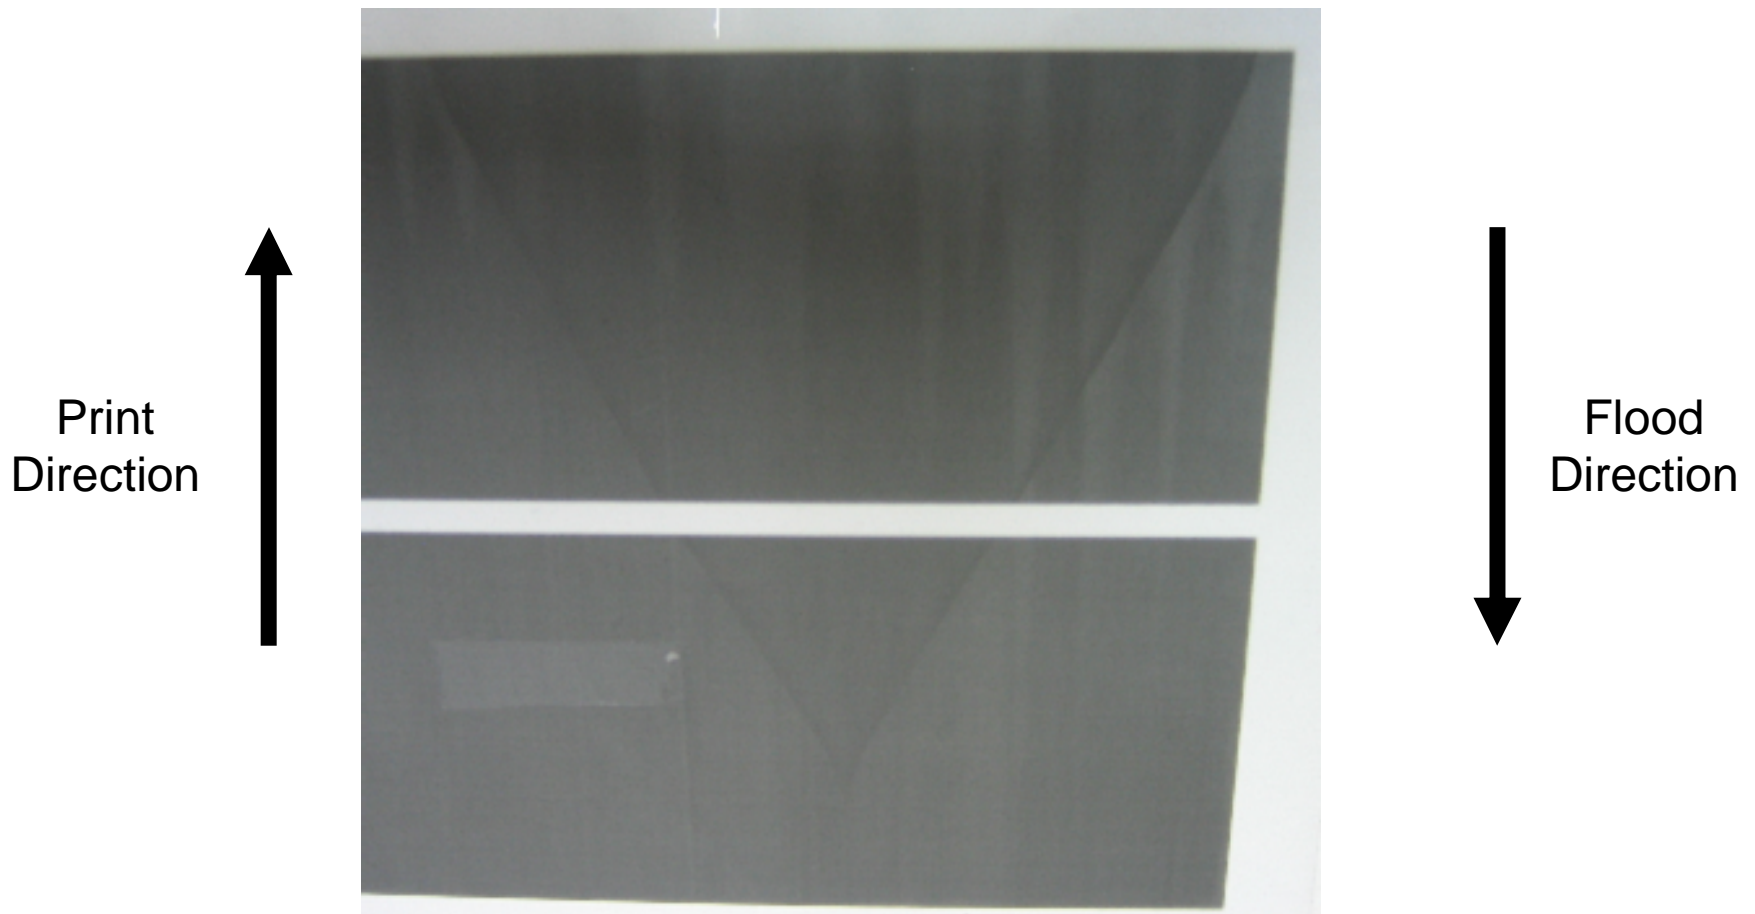
# V Flow Line Defect

- Obvious pattern seen in the printed ink – unsightly from a customer perspective
- The defect appears to align with one of the process directions

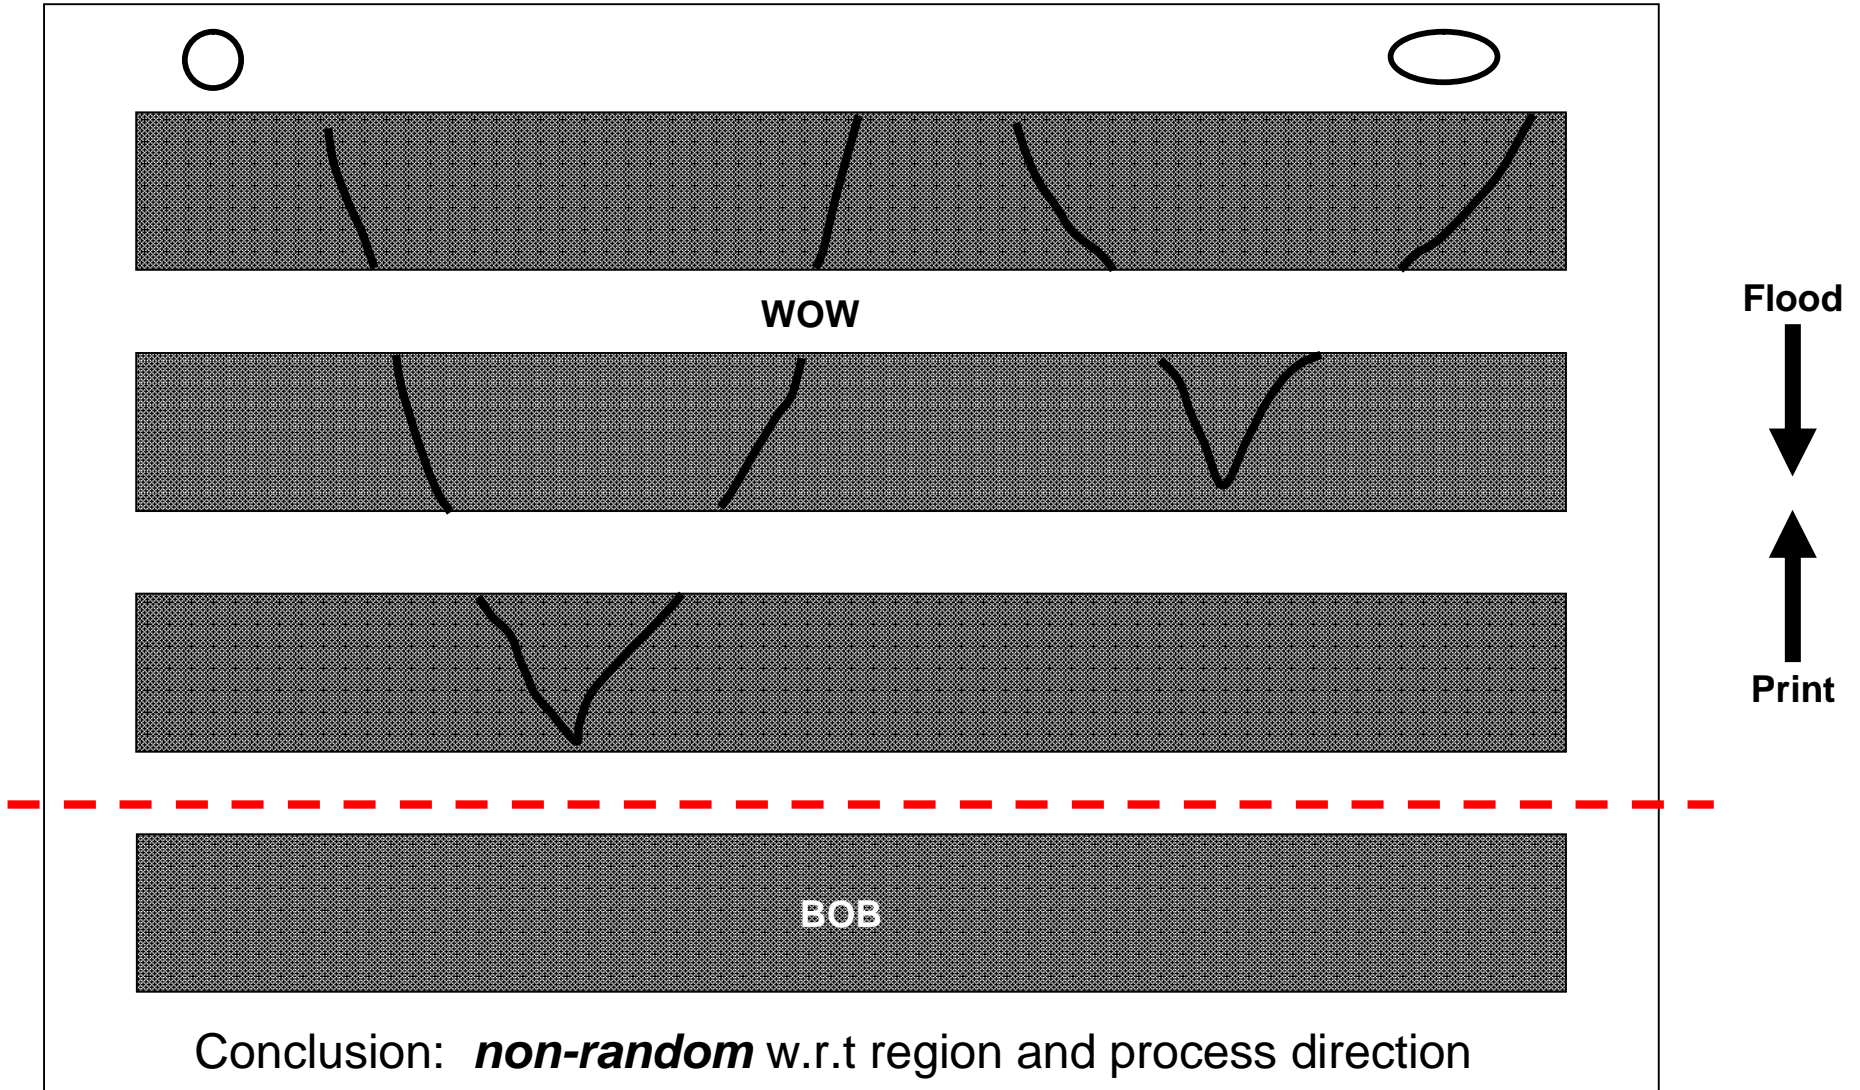
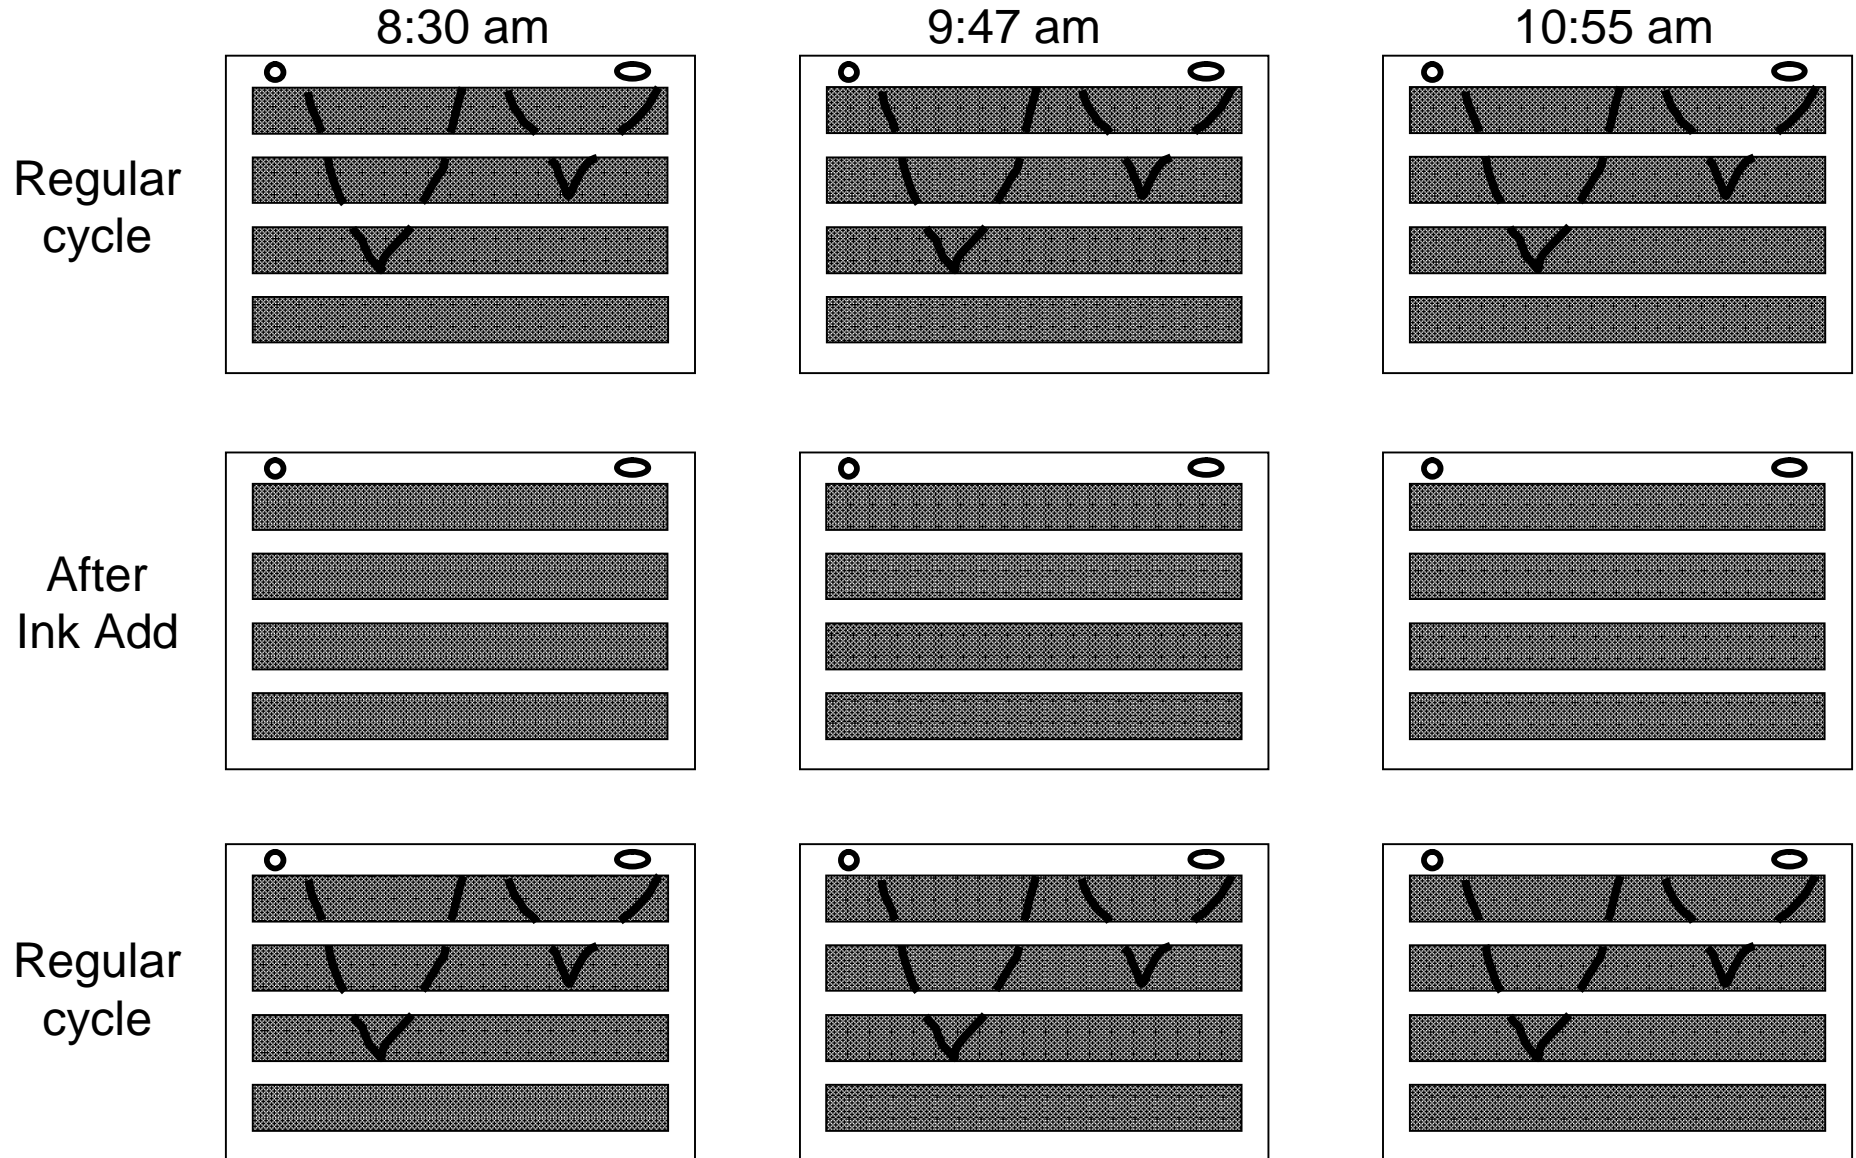
# V Defect - Concentration Diagram

Conclusion: ***non-random*** with respect to a process event.

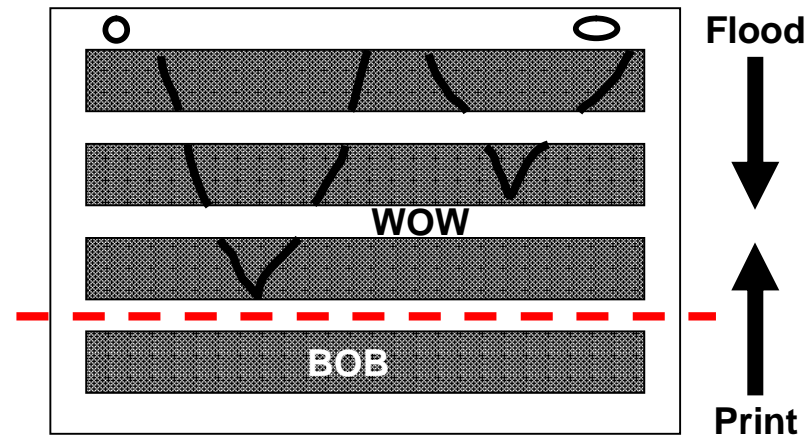
# V Flow Line – Strategy Diagram

BOB Point – WOW Point  
(WOW Region)

BOB Region – WOW Region  
(WOW Panel)

BOB Panel – WOW Panel  
(WOW Group)

BOB Group – WOW Group  
(WOW Run)

BOB Run – WOW Run

**Large contrast:** defect is isolated to a line. Good leverage relative to the process (pointed tip).

**Large contrast:** defects only on bottom edge. Good leverage (appears to follow flood).

**Good contrast:** WOW panels are few, but usually preceded by and followed by BOB panels. Good leverage (events).

**Some contrast:** slightly more defective groups at the start of the run. Small leverage.

**Some contrast:** some runs have up to 25% defects (can be reworked). WOW runs mostly with “large” artwork.

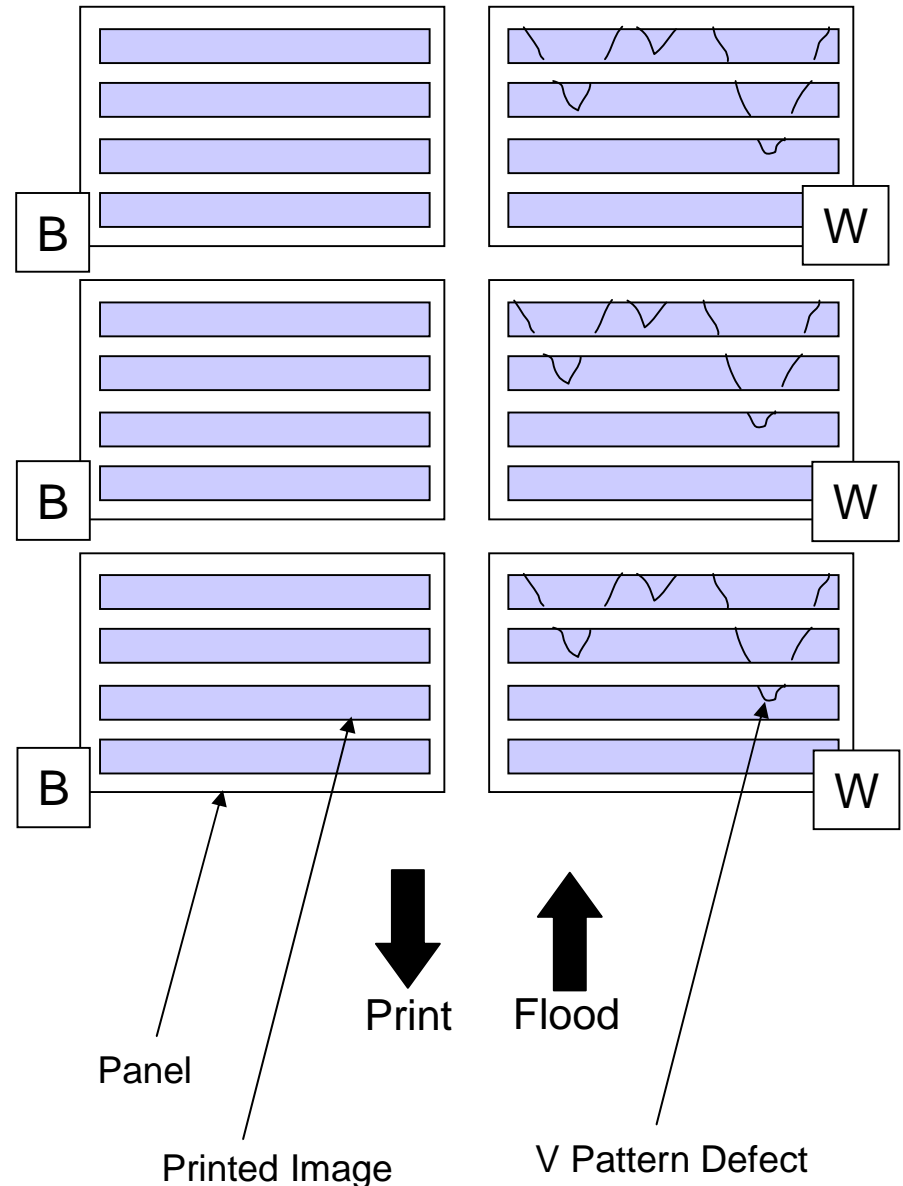
# Confirm Red X With “B vs. W” Test

- Green Y defect
  - Presence of “V pattern” flow lines
- Red X candidate
  - Time delay before flood coating screen
- B vs. W six-pack
  - W = 5 second delay before flooding
  - B = no delay
  - Printed in random order w.r.t. time
    - B, W, B, B, W, W
- Results
  - Rank ordered the results
    - Defect vs. no defect
  - All W's had V pattern flow line present
  - All B's were void of the defect
- Red X confirmed at 95% confidence

- The defect is completely eliminated with a 5 second delay after raising the squeegee before flooding the screen with ink
- Worked with machine maker to re-program the screen printing machine with a 5 second delay
- The increased yield and complete elimination of rework more than offsets the slightly reduced throughput
- Result: Scrap due to “V-lines” was completely eliminated
- Translation of benefits to other printed layers can reduce other visual defects also

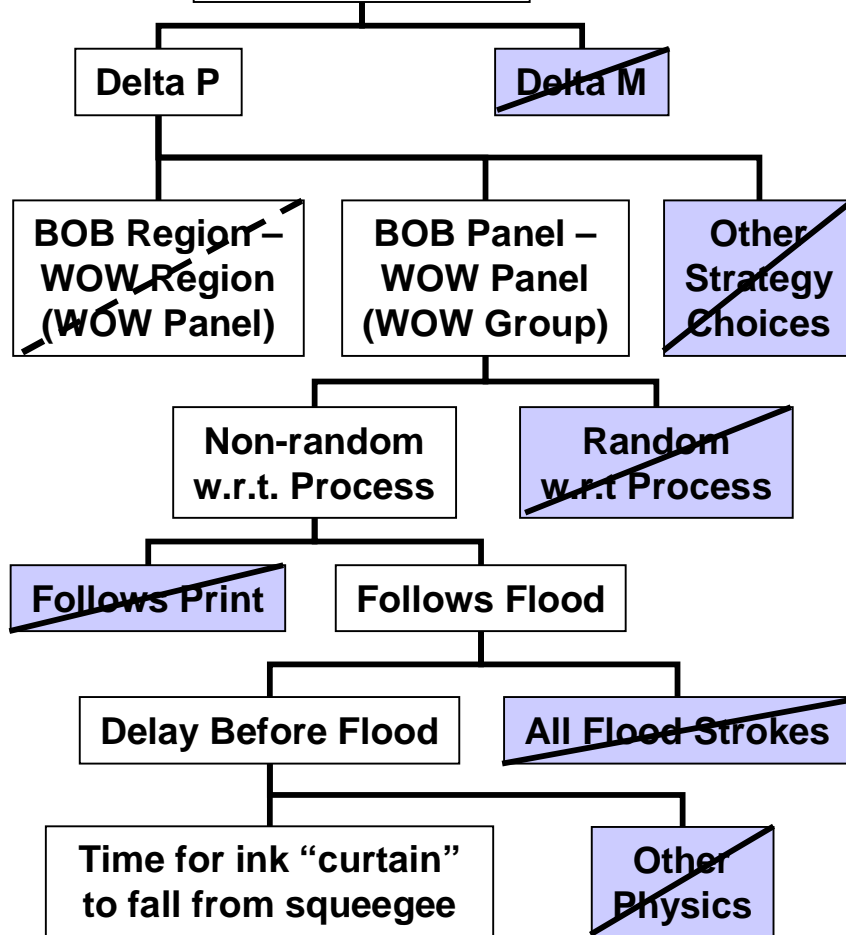
# Solution Tree for "V" Defect

The Green Y is the presence of V defects on lamp panels printed with overprint.

**Concentration Diagram:** BOB Panel-WOW Panel provides the best leverage by observing ink addition and scrape events. Use BOB Region-WOW Region contrast to focus observations on the flood stroke.

BOB panels occur only after ink additions or ink edge scrapes. WOW panels occur randomly throughout.

BOB and WOW panels both get the same print stroke. Only BOB panels have a different flood stroke.

Delaying the flood after printing creates BOB panels, never WOW.

Ink "curtain" from squeegee lays down in flood and causes "V" in printed image. Confirmed with B vs. W. Changed PLC program to add 5 seconds before flood.
