Case Study: Carbon Cracks

Solution Tree for Carbon Cracks

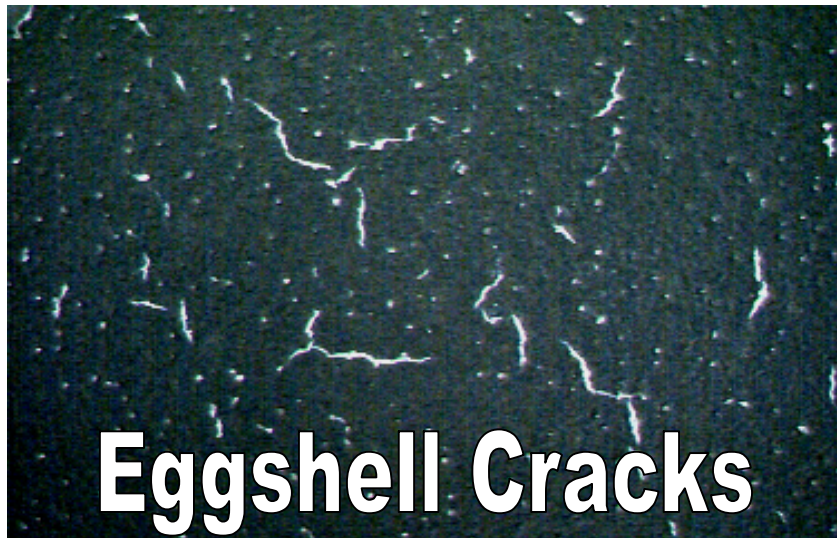
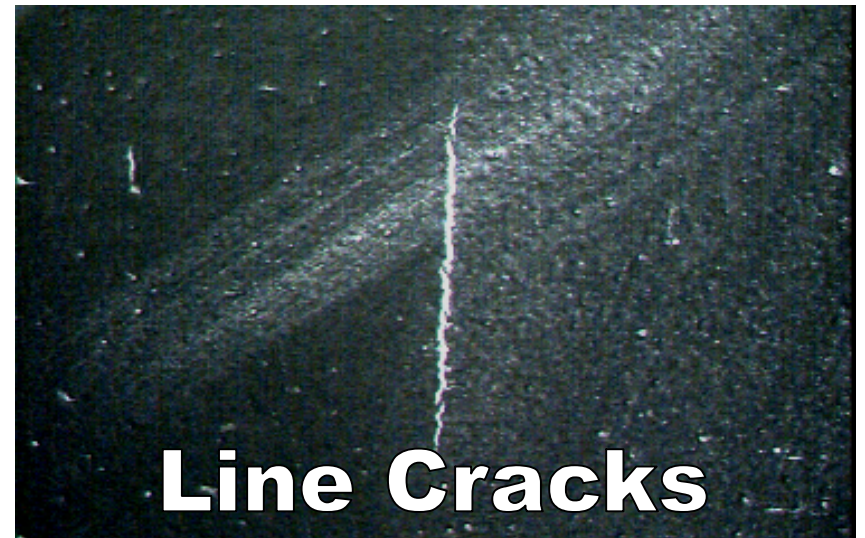
Carbon Cracks – Green Y

- Further inspection of the cracks revealed two defect footprints:
 - Line cracks
 - “Eggshell” cracks

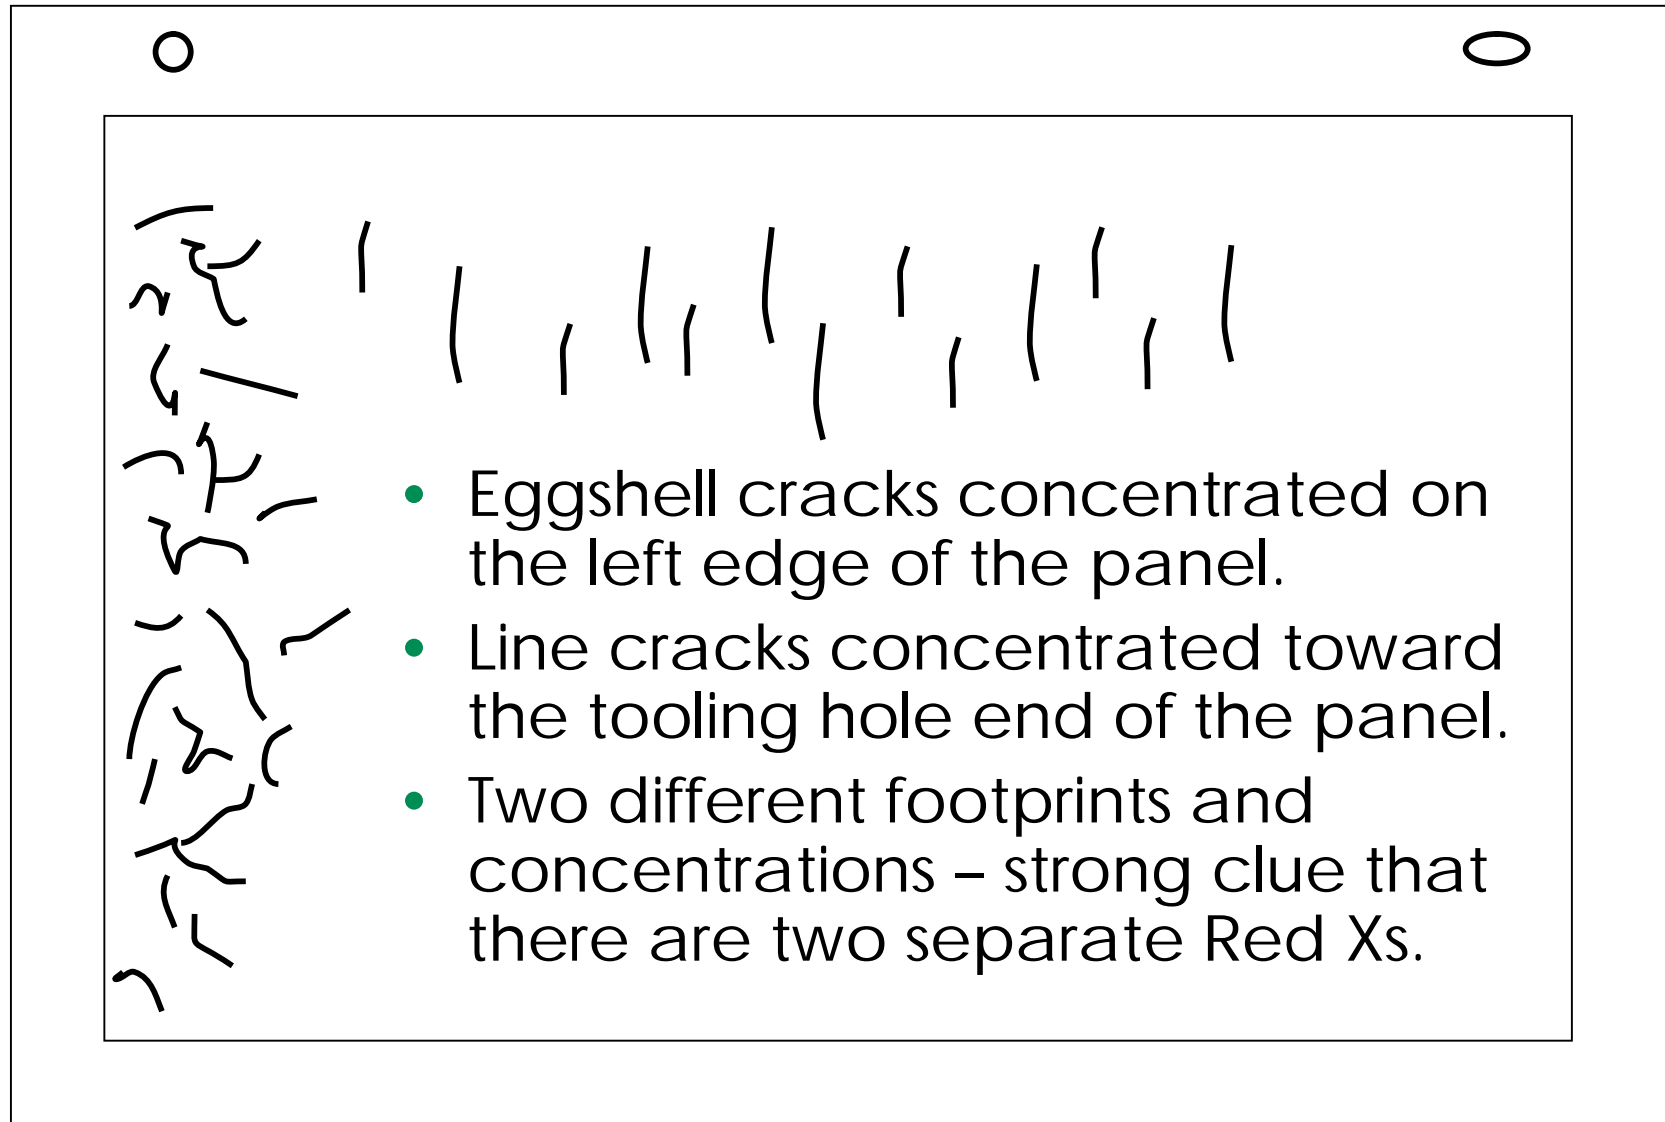
Carbon Cracks – Concentration Diagram

Concentration Diagram: eggshell defects on the left edge, which has excellent leverage in the process.

Defects only occur on the edge, which is very non-random relative to the process.

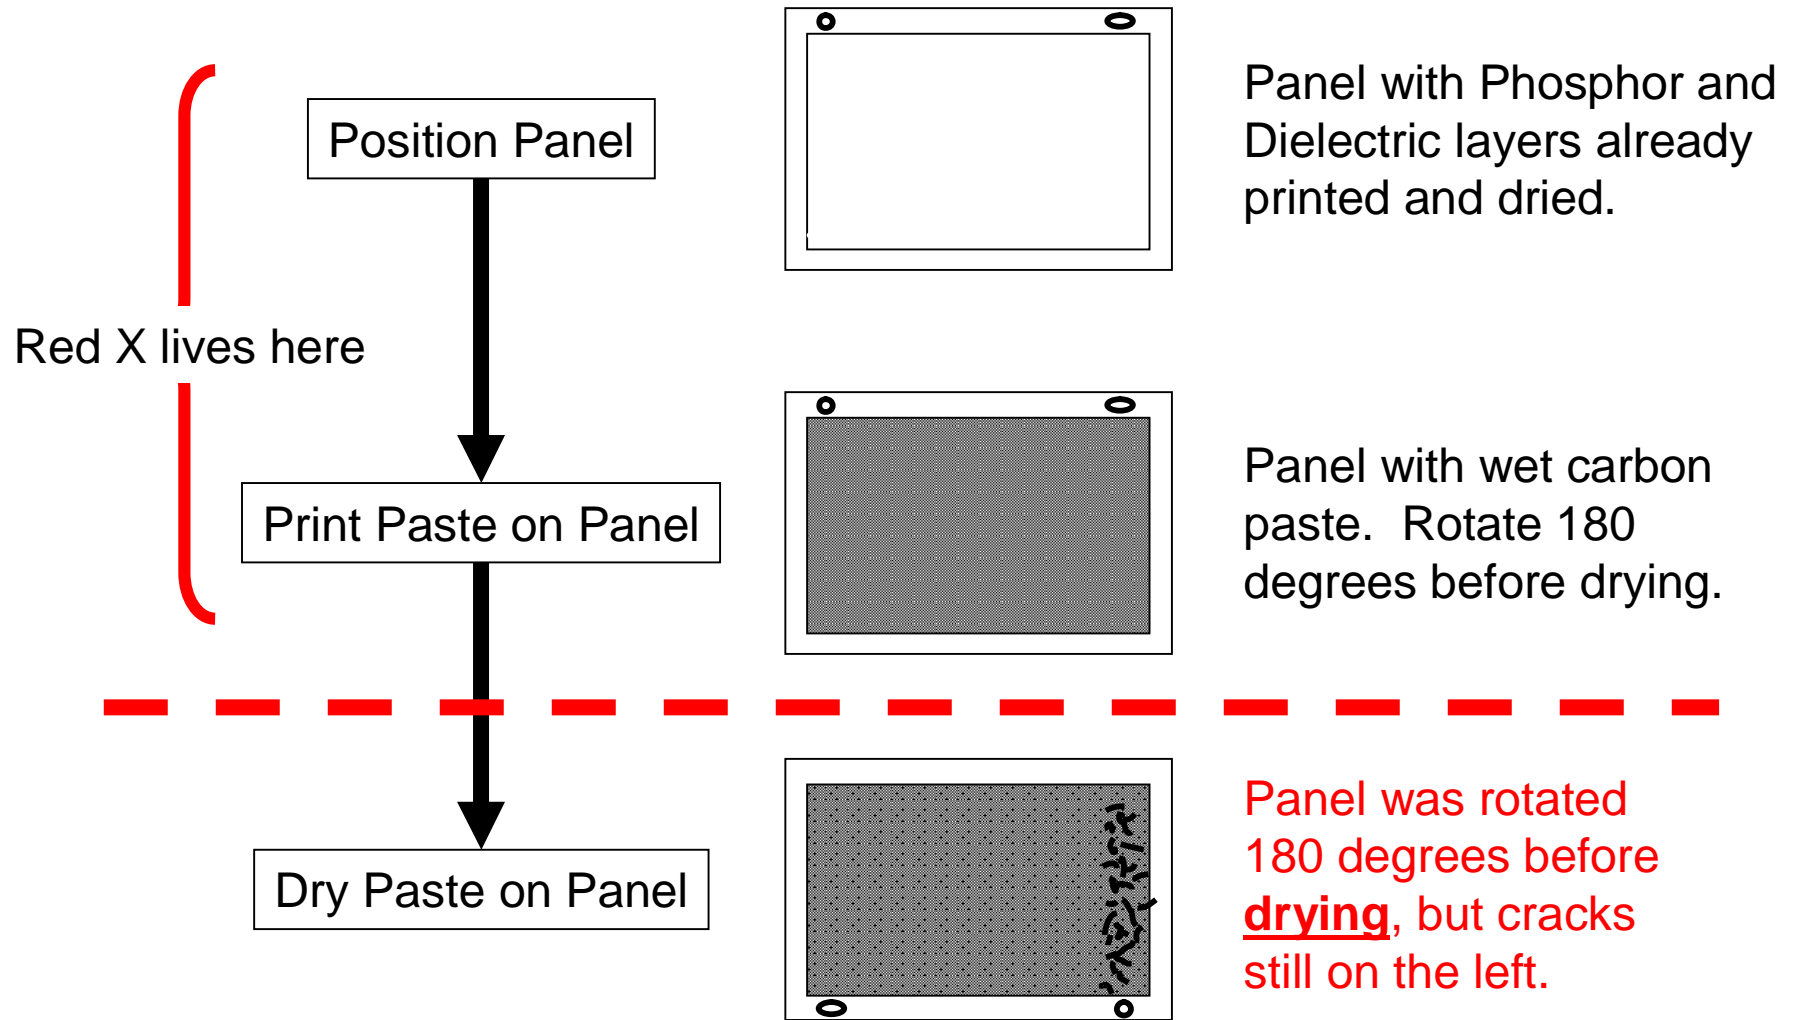
Carbon Cracks – Split #1

Result: Cracks stay on the left side relative to the process.

Conclusion: The Red X lives before drying (printing or the panel).

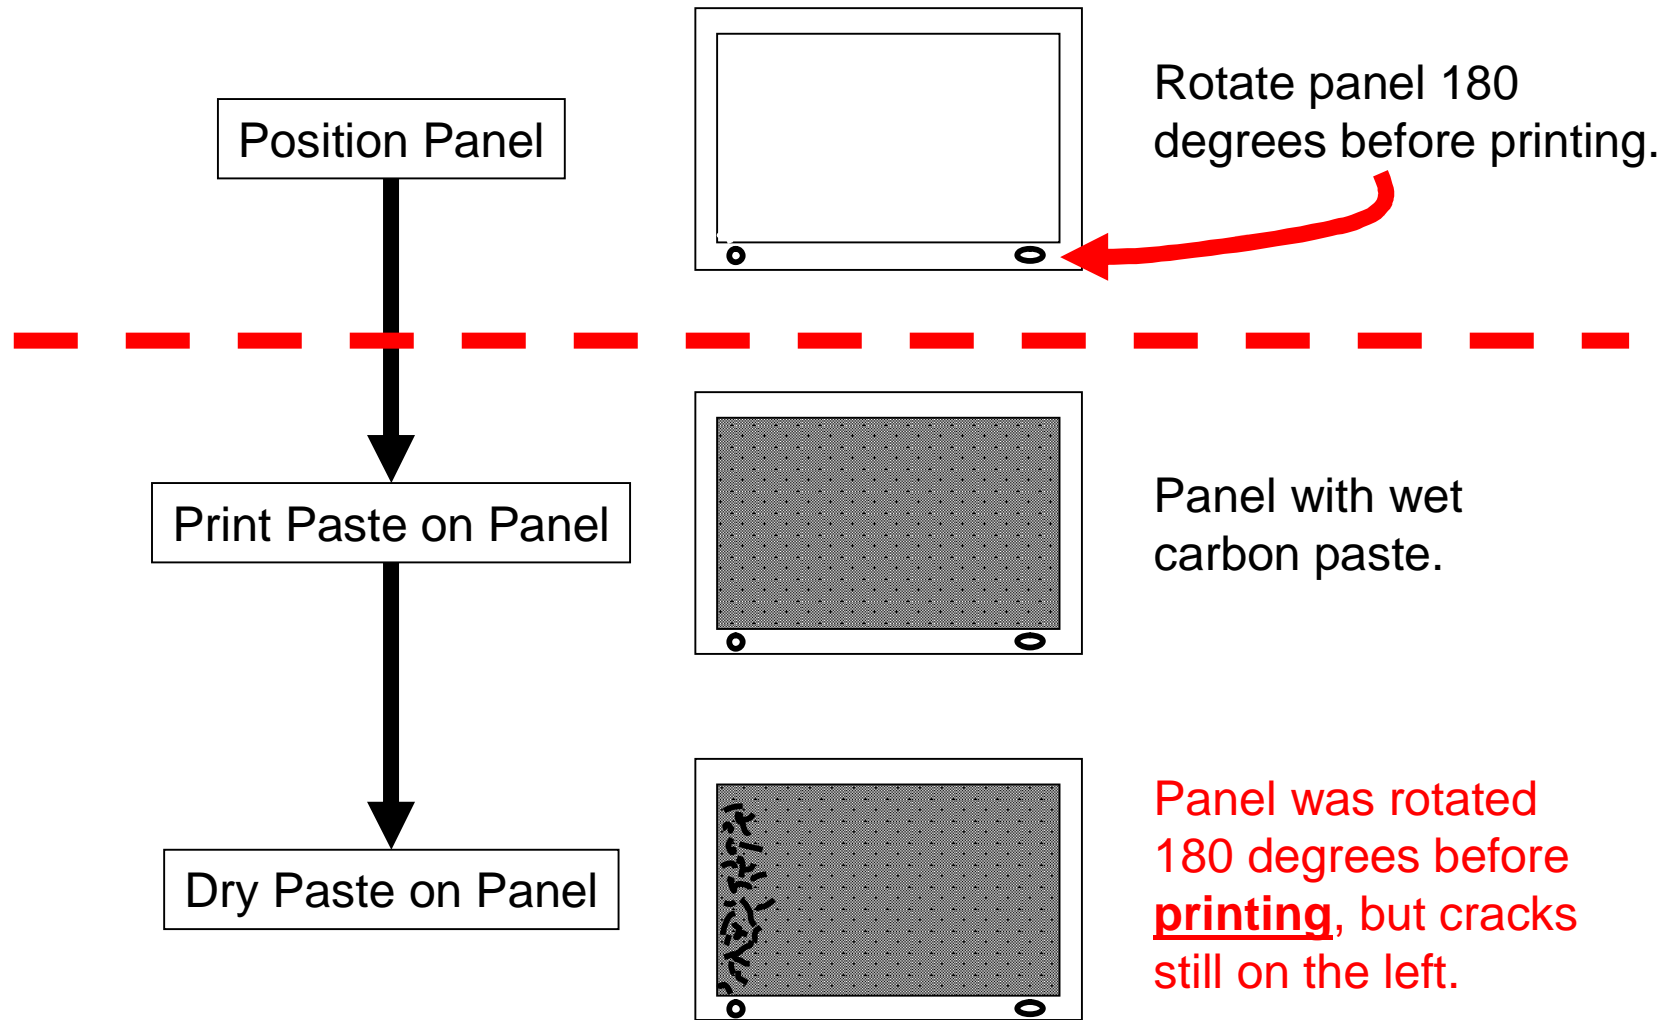
Carbon Cracks – Split #2

Result: Cracks stay on the left side relative to the process.

Conclusion: The Red X lives in the **print process**.

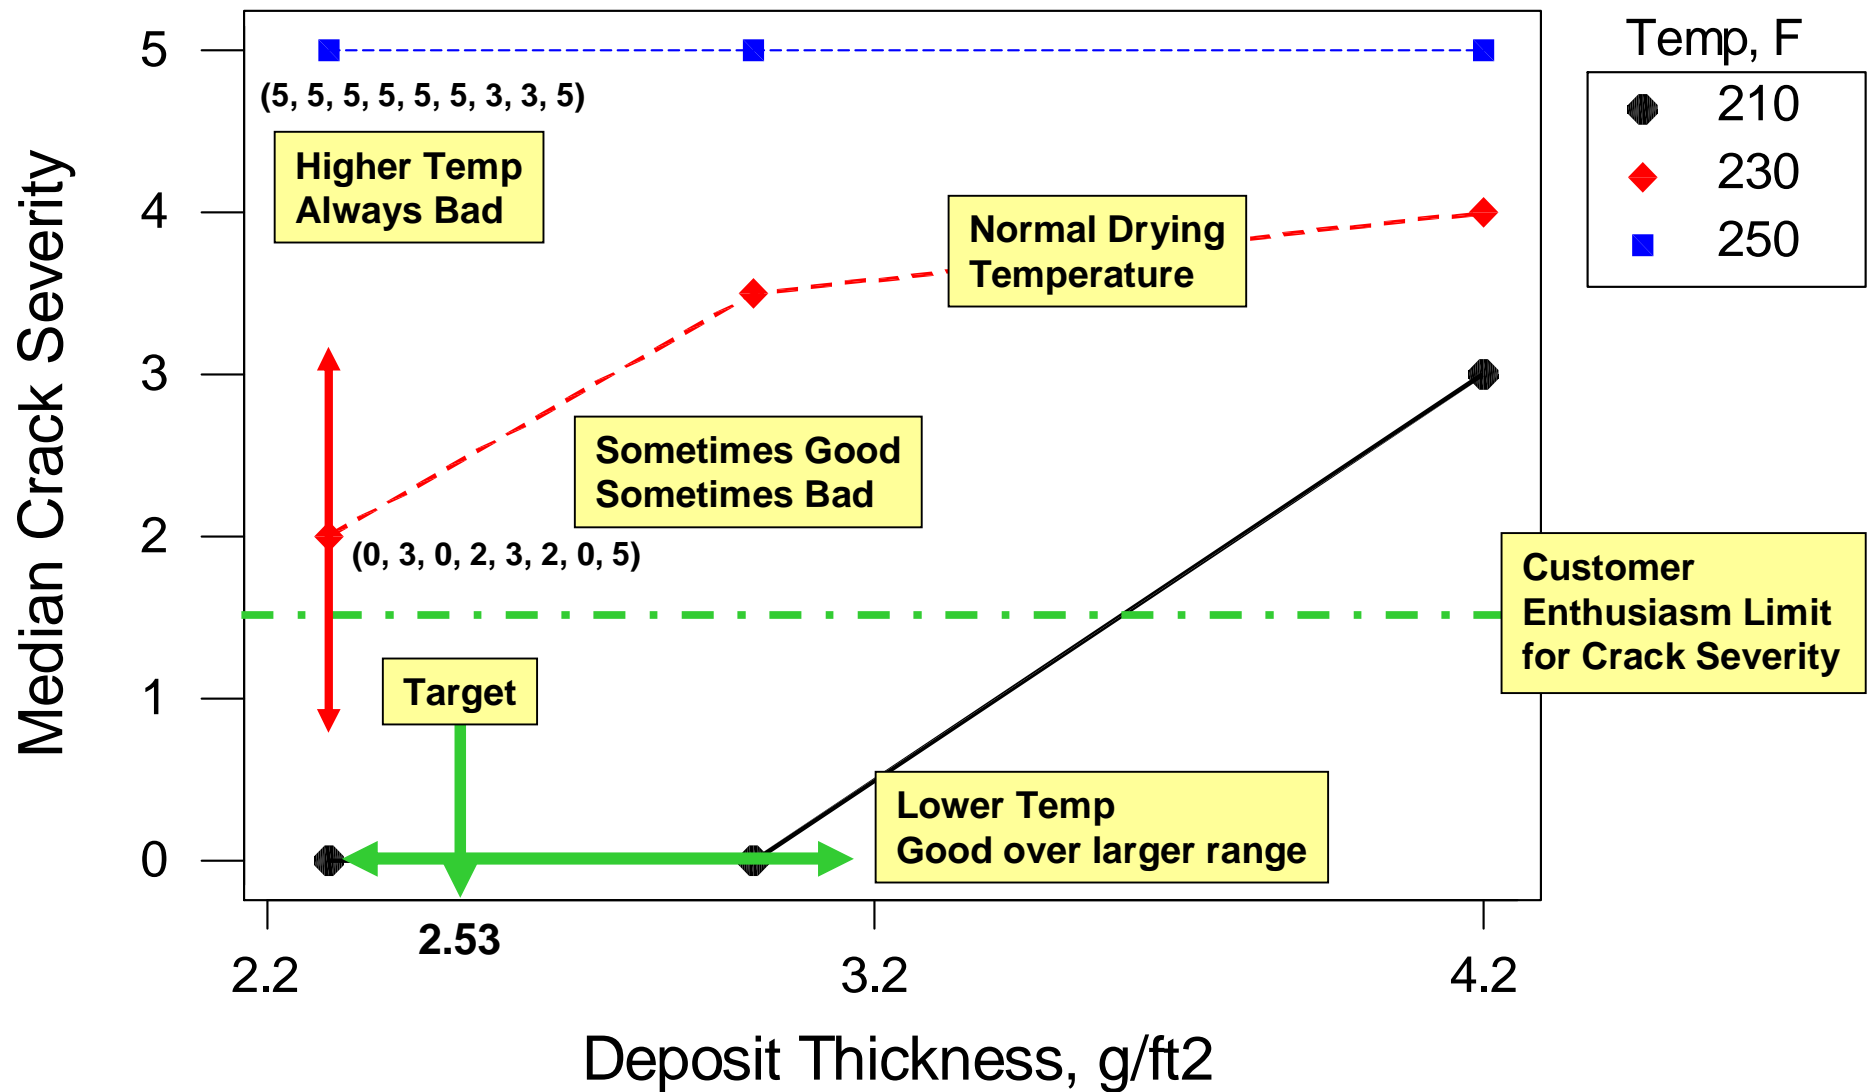
Sensitivity of Cracks to Oven Temperature & Thickness

Cracks follow a thick deposit. Can move it from side to side.

Strategy choice: thickness hard to control. Make insensitive by lowering drying temperature. Passes B vs. C. Green Y run chart confirms effectiveness.
