PROPERTY INSPECTION REPORT

Report #: WebNewrHmSample

Concerning: Could be your Newer Home, TX -
(Address of Inspected Property)

By: Rod Stewardson, #6291 12/02/2009
(Name and License Number of Inspector) (Date)

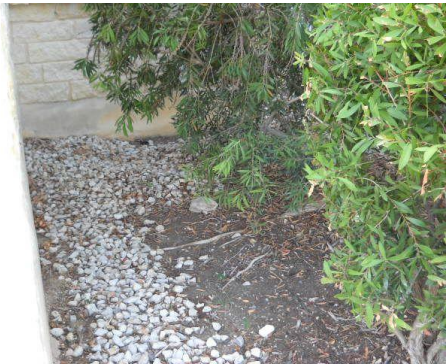
1. Soil grade and/or drainage patterns around some areas of the structure do not appear to properly direct water away from the structure/foundation. The grade should slope away from the structure at least 6" within the first 10' (3" in 5'). Lack of proper drainage can allow water intrusion in the structure and is a contributing factor to foundation movement. þ Front

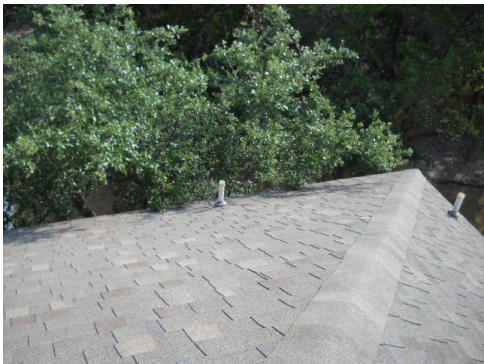
- **Recommend further evaluation/repair by Professional Roofing Contractor.**
 - Inspected from the roof where pitch and safety allow access. Not all areas of the roof were walked due to safety concerns.
1. þ Satellite dish ¨ Basketball net has been installed directly on to the roof covering. This condition can cause leaks around the attachment point. Recommend removing and installing in a more appropriate location.
 2. Tree branches are in contact (or are too close) with the roof. Recommend trimming tree branches back 3-5 feet to prevent roof damage. Right and left sides in places.

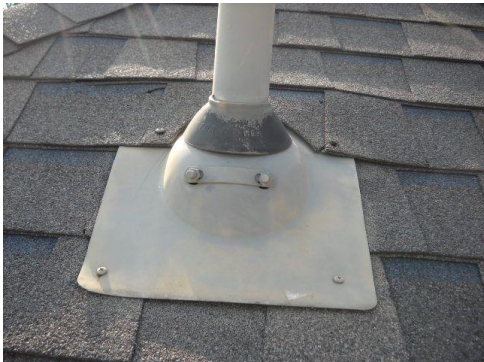
1. Roof (cap) shingles are not properly installed over the roof penetration flashing . Blowing rain can enter under the flashing without these shingles. Fasteners are installed over the shingles. Recommend proper shingles be installed. ☐ No evidence of current leakage noted in this area.

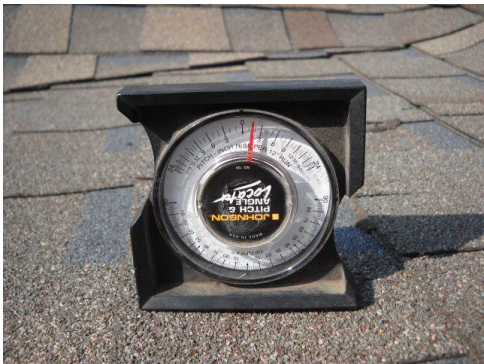
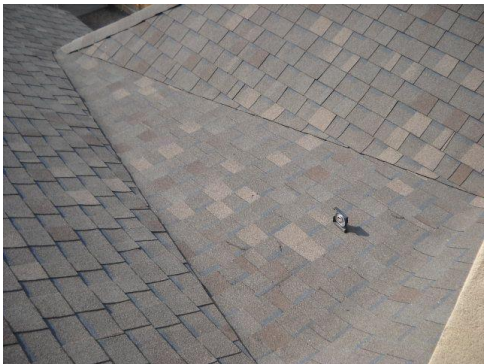
1. Shingle manufacture does not recommend that composition type shingles be installed on this low sloped roof. The minimum pitch for composition shingles is 2:12. Roof pitch is less than 2:12. Rolled type roofing is approved for this low slope. Increased **potential** for leakage. Valley behind chimney. Water staining is observed in the attic on the right side of the chimney chase.

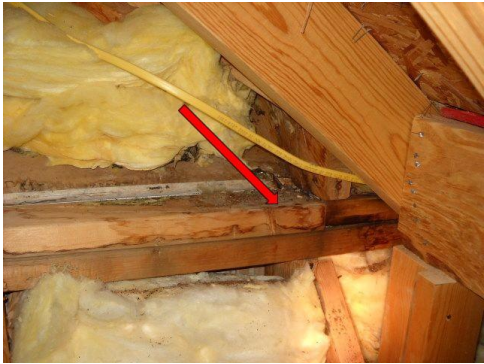
- Some areas of the attic were not accessible or inspected. Access was limited due to inadequate walkway, vaulted ceilings, deep insulation, ductwork, low clearances, etc. Attic viewed from mechanical access platform.
1. Evidence of moisture/water stains are visible at the roof decking and/or rafters adjacent to the Chimney roof penetration. No (average) moisture indications are present as measured with a moisture meter.

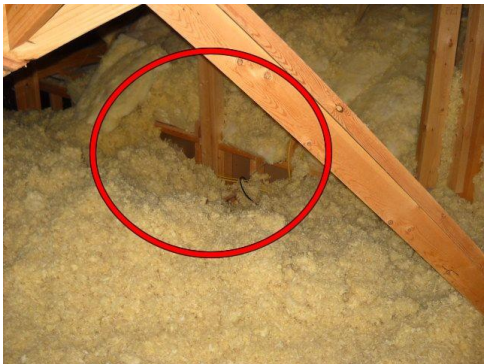
- 1. Areas of poor insulation coverage are present in areas of the attic. Entry way wall insulation should be spread out.

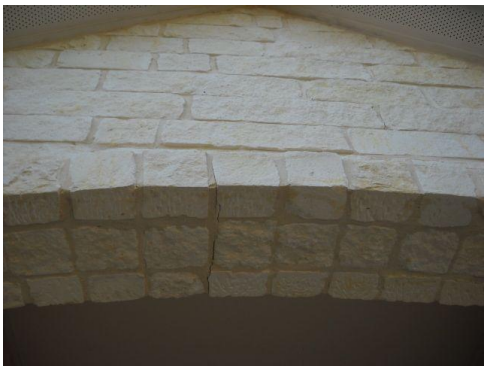
Exterior:
Note: Slight mortar crack in the entry way arch. Does not appear to be a significant structural concern at this time.

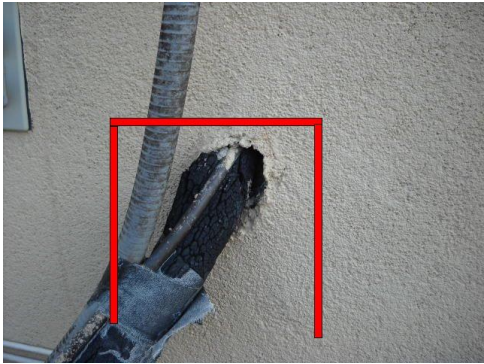
- 1. Hairline cracks are visible in the exterior stucco. All cracks should be sealed to prevent possible water intrusion. Isolated areas.
- 2. All exterior wall penetrations/openings (light fixtures, plumbing pipes, gas line wall penetration, electrical fixtures, HVAC plumbing penetrations, etc.) should be sealed to prevent moisture and air intrusion.
- 3. Sealed cover(s) should be installed at the exterior HVAC line transition to prevent water intrusion around the line.

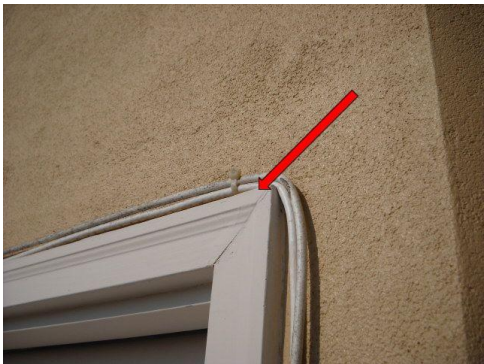
- Note: Exterior door frame is set directly into the wall with no protective flashing visible over the top of the door frame. Over time this installation can lead to door frame water damage. Master patio.

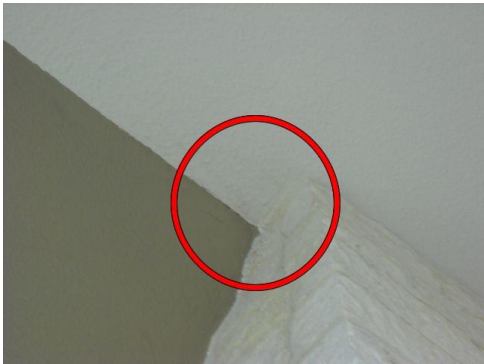
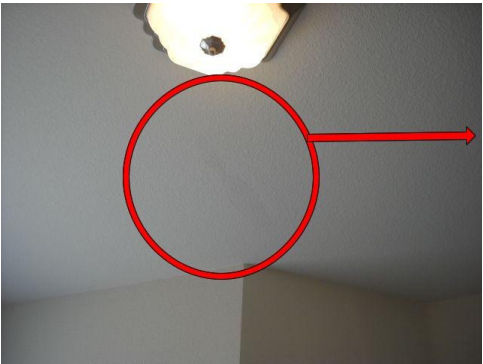
- Ceiling:**
1. Note: The ceiling is water stained. Rear side of fireplace stone, master bath (2 places). No (average) moisture indications are present as measured with a moisture meter.

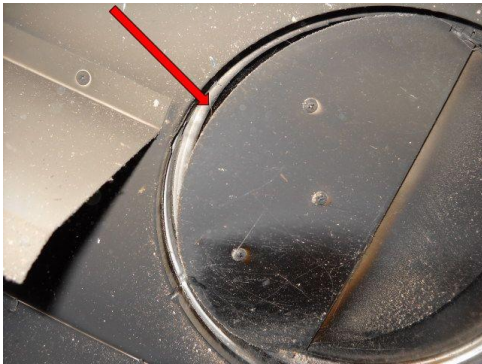
- It is recommend that cleaning and repair be performed by a Licensed Professional/Chimney Sweep who is a member of the Chimney Sweep Guild.**
1. Creosote build-up is present in the chimney flue. This is considered to be a **Fire Safety Hazard**.
 2. Flue damper does not close fully.

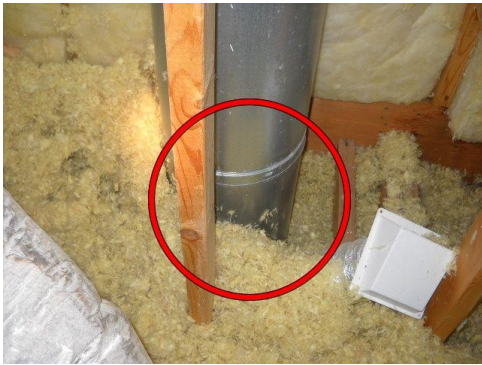
1. The chimney flue pipe is in contact with attic insulation. The placard on the flue pipe states that an airspace should be maintained between insulation and building materials.

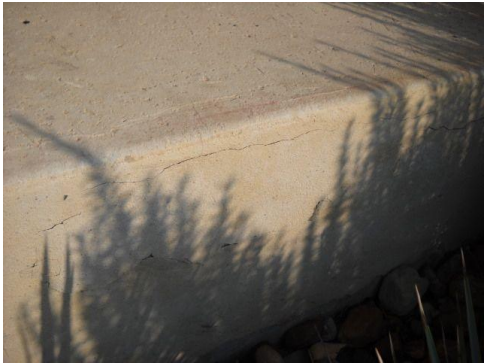
- Cracking in the rear concrete patio appears to be the result of shallow rebar. Cracking does not appear to pose a significant structural concern at this time.

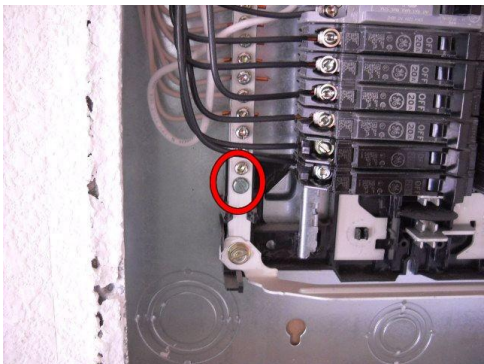
- Sub-panel(s)**
1. Arc-fault circuit interrupting devices are not installed protecting the electrical circuits of family rooms, dining rooms, living rooms, parlors, libraries, dens, bedrooms, sunroom's, recreations rooms, closets, hallways, or similar rooms or areas. (TREC Standard reporting). ⌋ Not required when house was built.
 2. Arc Fault Circuit breaker(s) installed are not the proper "Combination" type breaker. ⌋ Not required when house was built.
 3. The Ground and neutrals on the same bus bar (typically found in older homes). Today's higher electrical standards do not allow the grounds and neutrals to be connected to the same bus bar. A **Green** bonding screw/strap/wire is installed in the sub-panel. The sub-panel should not be bonded.

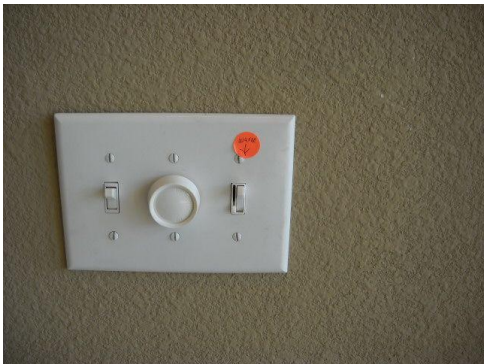
- 3. GFCI protected receptacles are not installed in accordance with **today's standards**.
- 4. Exterior outlet cover is missing. Rear porch.
- 5. Receptacle outlets for kitchen counter surfaces should be spaced so that no point is greater that 24" (2ft./ 4ft.rule). All counter spaces greater than 12" requires a receptacle. No receptacle, left side of sink.
- 6. Living area light switch/ rheostat is very warm. Rheostat may be defective. Recommend replacement.

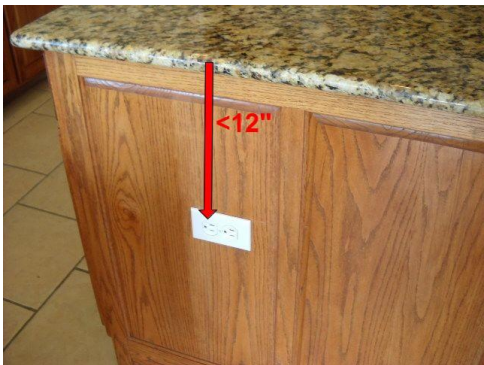
- 1. Some light fixtures and/or bulbs are missing or do not function. Recommend installing new bulbs to see if the fixtures are functional. Shared bath, Kitchen under counter lights.
- 2. Some ceiling fan(s) are inoperative, Left side bedroom.
- 3. The island/peninsula receptacle(s) are improperly installed. An island/peninsula requires outlets located **no more that 12" below the counter top**. The counter-top overhang cannot be more than 6".

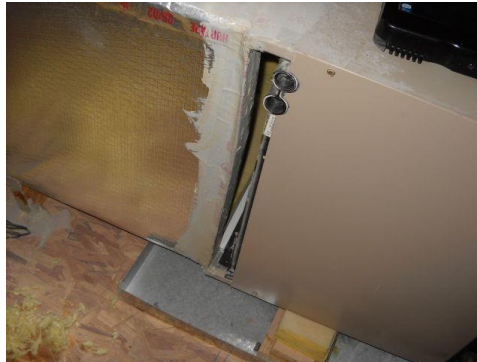
1. The drain pan needs cleaning. Recommend removing insulation and other debris to prevent possible clogging of the drain pan drain line if condensate forms in the pan.
2. Cover is missing at the plenum connection. Unit has been sucking unfiltered air. Coils are dirty.

Recommend cleaning, complete service check and further evaluation by a Licensed HVAC technician.

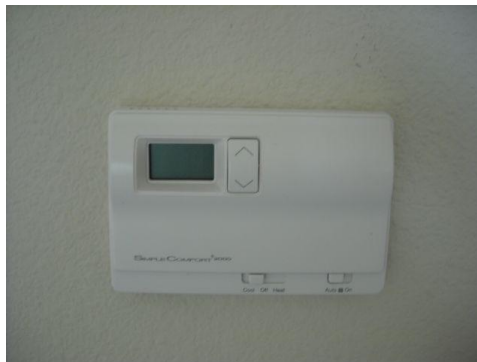
Unit #2 Right unit:

1. No indication at thermostat. Unit operates.

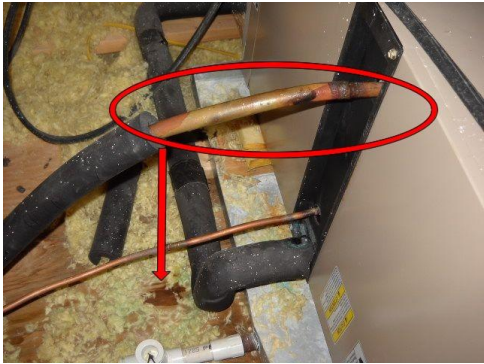
1. Suction line (large line to the air conditioning condenser) insulation covering should be sealed so that the line will be completely insulated at the unit connection. Exposed suction lines develop condensation during operation and drip which can cause water damage. **Water is dripping onto attic decking.**

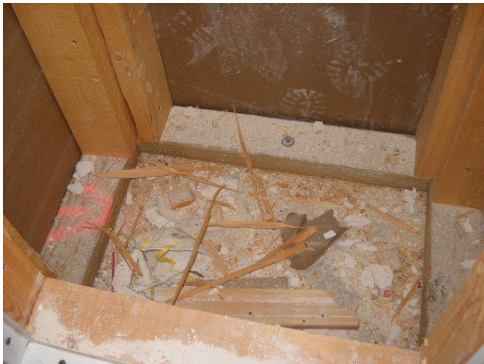
1. HVAC ceiling air vents are dirty. Dirty vents are an indication of possible dirty ducts.
2. The return air duct opening in the hallway is dirty. Recommend a thorough cleaning of this area. Left, right.

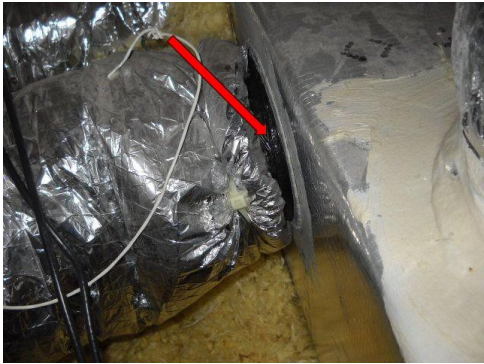
Unit #1 Left unit:

1. Air leakage is present (at the conditioned air side of the plenum). The plenum should be properly sealed with UL-181 Foil Tape or Mastic.
2. Duct connection mastic has not been applied at ducts connections and air is leaking. Recommend completely sealing duct connections to prevent loss of conditioned air. Typical of this age home.

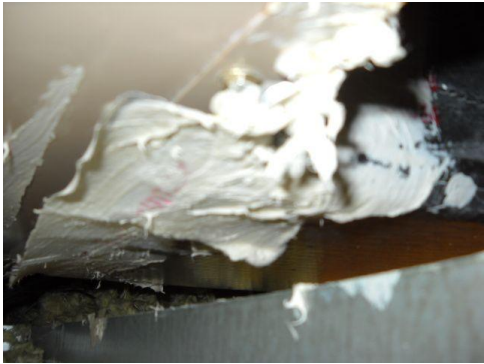
Unit #2 Right unit:

1. Air leakage is present (at the conditioned air side of the plenum). The plenum should be properly sealed with UL-181 Foil Tape or Mastic.

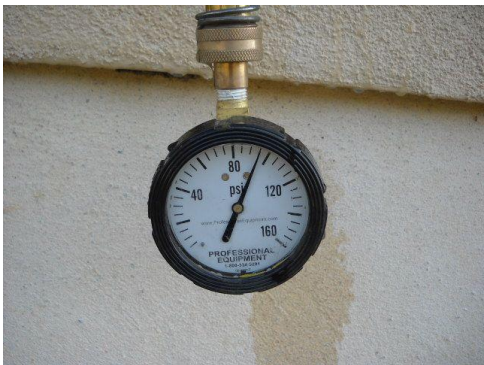
1. Exterior hose bibb vacuum breakers are not installed on one or more exterior faucets. Vacuum breakers prevents possible cross contamination of the potable water supply system due to negative pressure in the water supply lines. This finding is typical in older homes. Vacuum breakers are inexpensive to purchase and easy to install. **TREC SOP.**
2. Water pressure is higher than the normal 40-80 psi. Pressure was measured at an exterior hose bibb at **95 psi**. Pressure reducing valve should be installed in the main water line to bring water pressure into acceptable limits. **Recommend further inspection and repair by a reputable Licensed Plumber. Current standards also requires the installation of an expansion tank on the water heater when a Pressure Reducing Valve (PRV) is installed.**

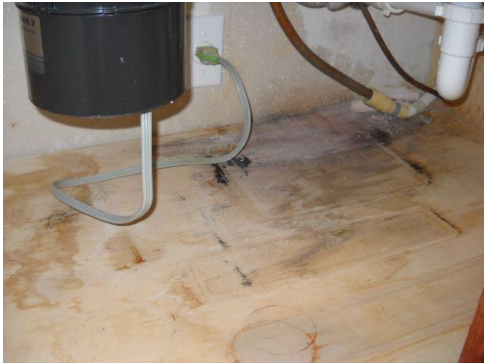
Kitchen Sink:

- Signs of previous leakage are present in the Kitchen under sink cabinet. There is no moisture indication at this time (confirmed with a moisture meter).

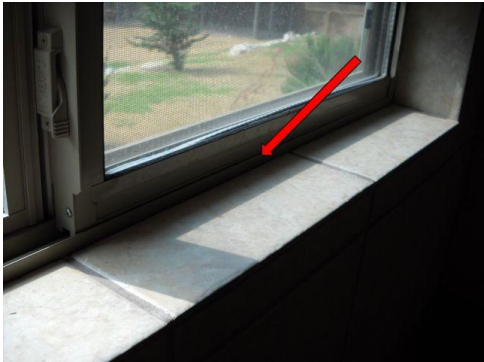
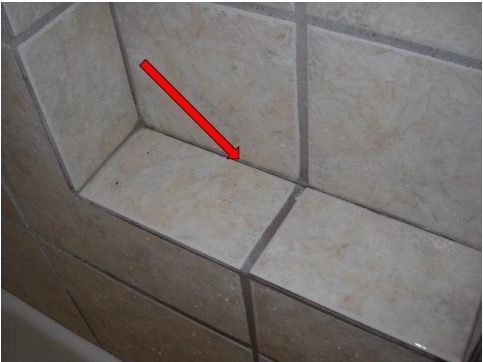
Left Shared Bath

- 1. Bath sink is slow to drain.
- 2. Sealant or grout is needed in areas around the tub/shower enclosure. Cracks in the sealant or tile grout can lead to water intrusion behind the wall. Especially at shower/tub window and soap holder inset.

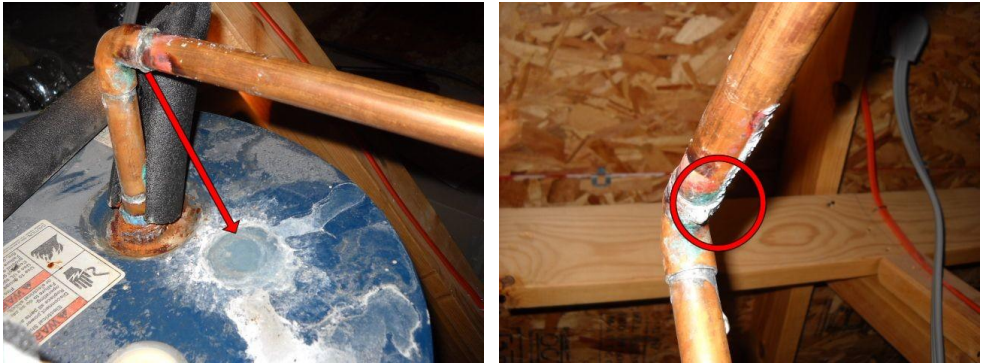
- 1. Water is leaking (slight) at the sweat fitting.

Recommend further inspection and repair by a reputable, Licensed Plumber.

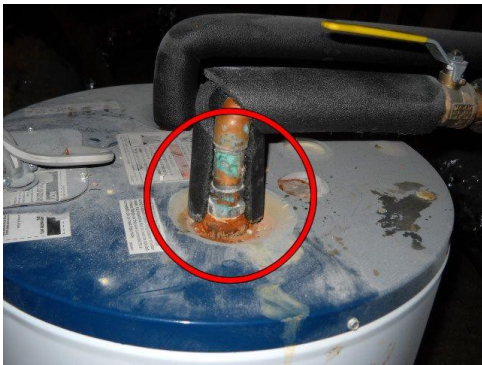
Left Attic Water Heater:

- 1. Corrosion is present at the plumbing line connections. Corrosion is an indication of a slight leak that has sealed itself over a period of time.

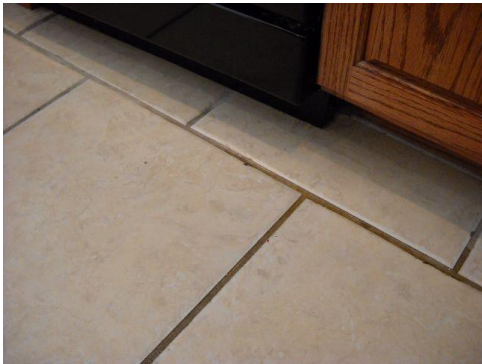
- 1. The dishwasher is not properly secured to the cabinet.
- 2. Drain connection may be the sound of the moisture under the sink. Recommend monitoring.
- 3. Rack rollers are missing (one or more).
- 4. Water is present on the floor in front of the unit. Recommend determining sources of leak.

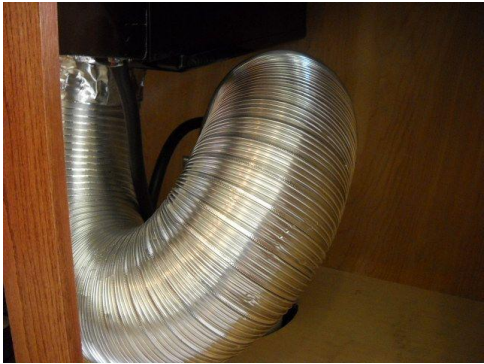
- C. Range Exhaust Vent - Comments**
- Downdraft: Jennair type (vented to the exterior).
1. The manufacture recommends that the downdraft duct pipe (under counter) be made of smooth metal ducting to prevent grease buildup in the duct.

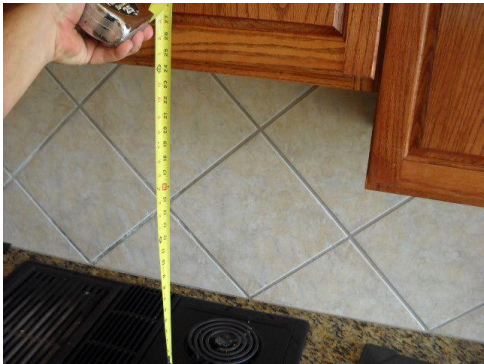
- D. Ranges, Cooktops, and Ovens - Comments**
- Oven tested at 350° Acceptable at: 350°
- Cook-top:**
1. Combustible cabinetry has been installed too close over the cooking surface. Manufactures installation instructions require at least 30" of clearance unless special non-combustible material is installed.

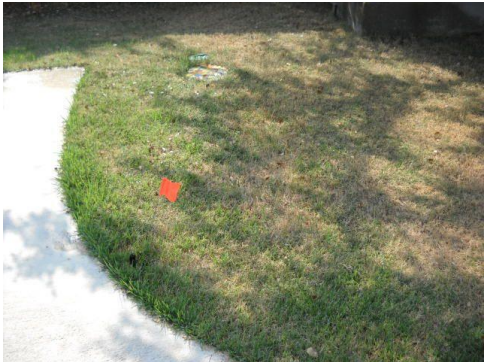
1. The sprinkler system spray heads should be adjusted/relocated so they do not directly spray onto the structure (doors and windows in particular), mechanical/electrical systems, pool equipment, porches/decks/sidewalks, etc. Allowing the sprinkler system to continuously spray on these areas can cause damage to the structure or equipment. **Numerous spray heads.**
2. Some spray heads are inoperative. They may be clogged or intentionally "shut off." Zone #4, left side yard.

Recommend further evaluation by an Irrigation Specialist.
