Engineering Assessment of Two Cylinders Observed at Douma -
Executive Summary

FINAL FOR INTERNAL REVIEW
Expanded Rev 1-27 February 2024

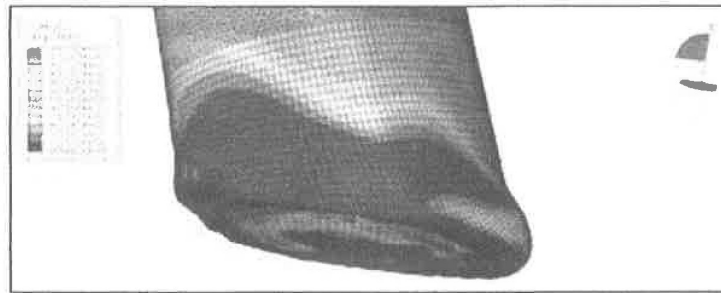
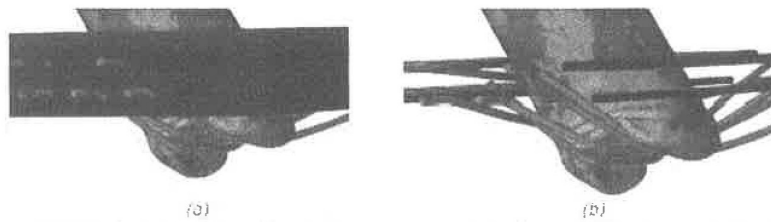
22. As mentioned above, the predicted cylinder deformation was not consistent with that observed on the cylinder observed at the scene at Location 2. The results predicted from the simulation were more consistent with images of deformed cylinders from earlier incidents of cylinders allegedly delivered from helicopters in the Syrian Arab Republic.

Figure 26: Final frame simulation of the impact of a vessel with an initial velocity of 100m/s.
(a) complete model and (b) visualization without concrete

Figures 1 & 2 (above): Predicted deformation; initial and final computational analysis

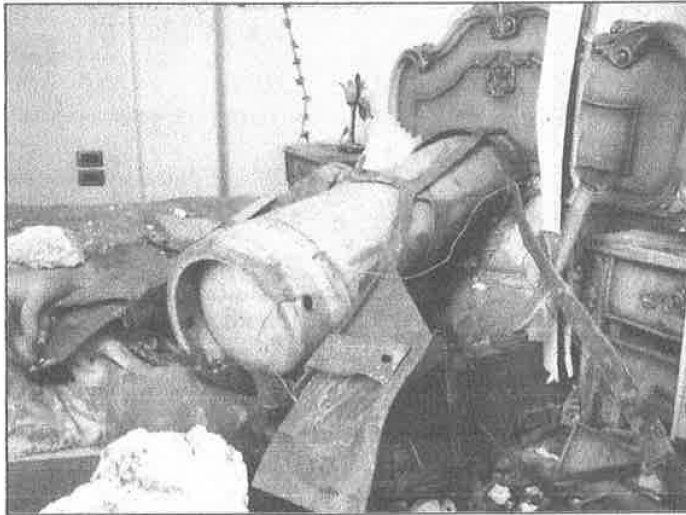
29. Examination of the cylinder, including paintwork, condition of the metal surfaces, and the mild steel attachments, indicated a significant degree of degradation (corrosion) as a result of weathering in the areas that had been damaged through impact. Whilst it may be speculative to consider it unlikely that an old, rusty, already-damaged cylinder would be deployed from an aircraft; the cylinder showed appearance of having spent some post-damage time being exposed to the elements, and would most likely not have degraded to such an extent in the case of it being inside the bedroom.

Figure 8: Cylinder at Location 4 ORW Sensmve
circulate

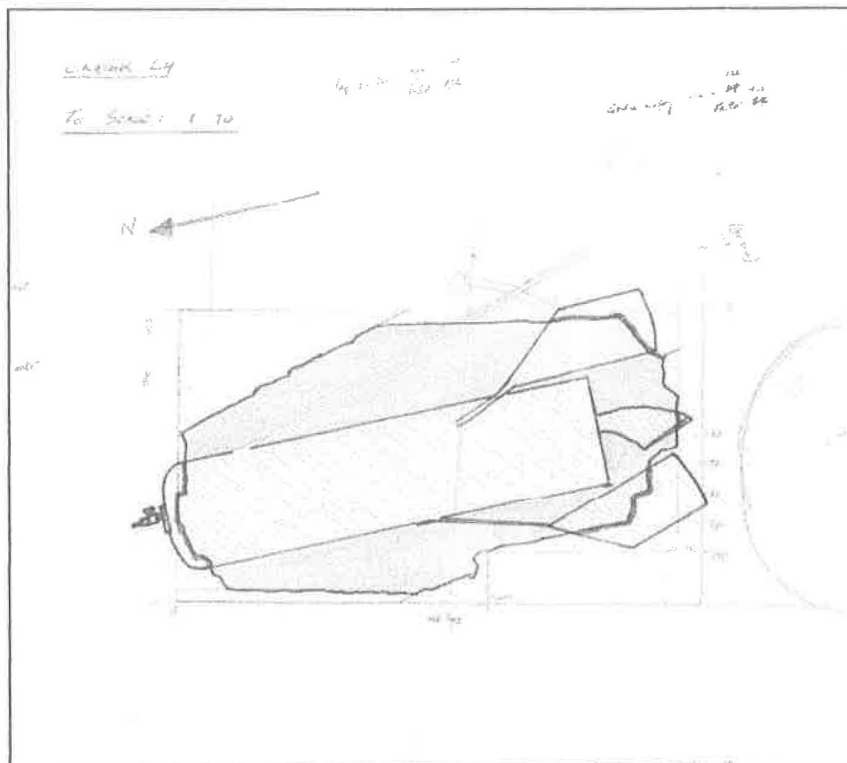
27. In the scaled dimensional analysis on the Location 4 cylinder, pre- and post-deformation, compared with the crater in the roof, it was not possible to establish a set of circumstances where the postdeformation cylinder could fit through the crater with the valve still intact (whether or not an endcap was assumed to have been fitted at the front end of the cylinder), and the fins deformed in the manner observed. The observed deformation of the cylinder and direction of apparent inertial deformation of attachments, were clearly consistent with a cylinder having impacted in a flat configuration on a horizontal surface, and not that of a cylinder having penetrated through a crater.

Figure 9: Location 4 cylinder post-impact superimposed onto crater (baseline configuration, for illustrative purposes). Sketch from a scaled drawing

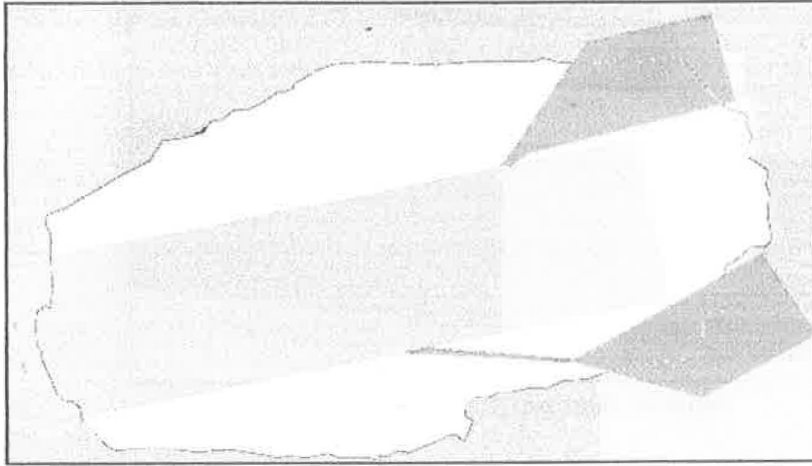
Figure 10: Location 4 cylinder post-impact superimposed onto crater, from dimensional model Sensitive
