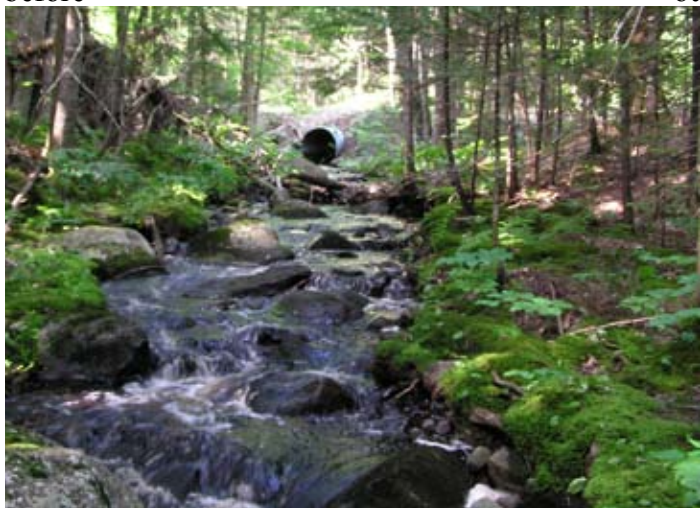
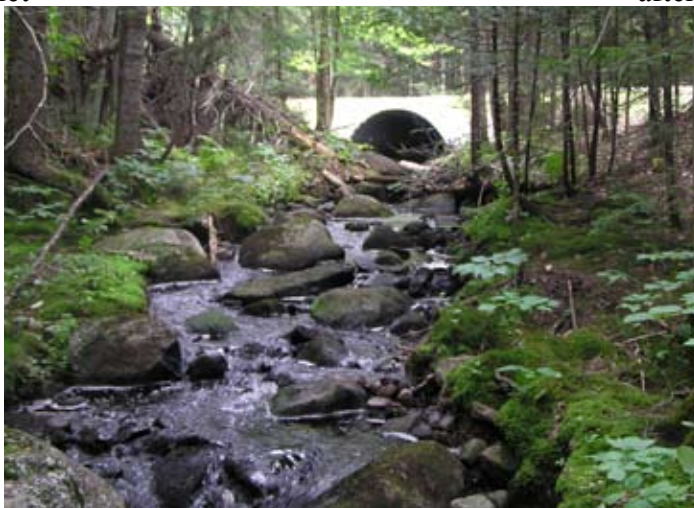
2006-025

before

outlet

after

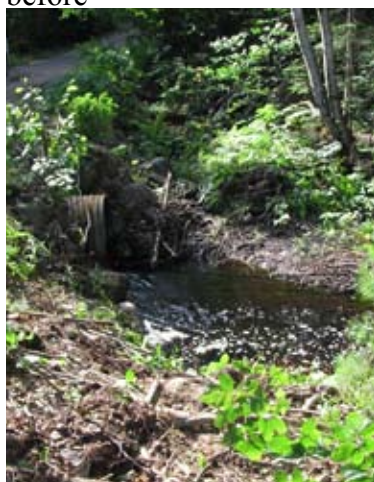
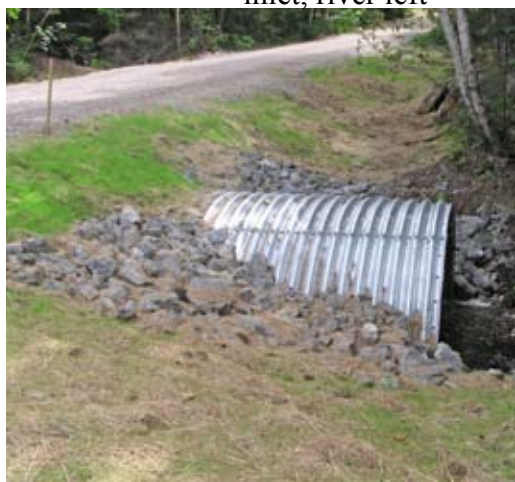
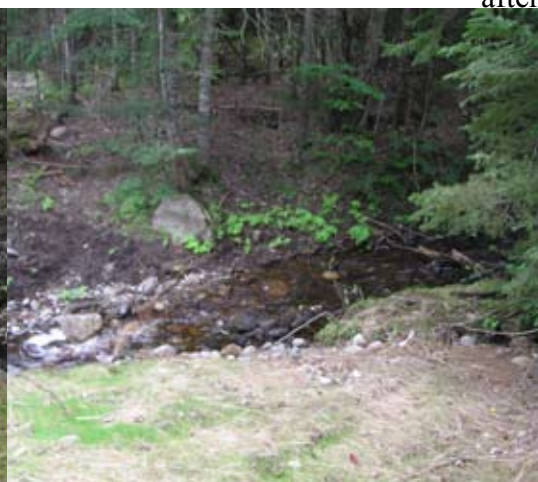
before

inlet, river left

after

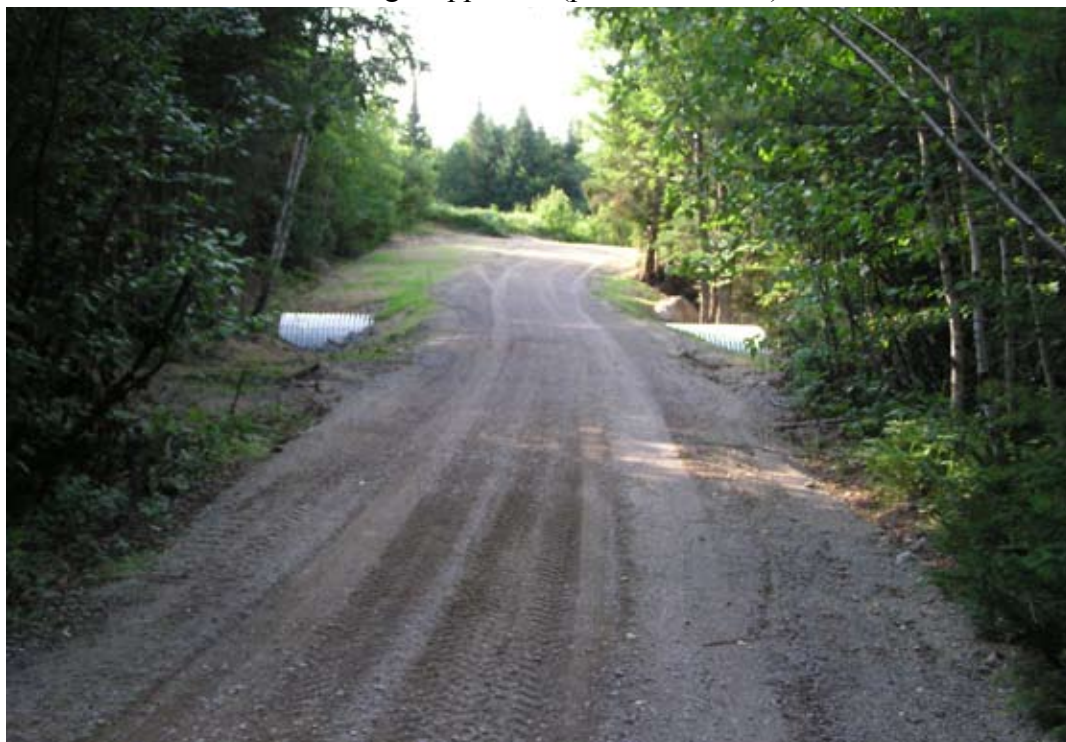
river right approach (post-restoration)

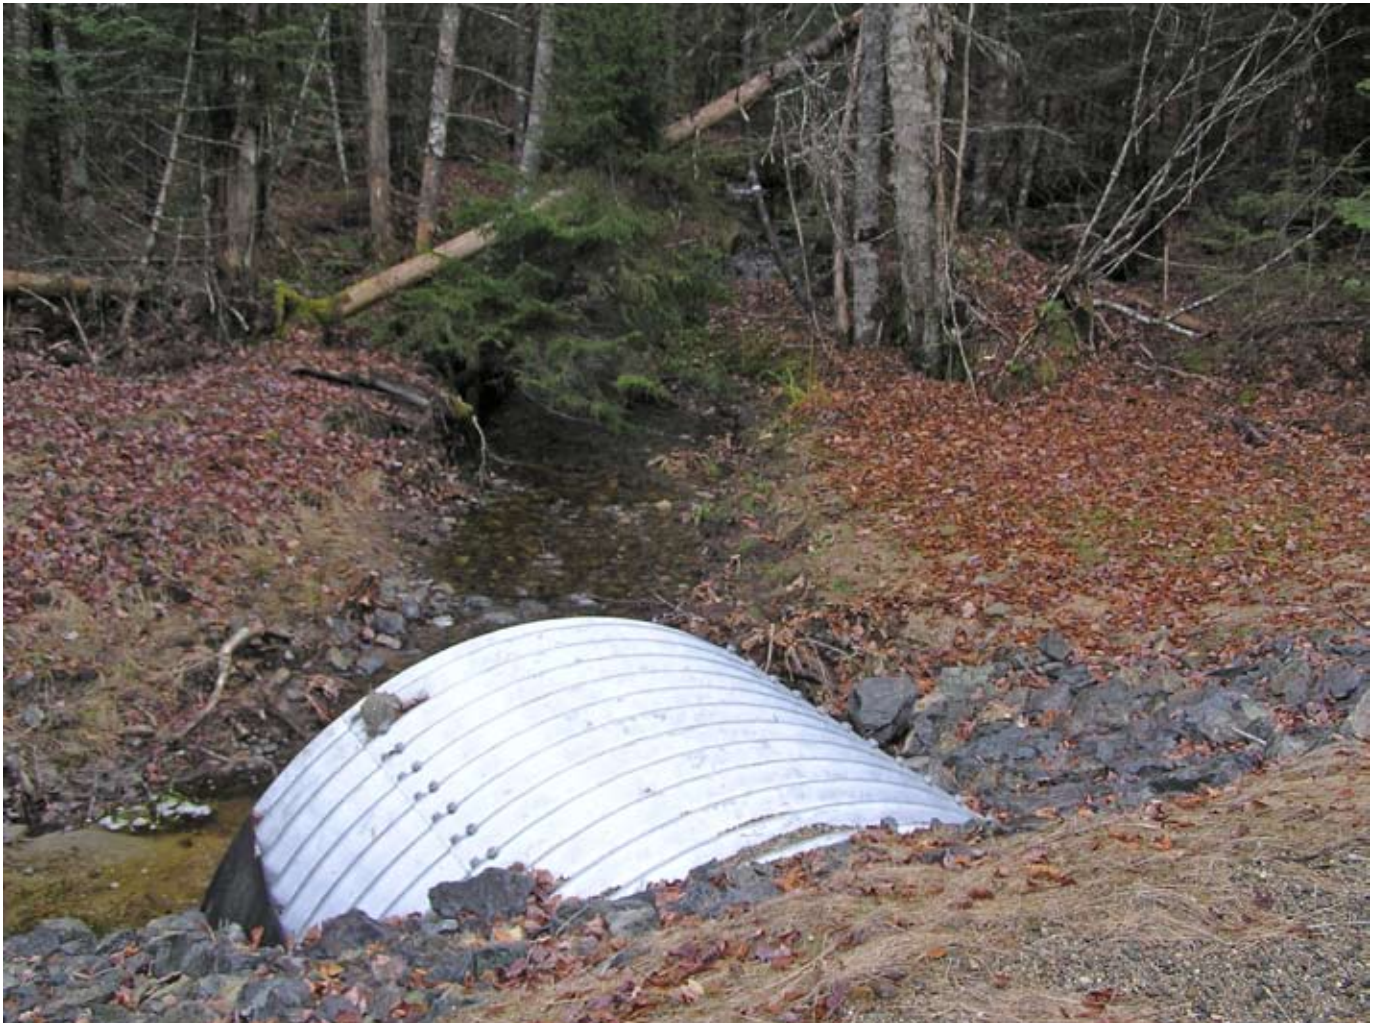
looking upstream from road

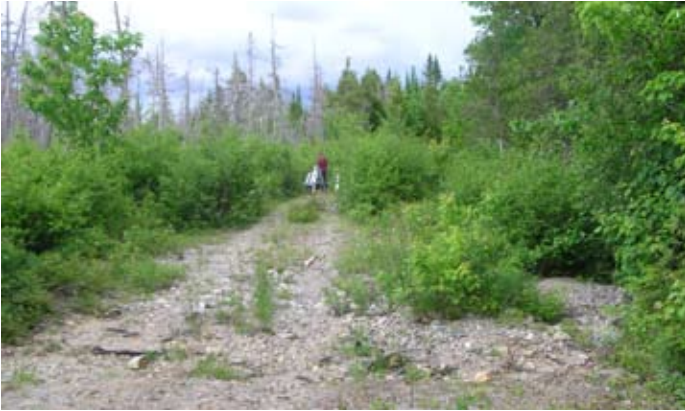
2006-041

river right approach (pre-restoration)

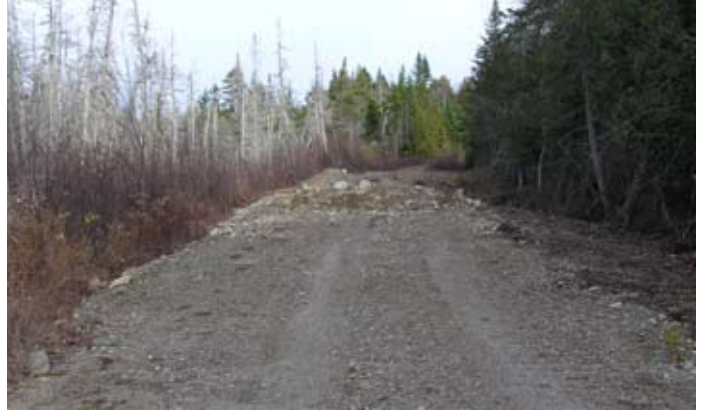
river right approach (post-restoration)

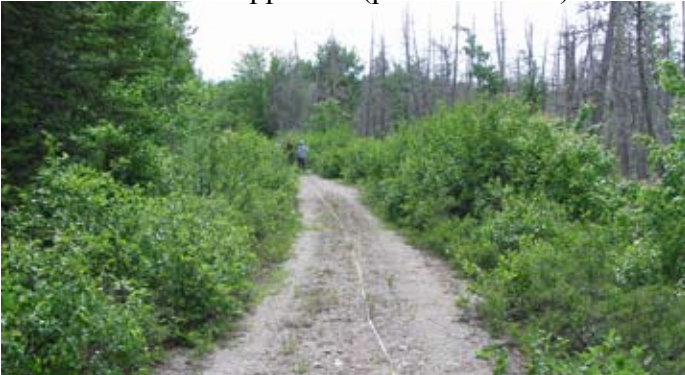
river left approach (pre-restoration)

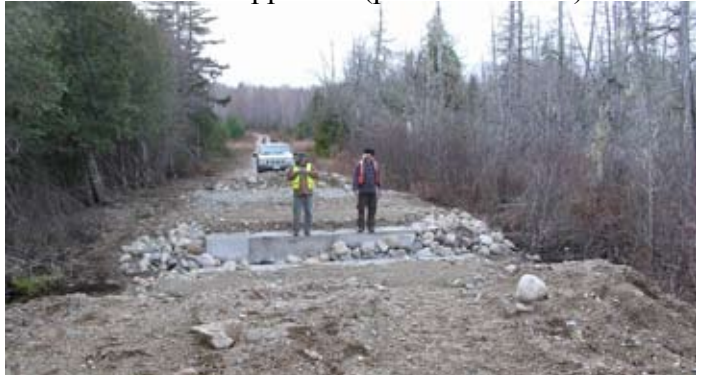
river left approach (post-restoration)

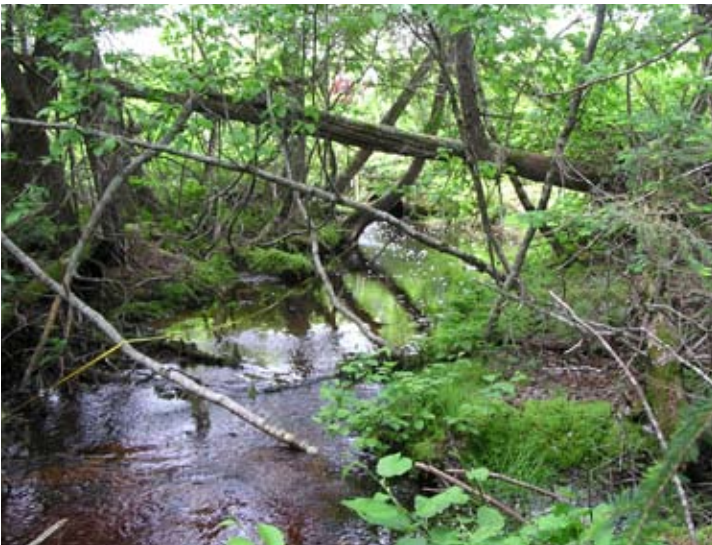
outlet (pre-restoration)

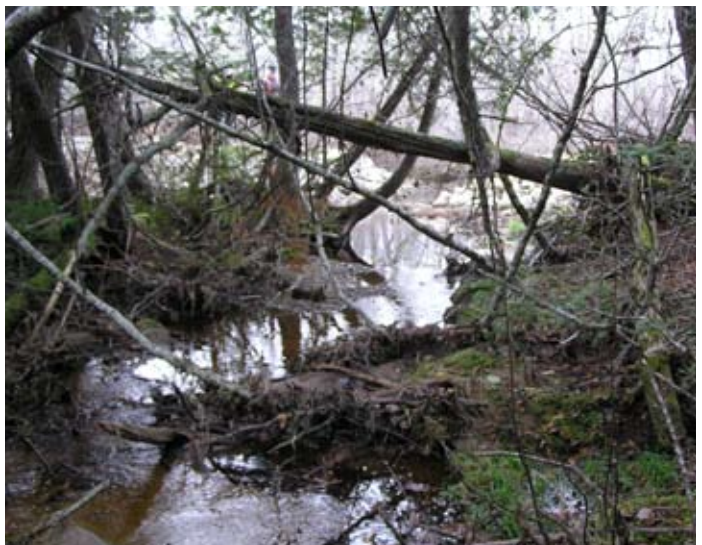
outlet (post-restoration)

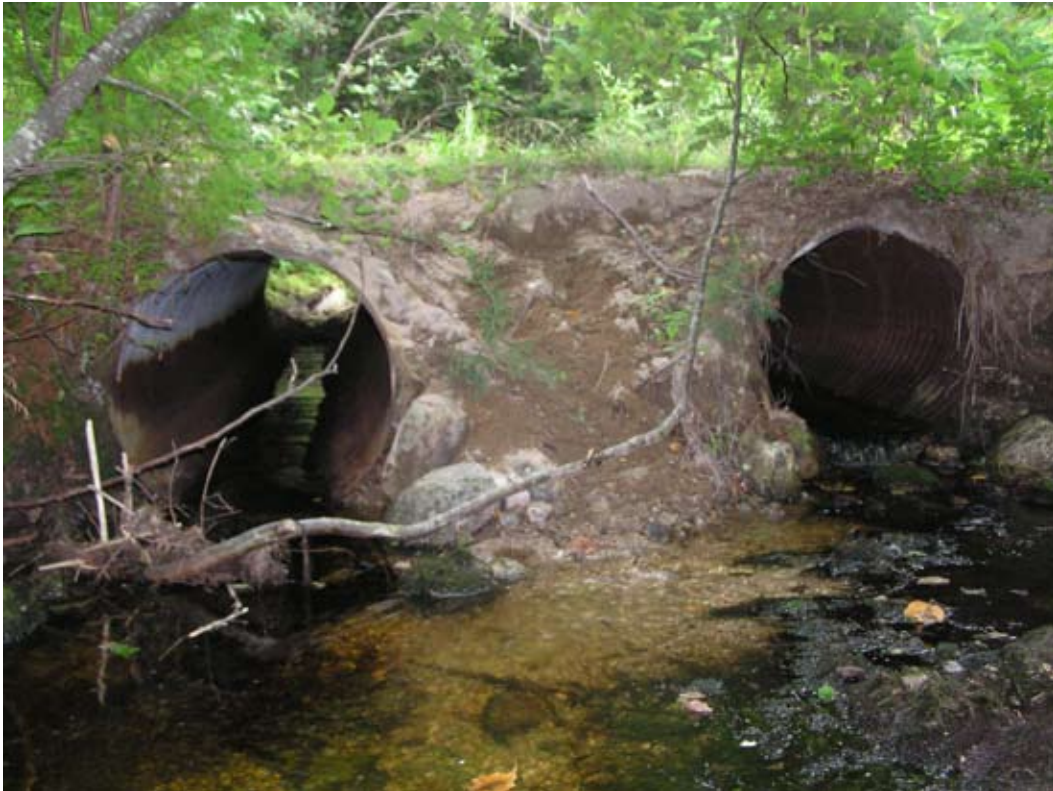
2007-177

Outlet, pre-restoration (post-restoration pictures will be taken this spring)

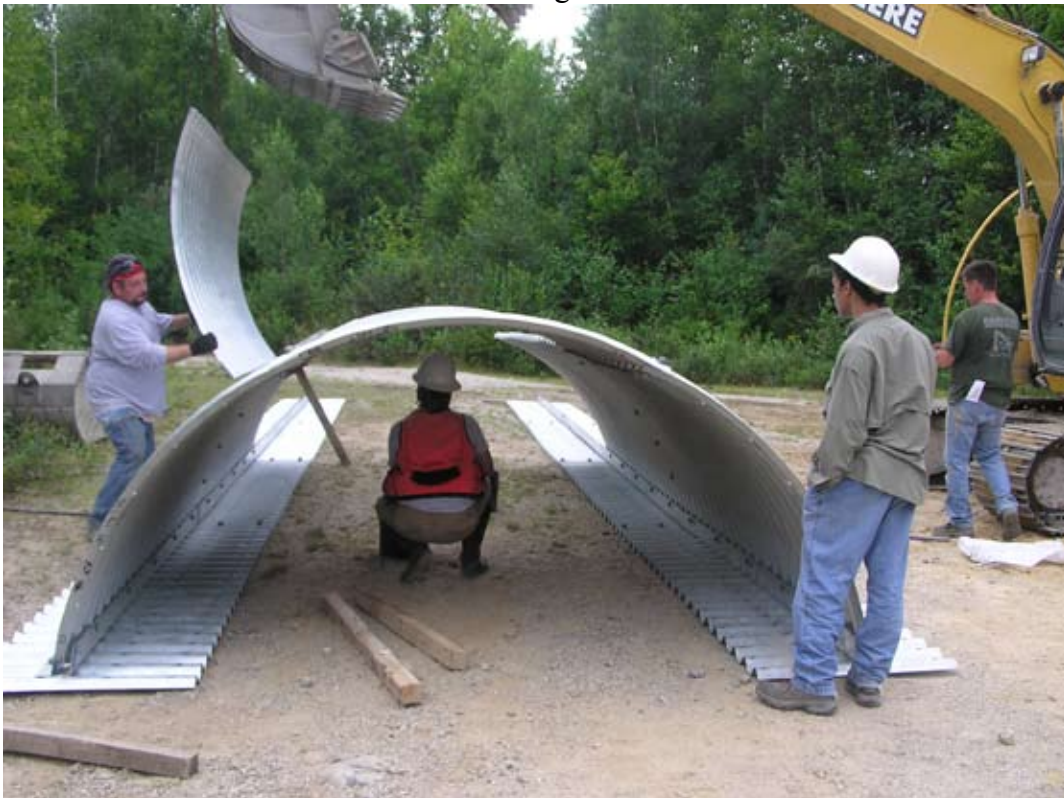
arch culvert being assembled

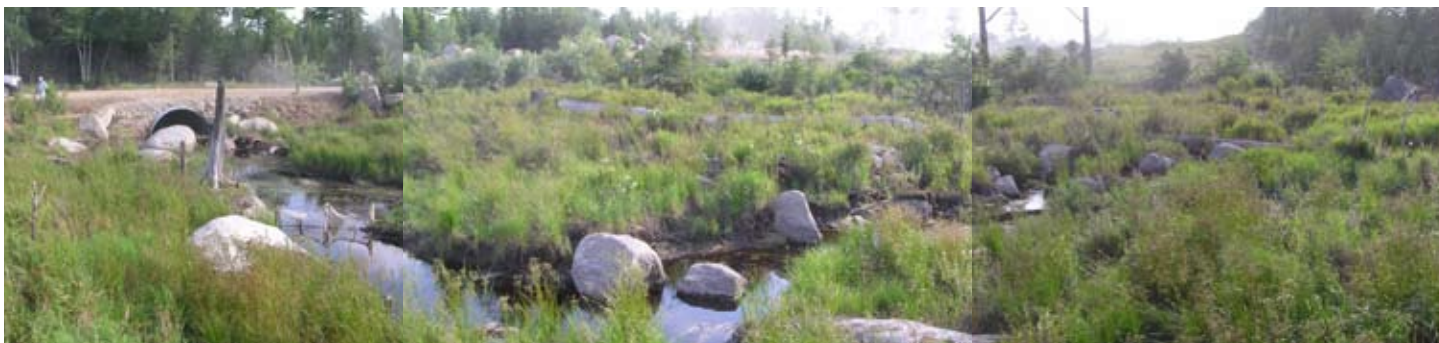
View of inlet and associated meadow pre- and post- restoration.

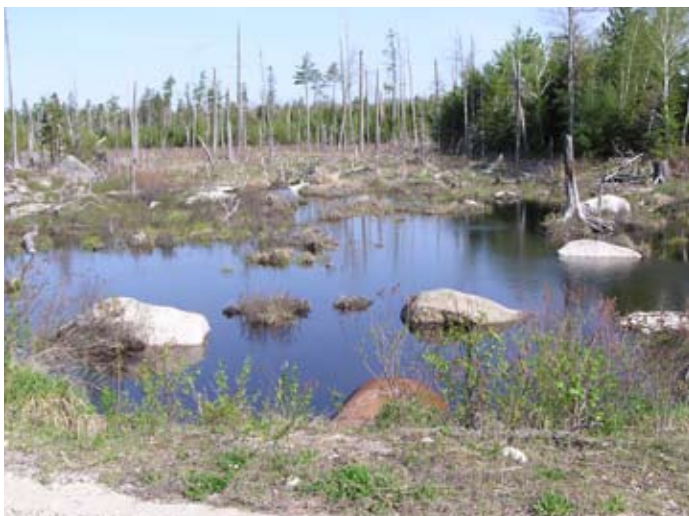
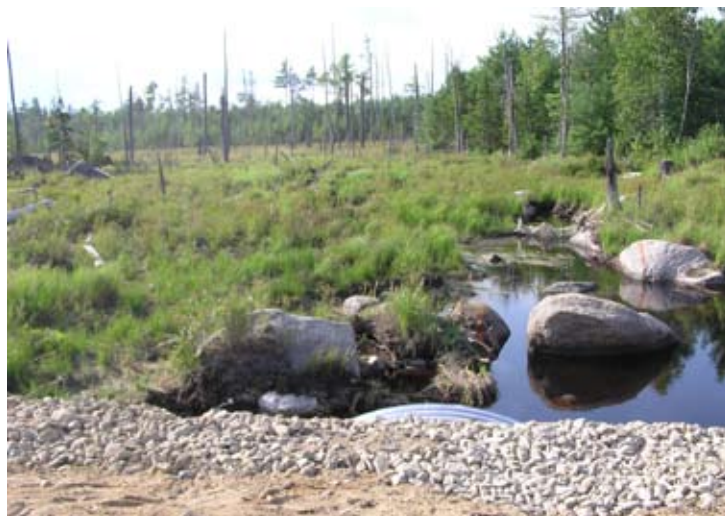
looking upstream pre- and post- restoration

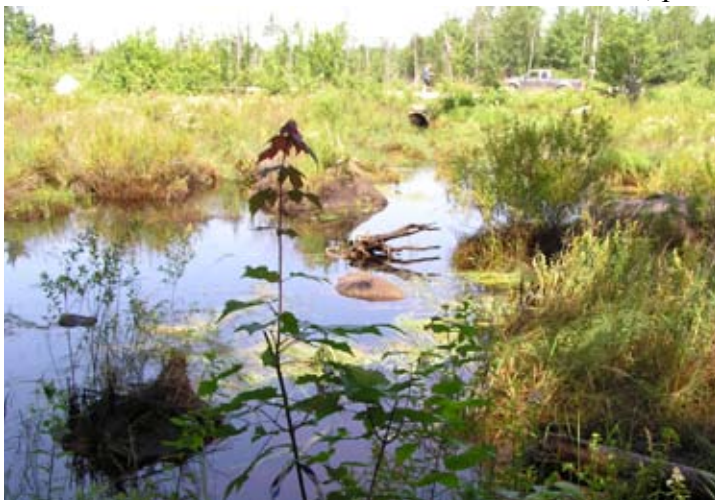
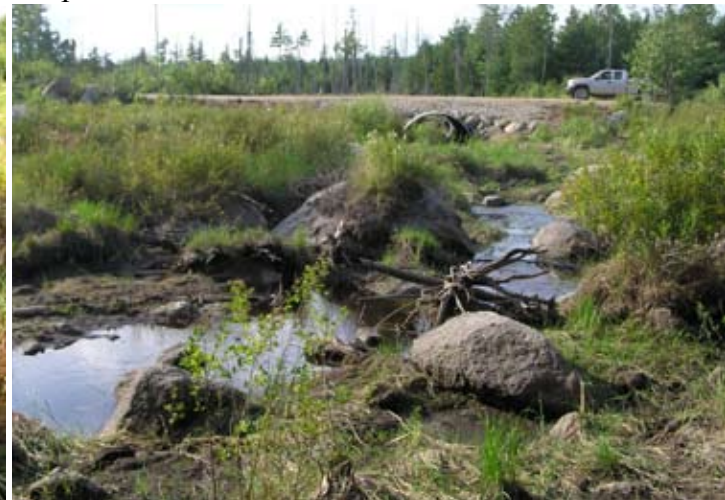
View of outlet, pre- and post- restoration

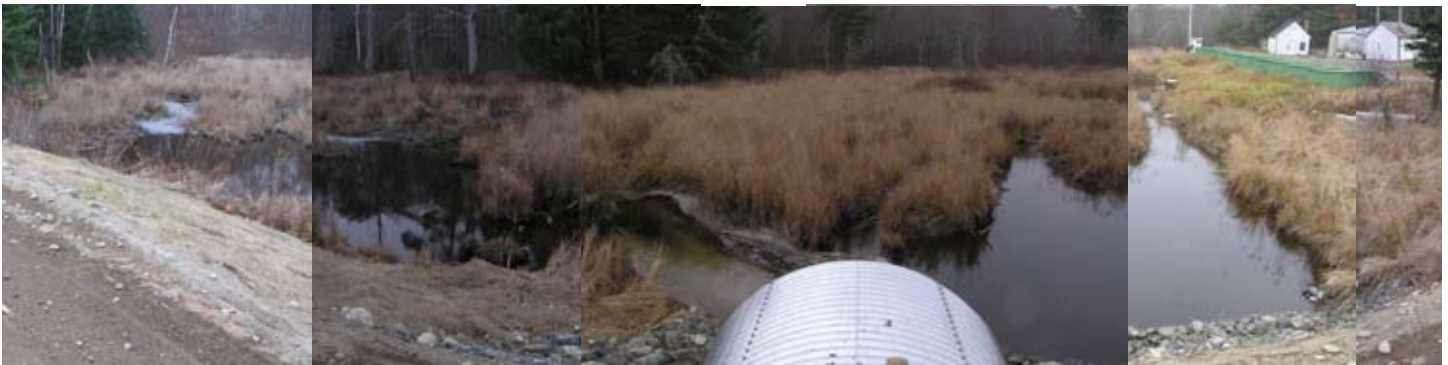
looking downstream (post-restoration of crossing)

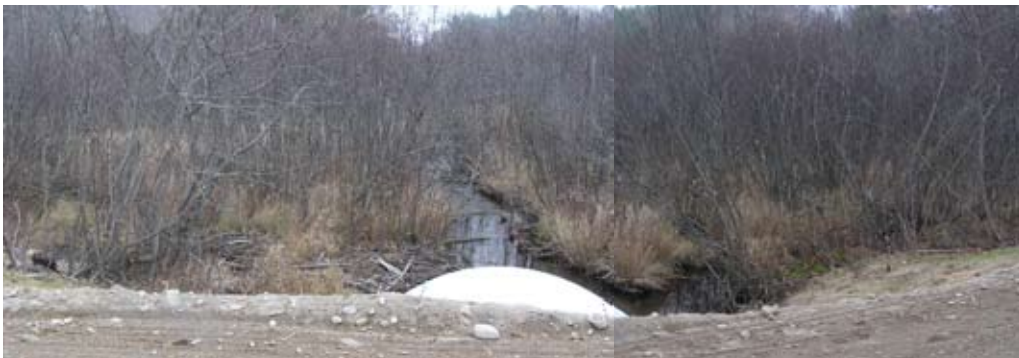
looking upstream (post restoration)

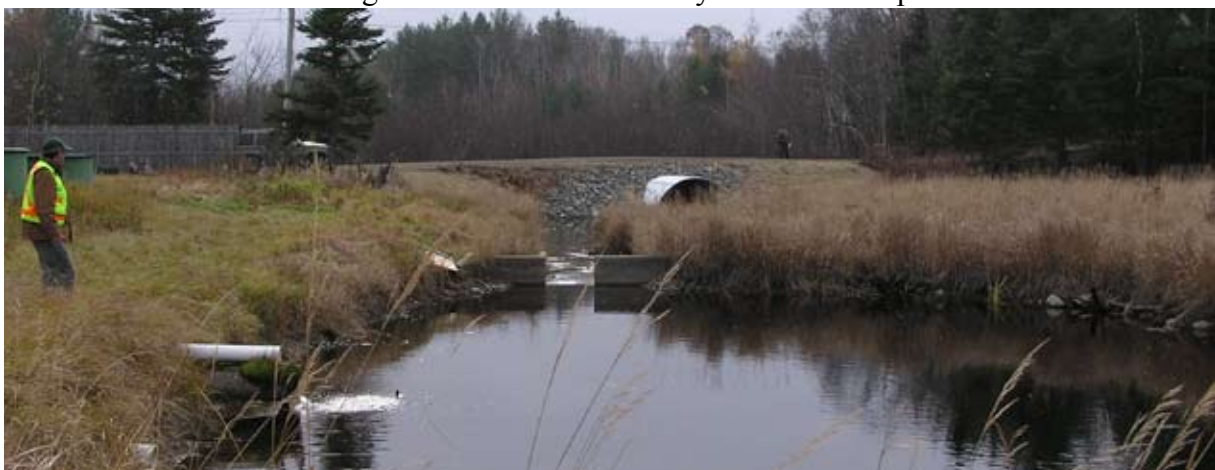
Looking at inlet from old hatchery water control pool

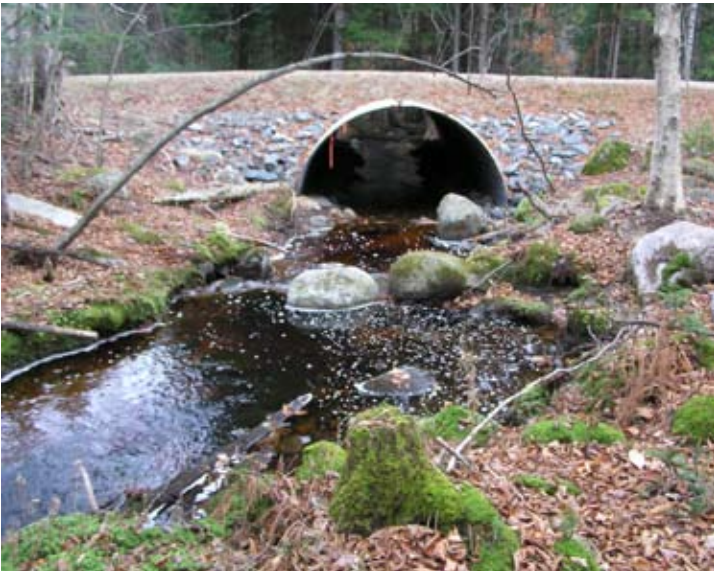
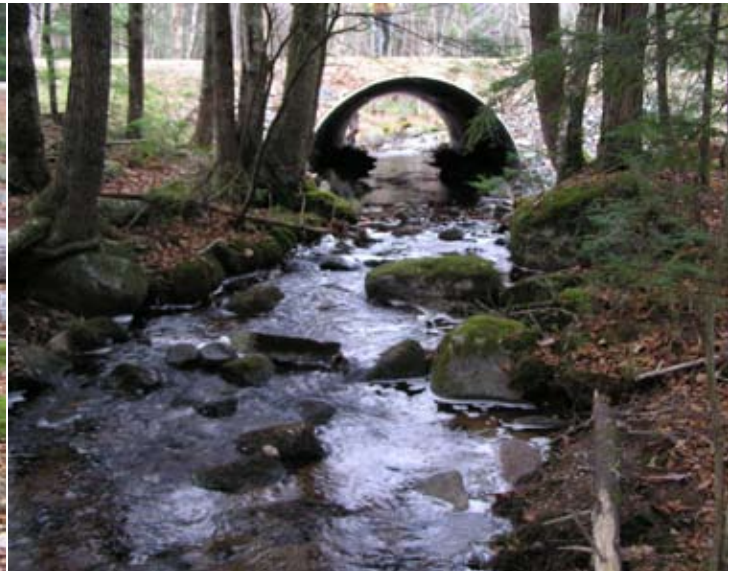
inlet and outlet, post-restoration

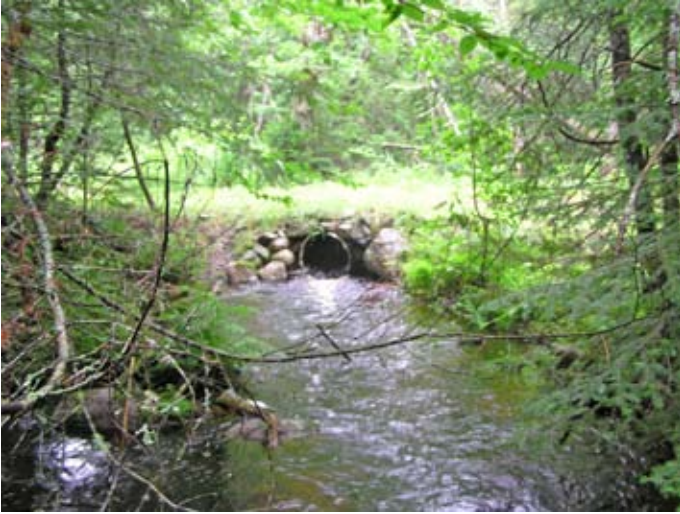
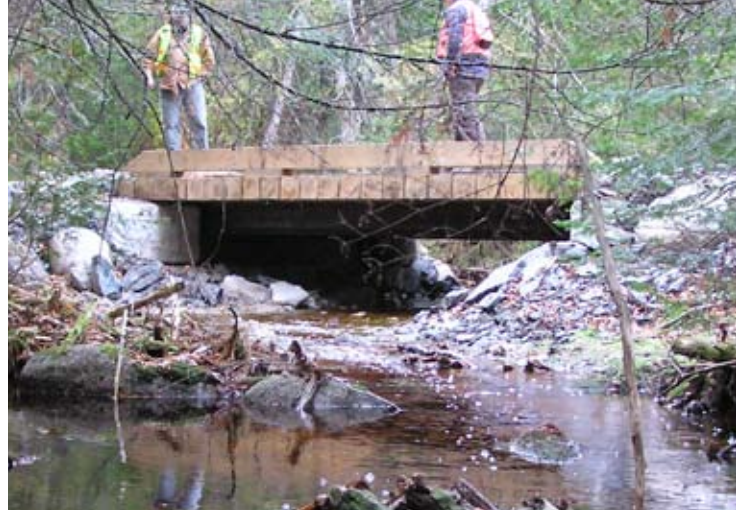
Hayes Brook

outlet, pre- and post-restoration

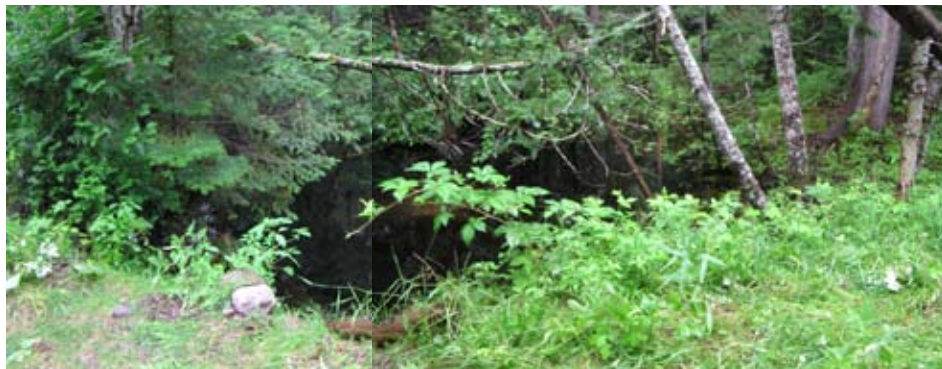
river left approach,
post-restoration

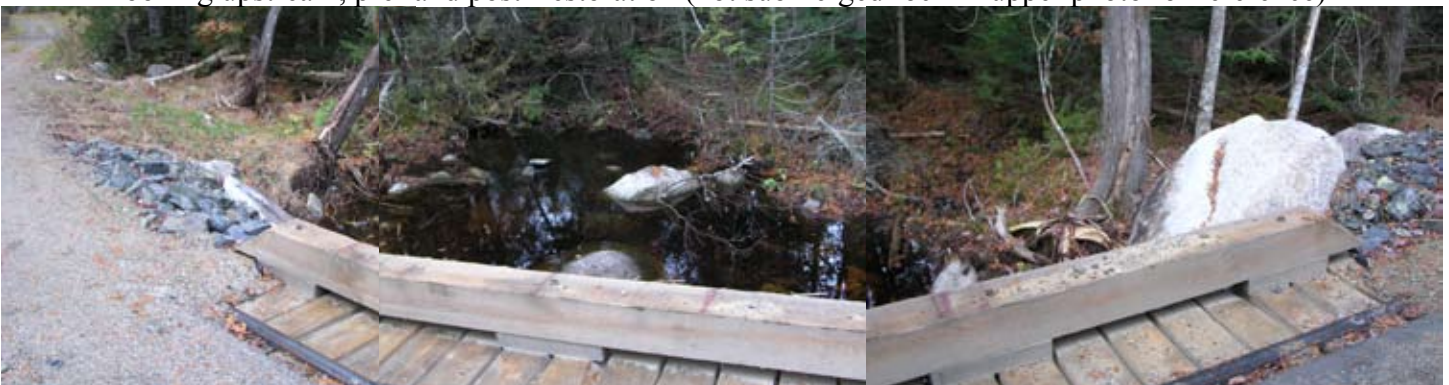
looking upstream, pre- and post- restoration (not submerged rock in upper photo for reference)

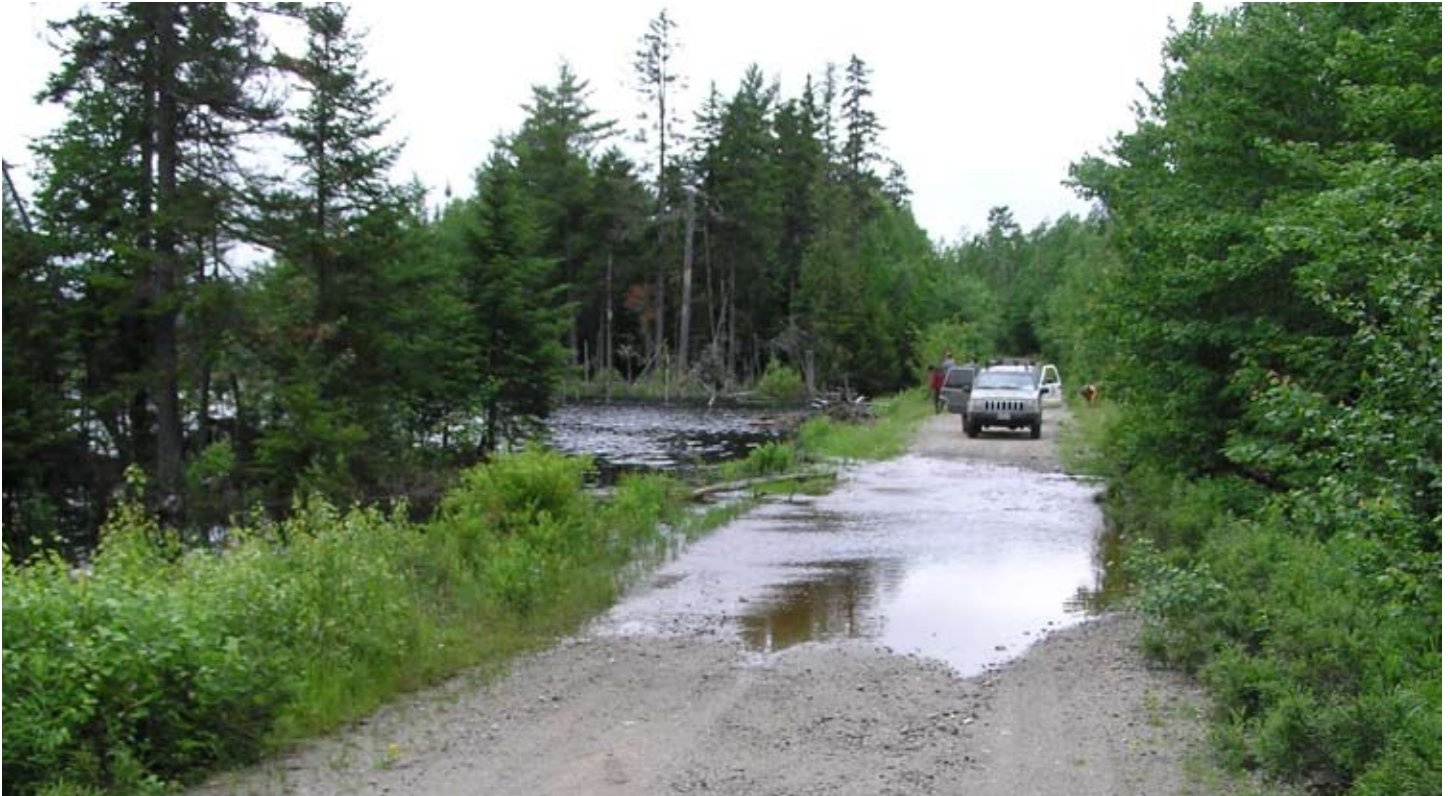
Bear Brook

river right approach pre-restoration

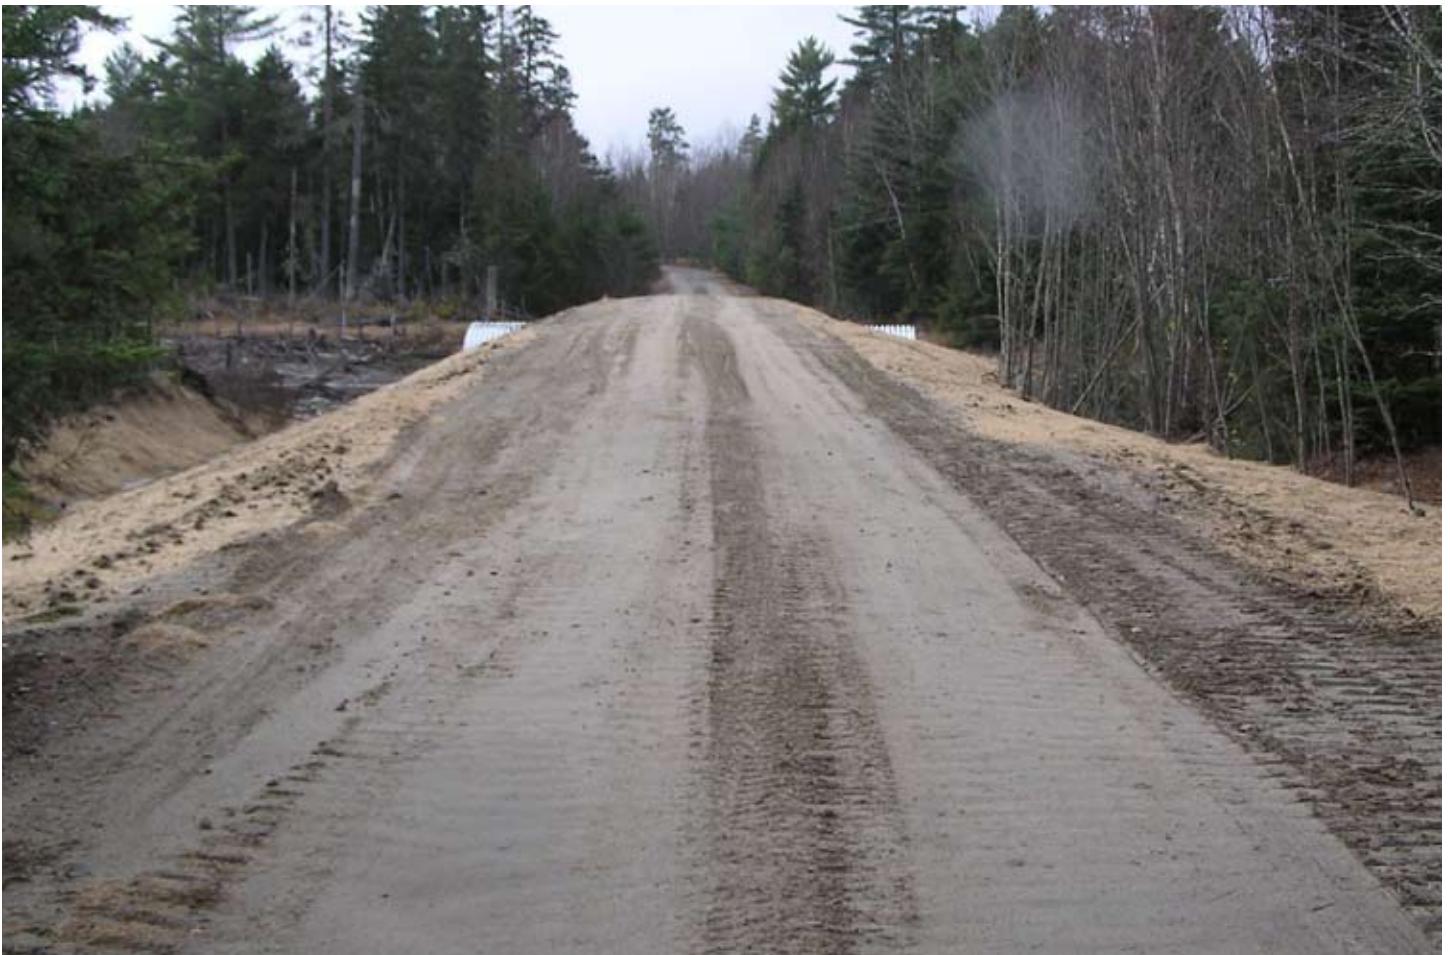
river right approach post-restoration

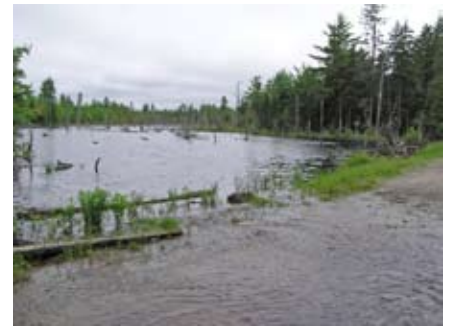
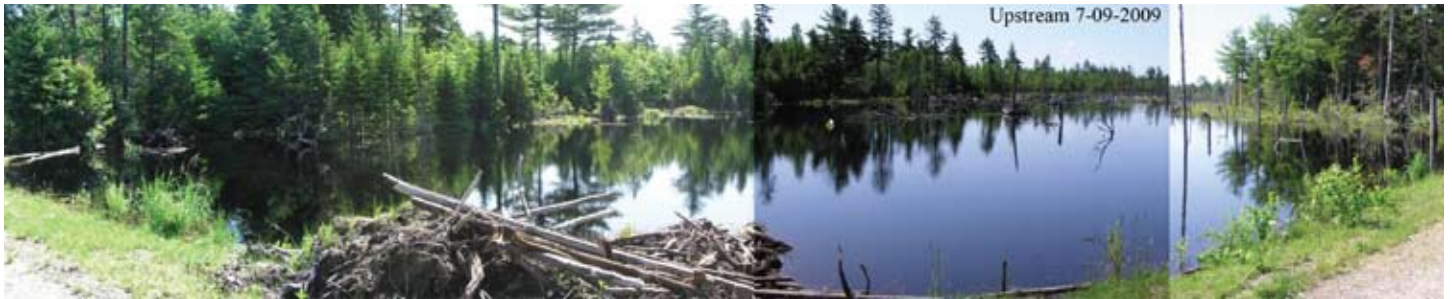
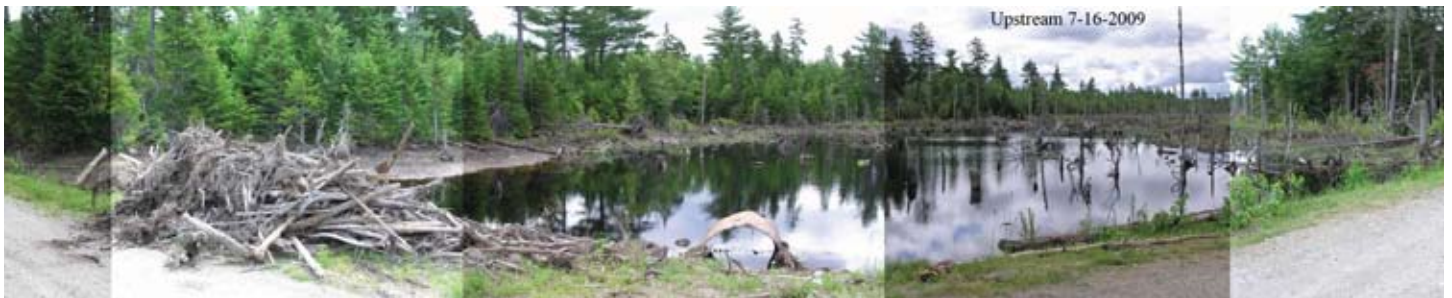
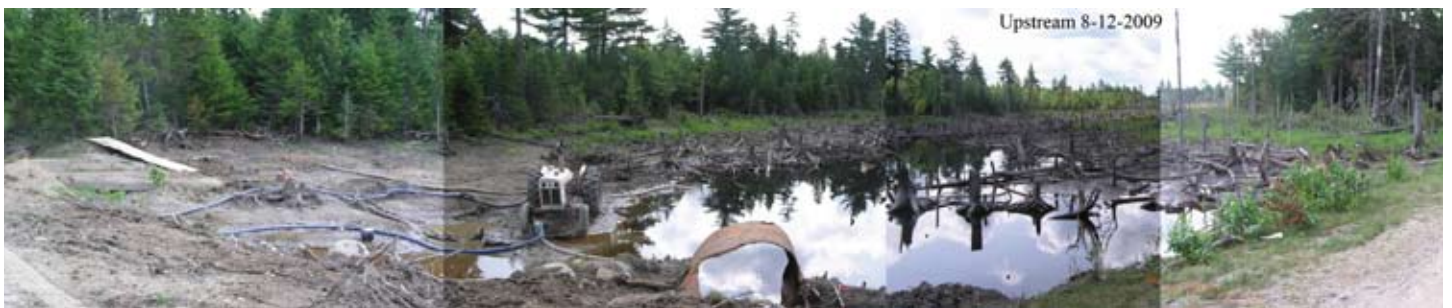
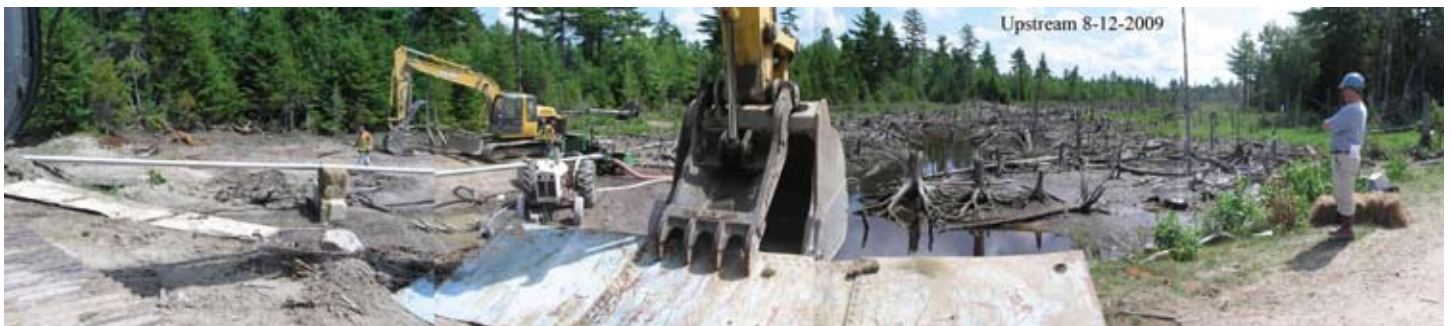
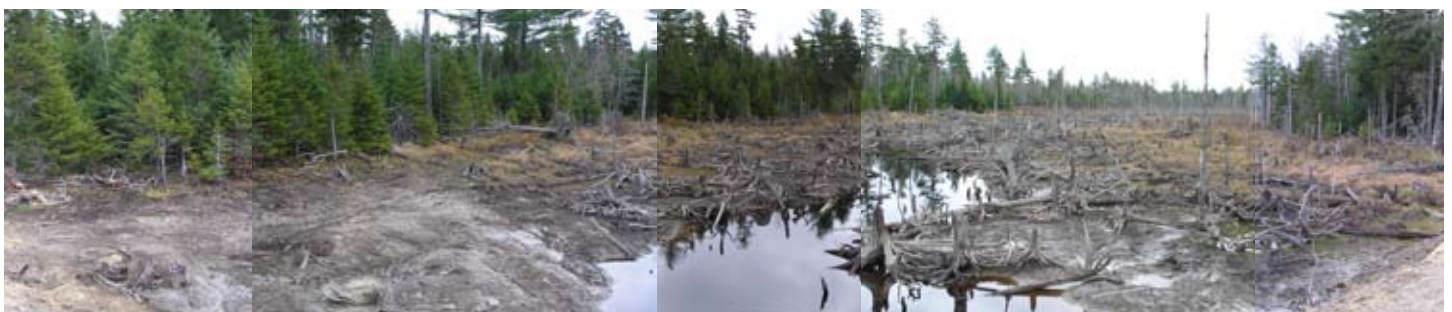
Bear Brook continued: sequence of draining upstream deadwater

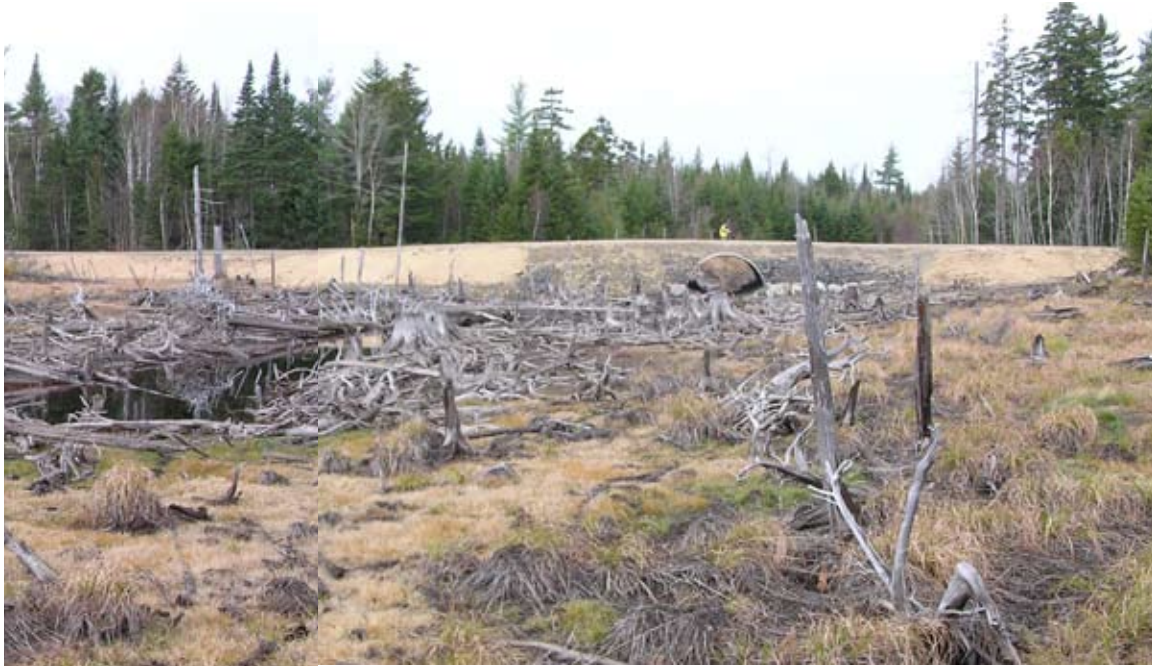
Bear Brook inlet, pre- and post- restoration

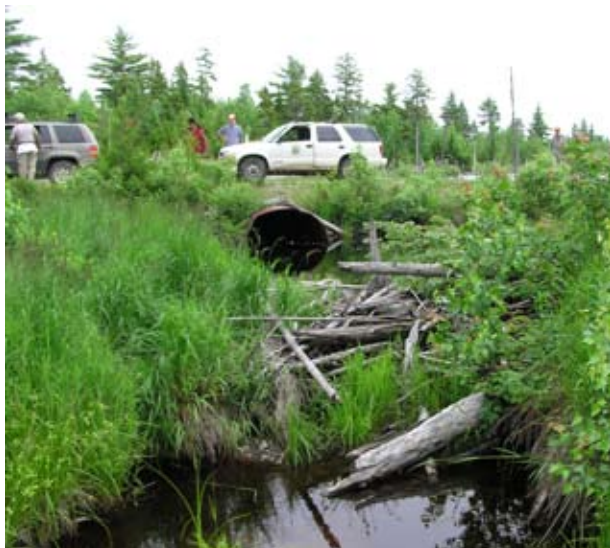
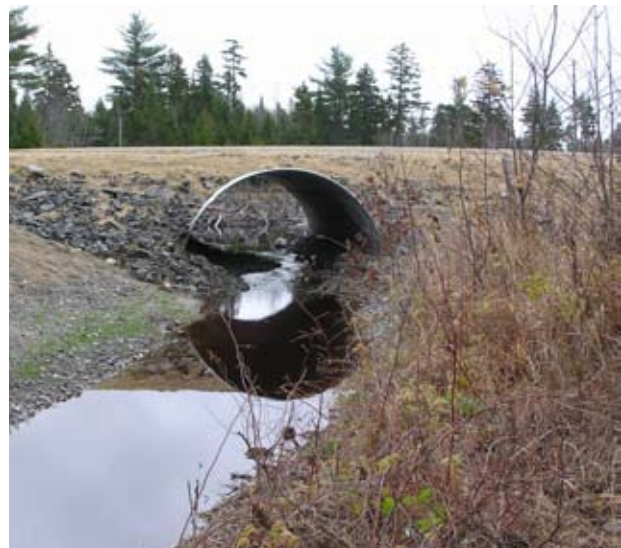
Bear Brook outlet, pre- and post- restoration
