Rail Accident Report

Train/vehicle collision on the Leighton Buzzard Narrow Gauge Railway 25 March 2007

Train/vehicle collision on the Leighton Buzzard Narrow Gauge Railway, 25 March 2007

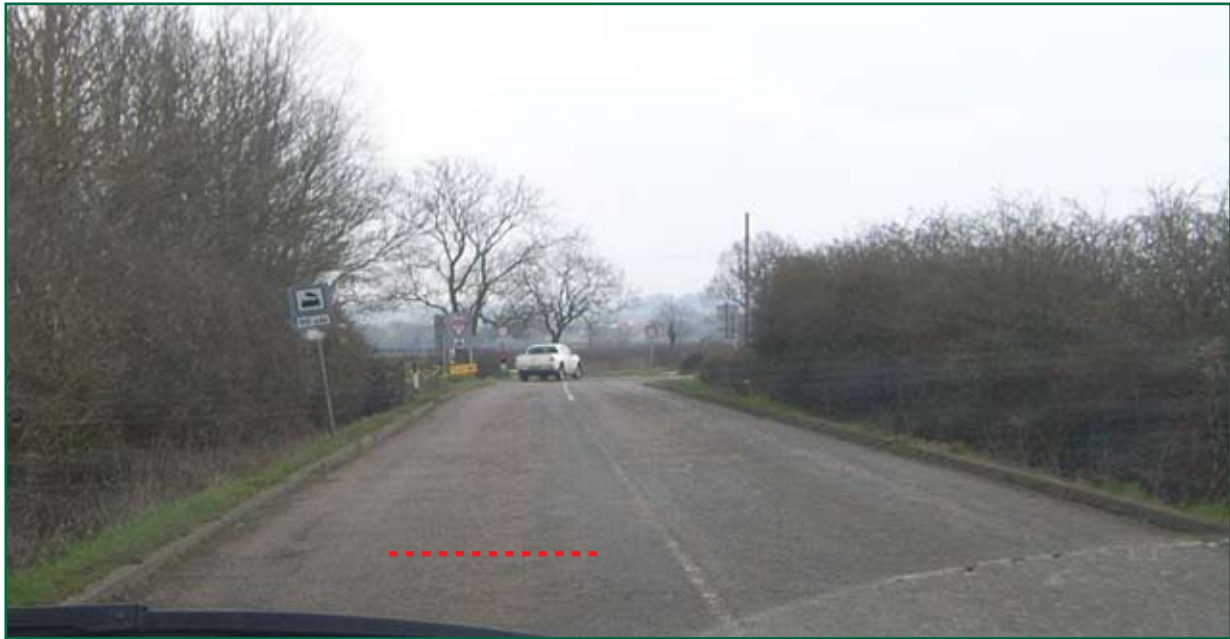
- 13 There is one advance sign on Shenley Hill Road indicating the level crossing, albeit not compliant to Diagram 771, and this is followed by two signs warning motor vehicles to give way, one for the crossing and one for the road junction. Both give way signs are accompanied by white stop lines painted on the road. The road markings are not clear and are in need of repair (see Figures 2 and 3).

Figure 2: View approaching Shenley Hill Road level crossing from North to South. A vehicle can be seen in space between the two give way areas waiting to turn right onto Mile Tree Road. The red line indicates the location, 40 m from the junction when the train can be partially seen from the left-hand side (LHS) in the direction of travel

- 14 There is space to allow a car to safely pass over the level crossing, stop and wait at the second give way signs, whilst still allowing a LBR train to safely pass behind the road vehicle (see Figure 2).

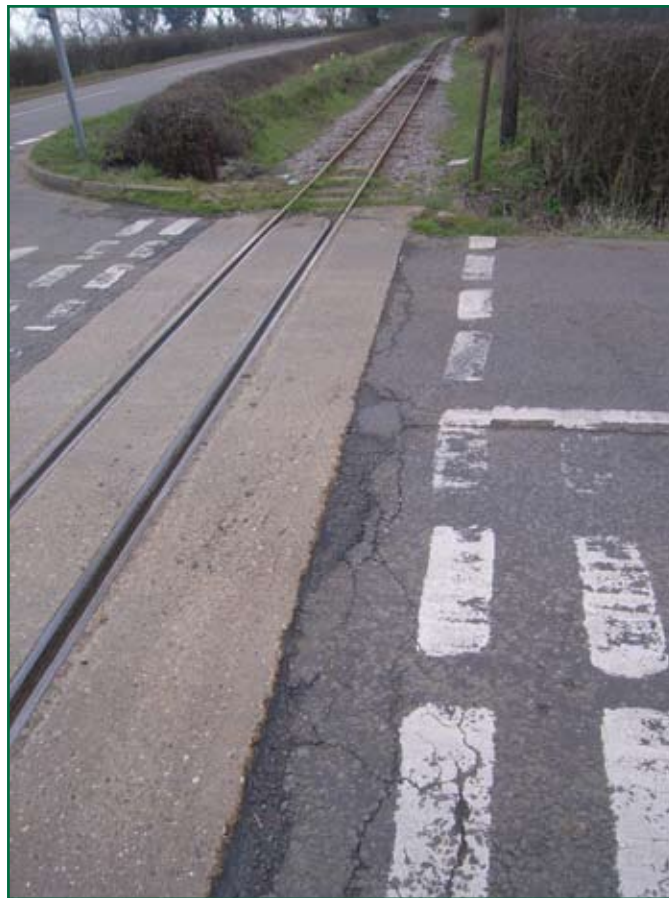
- 9 Shenley Hill Road railway crossing is located to the north side of a road junction between Shenley Hill Road and Mile Tree Road (see Figures 2 and 3). Shenley Hill Road runs north to south, and is to the north of Mile Tree Road. The rail crossing has been the location of five near misses in 2006 and one near miss incident in 2007. Two separate fatal road traffic accidents occurred at the road junction in 2001 and 2004 respectively. All of these road traffic incidents and accidents were reported to and dealt with by Bedfordshire Police.

Figure 3: View from east to west of Shenley Hill crossing

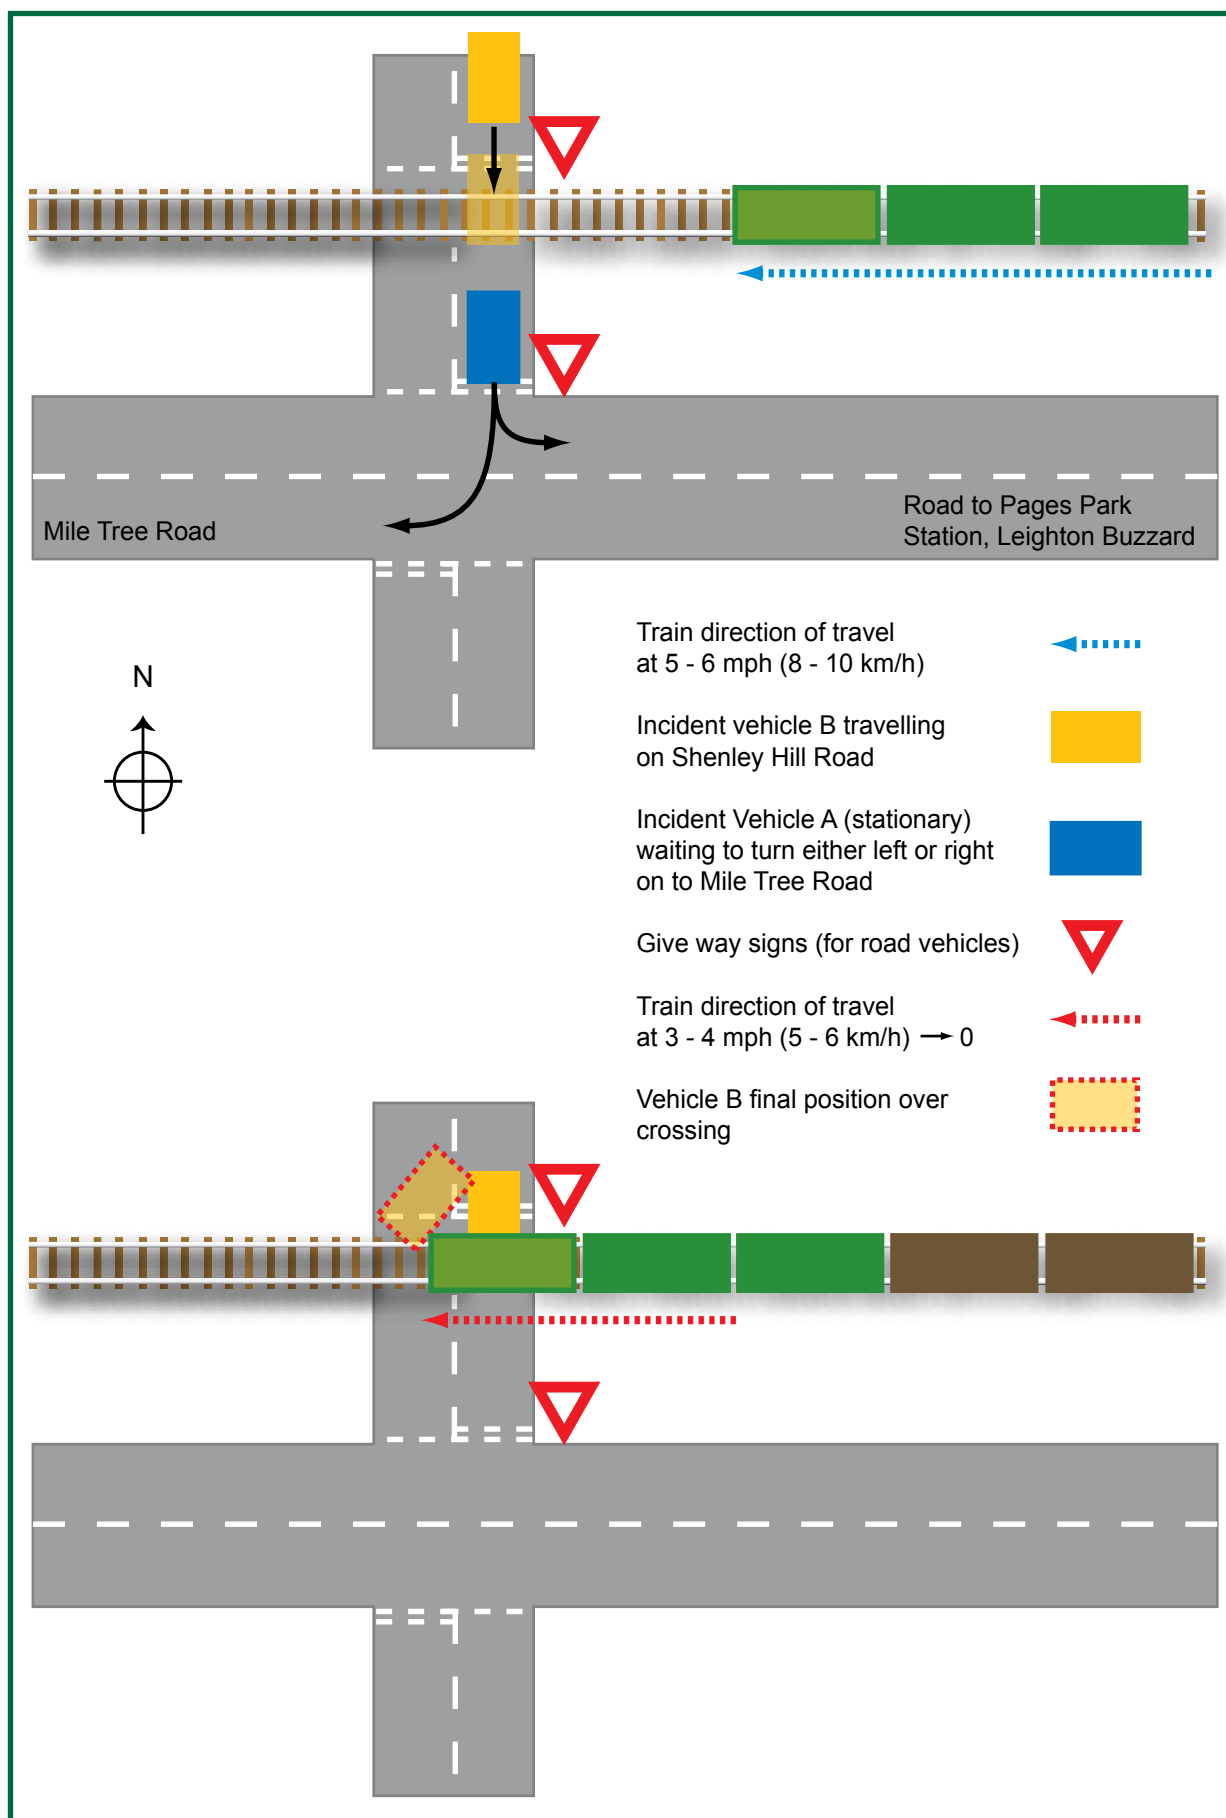
Figure 4: Plan view showing train and motor vehicle (a) and (b) positions before and at the point of collision

- 20 A Mercedes 4x4 motor vehicle was travelling along Shenley Hill Road en route from Leighton Buzzard to Luton at a reported speed of 30 mph (48 km/h) as it approached the level crossing (see Figure 4).

- 23 Both the train driver and the driver's assistant observed two road vehicles on Shenley Hill Road, approaching the crossing from the right to left in the direction of the trains travel (see Figure 4).

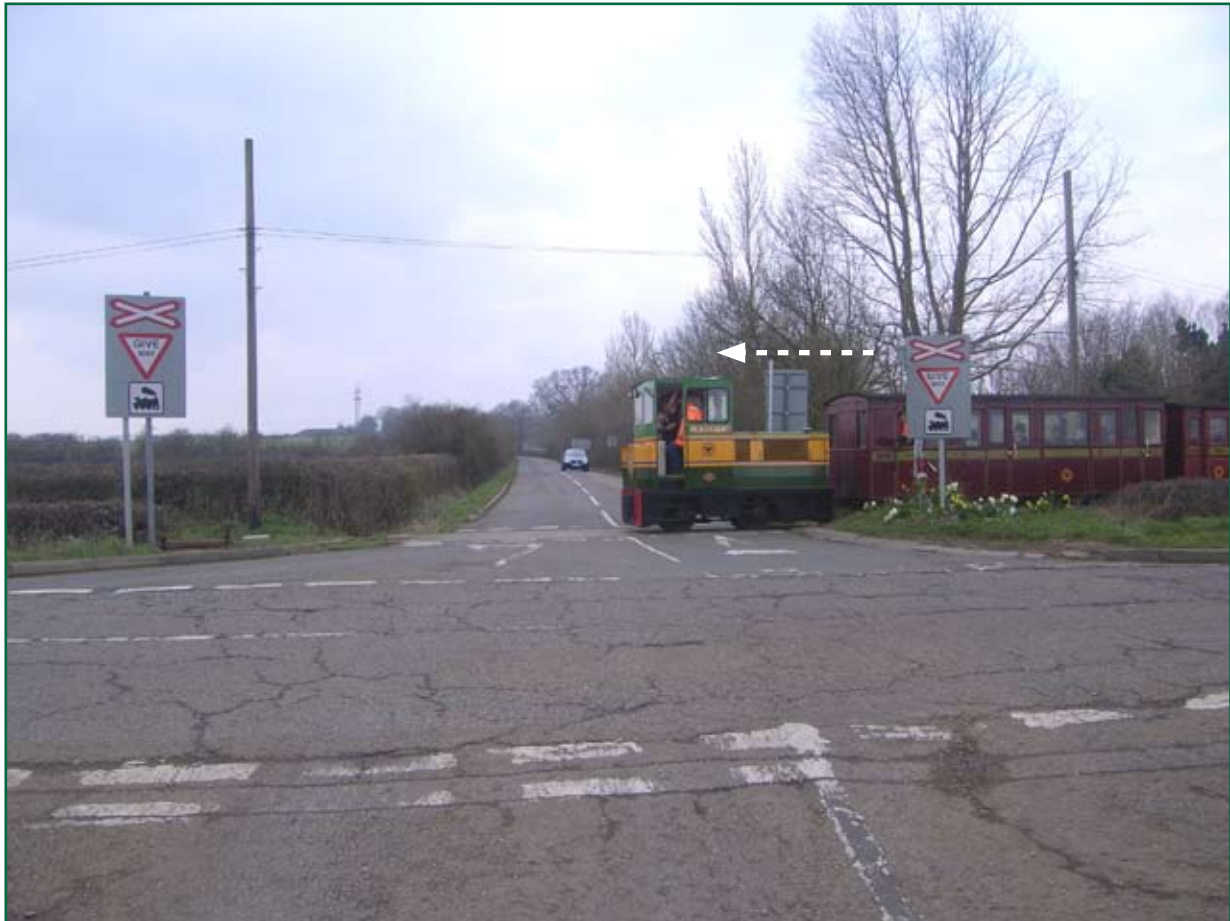
- 28 The passenger carriages had not entered the road area and all passengers remained safely in them (see Figure 5).
- 29 The only witnesses to the accident were the train driver, the driver's assistant, the Mercedes vehicle driver and the passengers in the car. No other staff or passengers on the train were aware anything was amiss until the collision.

Figure 5: South view looking at incident train and position of incident vehicle. A vehicle can be seen on Shenley Hill Road approaching the level crossing

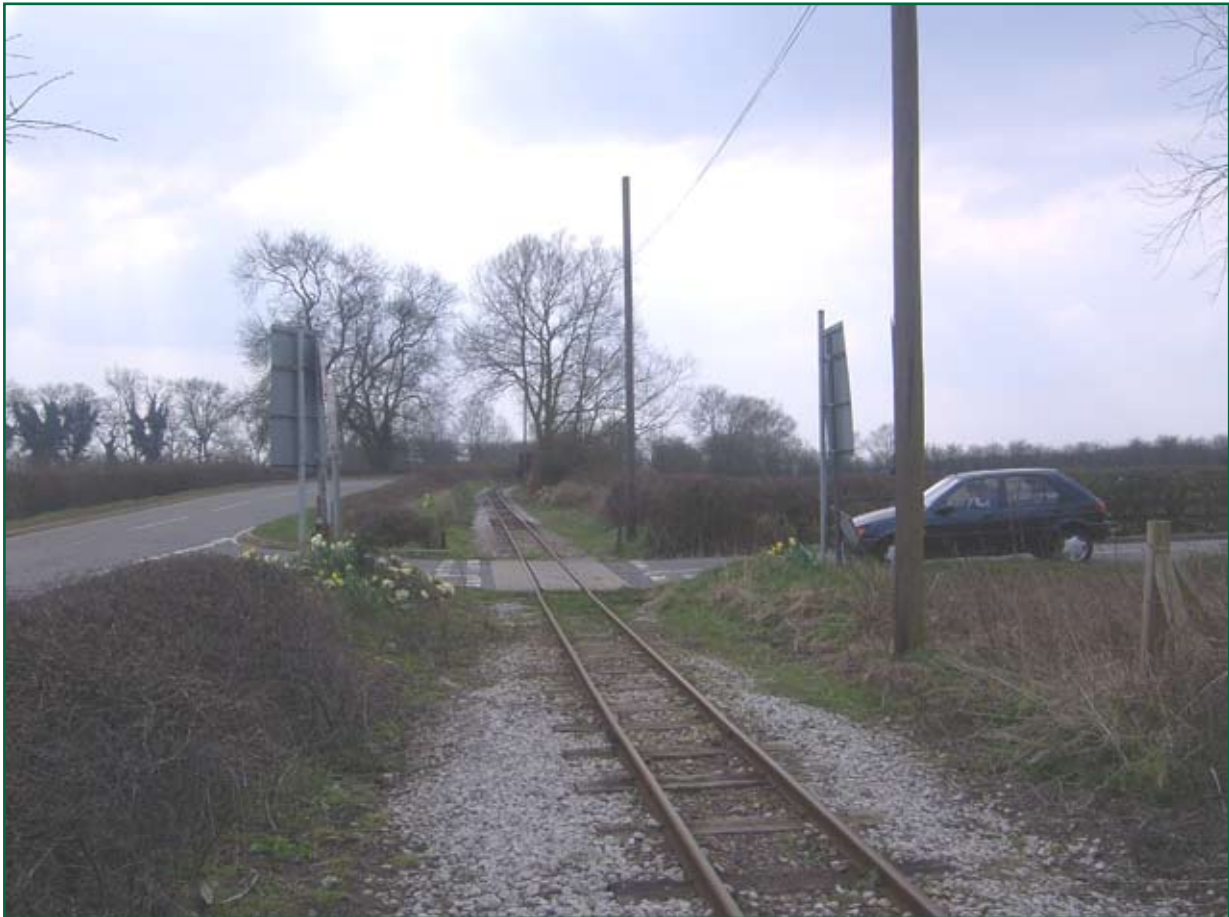
- 39 The motor vehicle driver was a local man and had a good knowledge of the Leighton Buzzard area, and in particular the town. He was aware of the LBR but assumed that all crossings were protected by a flagman. At the time of the incident he was travelling with young passengers.
- 40 As the motor vehicle driver approached Shenley Hill open level crossing he observed a vehicle waiting at the crossing to turn onto Mile Tree Road. He did not see a train and assumed that, as there was no flagman and a motor vehicle waiting to turn onto the main road, there was no train present. For this reason, he did not see a need to anticipate or brake for the first give way road marking; he drove his vehicle over the give way line without stopping and drew up to the rear of the motor vehicle waiting to turn (see Figures 6 and 7).

Figure 6: View from the east travelling towards Shenley Hill Road crossing

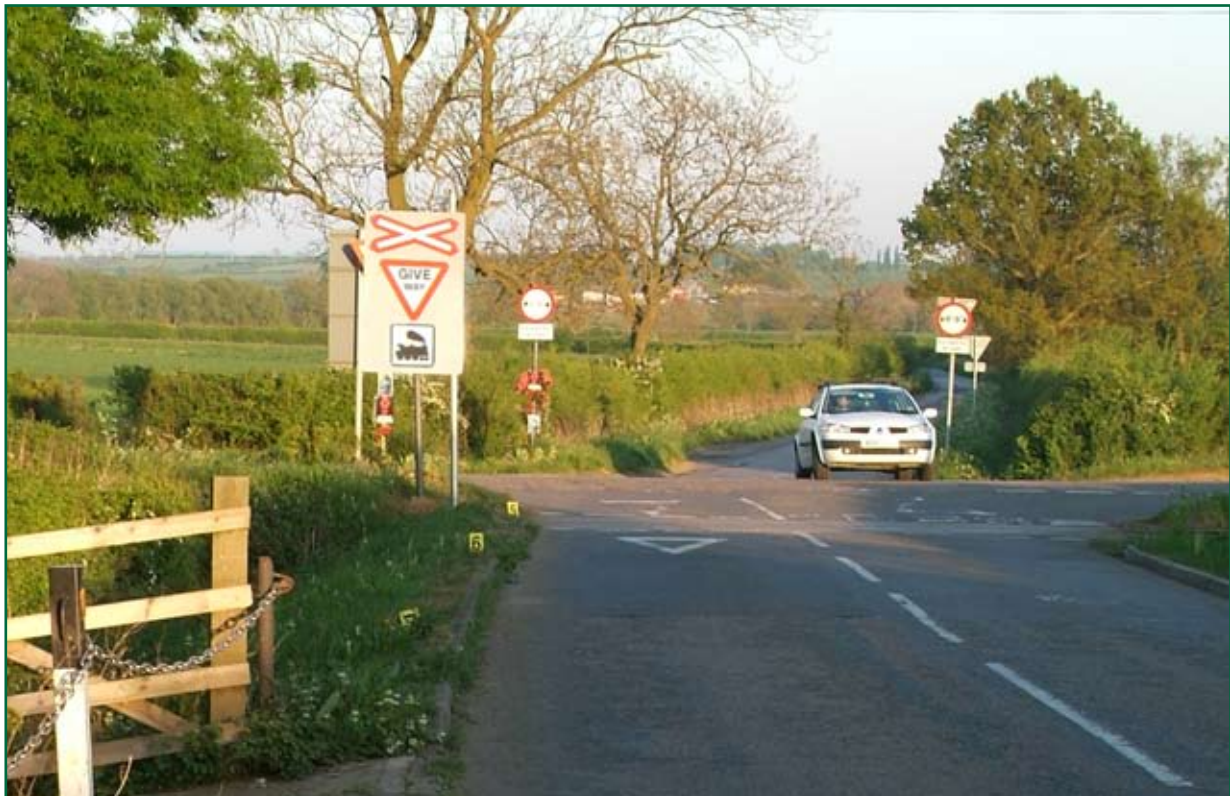
Figure 7: View on approach to Shenley Hill Road crossing (incident locomotive approached crossing from left of image)

- 50 As part of the investigation the LBR operated a test train over the Shenley Hill Road level crossing so that it came to a stand two metres away from the highway. On each occasion that the train was brought to a stand, road vehicle traffic, having observed the locomotive stationary at the crossing, stopped behind the northern give way sign, and in Mile Tree Road (see Figures 7, 8 and 9).

- 74 The RAIB evaluated the use of 'box junction' markings from the northern give way line until clear of the crossing on Shenley Hill Road (Diagram 1045 Traffic Signs Regulations and General Directions 1994). The layout of the crossing and dimension of vehicles that use the crossing preclude this from being an effective solution, because the distance between the two give way lines and a box marking road layout would cause a long vehicle such as an articulated lorry to disobey the law by default (see Figure 7).

- 78 Observations conducted during an RAIB visit concluded that bringing the train to a stationary position before crossing the highway ensures that road vehicle drivers are fully aware of the presence of the train and its driver's intention to pass over the crossing (see Figure 7).

- 79 Accordingly the RAIB is of the opinion that the best practicable way to reduce risk on the crossing is for all trains to stop and ensure that road traffic has halted before entering the crossing.

- 1 Leighton Buzzard Railway Ltd should change the method of working of Shenley Hill Road open crossing to require the train to stop and allow road traffic to halt before entering the level crossing.
- 2 Bedfordshire County Council should cut down the vegetation around Shenley Hill Road open crossing and introduce a process of vegetation management in order to meet the viewing zone requirements of RSPG 2E Appendix B.
- 3 Bedfordshire County Council and Leighton Buzzard Railway Limited, as appropriate should ensure that traffic signs and road surface markings for which they are each responsible at LBR level crossings comply with diagrams 771, 775 and 785 as defined in the Traffic Signs Regulations and General Directions 2002, and recommended in Railway Safety Principles and Guidance Part 2E (Health and Safety Executive, 1996), Diagram 6.

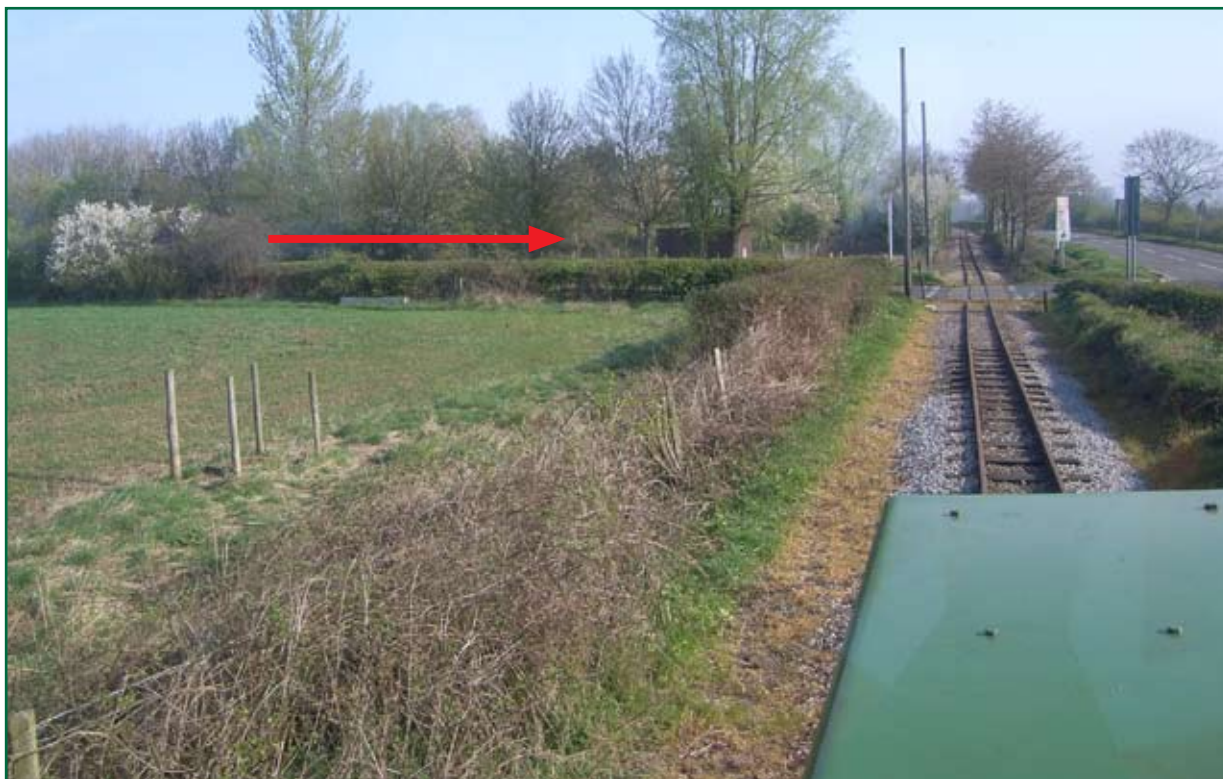
- 59 The viewing zones are not dependent on the speeds of trains, which are limited as in paragraph 55, or of road vehicles, but on the distances when the driver of the train observes the motor vehicle. Actual views from a road vehicle approaching from Shenley Hill Road, and trains approaching in both directions, are given in Figures 8 – 11.

Figure 8: Train driver's view 40 m from crossing as viewed from the west

- 60 Vegetation and trees obstruct the visibility for motor vehicles 20 - 40 m from the crossing on Shenley Hill Road and subsequently give intermittent visibility of the train approaching from Stonehenge Works Station.
- 61 Much of the vegetation that obstructs the visibility of approaching trains is outside the boundaries of both the railway and highway.
- 62 This limited visibility means that Shenley Hill Road crossing would not comply with requirements of RSPG Part 2E for viewing zone distances for motor vehicles and trains (see Appendix D and Figures 10 and 11). This lack of visibility may have contributed to the accident.

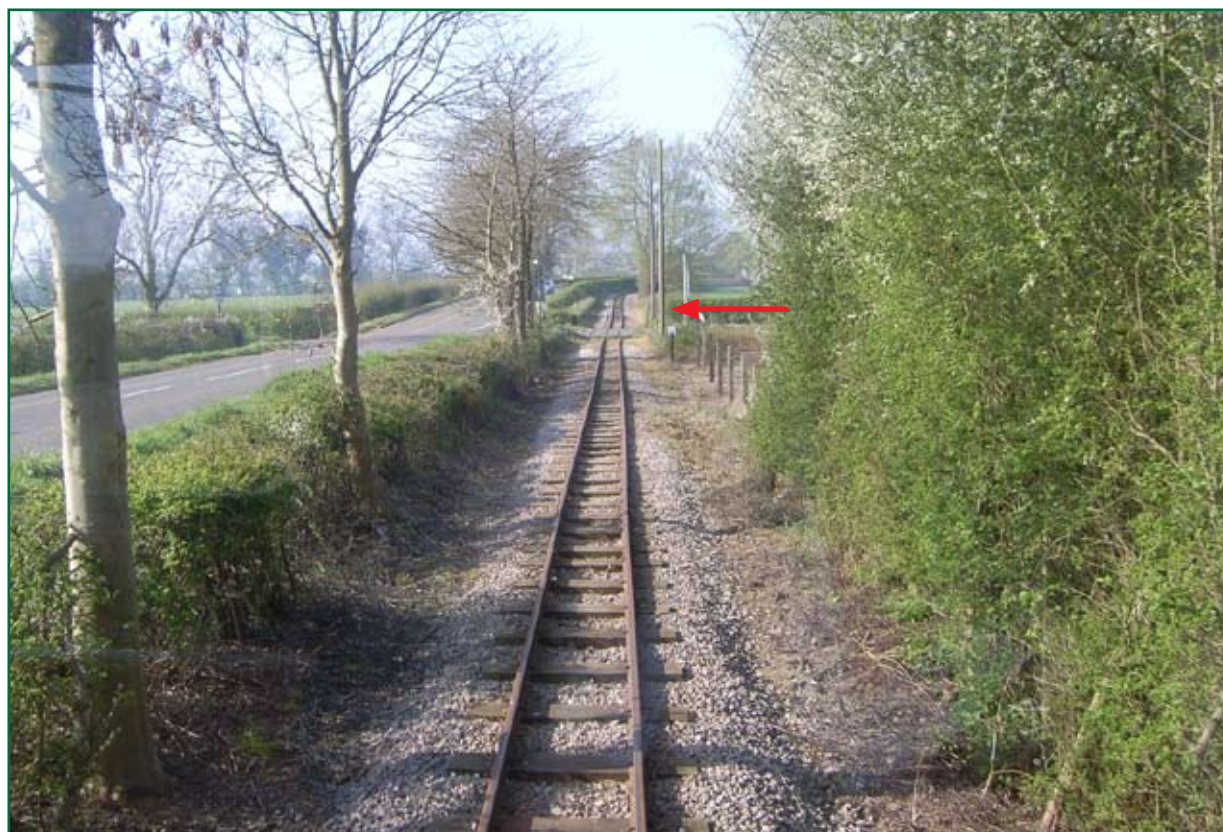
Figure 9: Train driver's view 20 m from crossing as viewed from the east

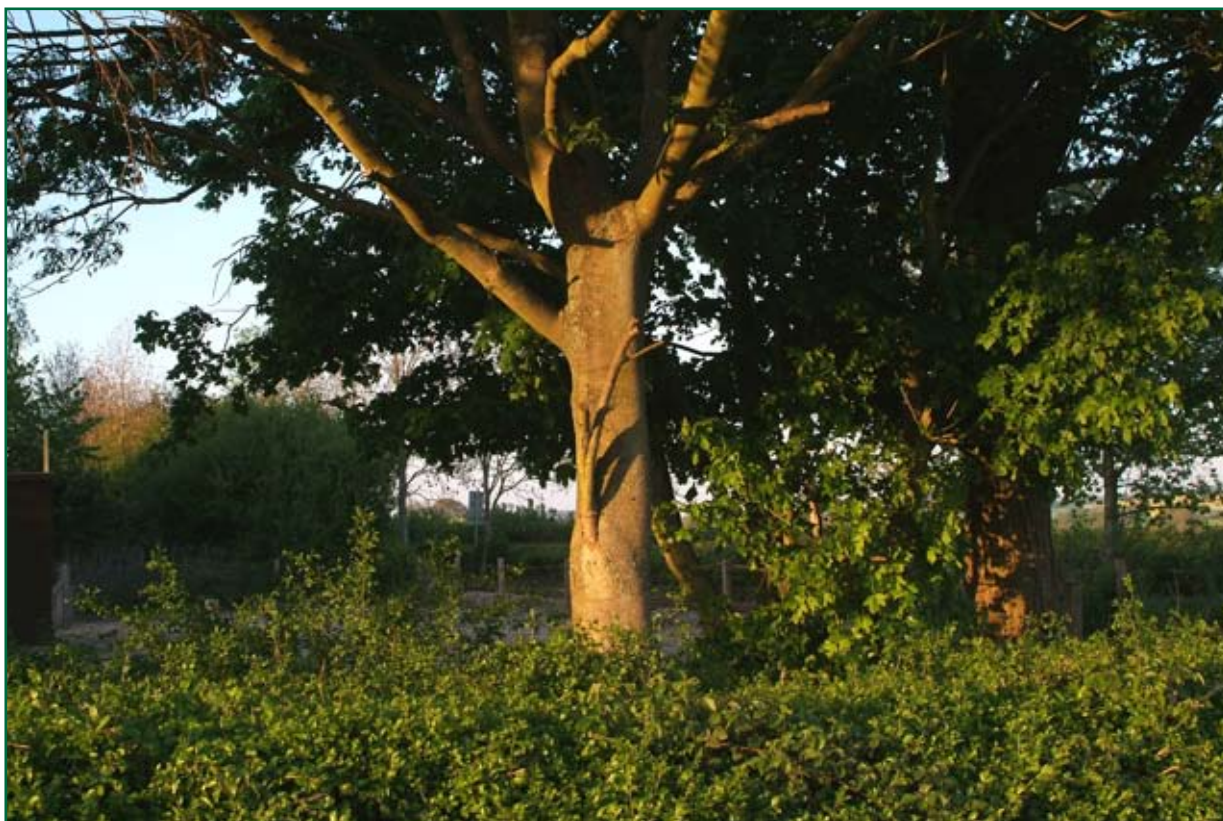
Figure 10: View from the train APPROACHING Stonehenge Works station

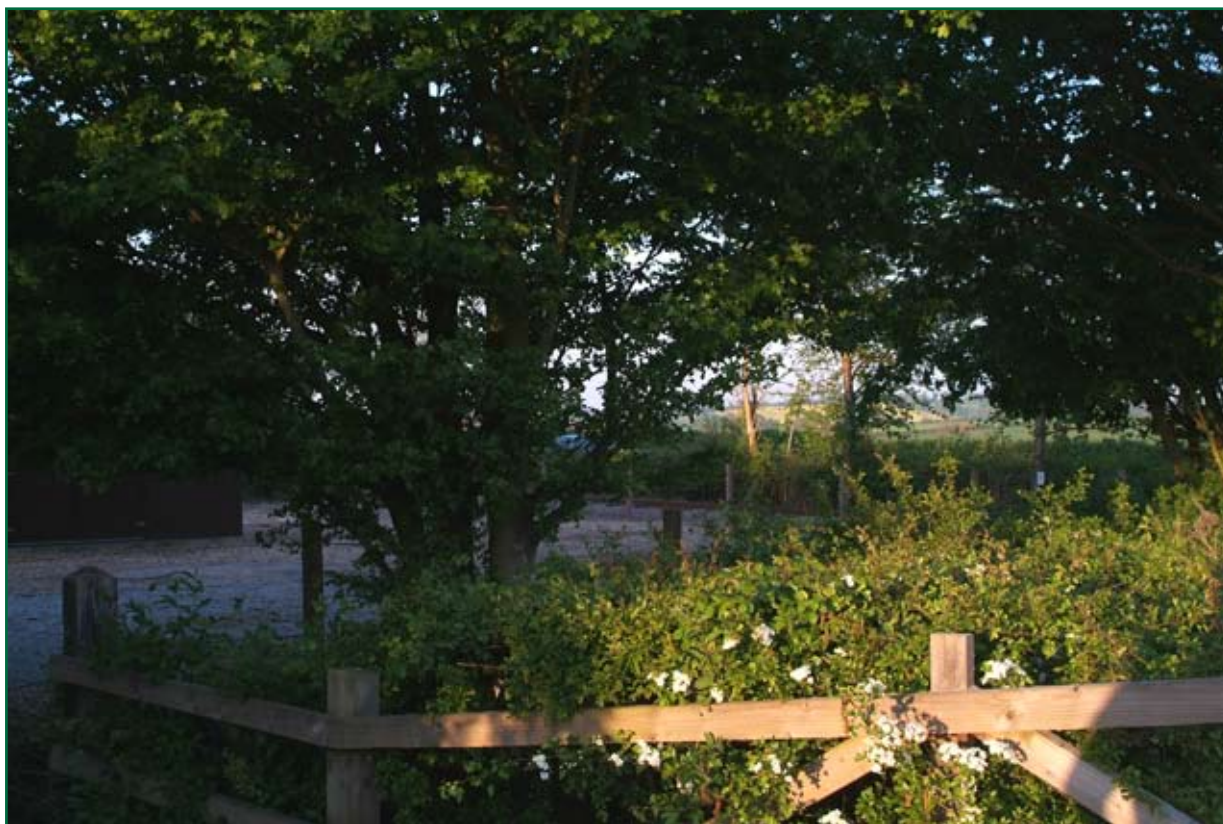
Figure 11: View from the train travelling FROM Stonehenge Works station
