Rail Accident Investigation Branch

Rail Accident Report

Runaway of a road-rail vehicle at Glen Garry 5 December 2007

5 December 2007

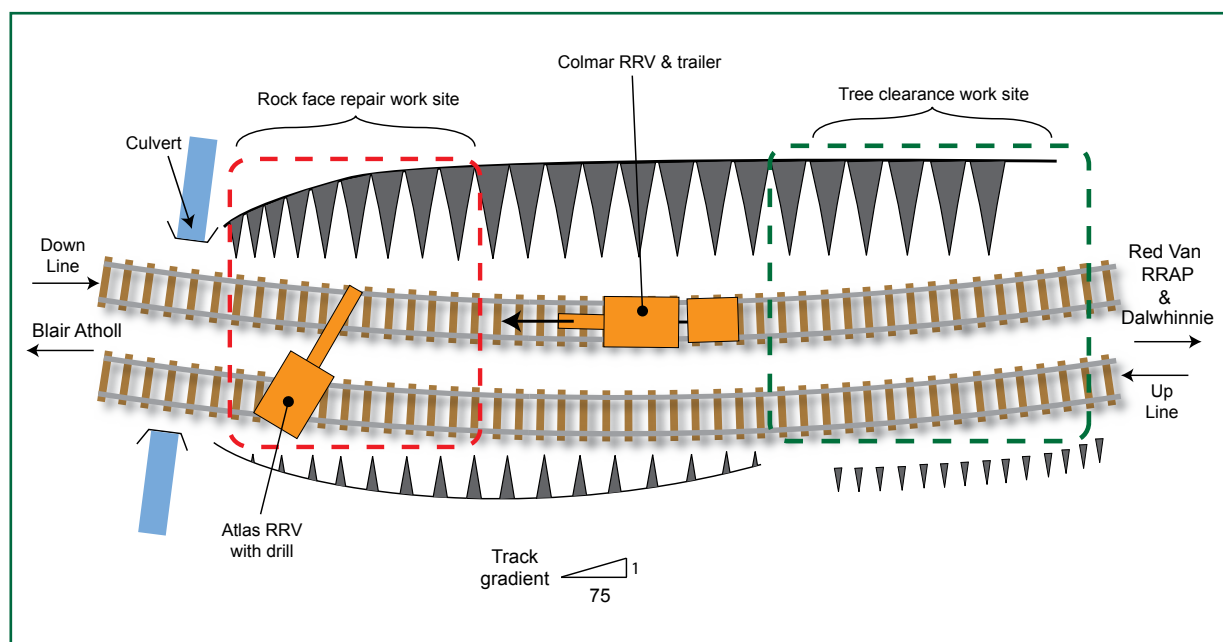
Figure 2: Sketch plan of the site of the incident

- 16 Work was being undertaken in an overnight T3 possession of the railway line between Blair Atholl and Dalwhinnie to repair rock cuttings. The repairs consisted of drilling holes in the rock face and attaching mesh to prevent rock falls. The work involved the use of an RRV with a drilling rig standing on the *up line* and reaching across the *down line*. Another part of the work involved an RRV with a trailer loaded with stone and *gabion baskets* running on the down line. Figure 2 shows a sketch plan of the site.

- 46 At the site, the Atlas RRV had drilled one hole and was finishing another when the block of rock it was drilling through became loose. Drilling was stopped and the driller called the geotechnical engineer over for advice. An abseiler was working on the rock face setting out hole positions to the geotechnical engineer's instructions and had to stop work when the engineer was called away.
- 47 The drill was pulled out of the hole, but was not withdrawn completely as it was feared that the loose rock might fall. The driller and the geotechnical engineer stood on the Blair Atholl (downhill) side of the drill boom (Figure 2).

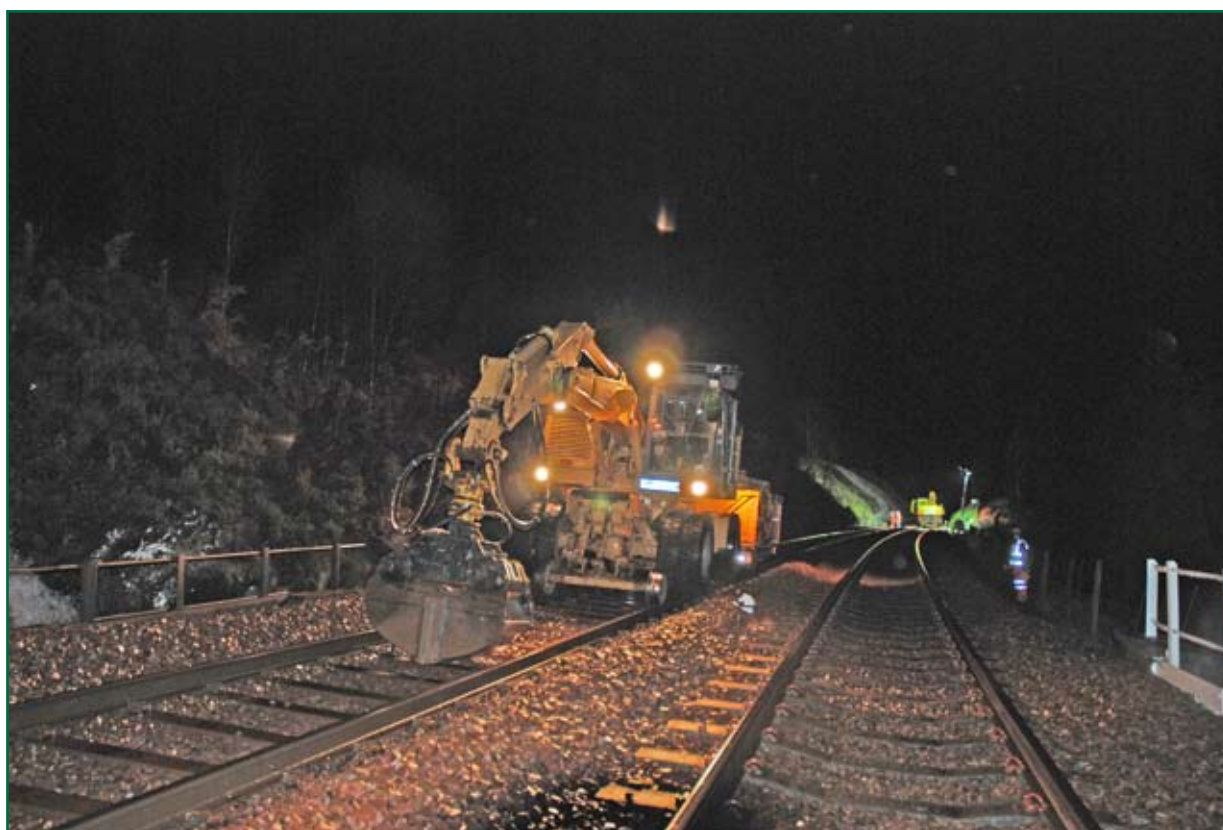
Figure 3: Colmar RRV and trailer immediately after incident (photo courtesy of Edmund Nuttall Ltd).

- 21 The RRV and trailer ran into the work area as staff ran out of the way. The boom of the moving RRV was out in front of the machine and in line with the boom of the drilling rig RRV. The drilling rig RRV operator saw this and quickly raised his boom to allow the other RRV to pass beneath it. A minor collision between the two RRVs occurred which damaged the cab body work on both machines and broke the windows in the drilling rig RRV. The moving RRV continued for a further 90 m before coming to a stand. Figure 3 shows that RRV and its trailer in their final stopping position.

- 57 The Atlas RRV's body was positioned at an angle to the track and this meant that its cab was foul of the up line. The cabs of the two RRVs came into contact as they passed, breaking the windscreen of the Atlas RRV and causing damage to the cab structures of both machines. The drill rod on the Atlas RRV was bent and the air hose connecting the drill rig to its compressor was cut through. If the Atlas RRV operator had not raised the jib in time a much more serious collision would have occurred.

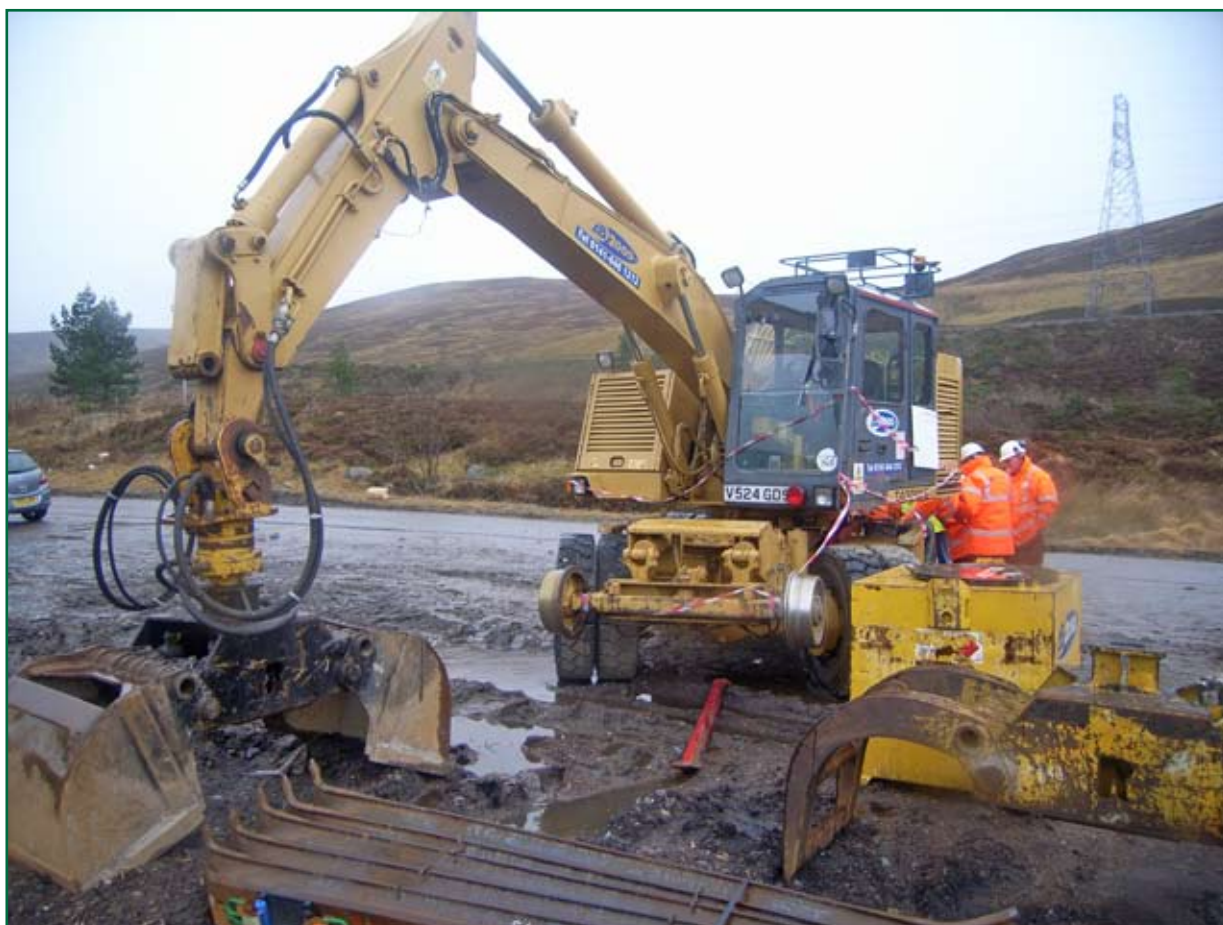
Figure 5: Colmar T4300FS RRV

- 34 The RRV that ran away was a '*high ride*' 360 degree wheeled excavator manufactured by Colmar Ltd (type T4300FS). The RRV was fitted with a *clam shell grab* and was towing a *Philmor trailer* fitted with a load carrying box. The load carrying capacity of the trailer was eight tonnes and its tare weight was two tonnes, giving a maximum total weight of ten tonnes. The load carrying box was loaded with stone gabion filling material, two filled gabions, some gabion mesh and various items of small equipment and materials. The total weight of the trailer and its load was estimated to be between nine and ten tonnes. The actual weight of the trailer's load was not recorded. Figure 5 shows the RRV parked at Red Van road rail access point.

- 105 The RRV was examined by the manufacturer's UK service agent under RAIB supervision. The rail and road wheels were examined and found to be within manufacturer's recommended limits with the exception of road wheel tyre pressure. These were found to be too low (between 4.0 and 4.8 bar, compared to the recommended 6.9 to 7.6 bar). Tyre pressure is significant in a high ride RRV as the relative position of the road and rail wheels is fixed by the rail wheel lowering mechanism, and so the contact area between the tyre and the rail wheel is also fixed. This means that the force between them is heavily dependent on the tyre pressure.

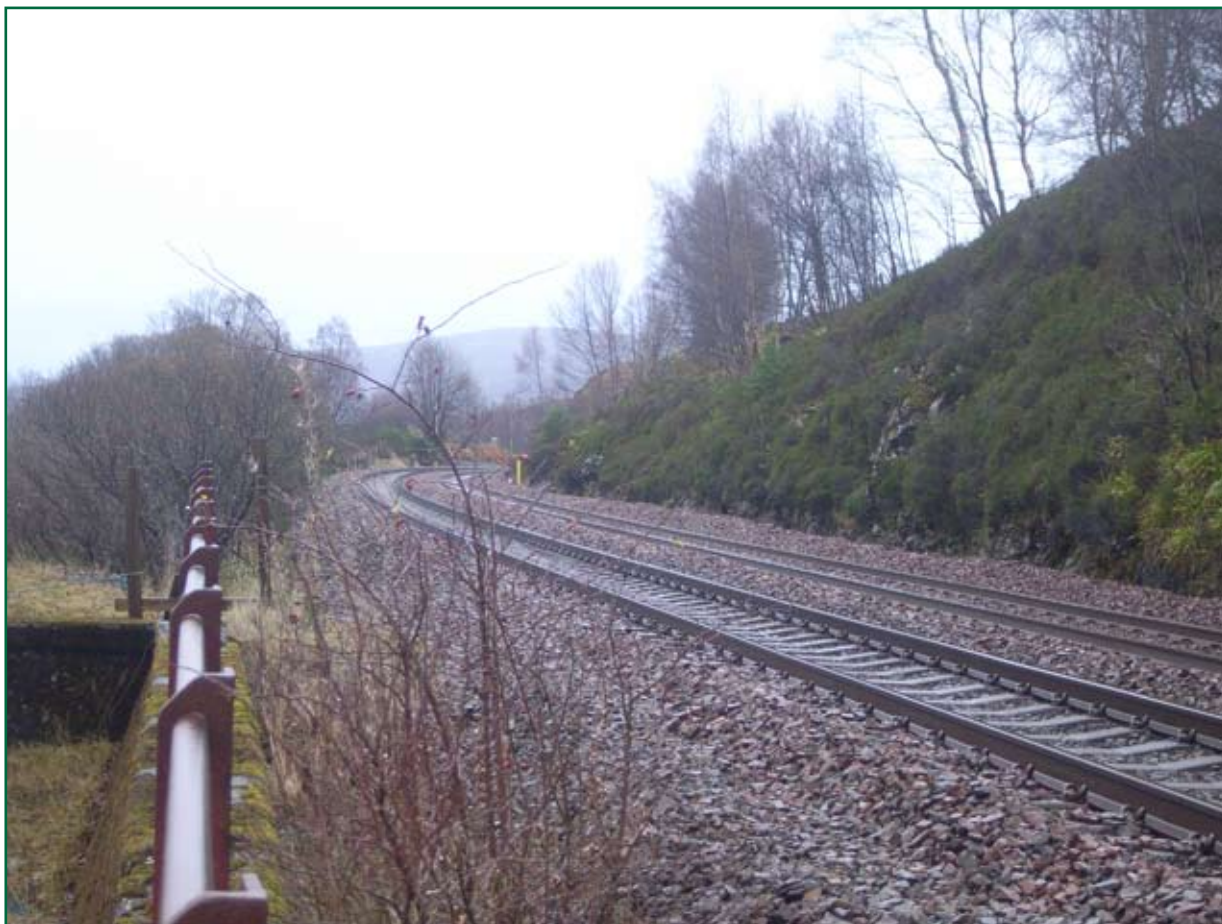
Figure 7: View towards the rock drilling site from the approximate location of the vegetation chipping site

- 18 Vegetation clearance work had taken place earlier in the shift and this involved dragging trees and branches across the down line. This may have contaminated the rail head with tree debris (paragraph 39). The presence of contamination could not be verified positively as the rail head condition was not examined after the incident.

- 45 During the time that it had taken for the Colmar RRV to on-track with its trailer, and to load the trailer with the materials and equipment, the Unimog RRV chipper had filled its chippings container and set off towards Red Van road rail access point on the up line, passing the Colmar RRV on its way. Figure 7 shows the view towards the work site from the approximate location of the chipping work.

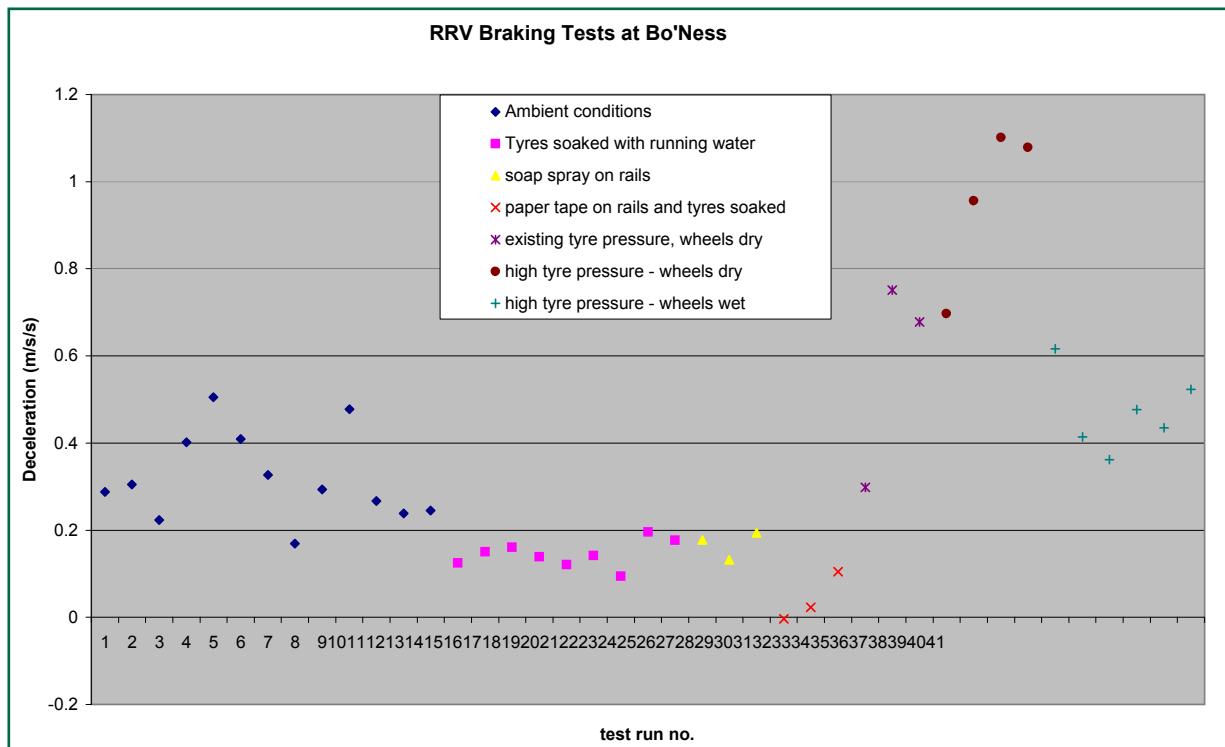
Figure 9: Deceleration rates for Colmar RRV and trailer on 1:66 gradient from tests at Bo'ness

- 101 The results of the braking tests on the gradient are shown in Figure 9 as deceleration rates. Calculations were made using the coefficients of friction derived from the test results to determine the maximum gradient on which the RRV could hold its load in wet and dry conditions with one or two trailers. These calculations indicated that the gradient at which the RRV would not be able to hold the weight of two trailers in the wet was between 1:25 and 1:34. Since RRVs of this type are allowed to operate with two trailers on gradients up to 1:30 without regard to the weather conditions, a hazard existed. Consequently, the RAIB issued an urgent safety advice to the industry on 21 December 2007 to bring this to their attention. One of the measures advised by the RAIB was to carry out a *running brake test* of the RRV/trailer consist when starting out, so that the operator has a feel for the conditions that prevail at the time. The full text of the urgent safety advice is given in Appendix C.

- 102 The tests with simulated leaf mulch on the gradient showed that the RRV and trailer was unable to stop on the contaminated rail, with slip occurring between the steel wheels and the rails. The coefficient of friction derived from the first test was 0.02, which is similar to friction values measured during braking tests on trains in low adhesion conditions. The paper tape, when used with trains, is quite robust but in the tests with the RRV it was found that the RRV wheels damaged the tape as they passed over it. Consequently, each of the following test runs encountered better adhesion conditions than the previous run as sections of paper tape were removed by each pass of the RRV. The friction coefficient therefore improved with each run; on the second run it was 0.03 and on the third it was 0.04. After each test run the RRV had to travel back up the gradient ready for the next run. When the RRV attempted to travel back over the paper tape it was found that the friction available between its wheels and the rails was insufficient to push the trailer up the slope.

- 104 The tests showed that the RRV with its trailer was able to stop on the gradient in wet conditions provided that the rails were not contaminated. If the rails were contaminated such that the friction was reduced to a similar level to that experienced by trains in poor adhesion conditions, the RRV would be unable to stop with its trailer and be unable to hold that trailer on the gradient.
