Rail Accident Investigation Branch

# Rail Accident Report

**Derailment of a freight train near Moor Street  
station, Birmingham  
25 March 2008**

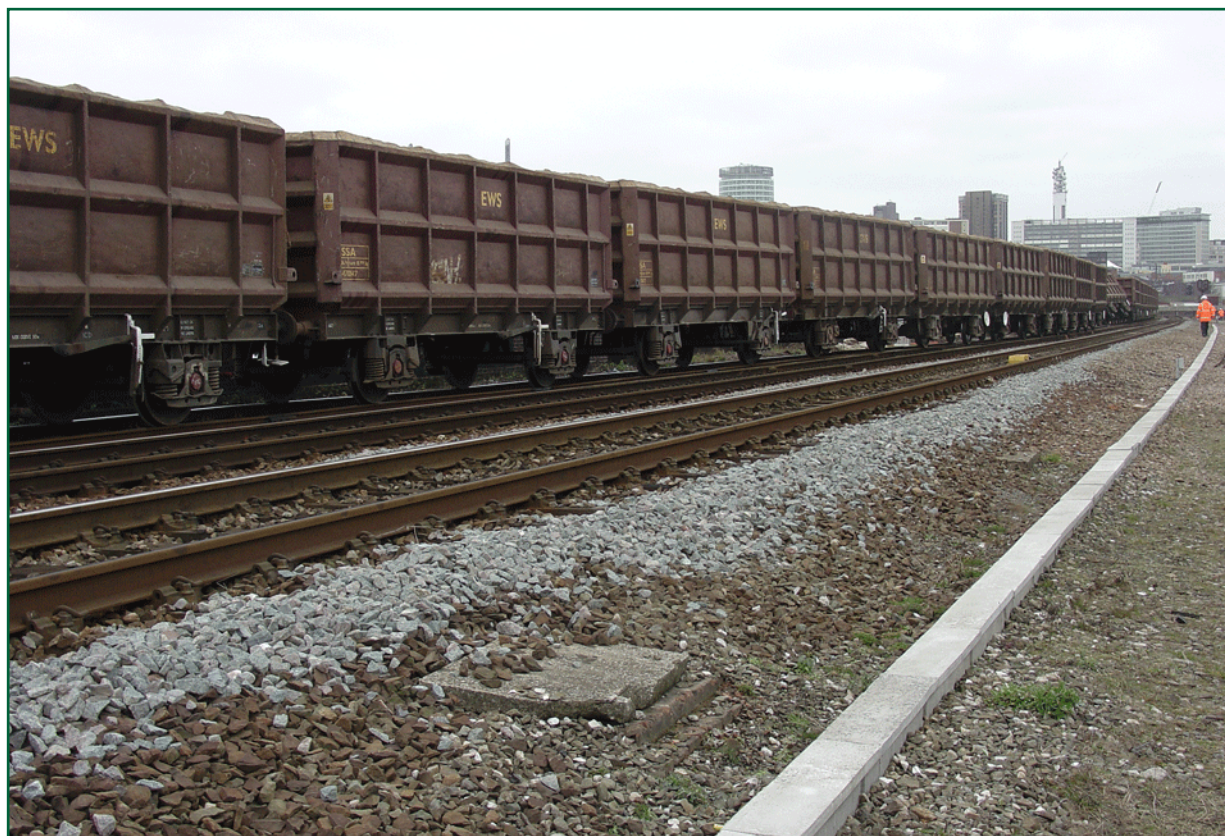
Figure 3: The incident site of the derailed wagons

- 9 There was significant damage to 677 points and some damage to 678B points, the operating equipment and *sleepers*, *baseplates* and *timbers* along the route of derailed running. A section of the adjacent viaduct *parapet* was demolished.
- 10 The 16<sup>th</sup> wagon suffered significant damage to its leading left-hand suspension assembly; the three other derailed wagons suffered less severe damage.
- 11 Rail traffic was initially stopped on all lines. The up Snow Hill line was released for *single line working* at 07:57 hrs. Repairs to the points equipment and track components were completed and normal operations recommenced on the down Snow Hill line and up Snow Hill line at 01:55 hrs on 26 March 2008.

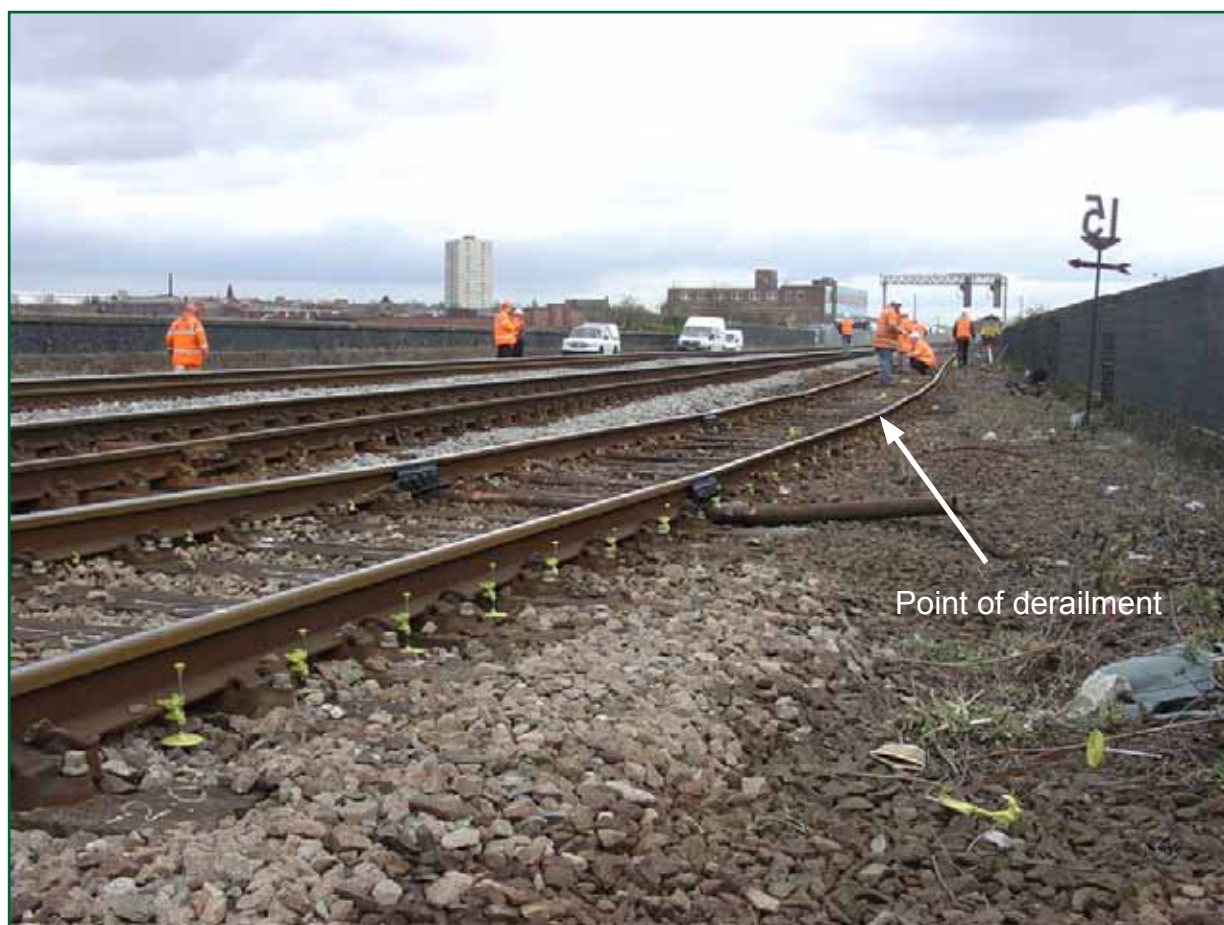
Figure 6: Track at the point of derailment

### Track

- 84 The 3 metre dynamic track twist at the point of derailment was 40 mm (1 in 74). This is more severe than the immediate action limit to close the line of a 1 in 90 twist (paragraph 71). The 3 metre static track twist at the point of derailment was 25 mm (1 in 120). This geometry defect is more severe than the 1 in 125 threshold set in NR/SP/TRK/001 and requires attention within 36 hours of discovery (paragraph 72). The point of derailment also occurred at the start of a short right-hand curve, which would have increased the probability of contact with the left leading wheel flange. That the track geometry was non-compliant, and was not detected and remedied are causal factors.

- 107 The geometry defects at the point of derailment have been corrected.
- 108 Network Rail West Midlands area have identified locations where reverse curves exist in track which is not measured by the track recording vehicles and where the rate of change of cant may make the visual identification of geometry faults difficult. These locations have been physically marked on the track and a local instruction given to ensure that measurements of cant are taken.
- 109 The following recommendation was made by the RAIB as a result of the investigation into a derailment at King Edward Bridge, Newcastle Upon Tyne (report reference 02/2008 Recommendation 4):

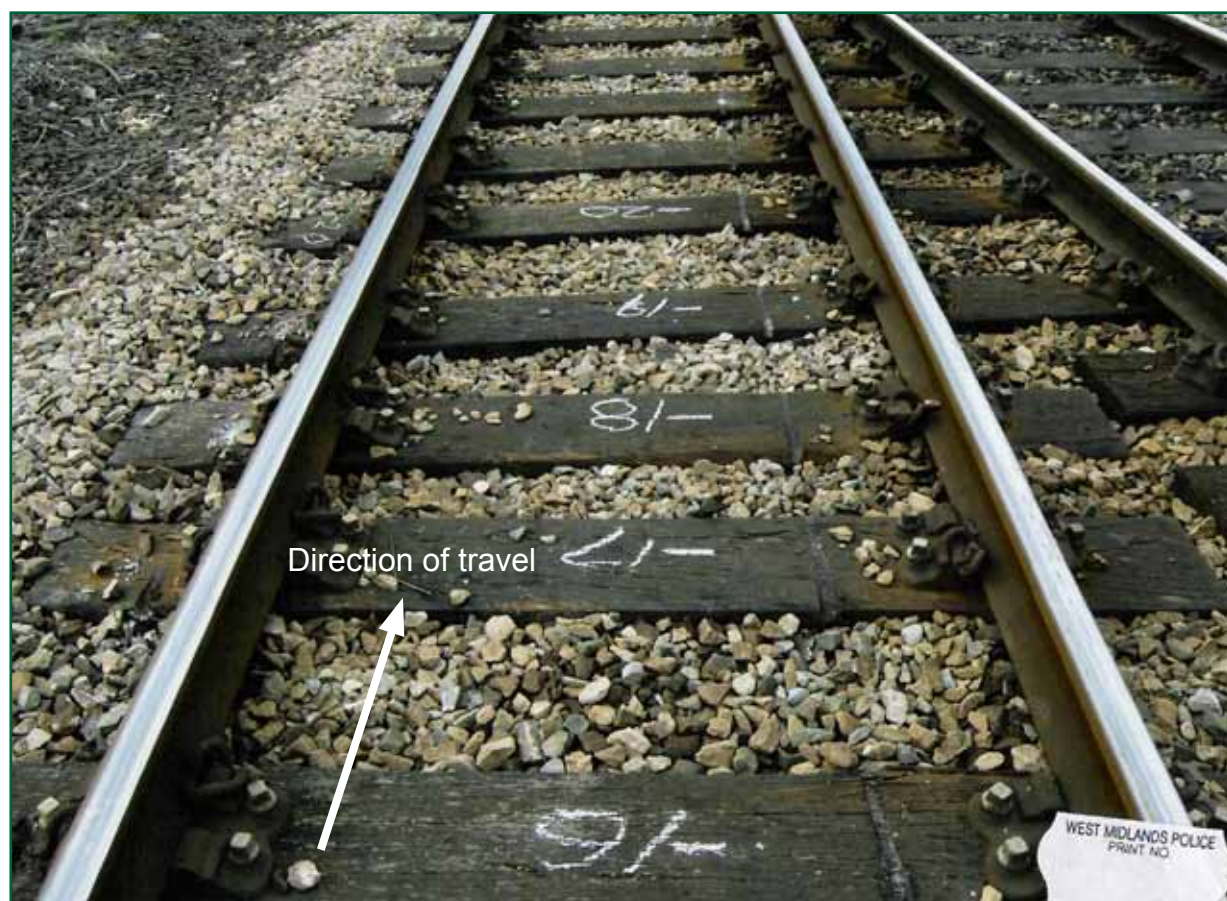
Figure 7: Damage marks (photograph courtesy of West Midlands Police)

- 30 Twenty four metres before the crossing of 677 points the left leading wheel of the 16<sup>th</sup> wagon, 470152, climbed onto the head of the left-hand rail. The wheel flange rode along the rail head for 3 metres before dropping outside the rail. Shortly afterwards the corresponding right leading wheel dropped inside the right-hand rail. Damage marks as a consequence of the derailment are shown in Figure 7.

- 83 The single flangemark on the head of the left-hand rail was clear evidence of a derailing wheel (paragraph 30). The rail head marks were long and light, which indicates a low vertical load and the absence of a large lateral force. From examination of the wagons in the train, due to the variation in the derailed running damage between the wagons, it was concluded that the left leading wheel flange of wagon 470152 rode over the left-hand rail at the location of the most severe track twist. This was the immediate cause of the accident.

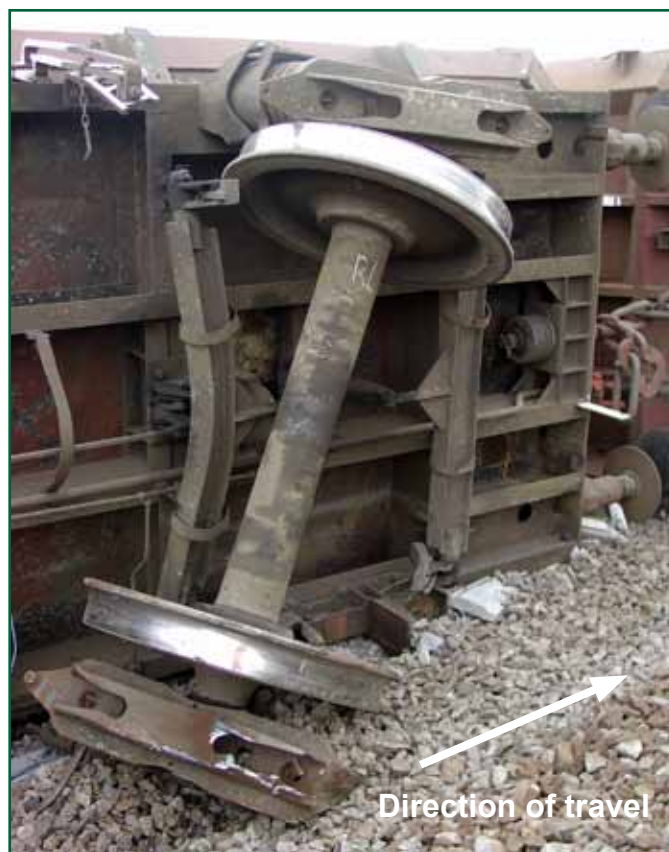
Figure 8: Damage to the left leading suspension of wagon 470152

- 34 Damage was sustained to the left leading suspension and wheel bearing of 470152 while running derailed (Figure 8). The suspension eventually failed with the springs coming adrift. The lower suspension and bearing of the left leading corner were ploughed into the ballast causing the wagon to yaw and diverge further to the left. The 15<sup>th</sup> and 16<sup>th</sup> wagons both overturned to their left-hand sides dragging the trailing end of the 14<sup>th</sup> and leading end of the 17<sup>th</sup> into derailment. During this time the *brake pipe* separated and the train brake was applied automatically.

- the 16<sup>th</sup> wagon, 470152, had significant damage to the left leading suspension, wheel and bearing and damage to other elements of its *running gear*.

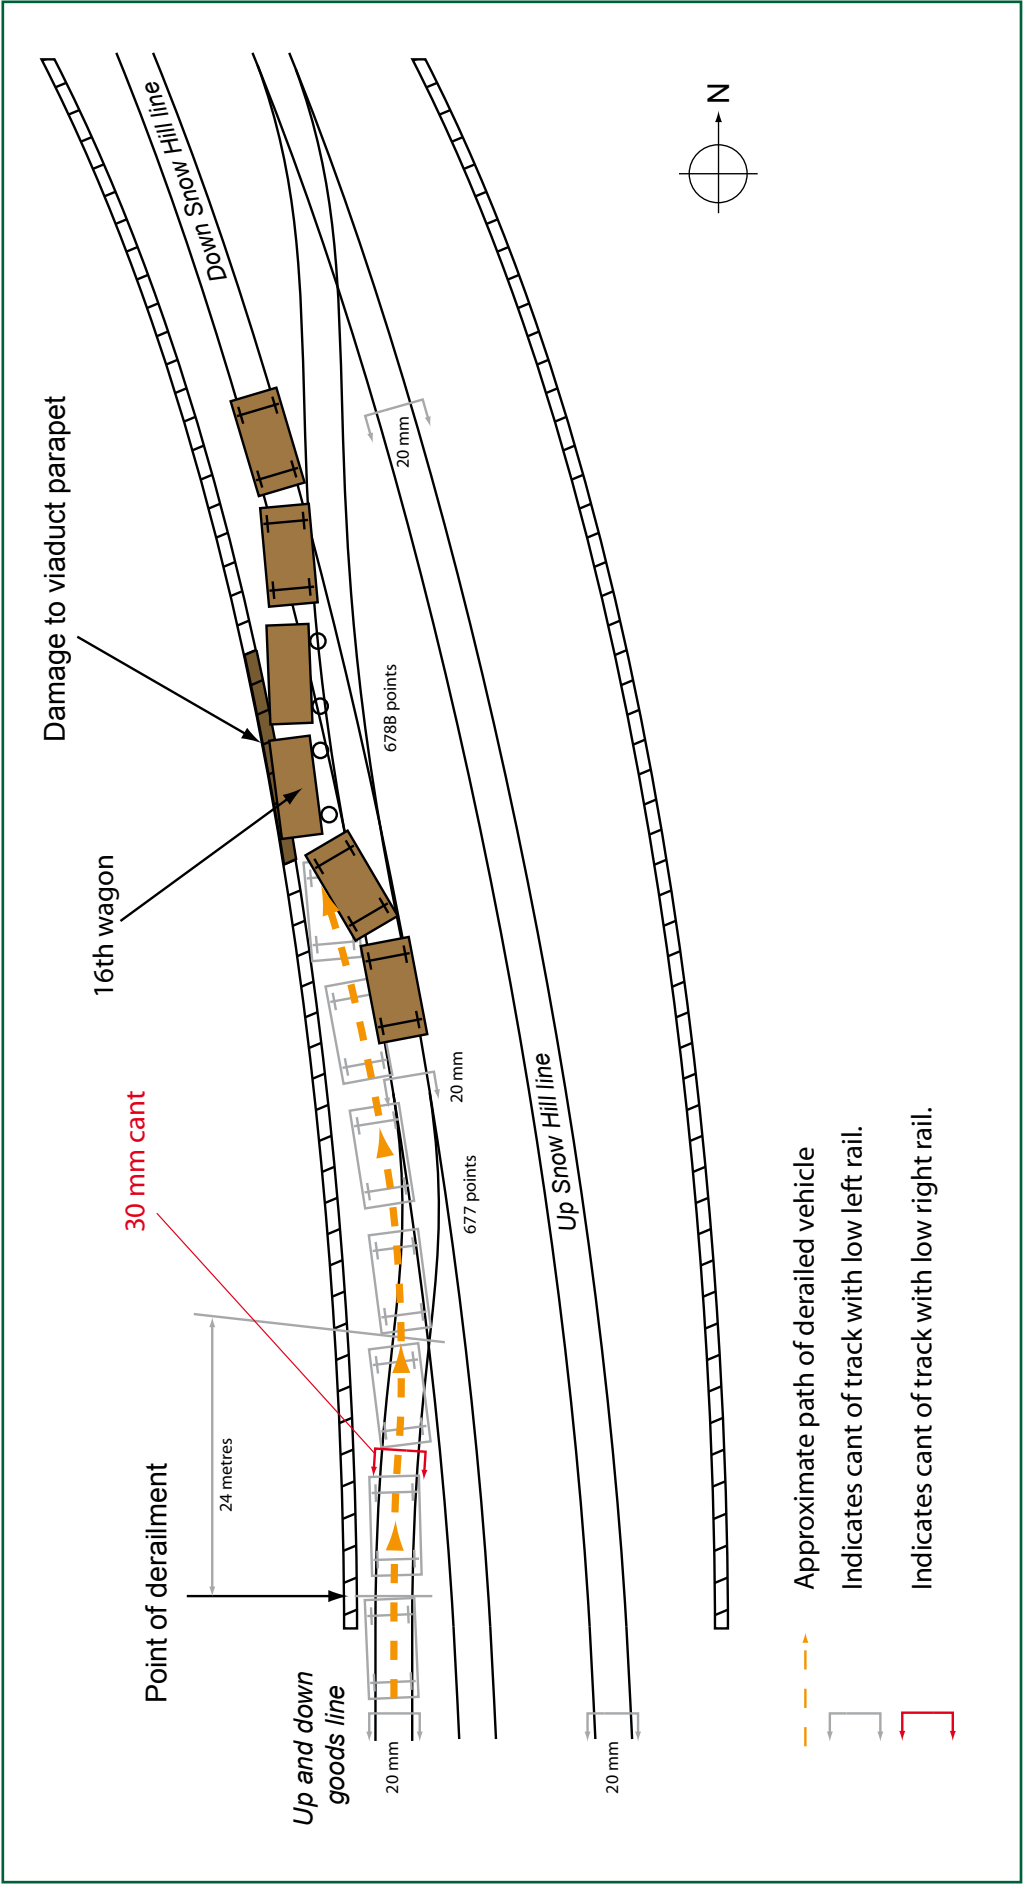
Figure 9: Diagram of derailment sequence

- 31 The wagon ran a short distance with its leading *wheelset* derailed until reaching 677 points. These points were trailing in the direction of travel and were set to allow the train access to the down Snow Hill line. The leading right-hand wheel struck the left-hand *closure rail* within 677 points and was deflected further to the left, crossing the left-hand *stock rail*. Its corresponding left-hand wheel was deflected across and outside of the left-hand *ballast shoulder* (Figure 9).

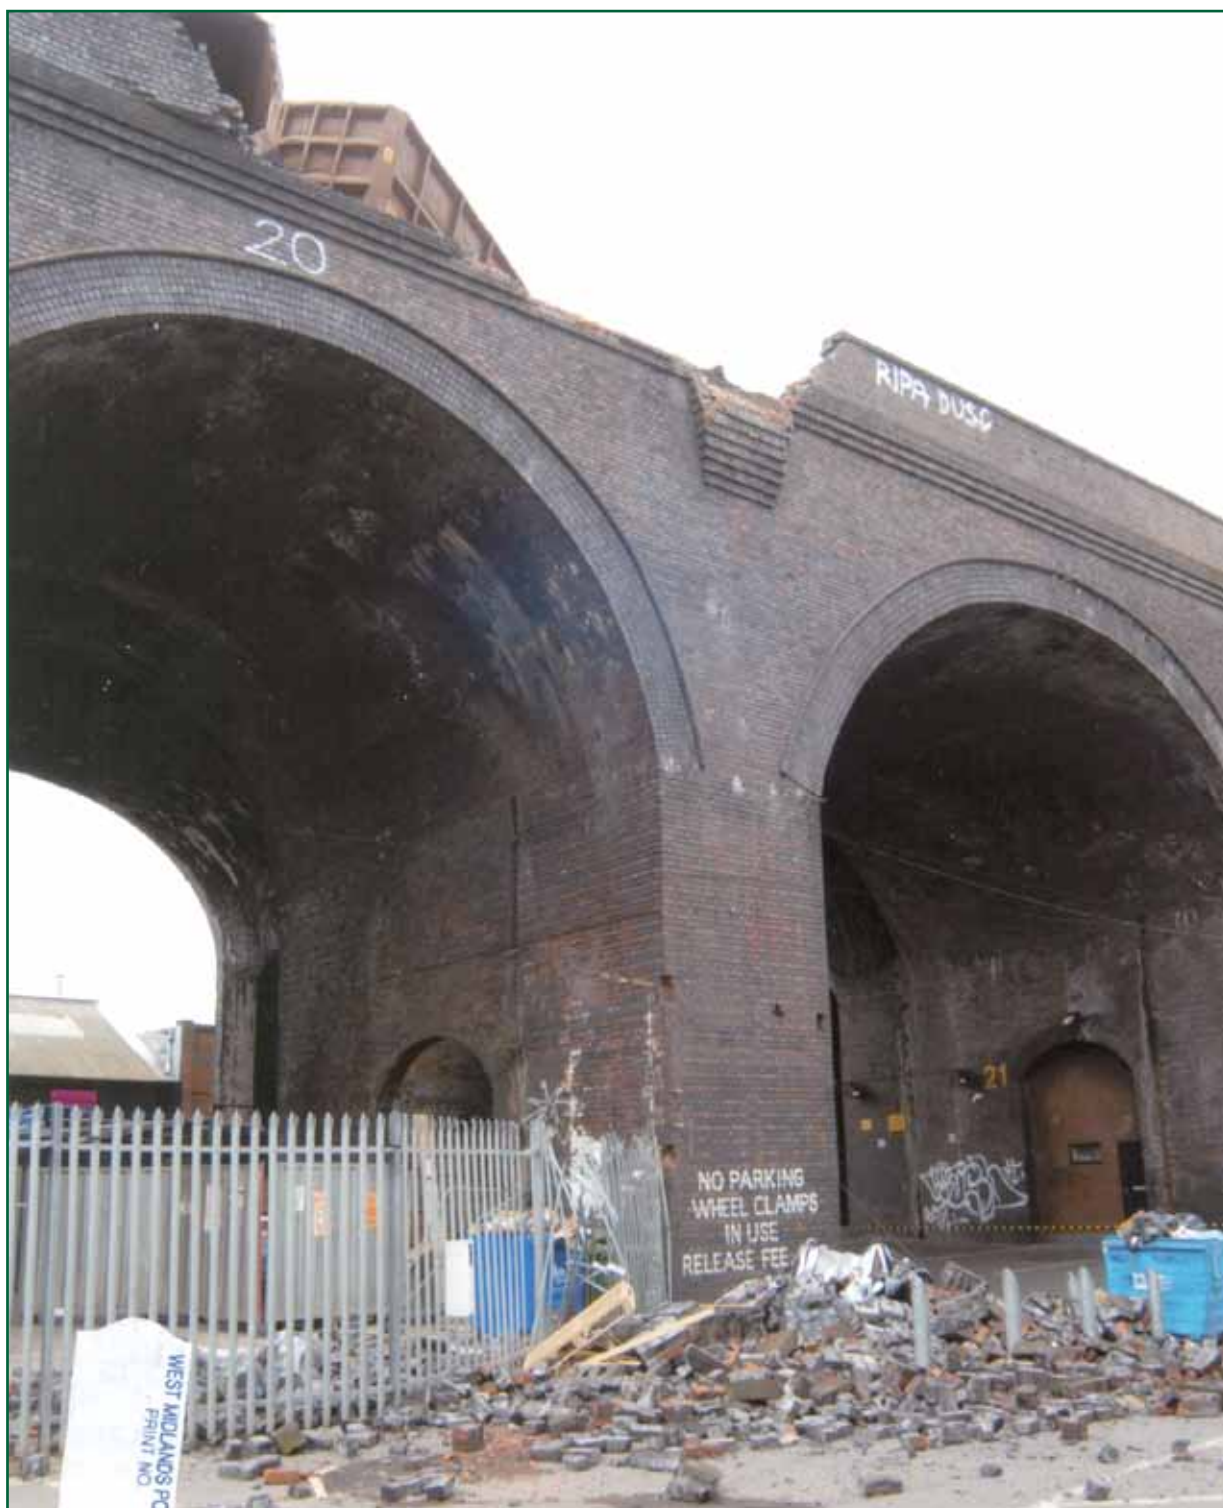
Figure 10: Fallen debris and damage to the parked car (image courtesy of West Midlands Police)

- 36 Just as the train stopped the upper trailing edge of the body of the 16<sup>th</sup> wagon, 470152, now lying and travelling on its left side, struck and displaced a 10 metre section of the brick parapet of the viaduct, which fell approximately 20 metres onto private ground below, severely damaging a parked car (Figure 10).

- 40 An unoccupied parked car was severely damaged by falling brickwork. The accident had potential for a more serious outcome, had there been any persons below the parapet.
