Rail Accident Investigation Branch

Rail Accident Report

**Collision between a train and a road vehicle on
the Leighton Buzzard narrow gauge railway
25 August 2007**

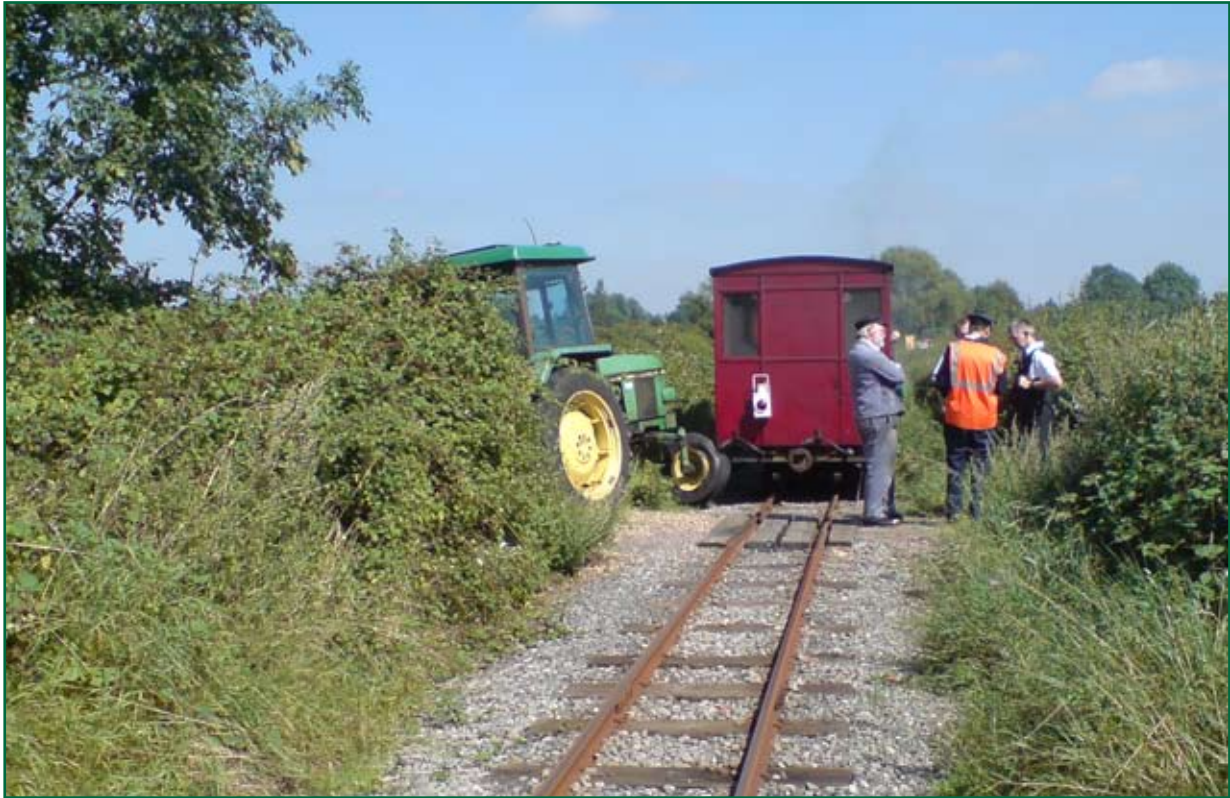
Figure 3: Position of train and tractor after collision (courtesy Leighton Buzzard Railway)

- 15 At approximately 12:20 hrs, steam locomotive, number 11, hauling three carriages, departed Pages Park station, en route to Stonehenge Works station. There were thirty seven passengers and four staff on board.
- 16 The train driver was accompanied by a *fireman* on the locomotive.
- 17 The locomotive was running chimney first. The driver was positioned on the right-hand side in the direction of travel (the south-eastern side of the locomotive).
- 18 Approximately 5 m short of the crossing the driver saw a tractor appear onto the crossing from his left hand side. He immediately applied the brakes, but was unable to prevent a collision. The tractor was pushed to one side by the locomotive, which stopped with its last carriage on the crossing and still in contact with the tractor (Figure 3).

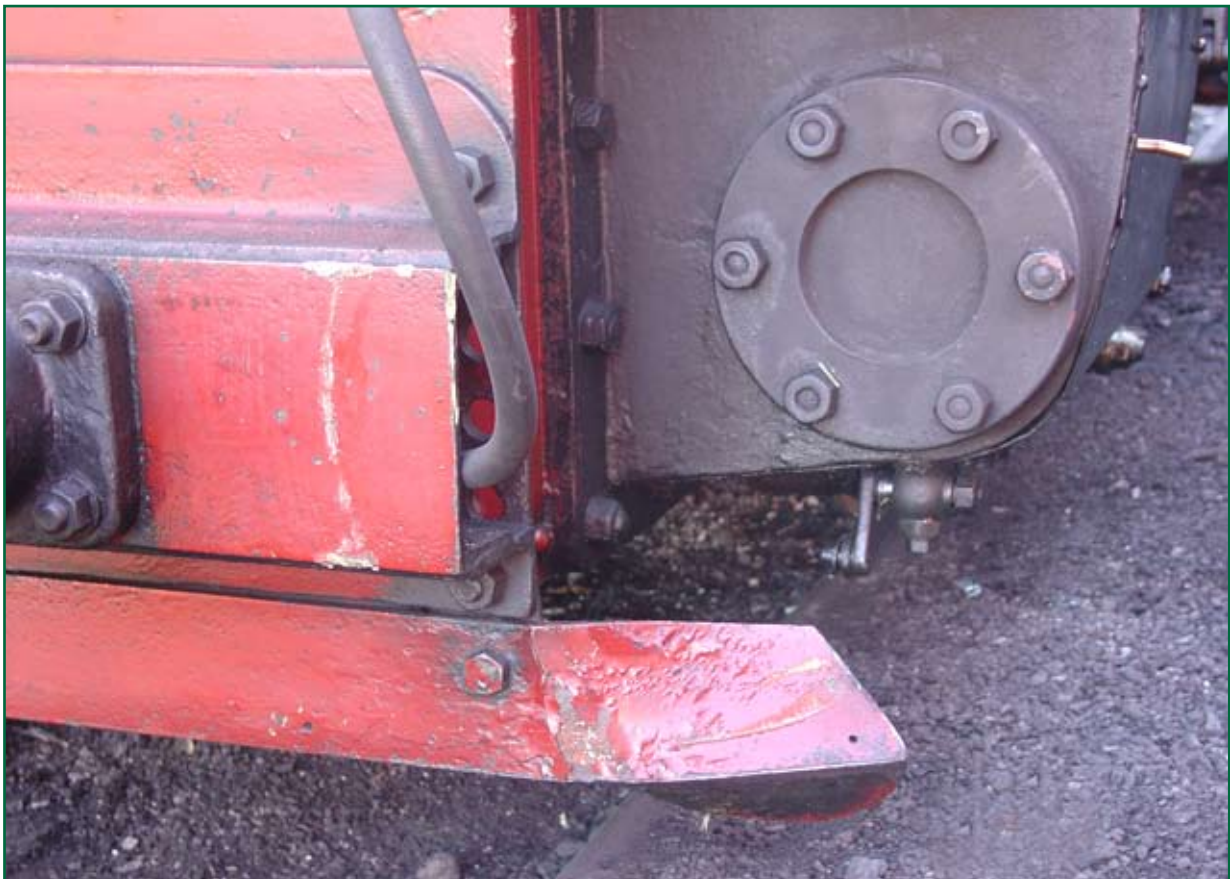
Figure 4: Damage to locomotive

20 The locomotive's front end was slightly damaged (Figure 4). The tractor's front wheels and steering were more substantially damaged.
