# Rail Accident Report

**Fatal accident at Tackley station level crossing,  
Oxfordshire  
31 March 2008**

# Fatal accident at Tackley station level crossing, Oxfordshire, 31 March 2008

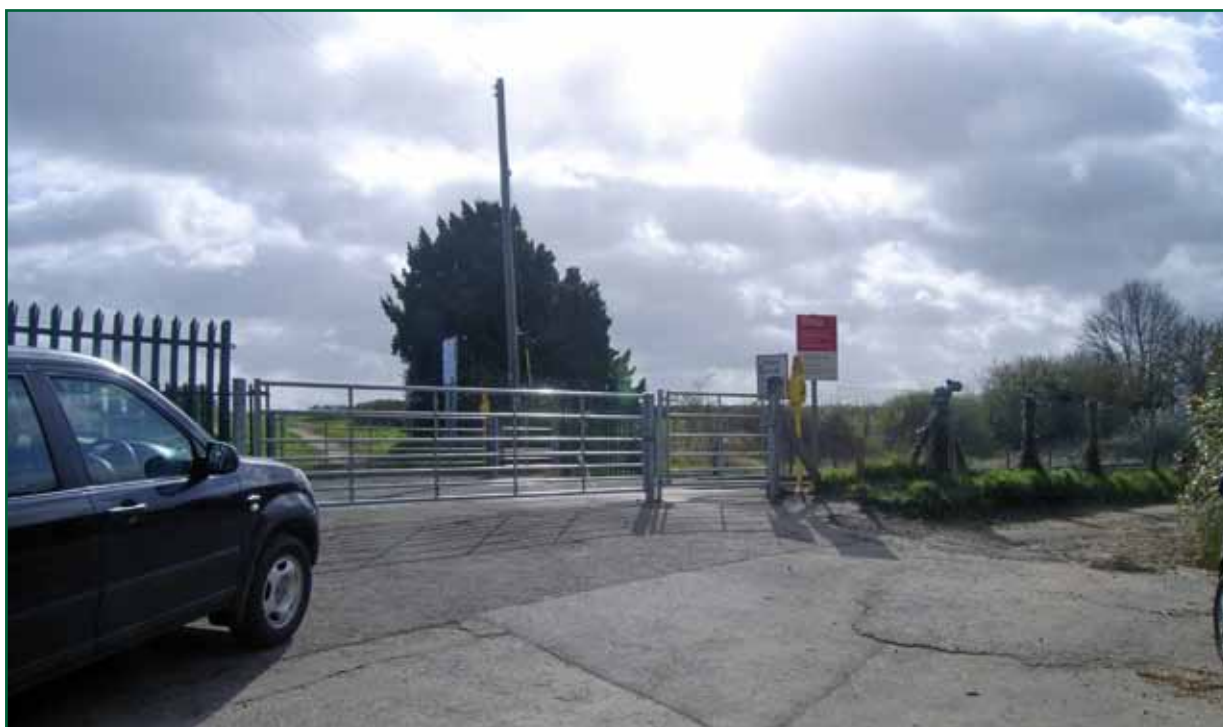
- 26 Tackley crossing is *user-worked* with separate vehicular and wicket gates, the vehicular gates normally being kept locked (Figure 2). The crossing provides three types of access:
- a. it is it is an *accommodation crossing* giving access for Tackley Estate, who are the only *authorised users*, and can use the crossing for farm vehicles in connection with managing and using the Estate;
  - b. it allows a footpath and bridleway to cross the railway, and forms part of an on-road cycle route promoted by the National Cycle Network; and
  - c. it is the only means of access to the up (London bound) platform of Tackley station from the village.

Figure 2: Approach to Tackley crossing from the down (ie village) side

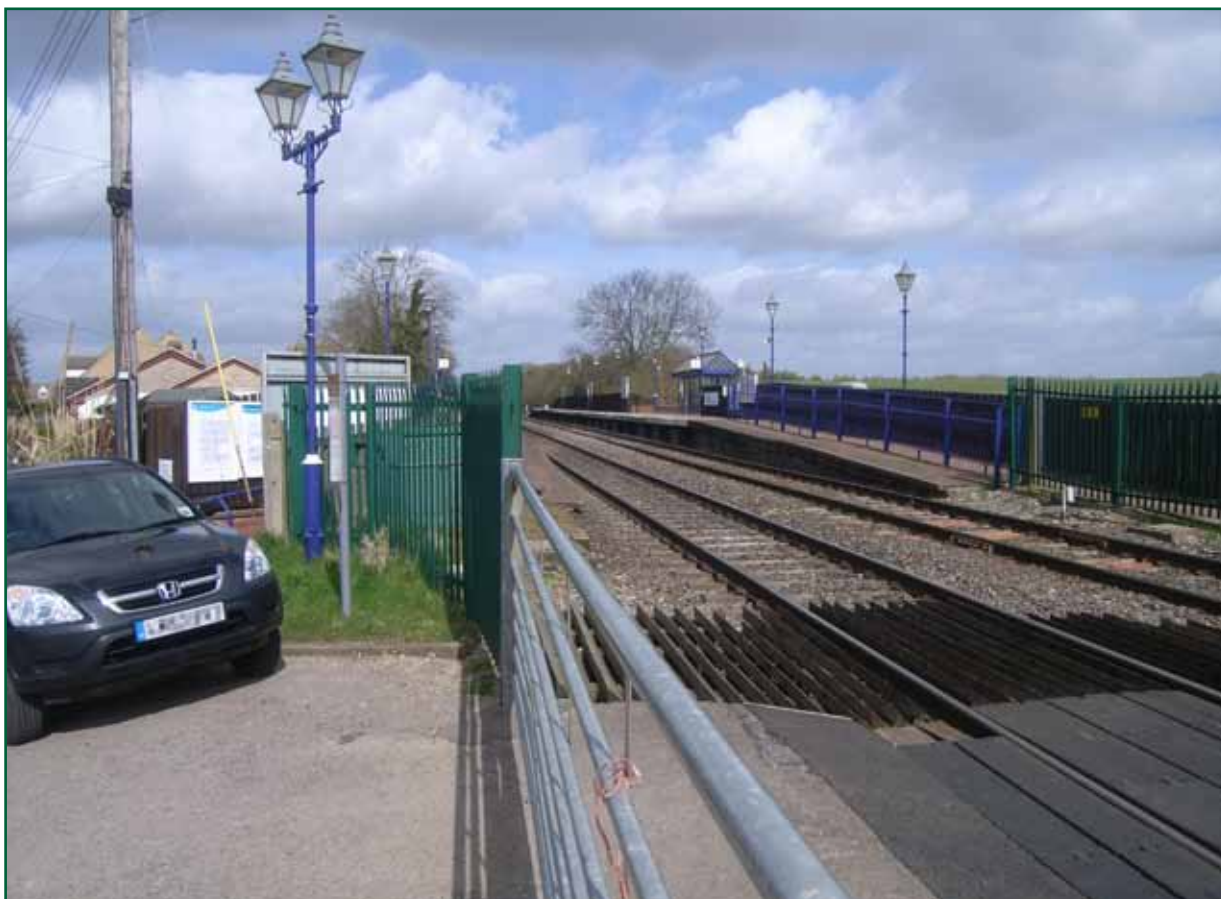
- 88 From the down side of the crossing, observing trains travelling on the up line (ie approaching from the north):
  - a. Just outside of the railway boundary (ie wicket gate): 120 metres, equivalent to 3 seconds at 90 mph (145 km/h). The palisade fence at the north-west corner of the crossing obstructed visibility from this position (Figure 3).

*Figure 3: Visibility from the down side of the crossing to the north, photographed from outside of the railway boundary*

- 116 The palisade fence reduced the visibility of trains approaching on the up line to 120 metres from outside of the wicket gate. This represents three seconds travelling time for a train travelling at 90 mph (145 km/h) and was inadequate to assess whether it was safe to cross. Adequate sighting could be obtained from within the wicket gate (paragraph 88b).

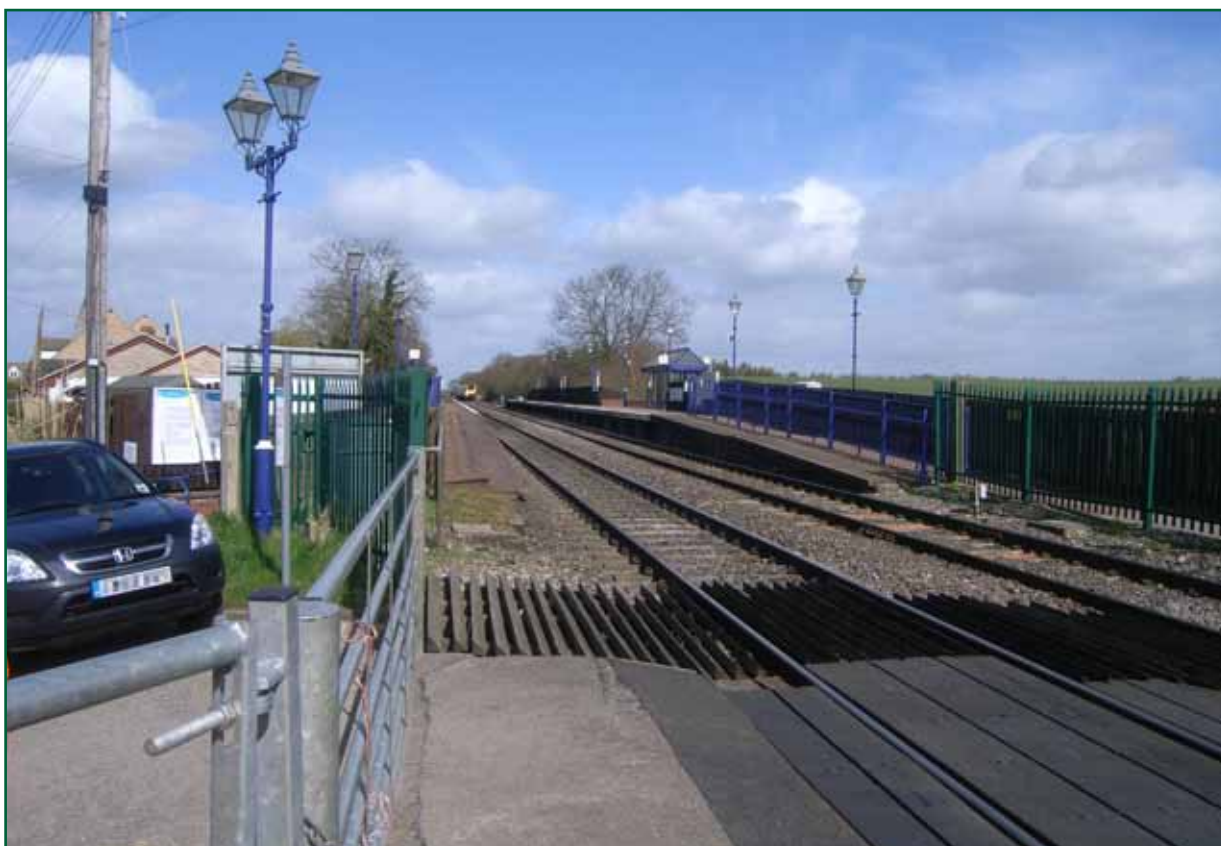
- b. Inside of wicket gate and approximately 2.2 metres from the running rail: 600 metres, equivalent to 15 seconds at 90 mph (145 km/h). This is the maximum possible distance due to curvature of the track and applies to sighting from both sides of the crossing (Figure 4).

*Figure 4: Visibility from the down side of the crossing to the north from within the wicket gate*

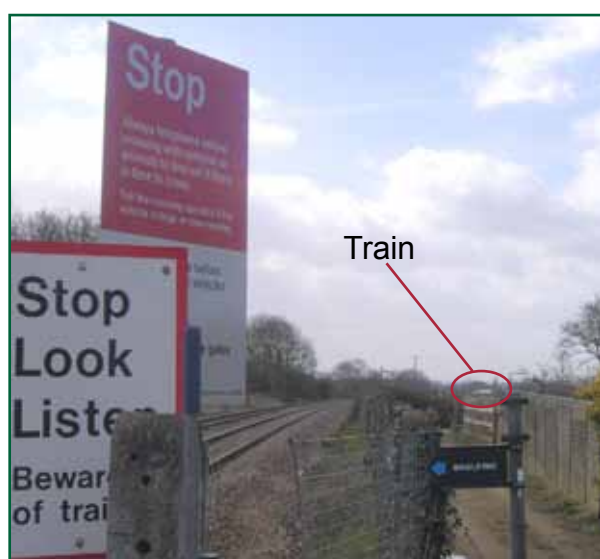
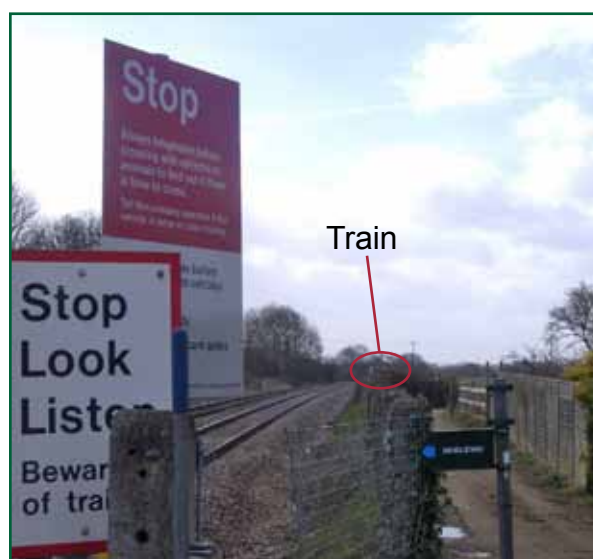
- 89 From the down side of the crossing observing trains approaching on the down line:
- Just outside of wicket gate: 925 metres, equivalent to 23 seconds at 90 mph (145 km/h). Approaching trains were visible across a field due to the curvature of the track.
  - Inside of wicket gate: 300 metres, equivalent to 7.6 seconds at 90 mph (145 km/h). Visibility from this position was restricted by vegetation on the inside of the curve growing on raised ballast, and by signs at the crossing. The roof of an approaching train was just visible above the vegetation as it passed the whistle board, 350 metres from the crossing (Figure 5) but this may not be apparent to all crossing users.

Figures 5 & 6: Train approaching on the down line, viewed from the down side of crossing outside of the wicket gate. The train is visible in the distance (Figure 5), but becomes hidden by vegetation as it approaches the crossing (Figure 6)

- 142 Sighting of trains approaching on the down line from the down side of the crossing was restricted by vegetation, some of which was growing on mounds of ballast deposited beside the track (paragraph 89, **Recommendation 6**).

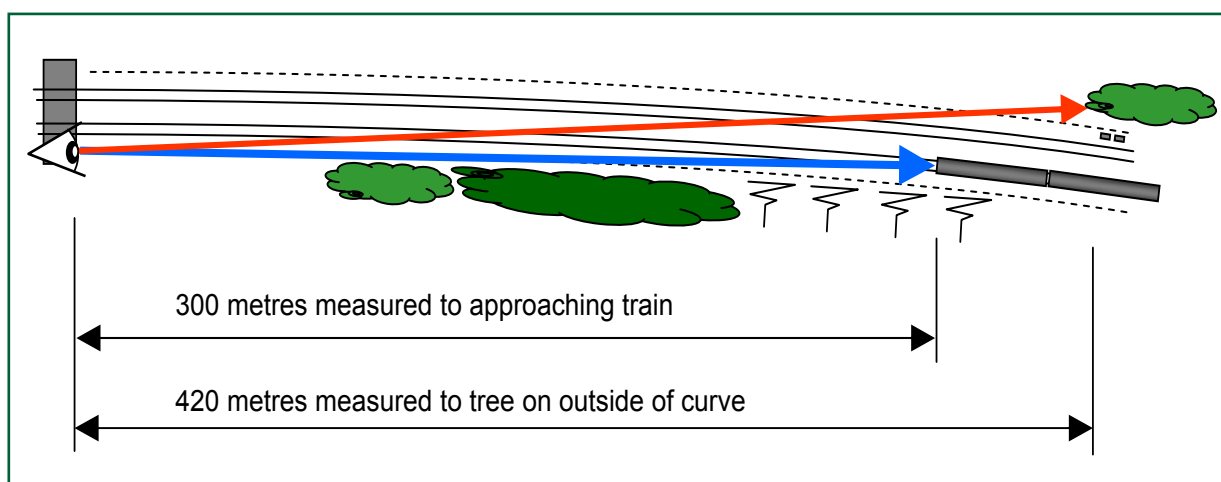
- 128 Network Rail provides training for staff responsible for inspecting level crossings and collecting data for ALCRM assessments. The training material identifies that both track curvature and vegetation can affect the sighting distance, but does not highlight the risk of error occurring if measuring to a non-specific point, or the effect of measuring to the outside of a curve (Figure 10). Range-finder equipment works by reflecting an infra-red beam off an object in its sightline. If there is no feature to reflect the beam at the required distance, the measurement will be incorrect.

Figure 10: Schematic diagram showing over-measurement of sighting distance on a curve

129 The difficulty in accurately assessing distances using range-finder equipment is evidenced by the April 2007 ALCRM assessment and December 2007 crossing inspection reports. Specifically, the ALCRM assessment used the distance to the outside of the curve, giving a sighting distance of 420 metres, 40 % greater than that calculated by the RAIB by observing approaching trains and using a stop-watch (paragraph 89b). The December 2007 level crossing inspection report gave a sighting distance from the up side of the crossing of over 800 metres, which is 30 % greater than that which is possible for trains approaching on the up line due to a curve in the track. The methods currently in use result in unacceptable variations in the measurement of sighting distances which could compromise the safety of crossing users.

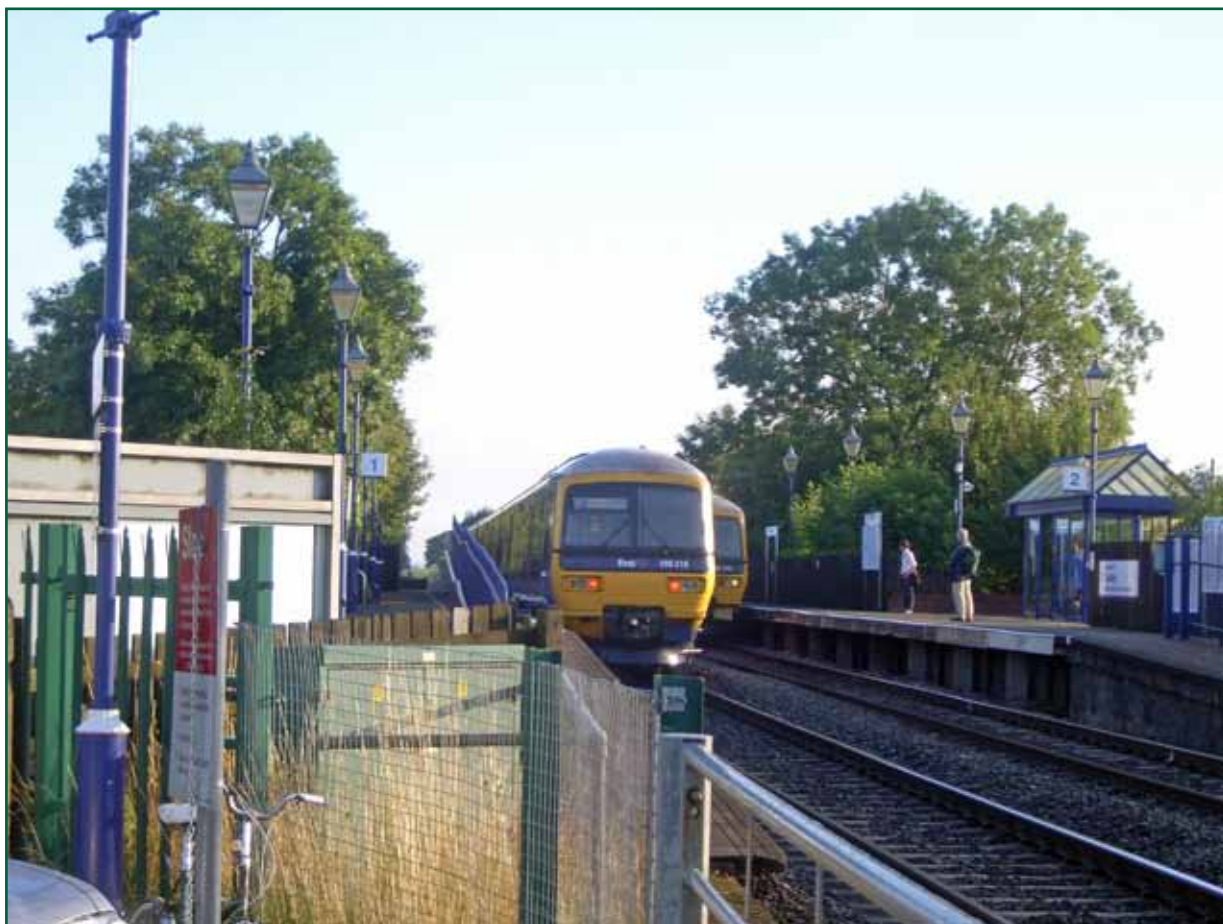
133 The visibility and audibility of trains approaching on the up line from the down side of the crossing is reduced when a train is stationary at the down platform. The respective layout of the station platforms and crossing means that a train travelling at 90 mph (145 km/h) becomes fully visible less than three seconds before it reaches the crossing. Network Rail refers to this phenomenon as a 'hidden train factor' (Figure 11).

*Figure 11: Photograph of train in down platform, in August 2008, illustrating the 'hidden train factor'. Note that the green palisade fence has now been removed, but that sighting is still affected by fencing on the platform*

134 This risk to crossing users is not identified by warning signs as the crossing is defined as a road to which the public have access, and all signs are required to comply with the traffic signs regulations. In these circumstances, the whistle board performs a vital function.

- 144 Fast trains approaching on the up line are visible for less than three seconds before they reach the crossing when a second train is stationary in the down platform. This risk is not identified to crossing users (paragraph 134, **Recommendation 1**).
