Rail Accident Report

**Derailment near Exhibition Centre station,
Glasgow
3 September 2007**

Derailment near Exhibition Centre station, Glasgow, 3 September 2007

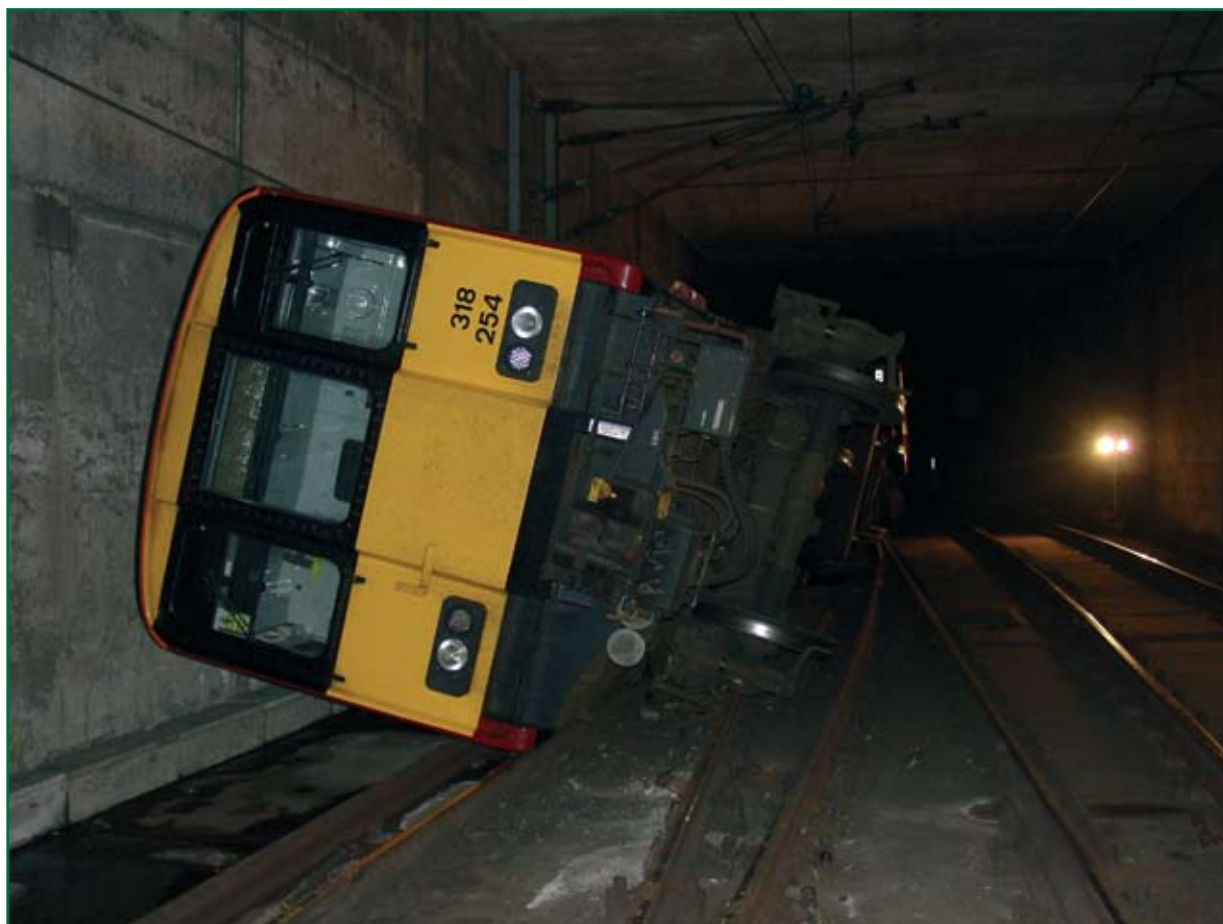
Figure 5: Photograph of the derailed carriage viewed from the Exhibition Centre end. This is shown as location 5 on Figure 3

- 60 The two drivers in the front cab heard a screeching sound and then a loud bang after which the trainee driver applied the emergency brake. As the train slowed to stop, the derailed wheels reached the crossing of 201A points and the whole bogie derailed. The vehicle immediately tilted to the left and fell against the tunnel wall coming to rest at an angle of 75 degrees from vertical.
- 61 The Motherwell driver had moved into the rear cab and was standing there, and the ticket examiner was sitting in the rearmost saloon area of the third carriage when the derailment occurred. The ticket examiner went into the rear cab to find out what was happening. As the vehicle toppled over both men were thrown and landed on the lower side, sustaining minor injuries.

- 70 The third vehicle, 77244, sustained significant damage. The second vehicle, 62870, suffered damage, particularly in the *bar coupler* housing areas.

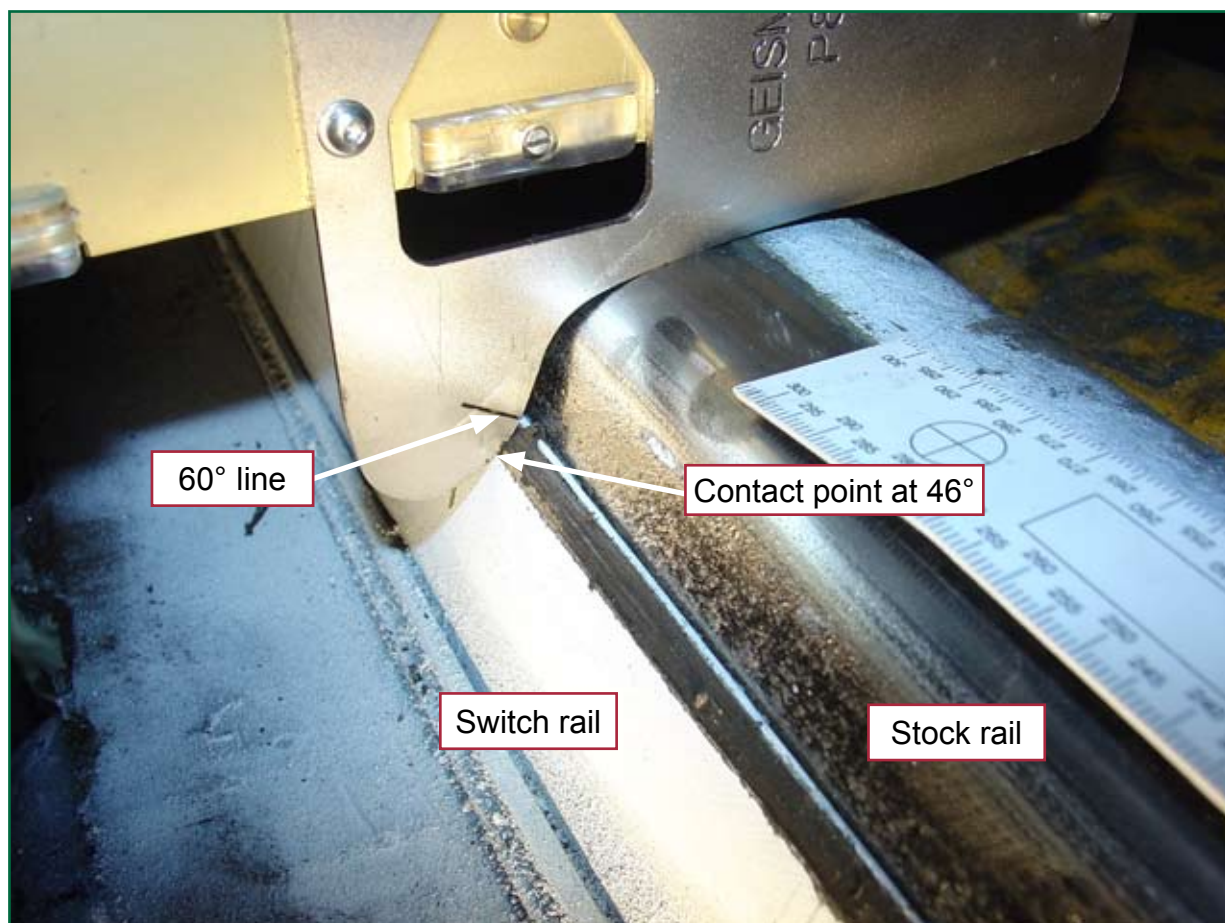
- 82 Following the derailment a track survey was undertaken in the vicinity of 201A points to check the gauge and whether track twist existed. The results of this indicated there was an area of tight gauge at the switch blades, 1429 mm at the worst point and with an average of 1430 mm. The minimum gauge permitted by *Railway Group Standard* (RGS) GC/RT5021 'Track System Requirements' at vertical points is 1430 mm with a maximum of 1438 mm. No track twist was present and apart from the defect identified in the next paragraph, there were no other factors present to initiate derailment.
- 83 There was a hazard 2 defect present on the right-hand switch rail from about 400 mm to about 710 mm from the toe. Presentation of the TGP8 gauge wheel profile clearly showed that the contact point was at 46°, significantly and noticeably below the 60° indicator line (Figure 11).

Figure 11: The TGP8 gauge used by the track inspection special examination team and 201A switch right-hand half set, with the 60° indicator well above the switch rail contact point

- 95 The NR/SP/TRK/053 tests (paragraph 73 onwards) were not carried out correctly following the grinding repair. The two inspectors did not use the TGP8 gauge in the approved manner, and consequently did not see that the contact angle was less than 60°. Firstly, they did not use the gauge at sufficiently small distances along the switch rail to find the short area with the hazard 2 defect. When measured by the RAIB at the point of flange climb, the contact angle on the gauge was found to be 46° (Figure 11). Secondly, following their briefing, the inspectors pushed the gauge over the switch rail and towards the stock rail so that the profile above the 60° mark made contact with the stock rail. This lifted the tread profile of the dummy wheelset off the rail top by 8 mm, however the inspectors did not notice the potential for the flange, below the 60° mark, to run on to the top of the switch rail.

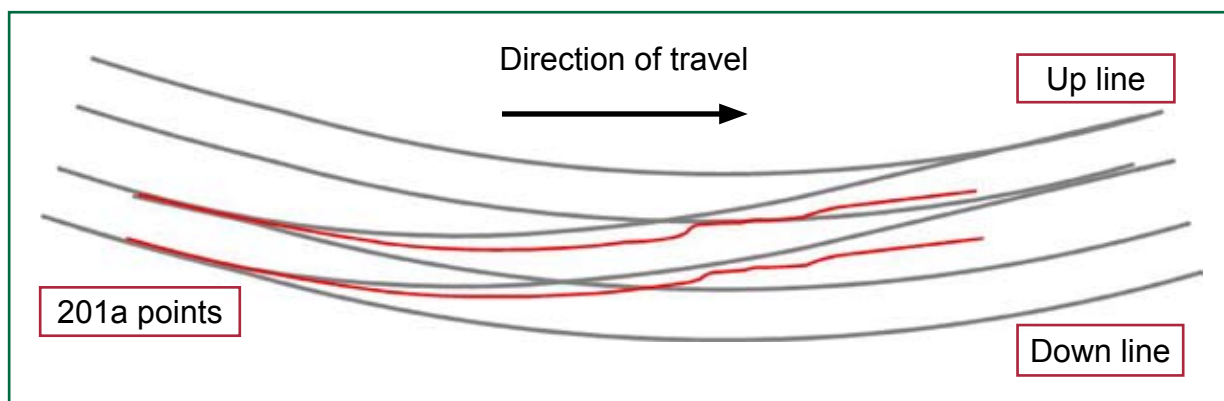
- 84 On the right-hand switch rail there was a fresh flange climb mark present from a point 410 mm from the toe, and this continued as a flange running mark across the rail head before dropping off the outside of the switch rail at the point where it diverged from the stock rail. A corresponding drop mark was noted on the left-hand stock rail where the left-hand wheel tread had been pulled off the rail.
- 85 The route of the derailed wheelset was visible by score marks in the concrete slab and broken fastenings until the left-hand wheel was 1000 mm short of the crossing. At this point there was evidence that the wheels on the second axle had derailed to the right, and had steered the third vehicle, 77244, towards the six-foot side of the track (Figure 12).

Figure 12: Illustration of the trajectory taken by the derailed wheelsets

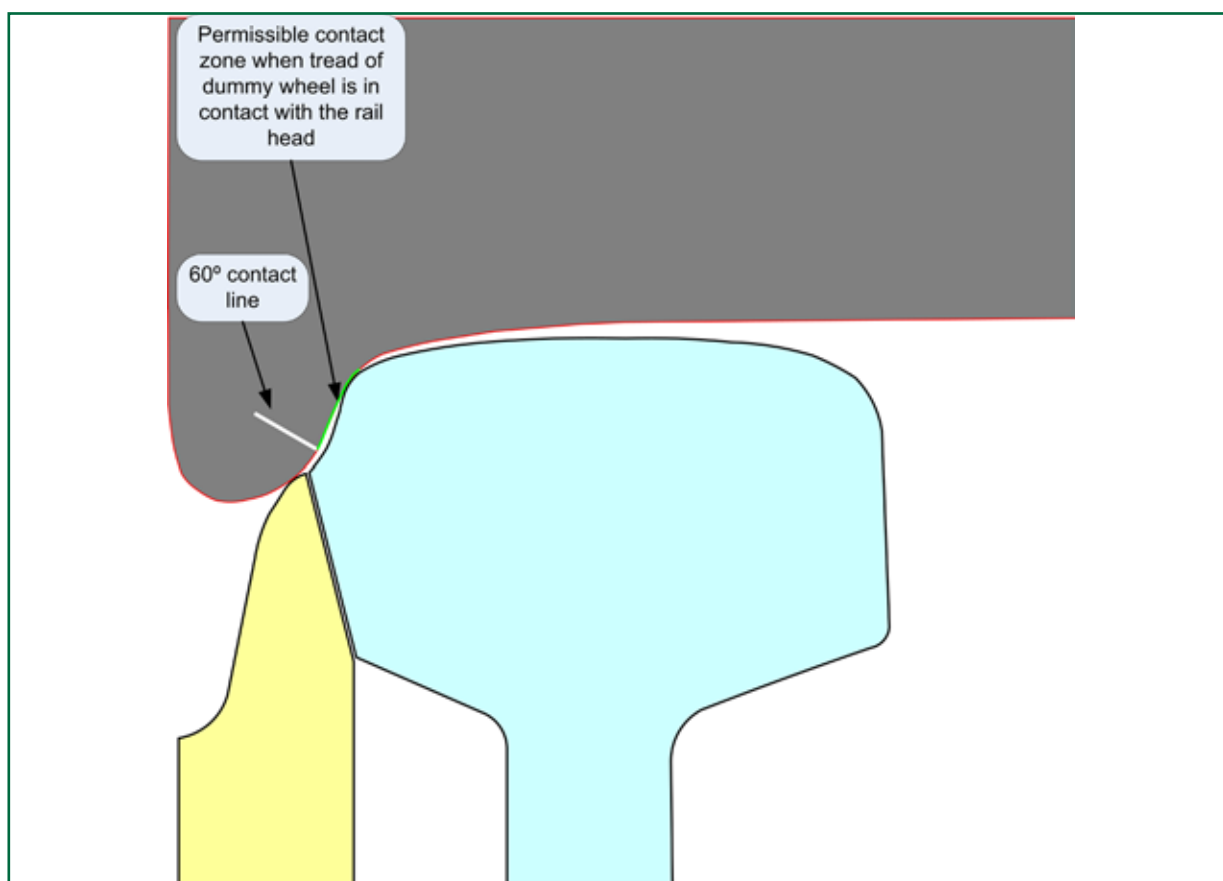
Figure 14: Diagram showing how the TGP8 gauge was used on 31 August 2007 (not to scale)

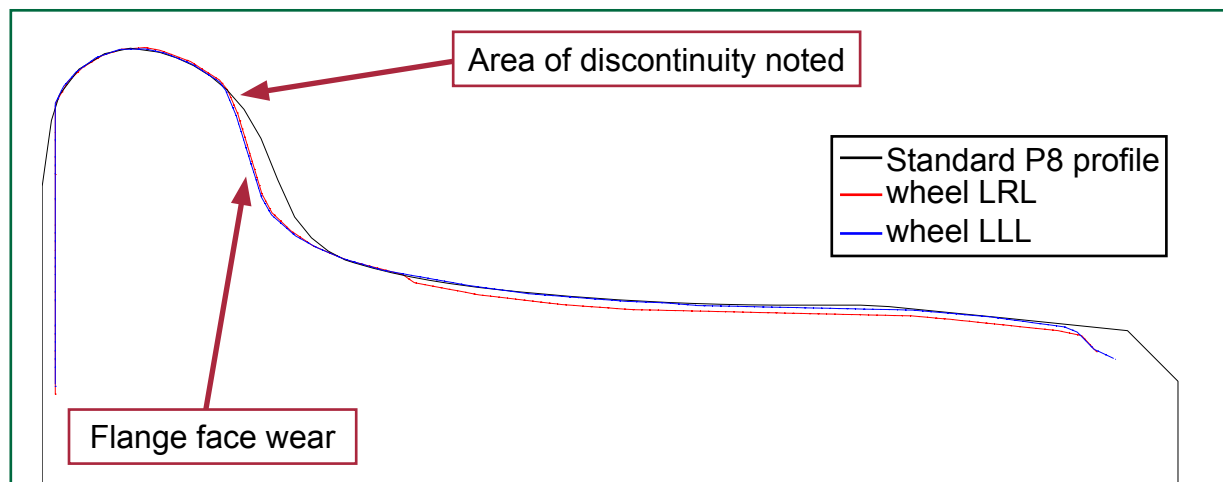
- 102 The RAIB measured the wheel profiles on coach 77244, the vehicle that derailed. These were compared to the standard P8 profile as described in GM/RT 2466 (Figure 15).

Figure 15: Overlay of wheel profiles recorded on 77244 leading axle

- 103 There was some damage sustained by all the wheels as a result of the derailment.
- 104 Certain wheel profiles on coach 77244 showed flange face wear and a discontinuity where the thinning of the flange met the normal profile of the flange tip. Figure 16 shows the nomenclature used for wheelset identification. The discontinuities were found on the wheels in positions LRL, LLL, LRT, LLT and TRT wheels.

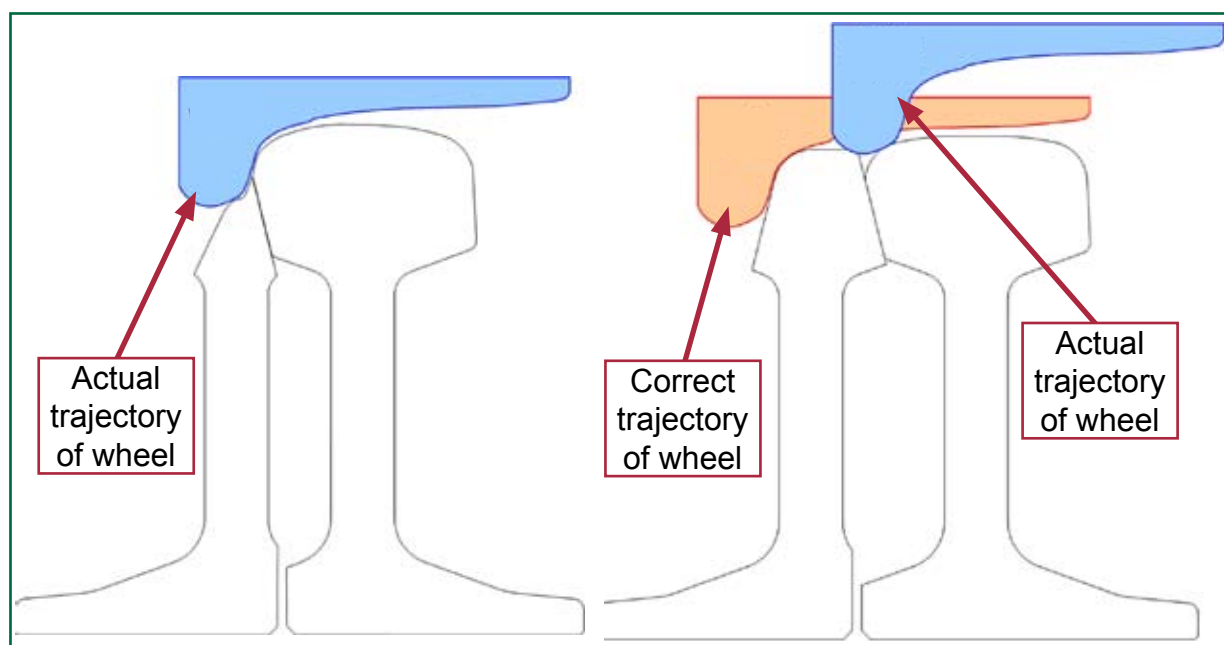
- 141 Detailed analysis of the LRL wheel of coach 77244 at the right-hand switchblade of 201A points indicates that the discontinuity described in paragraph 104 would not have initiated wheel flange climb. The discontinuity may have been caused by roll-over of material from the flange thinning however the RAIB found no firm evidence to confirm or discount this hypothesis. Once the wheel climb had started, the profile may have actively assisted further flange climb leading to the subsequent derailment. This was a possible contributory factor to the derailment.

- 142 The high rates of wheel wear reported by First ScotRail for the six months prior to the derailment (paragraph 97) are consistent with the generation of the wheel profiles found on unit 318254, which were within permitted tolerances.

Figure 17: 77244 LRL wheel profile overlaid on 201A switch profile

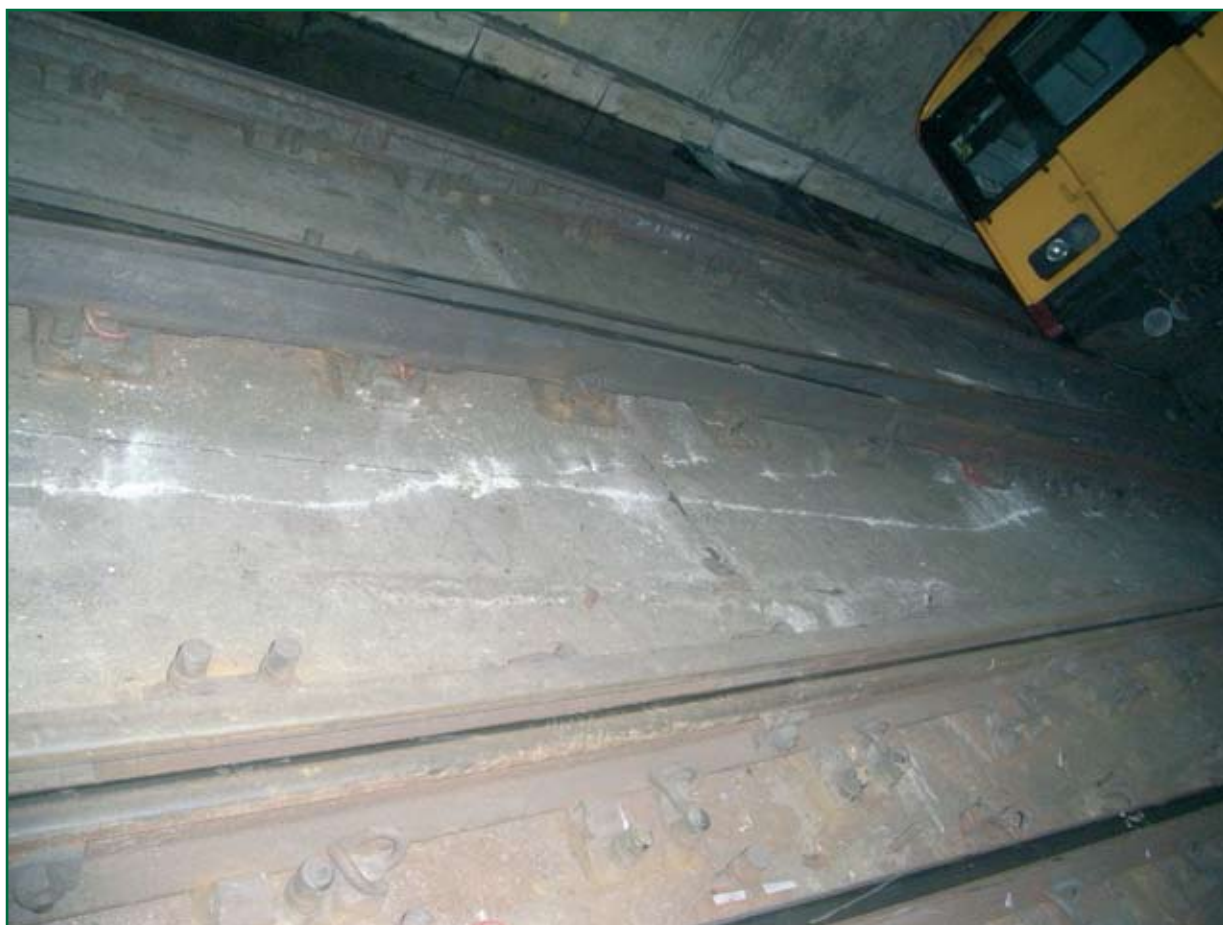
147 The extent to which vehicle 77244 rotated and toppled over was unusual in such a slow speed and short distance derailment. That may be due to the fact that the derailment occurred on slab track (paragraph 143).

Figure 18: Slab track with fixtures connected directly to the base concrete. Also scores made by the flanges of the derailed wheels.
