Rail Accident Report

**Signal passed at danger and subsequent
near miss at Didcot North junction
22 August 2007**

Signal passed at danger and subsequent near miss at Didcot North junction, 22 August 2007

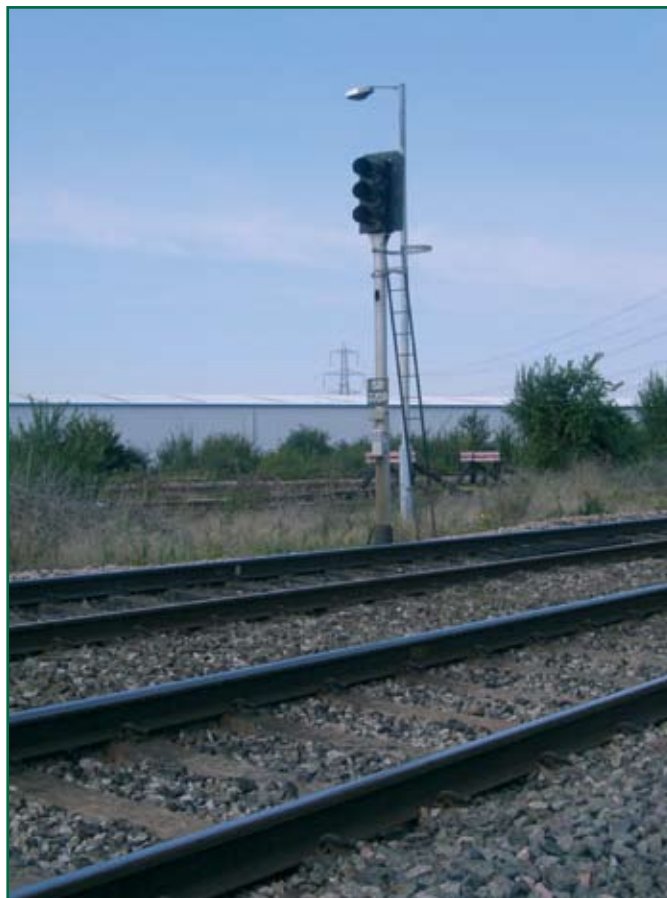
Figure 2: Signal SB2209

- 22 The signal that was passed at danger during this incident was located at the north end of the Down Avoiding line, 225 m south of Didcot North junction.

- 130 The visibility of signal SB2209 had been assessed by a Signal Sighting Committee following the incident in March 2004. The committee concluded that the aspect of SB2209 would become visible to a driver at a distance of 400 m. This was greater than the 250 m that had been assessed as the *minimum reading distance* for the signal. The committee did not identify any factors that would cause the sighting of the signal to be non-compliant with the relevant RGS, GE/RT8037, nor did it identify any additional measures other than the clearance of vegetation on the approach to signal SB2209. This finding was reflected in a recommendation of the investigation panel (paragraph 79).

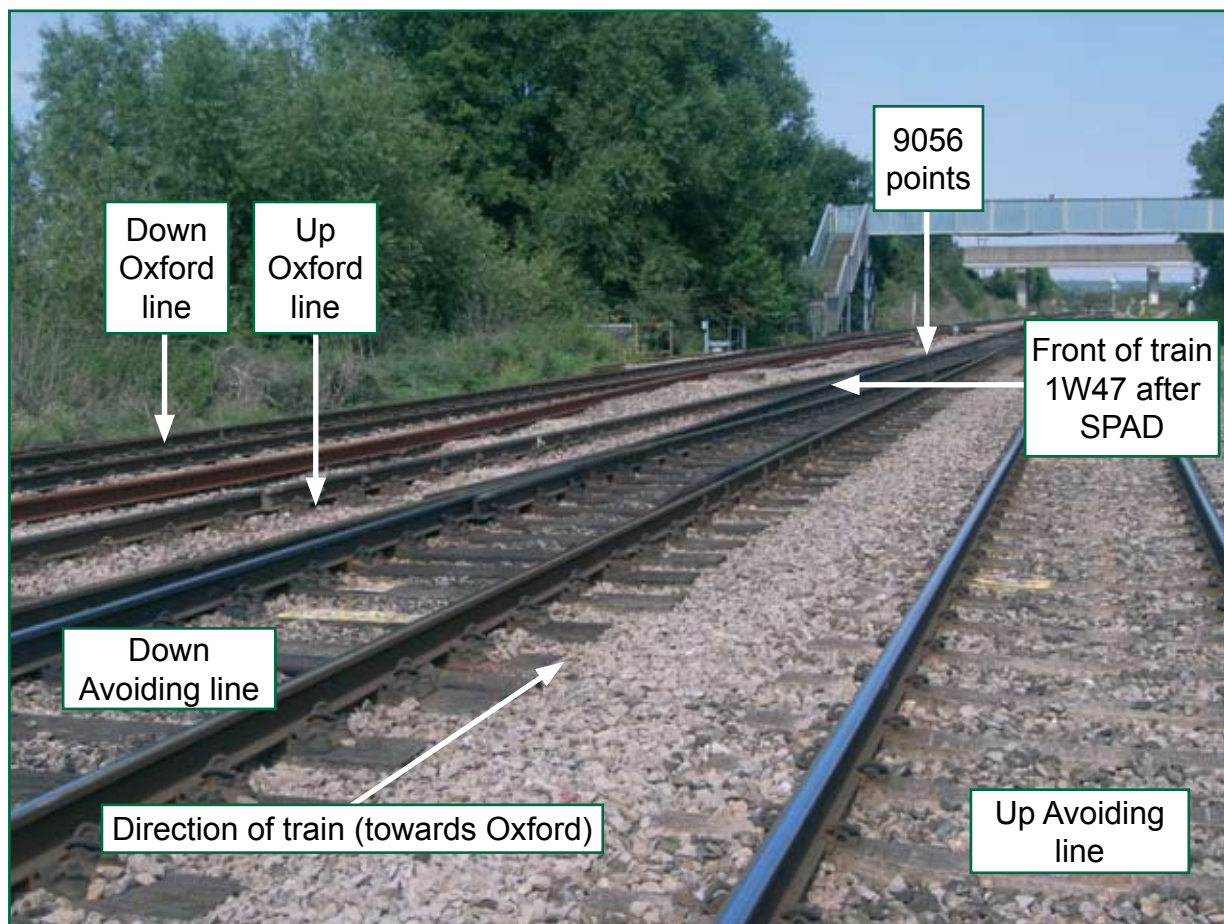
Figure 3: Didcot North junction

- 5 At 16:38 hrs on 22 August 2007 train 1W47, the 15:51 hrs First Great Western passenger service from London Paddington to Worcester Shrub Hill, formed by a High Speed Train (HST) set, passed SB2209 signal at danger on the *Down Avoiding line* to the north of Didcot Parkway station. At the same time train 2P66, the 16:21 hrs First Great Western passenger service from Oxford to London Paddington, was just passing clear of the junction after being routed from the *Up Oxford line* towards Didcot Parkway station. Despite the correct operation of the *Train Protection Warning System* (TPWS) equipment, train 1W47 did not come to a stand until it had run onto the Up Oxford line, foul of the junction (Figure 1).

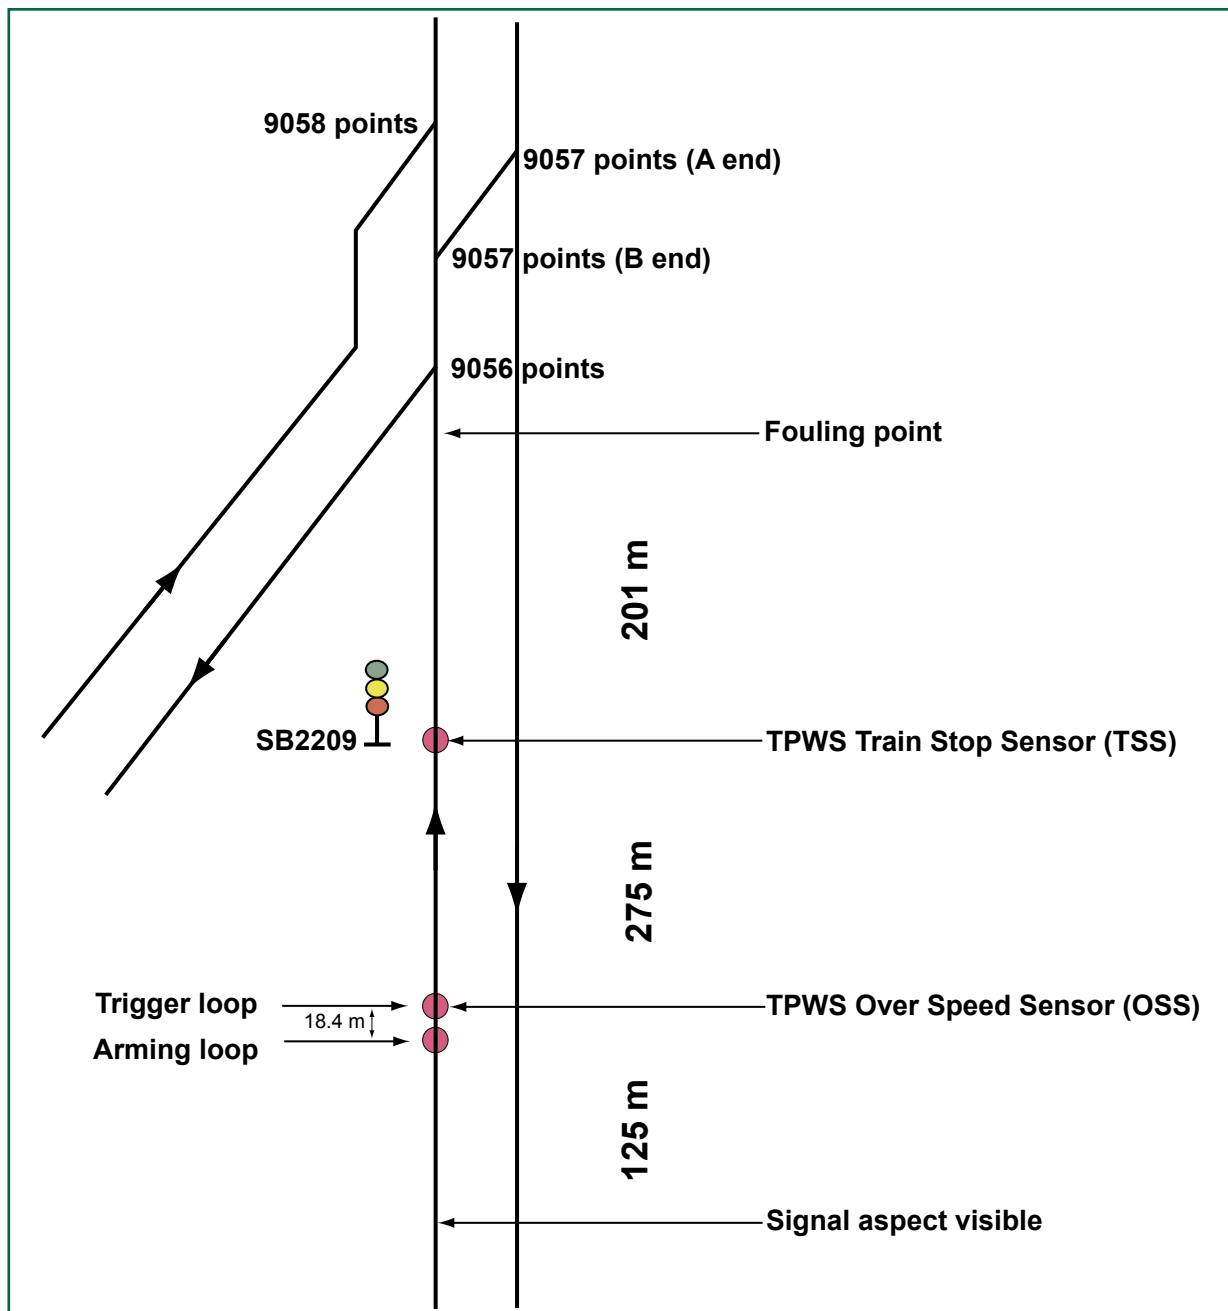
Figure 6: Track layout, the arrangement of signalling equipment, TPWS and key dimensions in the immediate proximity of signal SB2209

<i>Sighting distance</i> of signal SB2209	400 m
Distance between over speed sensor <i>arming</i> and <i>trigger loops</i>	18.4 m
Distance between over speed sensor trigger loop and signal SB2209	275 m
Speed at which the over speed sensor would cause the emergency brakes of a passenger train to apply	41.5 mph (67 km/h)
Distance between signal SB2209 and fouling point	201m

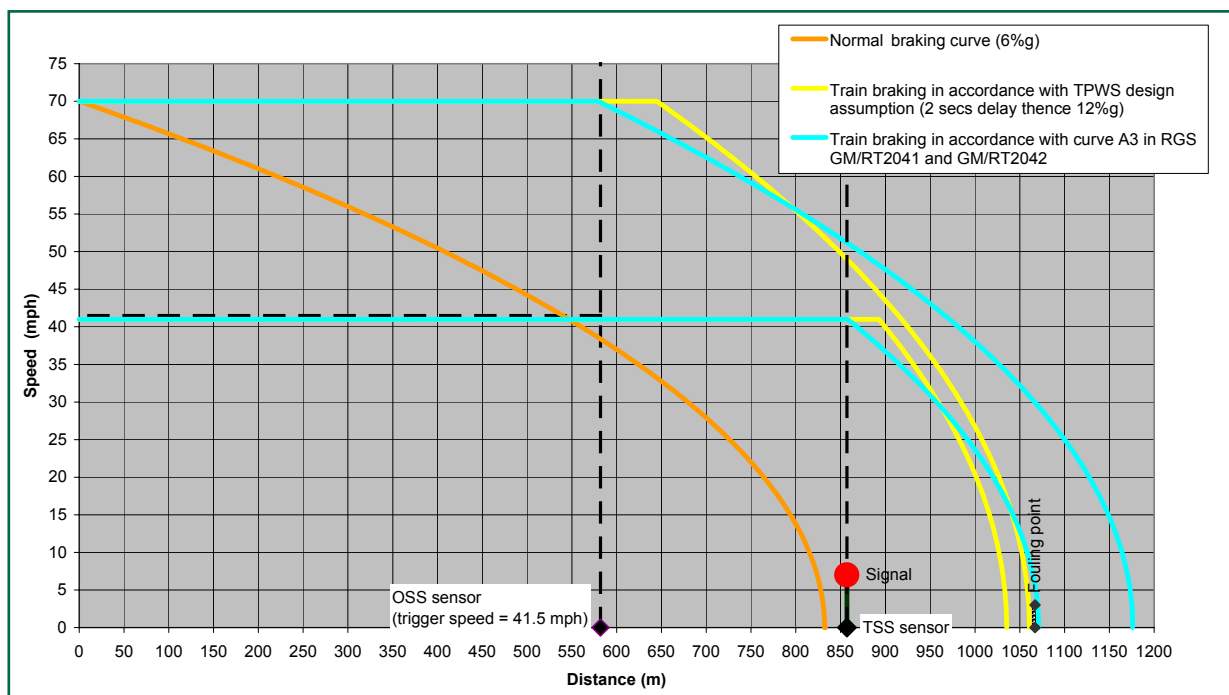
Figure 8: Typical TPWS arrangement for permitted speed of 70 mph with a 'safe over-run distance' of 201 m

- 142 The graph at Figure 8 demonstrates that the typical configuration of TPWS equipment is sufficient to bring a train that has passed a signal at danger to a stand before the fouling point, provided its braking performance is at least consistent with the TPWS design assumption. However, this performance cannot be assured for trains that are designed to comply with the minimum requirements of current Railway Group Standards.

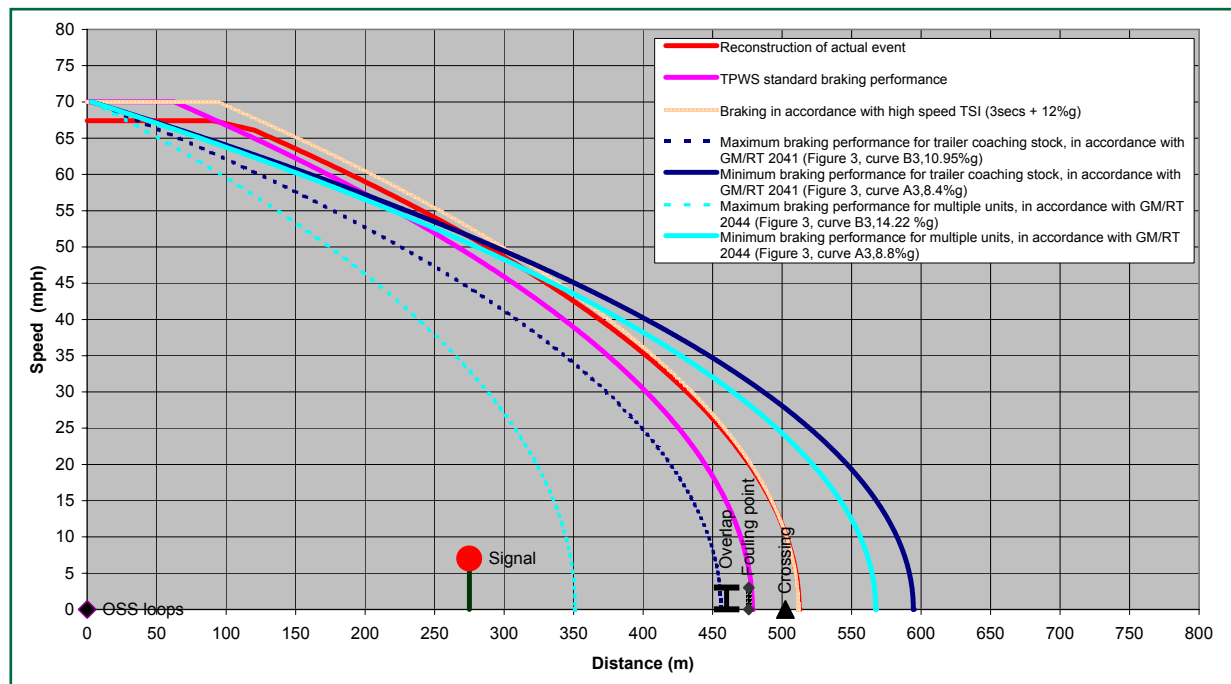
Figure 9: Standard braking curves from 70 mph following TPWS intervention at OSS loops ('classic' TPWS configuration - as signal SB2209, Didcot)

212 Even new passenger trains designed in accordance with the current Railway Group Standards are not guaranteed to possess braking performance consistent with that specified for TPWS. The graph at Figure 9 shows that the minimum braking performance specified for new trailer coaching stock and multiple units in RGS GM/RT 2041 and 2044 is below that assumed in the design of TPWS.
