Rail Accident Report

Collision at Exeter St Davids station 4 January 2010

This report is published by the Rail Accident Investigation Branch, Department for Transport.

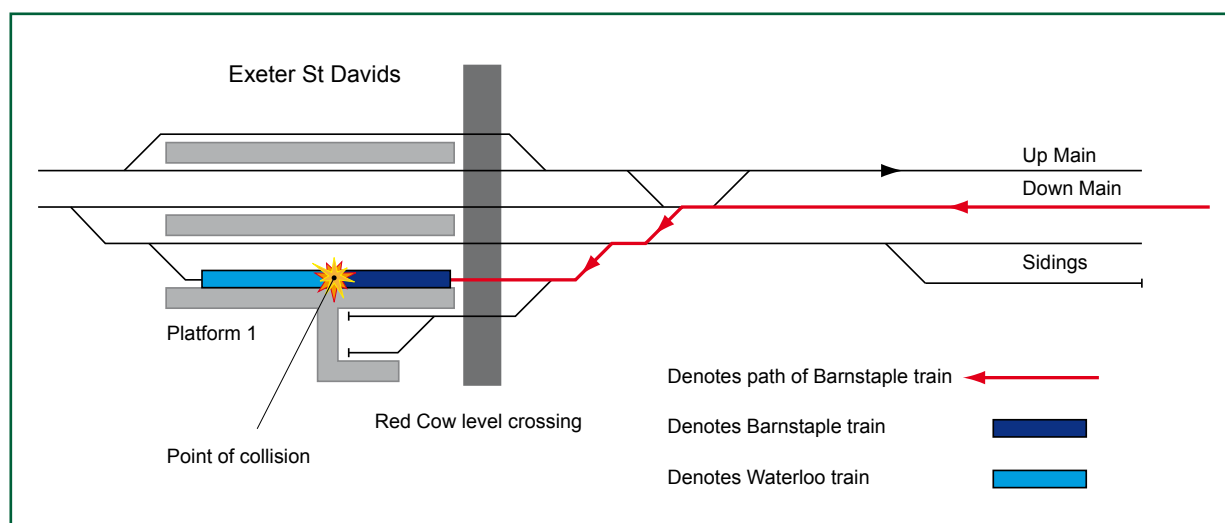
Figure 2: Layout of track and path of train involved

- 15 On the immediate approach to platform 1 from the east end of the station, trains pass over Red Cow closed circuit television (CCTV) level crossing (see figure 2). This level crossing is situated on a busy road linking the A377 with the Exwick area of Exeter.

- 77 A causal factor was a length of low adhesion at Red Cow level crossing and at the eastern end of platform 1 at Exeter St Davids station (paragraph 33).

Train operators should, for locations where hazards exist immediately beyond a level crossing such as high risk signals, bay platforms or stations with permissive working, highlight within their route risk assessments and route learning and briefing material the possibility of drivers encountering unexpected low adhesion conditions at that crossing and the risk arising from wheel slide (paragraph 79b).

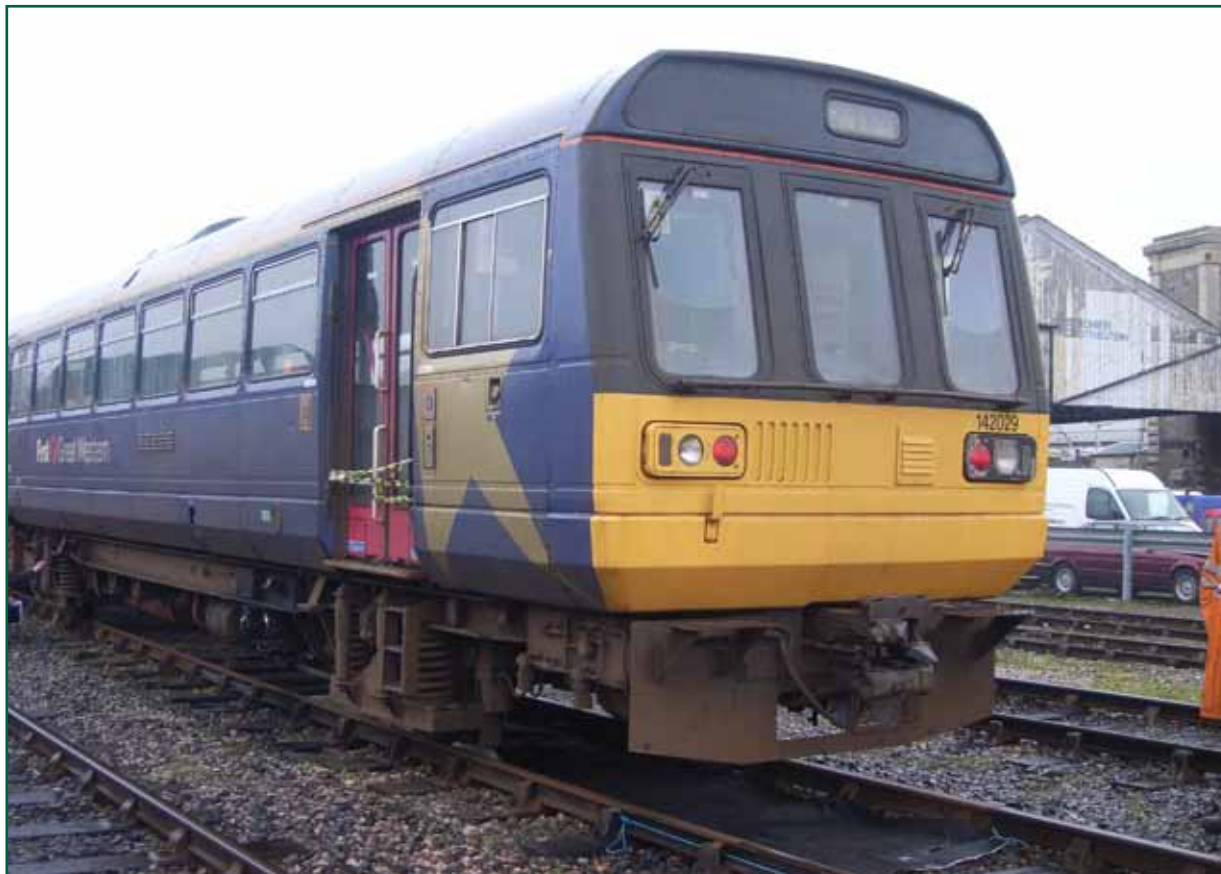
Figure 3: Class 142 'Pacer' unit involved in the accident at Exeter St Davids

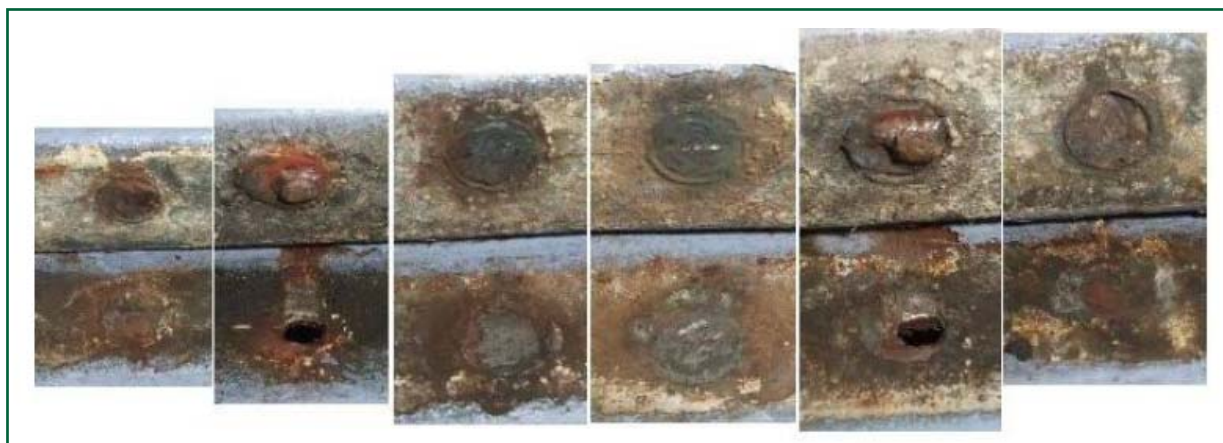
Figure 5: Failed welds (channel weld portion in top images and doorframe in bottom images) (Images courtesy of FGW)

- 79 Although not linked to the accident at Exeter St Davids on 4 January 2010, the RAIB observes that:
- a. the failure of the welds holding the window in the door giving access to the rear driving cab from the passenger saloon and subsequent detachment of the glass on the class 142 unit created the potential for an injury for anyone who had been in the vicinity (paragraph 73, see paragraph 80);
 - b. not all train operators systematically identify in their route risk assessments the potential hazards associated with low adhesion where there may be a need for trains to stop immediately beyond a level crossing (paragraph 75, **Recommendation 1**).

- 80 Following the accident, FGW issued an urgent safety advice in accordance with Railway Group Standard GE/RT8250 'Reporting High Risk Defects' to inform other operators of class 142 units of the door glass detachment weld issue.
- 81 In the light of this action addressing the factor identified in paragraph 79a, the RAIB has decided not to issue a further recommendation.
