# Rail Accident Report

## **Derailment of a freight train at Carrbridge, Badenoch and Strathspey 4 January 2010**

# **Derailment of a freight train at Carrbridge, Badenoch and Strathspey, 4 January 2010**

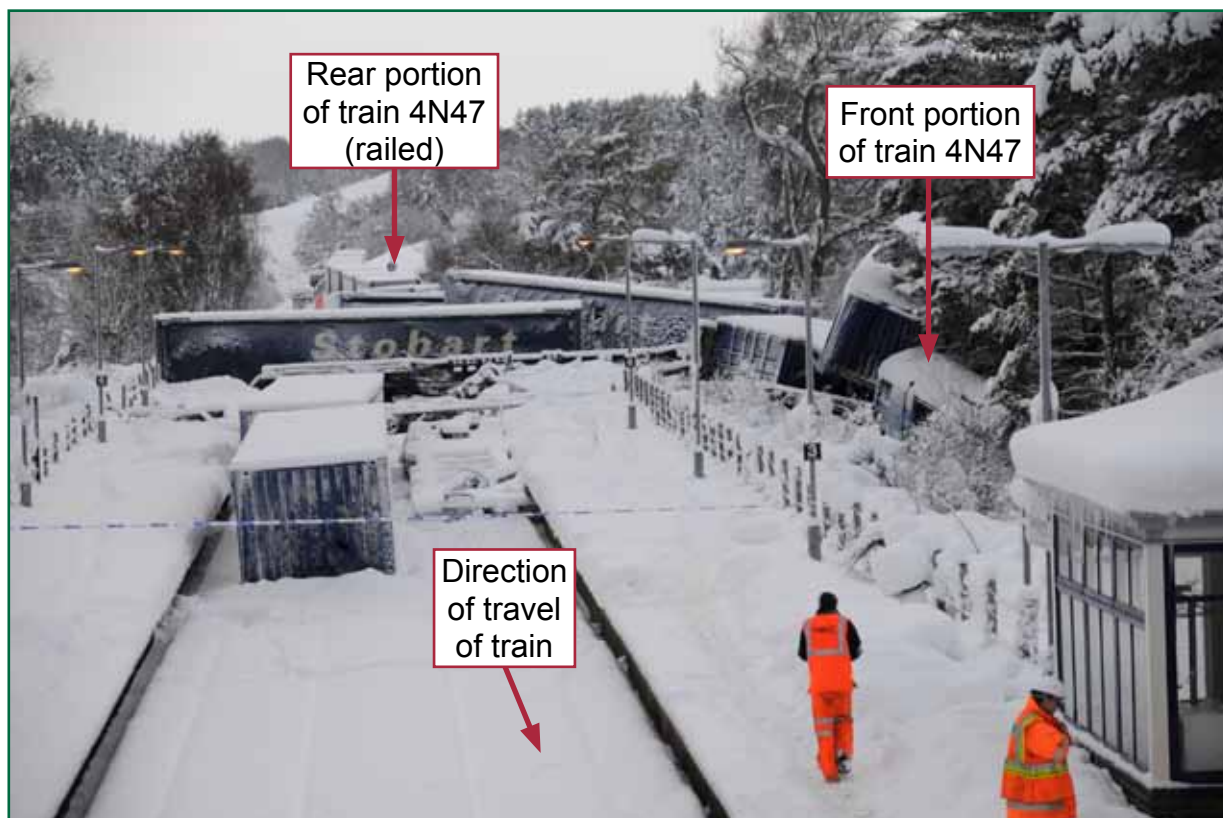
- 61 The locomotive and the front six wagons (twelve elements) derailed. They, and some container loads which had become loose, came to rest in a number of locations, including within the gardens of nearby houses and foul of the running lines through Carrbridge station. The rear four twin wagons (eight elements) did not derail or lose their containers.

Figure 11: Train 4N47 on the morning of 5 January 2010 (image courtesy of the British Transport Police)

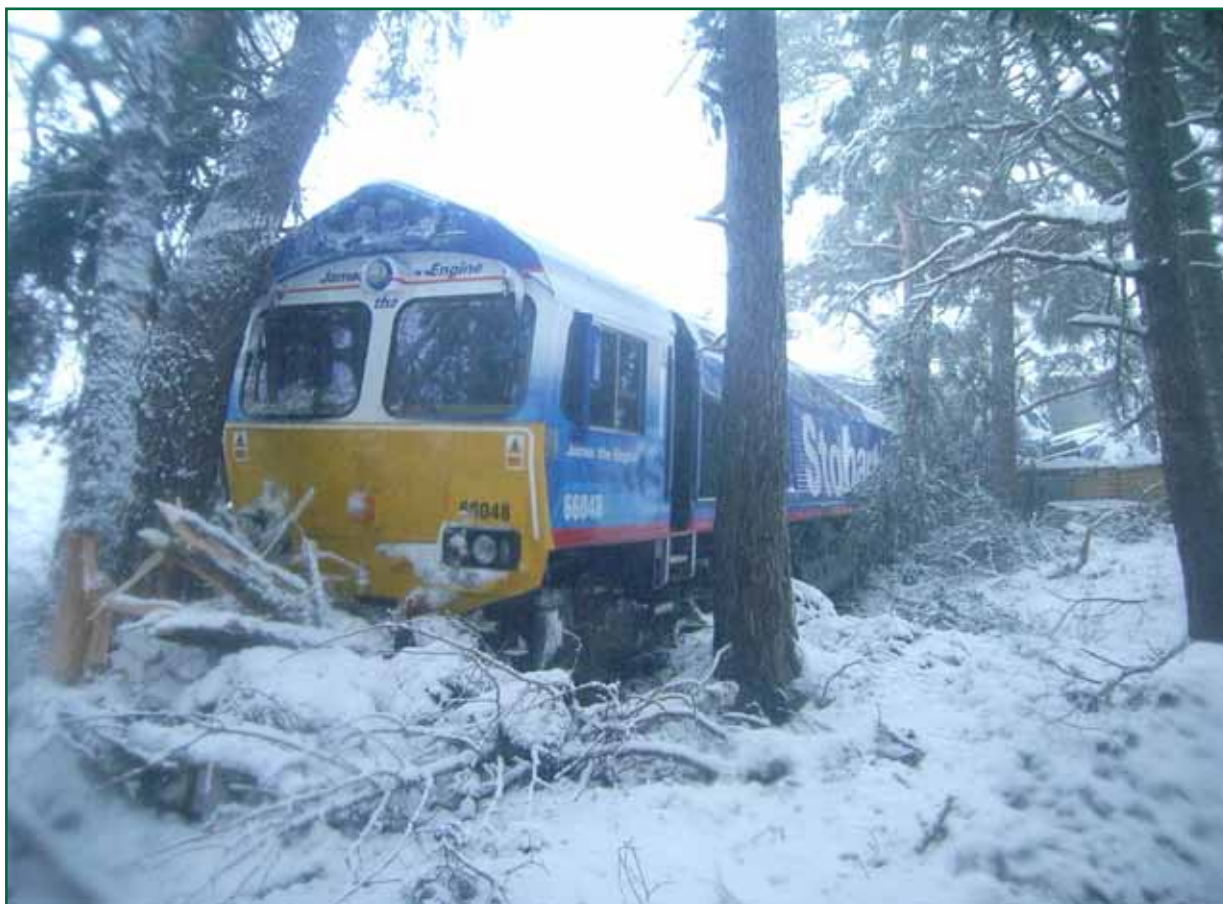
- 62 Both staff onboard 4N47 received minor injuries as a result of the derailment.
- 63 Locomotive 66048 was damaged during the derailment and remained out of service for some months. All six wagons which derailed were damaged, as were their container loads; some of these wagons and containers were damaged beyond economic repair.
- 64 There was damage to the infrastructure including the destruction of signalling equipment and points, damage to the track and damage to the platform at Carrbridge station. There was also damage to the gardens of the houses affected.
- 65 The line through Carrbridge station remained closed until 11 January 2010.

Figure 12: Final resting position of locomotive 66048

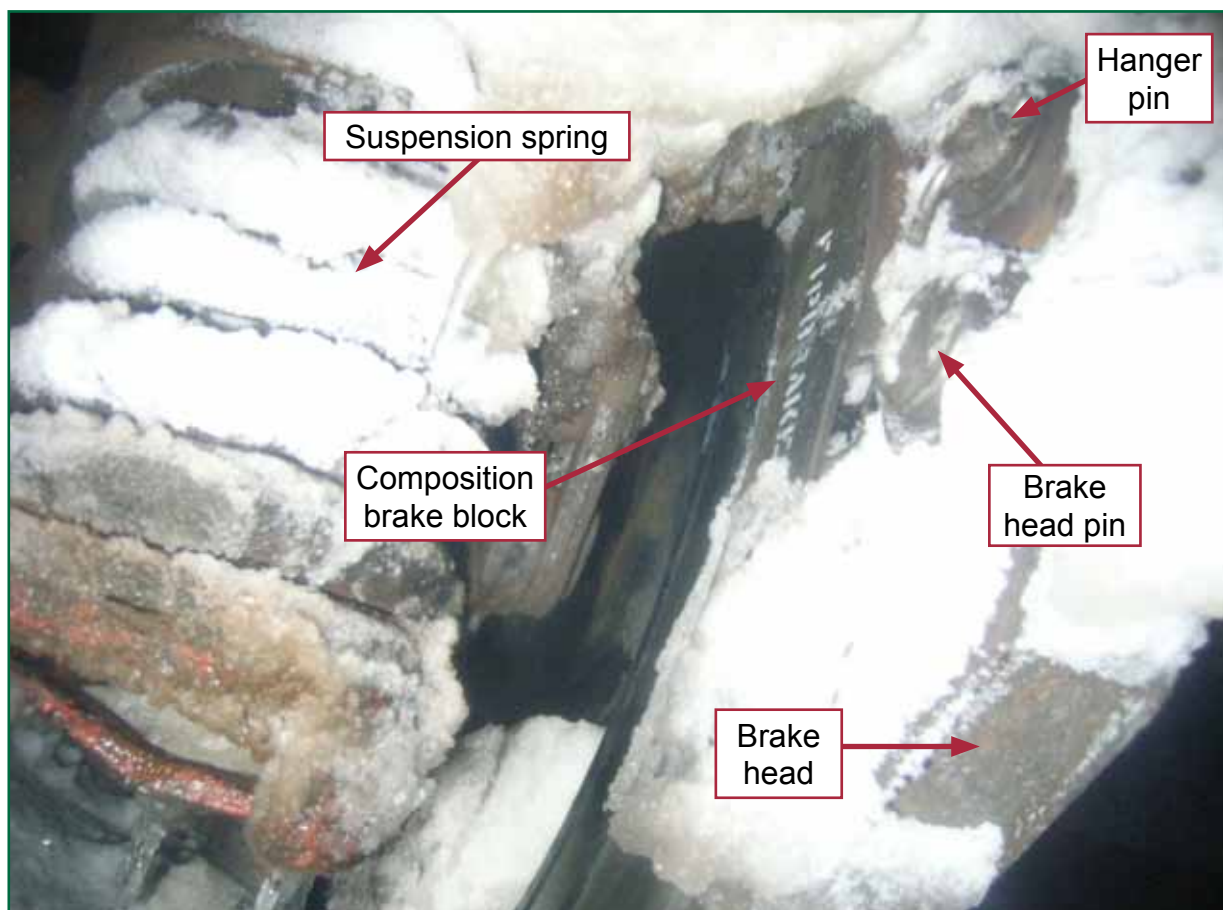
- 90 Snow and ice ingress between the brake block and the wheel tread can reduce the effective coefficient of friction for the portion of the block affected when it is applied to the wheel tread. This would in turn reduce the total braking force being generated to retard the wheel.
- 91 Photographs of the train taken in the hours following the derailment show that, on some of the wagons which did not derail, the brake blocks, brake heads, suspension springs and underframe were coated in a layer of snow, ice and slush. In some cases a thin layer of ice and snow could also be seen between the lower portion of the brake block and the wheel tread (see figures 13, 14 and 15).

Figure 14: Photograph taken on the night of the accident showing snow, ice and slush coating the brake block, brake head and suspension springs of one of the FKA wagons which did not derail

- 92 Snow and ice ingress between the face of the brake block and the wheel tread would have the effect of reducing the effective coefficient of friction for the portion of the block face affected when it was applied to the wheel tread. This would in turn reduce the total braking force being generated by the block to retard the wheel. If the entire face of the block were to be covered with ice and snow, this would remove almost entirely any retardation of its associated wheel.

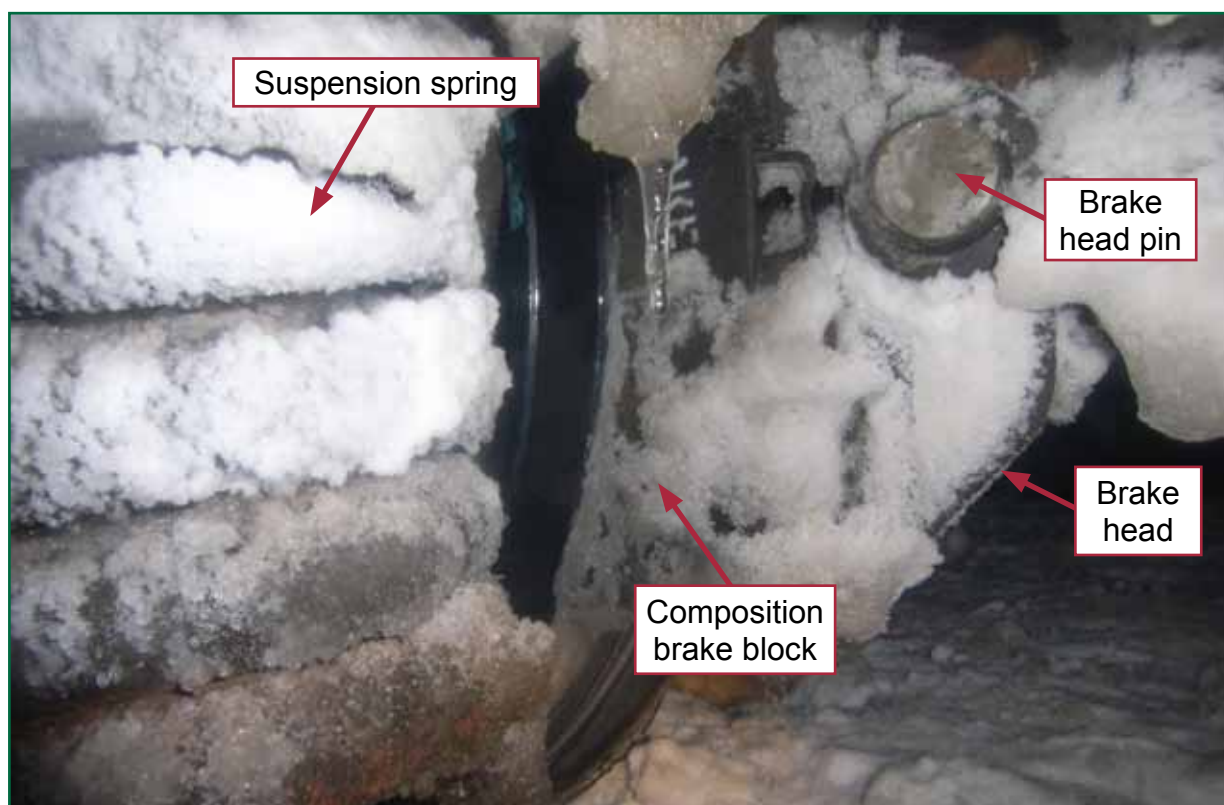
Figure 15: Photograph taken on the night of the accident showing snow, ice and slush coating the brake block, brake head, suspension springs and underframe of one of the FKA wagons which did not derail

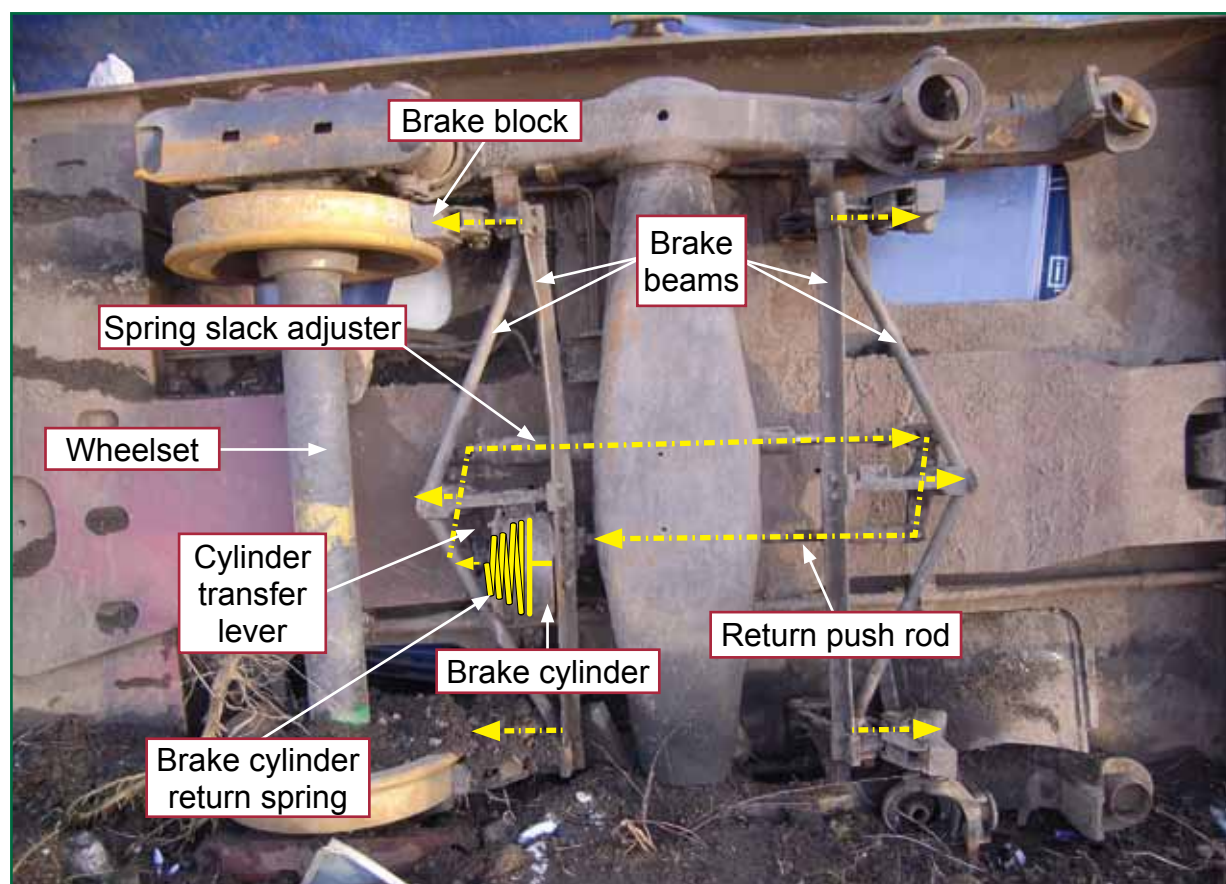
- 101 Testing on a comparable wagon demonstrated that an obstruction of the rigging at any one wheel on a bogie would not affect the application of the other brake blocks on that bogie. This means that for a widespread loss of braking to occur, blockages would have to have occurred either concurrently at multiple wheel locations or at a point which could have a common effect on all wheels on a bogie simultaneously (for example at the brake cylinder or cylinder transfer lever, as shown in figure 16).

*Figure 16: A photograph taken post-accident of the brake rigging of a derailed FKA wagon - note that the right-most wheelset is missing from this bogie. Direction of movement of the brake rigging and brake blocks on application are shown by the dotted yellow lines.*

- 102 Around 24 hours after the accident, the brakes on the wagons which did not derail were tested. The brakes were found to have become jammed in the applied position and could only be released once an external force was applied. It was found that these wagons, which had been left standing in freezing conditions during this period, had ice and snow on their brake rigging. This ice and snow had stopped the rigging from moving and releasing the brakes.

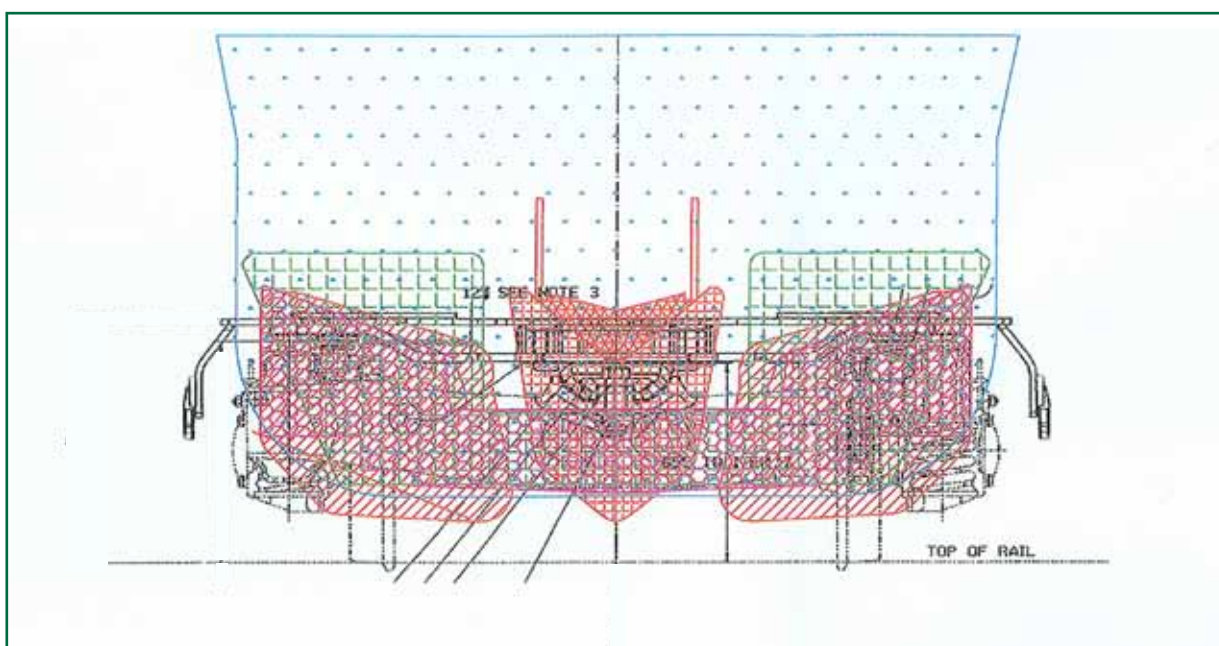
- 118 DB Schenker produced a diagram (see figure 17) which shows the combined 'ploughing' profile that the MSP equipped line proving locomotives and the other freight and passenger stock types running on the line would produce in lying snow. This shows that the combined 'ploughing' profile left snow lying close to the line. When compared to the profile of an FKA wagon, it could also be seen that the lower portion of the bogies' axleboxes and suspension springs were not covered by this combined 'ploughing' profile, meaning that they could potentially have run through lying snow.

Figure 17: Profile of an FKA wagon element compared with the combined ploughing profiles of MSP-equipped stock and other trains running between Inverness and Carrbridge (coloured sections) (image courtesy of DB Schenker)

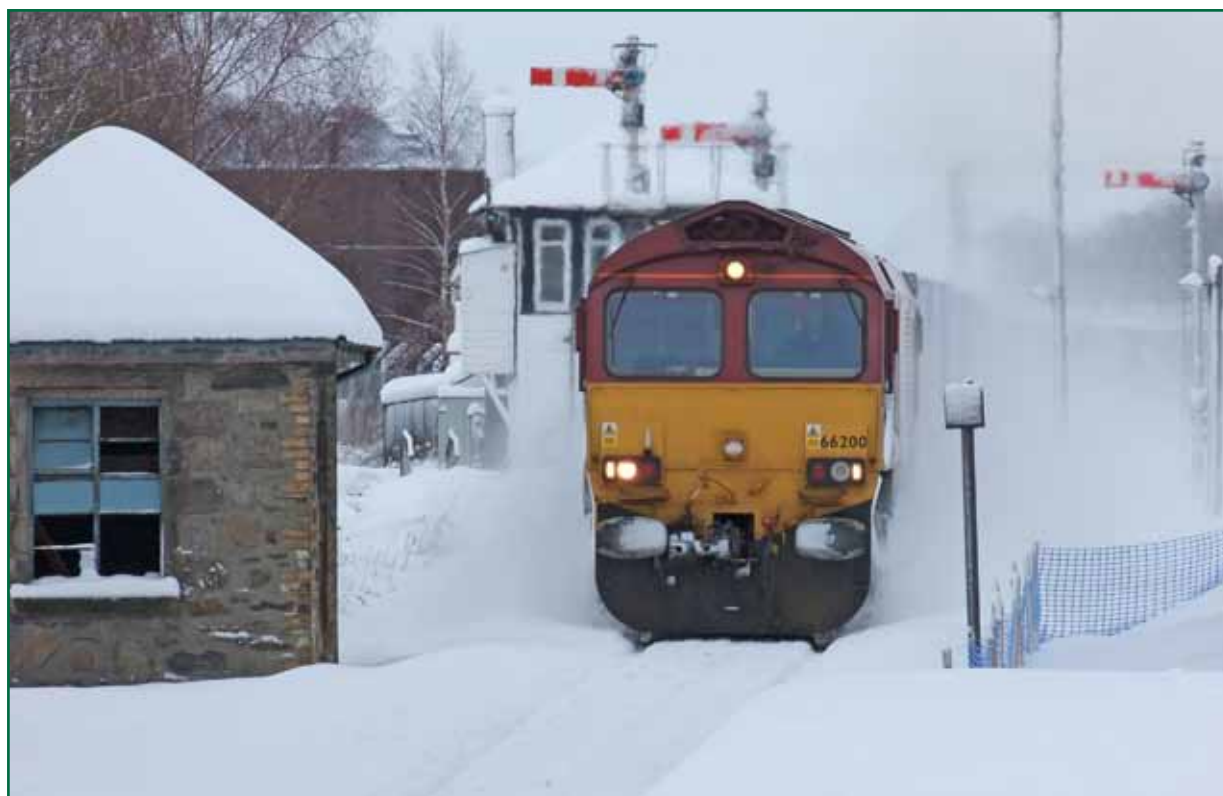
122 Lying snow being disturbed by the passage of trains and accumulating on bogie and brake components is understood, both in the UK and internationally, as having the potential to cause a reduction in braking effectiveness. This disturbance can take the form of a passing train throwing up loose snow flakes from the ground (sometimes described as 'snow smoke', see figure 18) or in snow which is coating the rail head being picked up by a train's wheels. This can result in the wheels spraying out a snow-water mix as they roll and in an accumulation of wet snow around brake block edges. Falling snow can also form a coating on the braking equipment components on some types of rail vehicle.

*Figure 18: A Class 66 locomotive and FKA wagons disturbing lying snow on 6 January 2010 (image courtesy of Trevor Roots)*

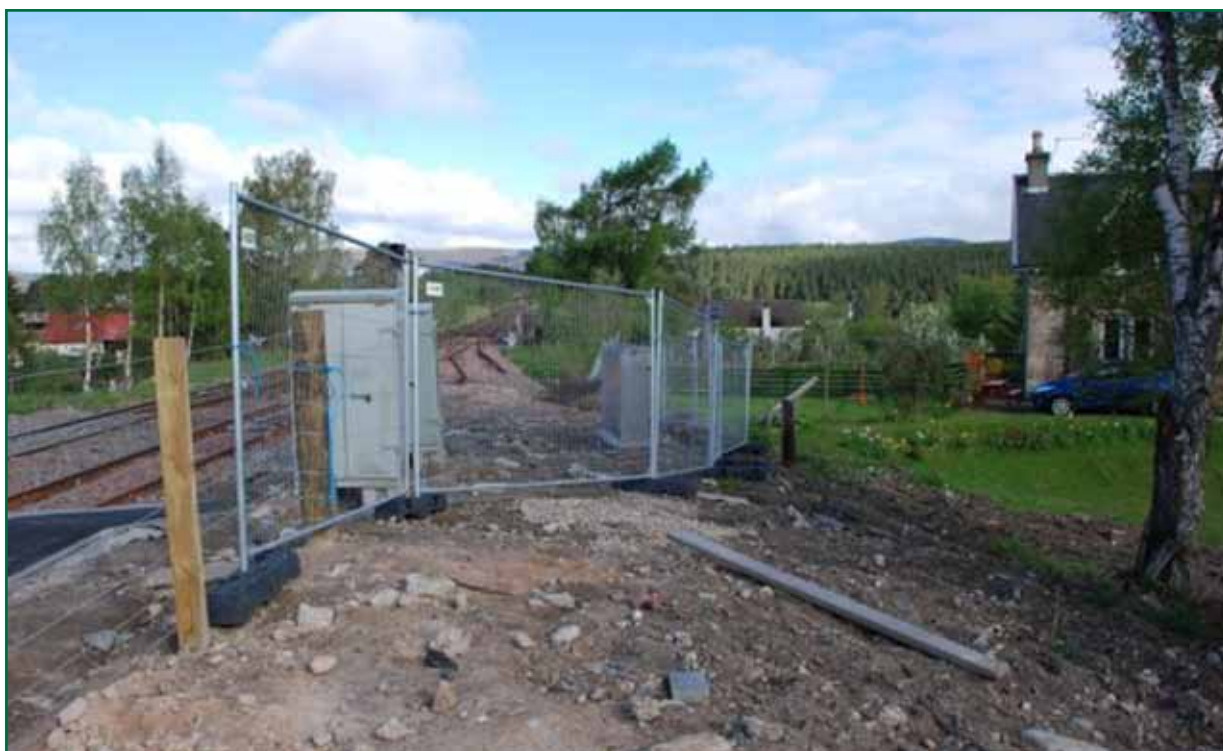
- 191 The rail industry's own formal investigation into the derailment found that, given the speed of train 4N47 when it passed over 116 points, the *drag length* required to stop a train following a similar derailment occurring would be approximately 600 metres. In the opinion of Network Rail, topography and landscape meant that such a drag length could not be achieved in practice.

Figure 21: The run-out at 116 points as restored post-accident (image courtesy of Peter Carson).
