# Rail Accident Report

## **Derailment of a passenger train near Kemble 15 January 2007**

## **15 January 2007**

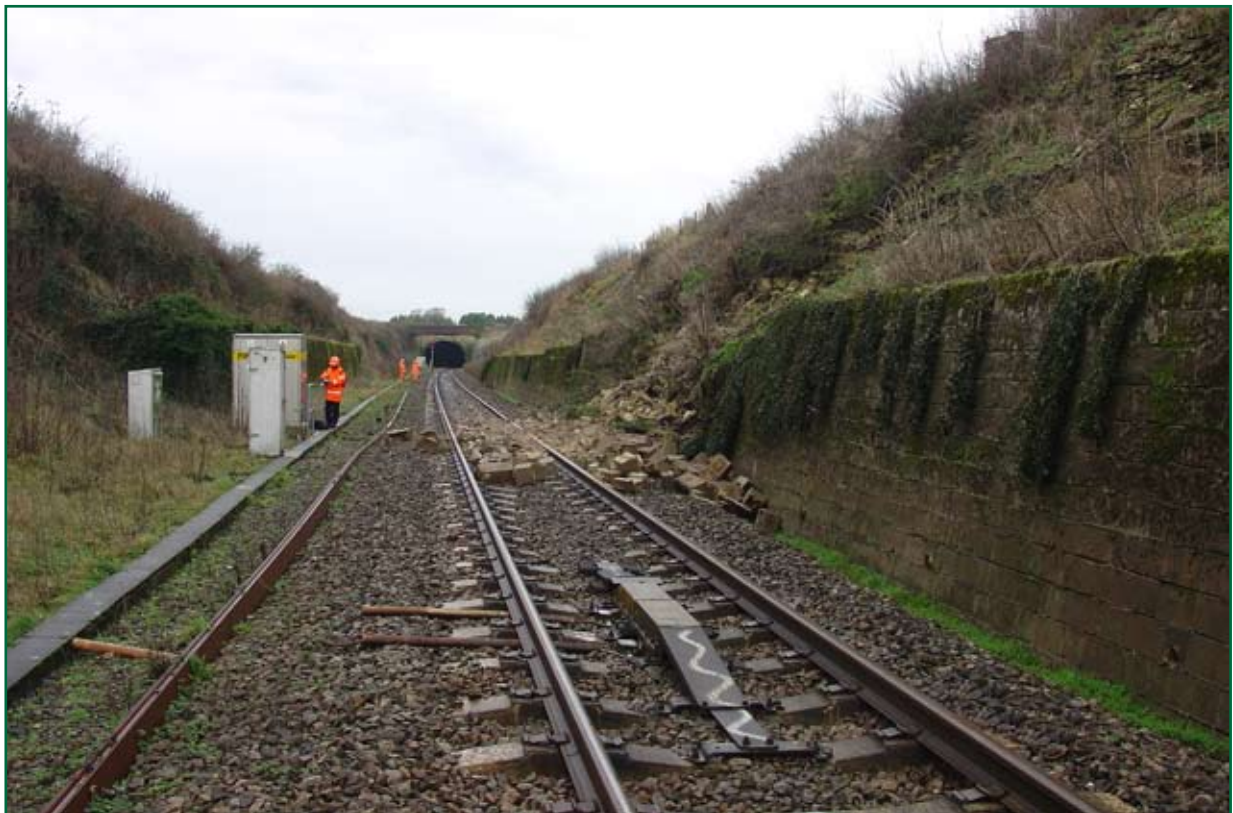
*Figure 2: View of derailment site in the direction of travel*

- 63 At the location of the cutting slip, the wall rises to a height of approximately 2.4 m above rail level. Its foundation is in the cess, set 2.4 m from the cess rail (Figure 2). The crest of the cutting rises a further 6 m above the top of the wall. The wall is constructed from a double row of hollow concrete blocks filled with a *lean-mix concrete* and has an overall thickness of approximately 450 mm. The face of the wall slopes away from the track at an angle of approximately 10 degrees.

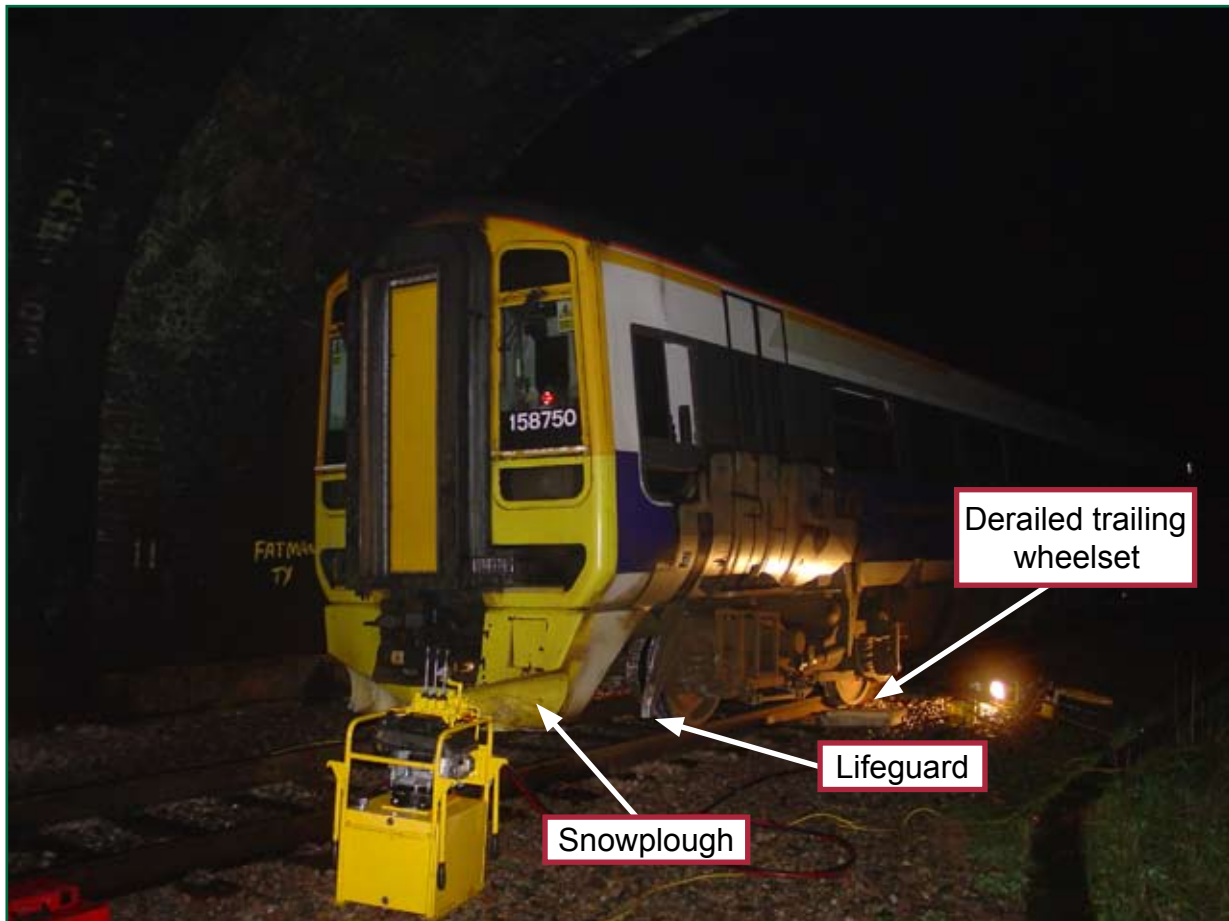
Figure 3: Leading end of Unit 158750 and derailed leading bogie

- 32 There was significant damage to the equipment on, and the wheelsets of the leading bogie. The leading vehicle sustained minor impact damage to the snow plough.
- 33 There was extensive damage to the track from the POD to the southern portal of the tunnel. Approximately 130 concrete sleepers and numerous rail fastenings were damaged. The left hand rail was broken at four positions where the derailed wheel had struck welded joints. The pile of concrete blocks, which had fallen from the collapsed wall and which were partially flattened by the train, covered the track over a length of 14 m (Figure 3).
