Rail Accident Investigation Branch

# Rail Accident Report

## Track worker fatality at Ruscombe Junction 29 April 2007

## 29 April 2007

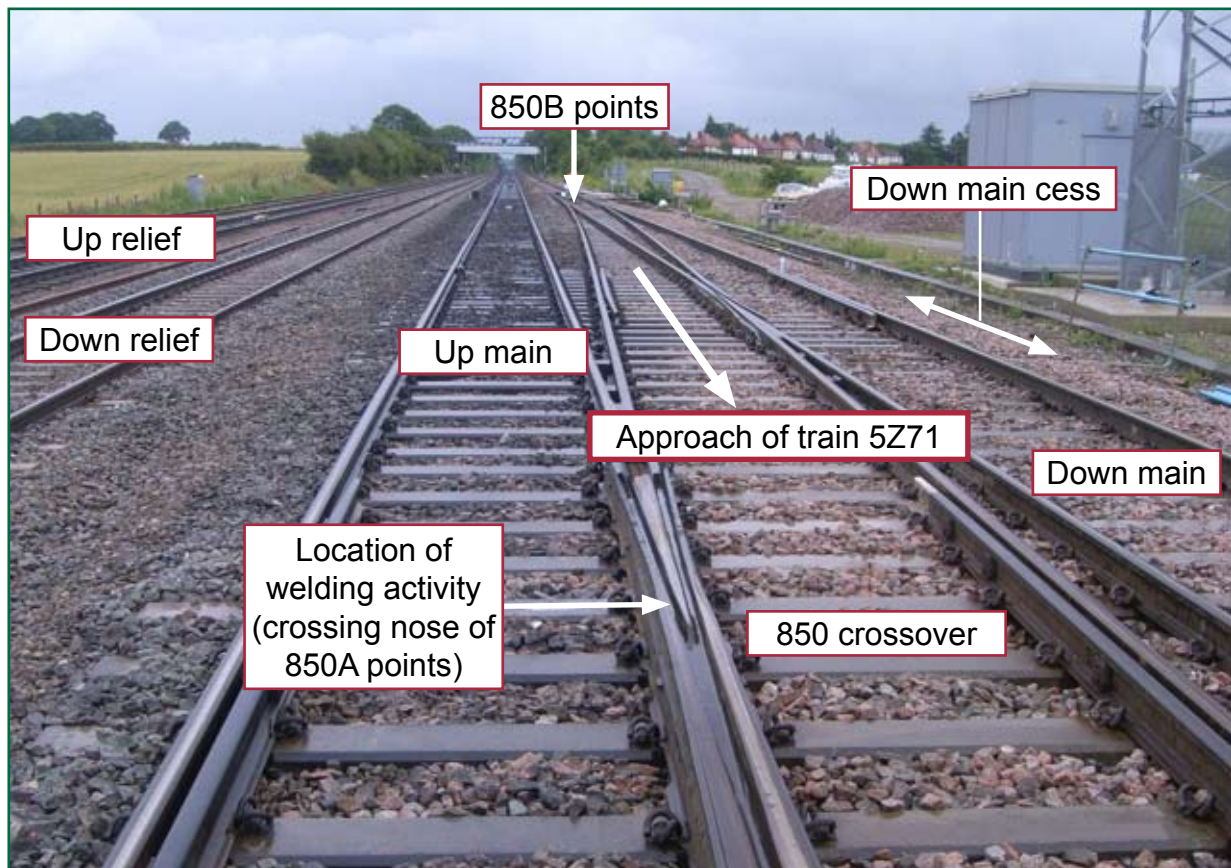
Figure 3: Ruscombe Junction (looking east at the crossing nose of 850A points)

- 36 Crossovers and especially the crossing nose of a high speed crossover are subject to heavy loading from the regular passage of trains through them and consequently wear rapidly.

- 37 Damage to the crossing nose is repaired by arc welding. This involves the crossing nose being cut back to sound metal by grinding and weld material being built up in layers. The finished repair is ground to its final profile.
