Rail Accident Report

Signal passed at danger at Stafford
26 April 2012

Report 16/2013
September 2013

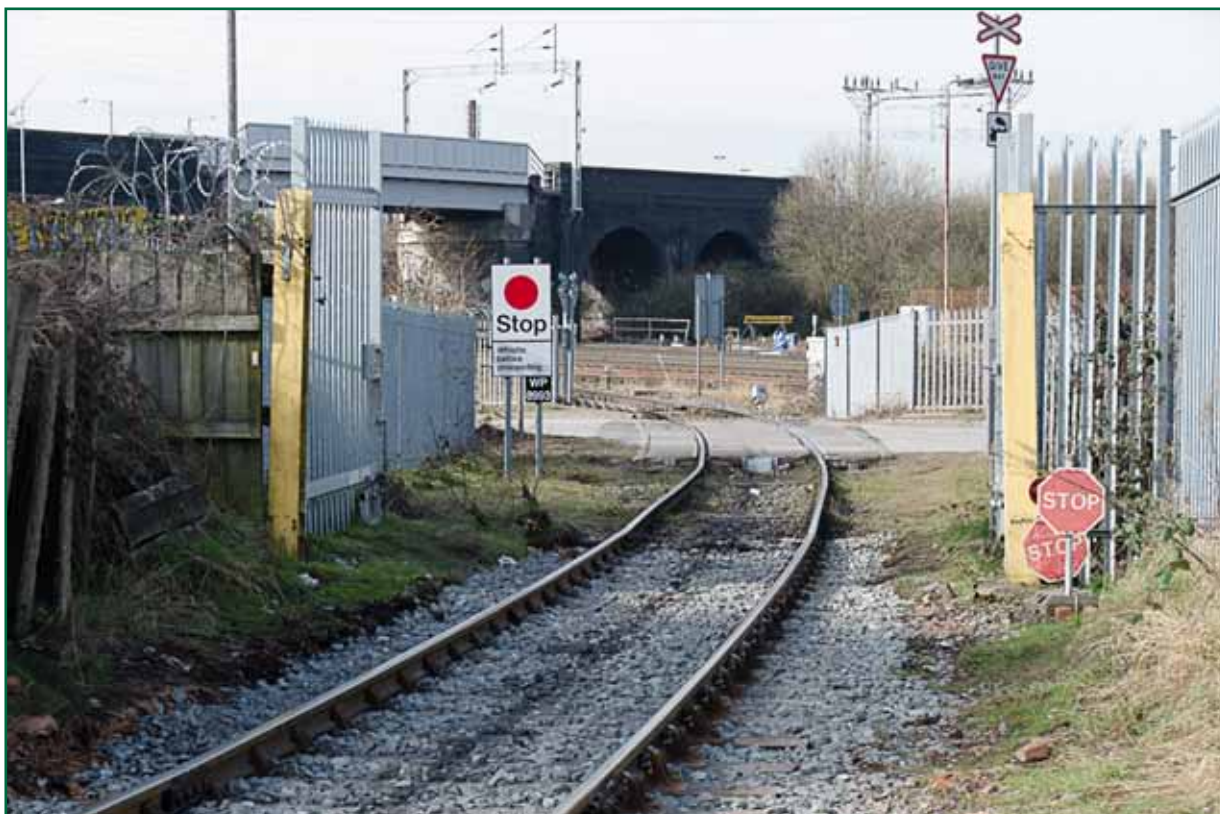
Figure 5: Approximate location where the DSD was isolated, prior to entering Network Rail infrastructure

- 26 Although the depot manager had repaired the DSD, it failed again and was isolated by the technician on board the locomotive, in the vicinity of the gates just before the locomotive crossed the boundary between Washwood Heath depot and Network Rail's main line infrastructure, figure 5. Module TW5 of the *Rule Book* does not permit a train to enter service if the DSD is defective. The locomotive's *national radio network* (NRN) radio also failed at Duddleston Junction, after the driver and technician changed ends to reverse the locomotive immediately following departure from the depot. The driver did not stop and report the failure of either of these safety systems to the signaller as required by Module TW5 of the *Rule Book*.

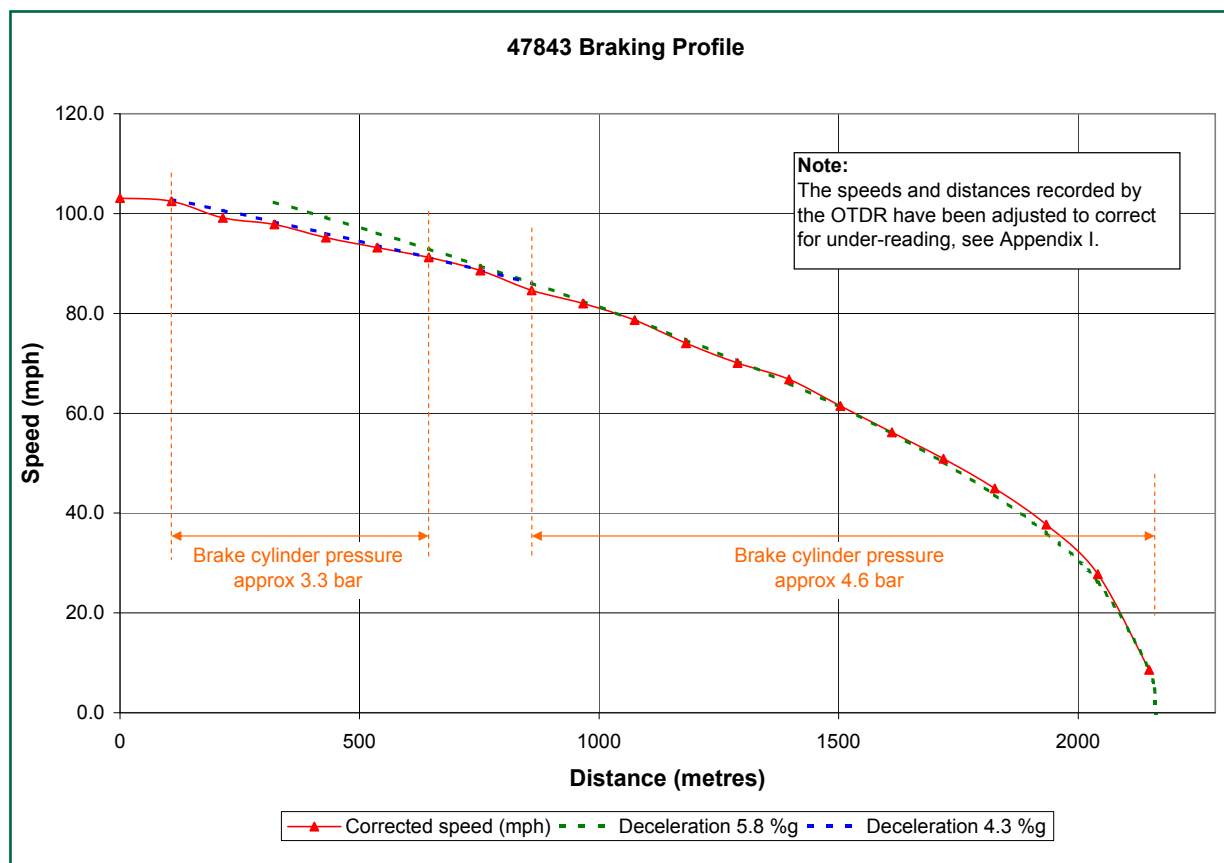
Figure 7: 47843 braking profile

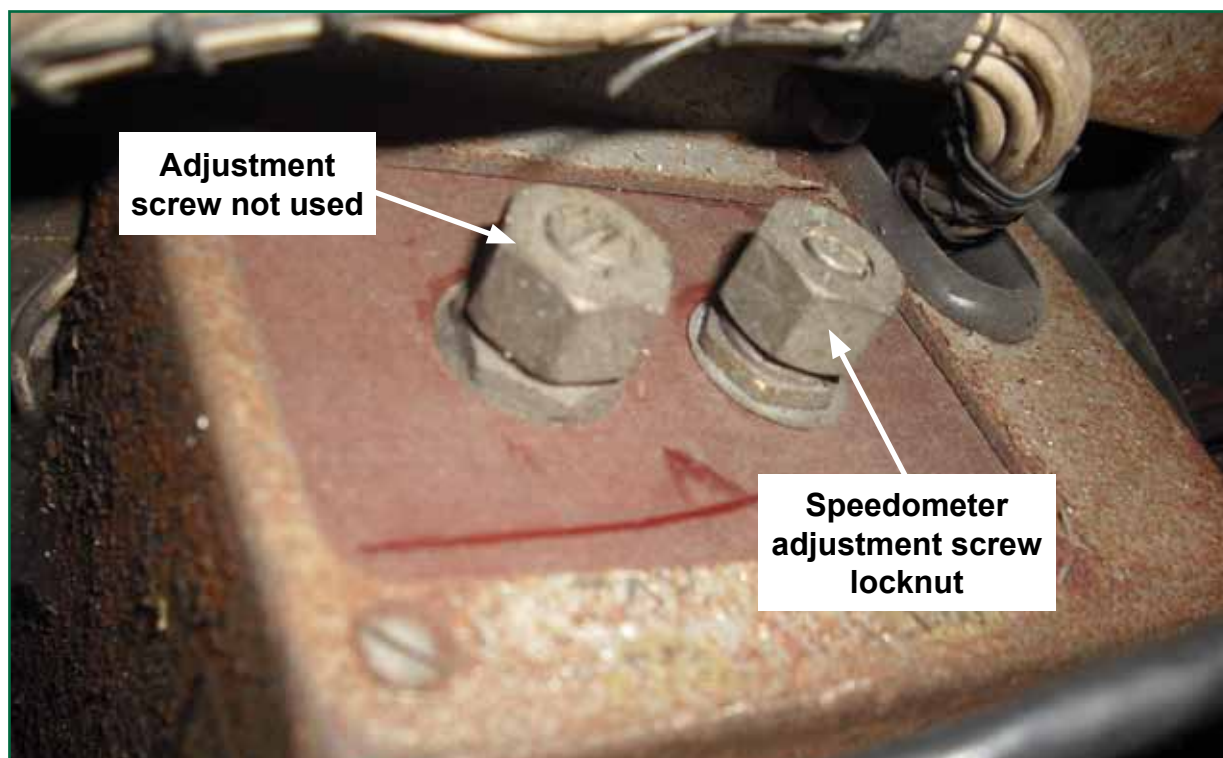
- 59 RTL subsequently tested the speedometer at Crewe on 14 May 2012 and found that it was under-reading by 13%. It had previously been calibrated on 17 September 2009, as part of the locomotive's last scheduled B exam (see appendix B), at which time no adjustment had been necessary¹³. Since that date, the locomotive had spent the majority of its time carrying out shunting and train heating¹⁴ duties at Crewe: records provided by RTL indicate that, until its hire by DCR on 24 March 2012, its main line duties had consisted of two return trips from Crewe to Warrington and one from Crewe to Derby.

- 60 Representatives of RTL and DCR reported that when they examined the locomotive at Crewe, they found that the locknut on one of the adjustment screws on the speedometer equipment box was loose and that the screw itself showed signs of recent adjustment (figure 8). This screw provides a coarse adjustment of the speed displayed by the speedometer; its condition apparently explains the discrepancy of 13% in the speed displayed, although it would not have caused the alleged sticking of the speedometer (paragraph 27). The RAIB has been unable to establish why or when the locknut on the adjustment screw had been undone.

Figure 8: Close up of the coarse adjustment screw for the speedometer on 47843 (courtesy RTL)

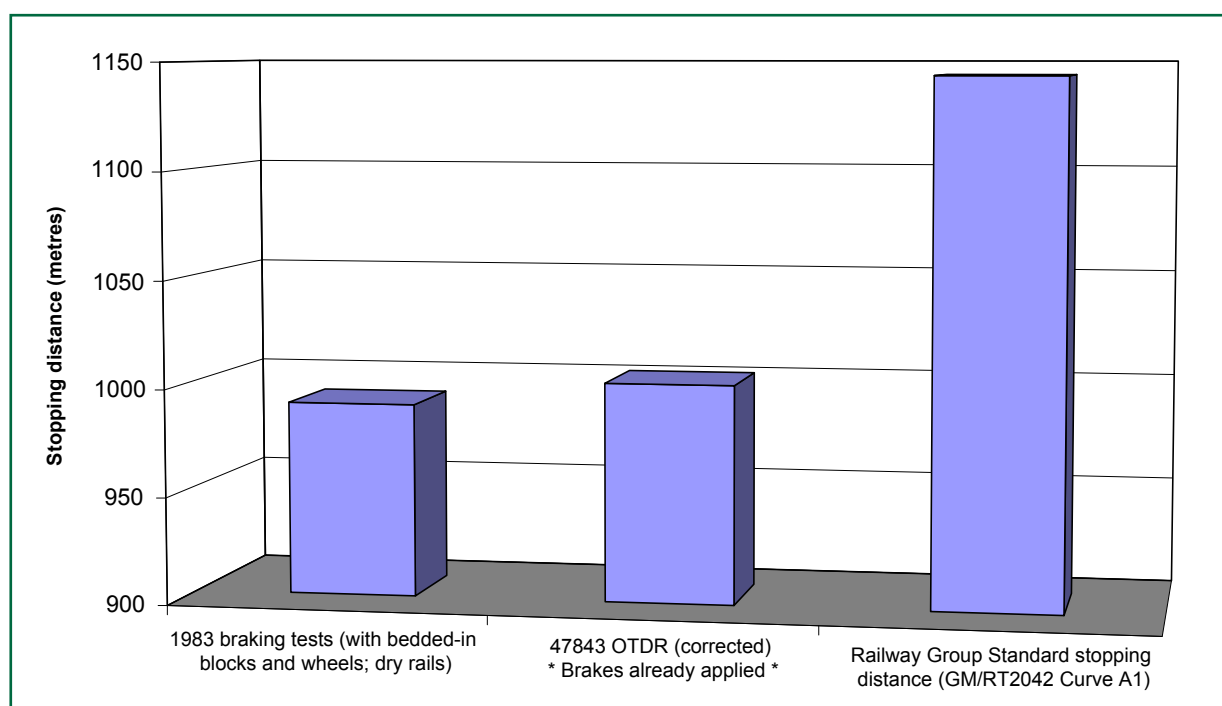
- Cast iron brake blocks exhibit different coefficients of friction depending on the starting speed of a brake application: the higher the initial speed, the lower the coefficient of friction throughout that particular brake application. This means that the stopping distance of the locomotive, if it had started braking at 75 mph (121 km/h), would have been less than the distance required to stop from 75 mph while braking from 103 mph (166 km/h).

Figure 9: Comparison of stopping distances from 75 mph (121 km/h)

- 68 The RAIB has concluded that the braking performance of the locomotive was broadly as effective as that of the class 47 locomotive tested by British Rail in 1983, and that it would have complied with the relevant standard (curve A1 in GM/RT2042). It was therefore not causal to signal SD4-81 being passed at danger on 26 April 2012. The condition of the brake blocks is discussed at appendix H.

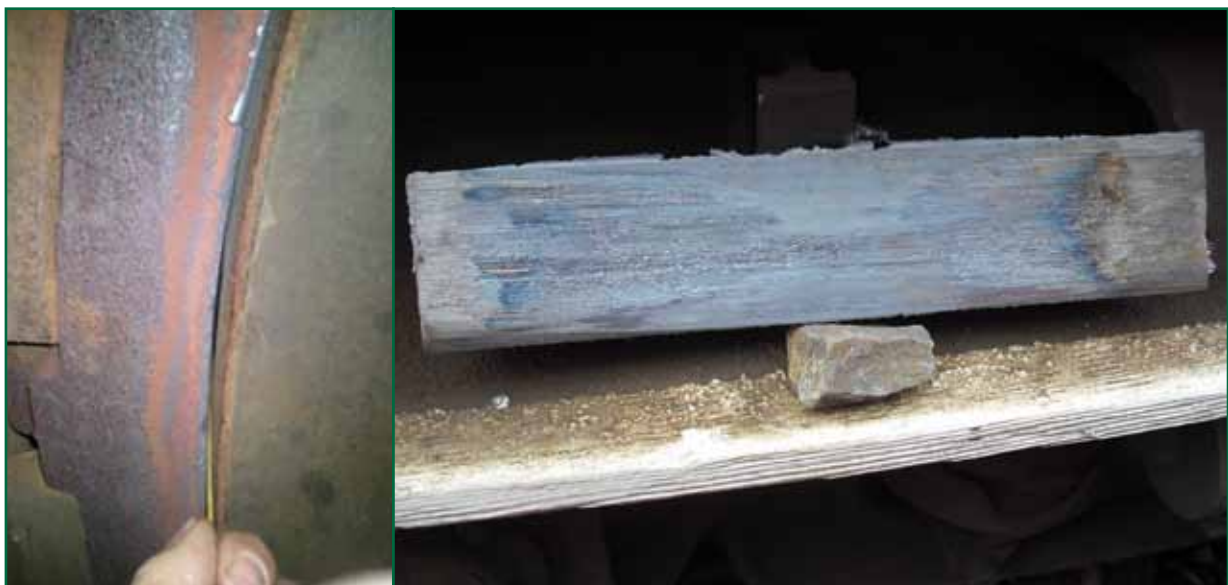
- H1 In the immediate aftermath of the incident of the SPAD incident at Stafford on 26 April 2012, arrangements were made for an independent engineer from URS to examine the brakes on the locomotive. The URS report concluded that second hand brake blocks had been fitted to the locomotive, with the result that only 57% of the friction surface was in contact with the wheels (paragraph 66). The principal evidence cited in support of this hypothesis was that the internal diameter of the blocks' friction surfaces appeared to be smaller than the external diameter of the wheels. Figure H1a shows the gap between the centre of one of the brake blocks and the wheel tread, which was observed before locomotive 47843 was moved from Stafford. Figure H1b is typical of photographs taken by RTL at Crewe on 14 May 2012, and shows a brake block after removal from the locomotive; the centre of the block is '*blued*' (defined at Appendix B) due to overheating. This is the part of the block that was not in contact with the wheel in Figure H1a. The URS hypothesis does not account for the recent bluing, scoring and burring which is evident in the centre part of the brake block.

- H2 Advice given to the RAIB by Interfleet Technology, Railway Brake Services and a train operator with relevant experience suggests that the condition of the blocks is probably attributable to a sustained high-speed application of the locomotive's brakes; this is consistent with the opinion of the locomotive's owners, RTL. A possible mechanism for the damage to the inside face (the friction surface) of the brake block is that, during such a brake application, the friction surface experiences an extreme temperature, whereas the mounting point on the outside of the block acts as a heat sink. The temperature gradient through the brake block causes the inside face to expand more than the outside, and therefore tends to flatten its curved shape; on cooling, the block contracts again. The energy needed to stop a vehicle from 103 mph (166 km/h) is 189% of that needed to stop it from 75 mph (121 km/h); this energy must be dissipated by the brakes. The light wear at the ends of the block is likely to have been caused by the subsequent use of the locomotive's brakes when it was moved from Stafford to Crewe after the incident.

Figure H1a and H1b: Brake blocks from locomotive 47843, when examined after the incident (courtesy URS and RTL)
