Rail Accident Investigation Branch

Rail Accident Report

Passenger train derailment near Fisherground on the Ravenglass & Eskdale Railway 12 May 2007

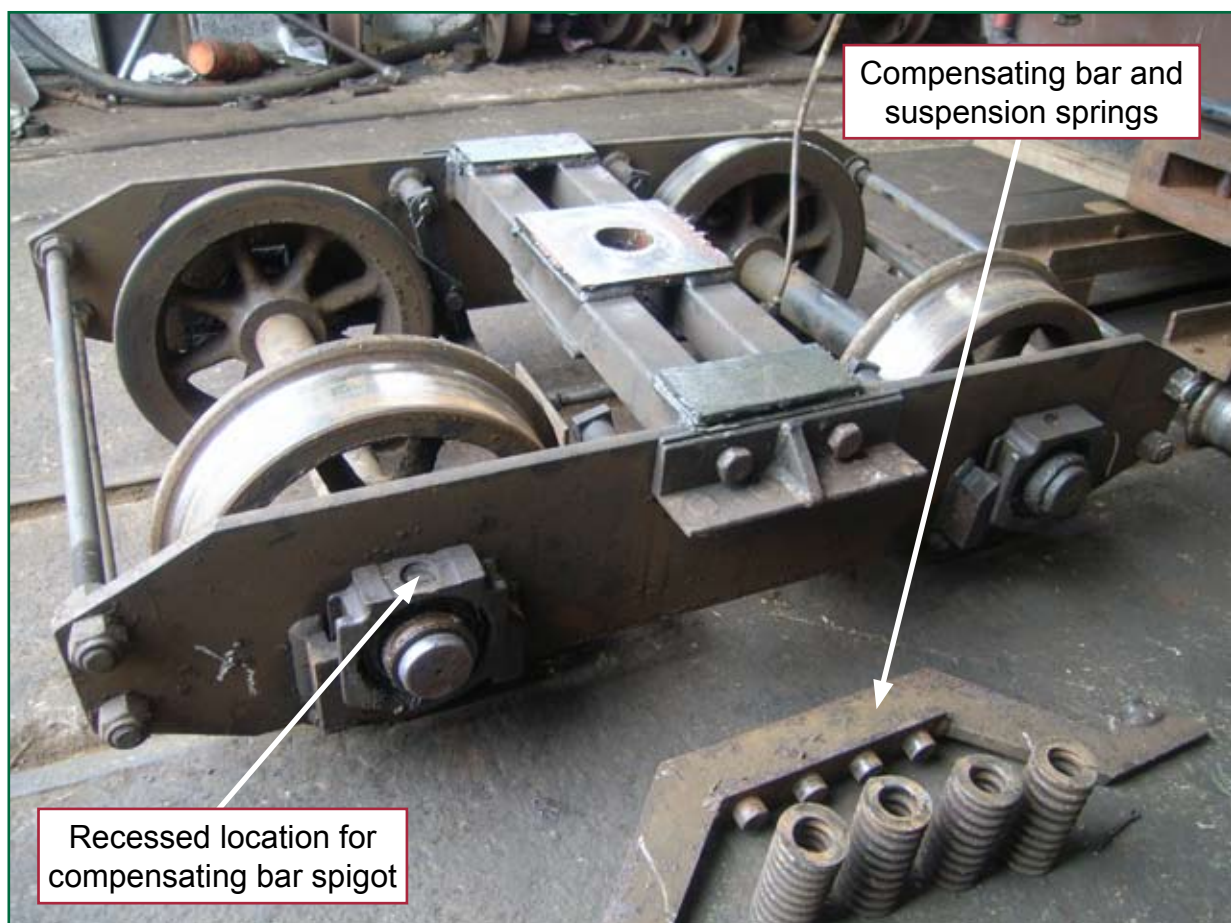
Figure 5: Derailed leading bogie from Maxi coach 131 with compensating bar detached from left-hand side

- 28 The compensating bar and the four coil springs on the left side of the leading bogie had fallen off 14 sleepers before the POD, causing the suspension on that side to collapse but without causing derailment of the leading bogie.
- 29 Each end of the compensating bar has a spigot which normally sits in a shallow locating recess on the top of the *axlebox* (Figure 5). The spigot at the leading end of the left hand compensating bar was severely scored with signs of overheating where it had been rubbing on the adjacent axle. The top of the axlebox also had signs of wear indicating that the spigot had been riding outside its recessed seat. The axle end showed corresponding signs of heavy wear confirming that the detachment of the bar and the subsequent drop onto the track was the initiating event rather than consequential.

- 32 Interview evidence indicated that the most likely cause of the compensating bar coming adrift at Hollin How was that it had not been properly seated in its axlebox locating recess when the bogie was reassembled. The work had been carried out under some time pressure due to the high workload at the time and the R&ER maintainer, who had over 20 years experience on this type of work, had not spotted the problem when the bogie was fitted to coach 131. The task sheet for the inspection contained only the result tables to be filled in as measurements were taken. There was no checklist for reassembly or any requirement for an independent check to be done following reassembly of the bogie.

- 33 Even with the spigot of the compensating bar sitting on the outer edge of the axlebox, the bogie can still be reassembled and will appear to run normally. However, in this condition the bar can shuffle along and fall off onto the axle end where it could ride for some time before falling off completely. This sequence of events appears to have been what happened in the lead up to the derailment and was confirmed by testing the bogie on coach 134 which was also found to have a displaced compensating bar. When suspension movements were induced by swaying the coach body from side to side, the compensating bar moved toward the outboard edge of the axlebox and had it been tested further, would have fallen onto the axle end.

- 40 The reason that the suspension collapsed on the leading bogie was that the left hand compensating bar fell off, probably because it had not been fitted correctly when the bogie was reassembled on 26 April 2007. Testing of the coaches (paragraphs 34 and 35) and previous service experience on the R&ER confirm that correctly fitted compensating bars do not work themselves out of their recessed housing on the axleboxes. The incorrect assembly of the compensating bar was therefore a causal factor. Time pressure due to the high workload at the time may have been a contributory factor (paragraph 32).

- 43 R&ER have carried out the following actions since the derailment:
- Modified their bogie maintenance procedure to include an independent safety check by a competent person following bogie reassembly.

- Commenced fitting of retaining brackets to Maxi coach bogies and other bogie designs which feature compensating bars. The brackets are designed to keep the bars in place if they become dislodged from their axlebox housing for any reason.

1. Review and identify safety critical elements of engineering work on their bogies, including the re-fitting of compensating bars, and implement work procedures which include:
 - a primary check by the person undertaking the work; and
 - a secondary independent check signed off by a competent R&ER person to ensure that any problems are detected before entering service (paragraph 41).
2. Review their safety management system and operational procedures to identify if there are other areas where safety critical maintenance or design work is undertaken, or decisions are made, which should be subject to independent checking, and implement appropriate changes to procedures (paragraph 42).
