Rail Accident Investigation Branch

Rail Accident Report

**Dangerous occurrence at Lindridge Farm user
worked crossing, near Bagworth, Leicestershire
22 March 2012**

Report 11/2013
July 2013

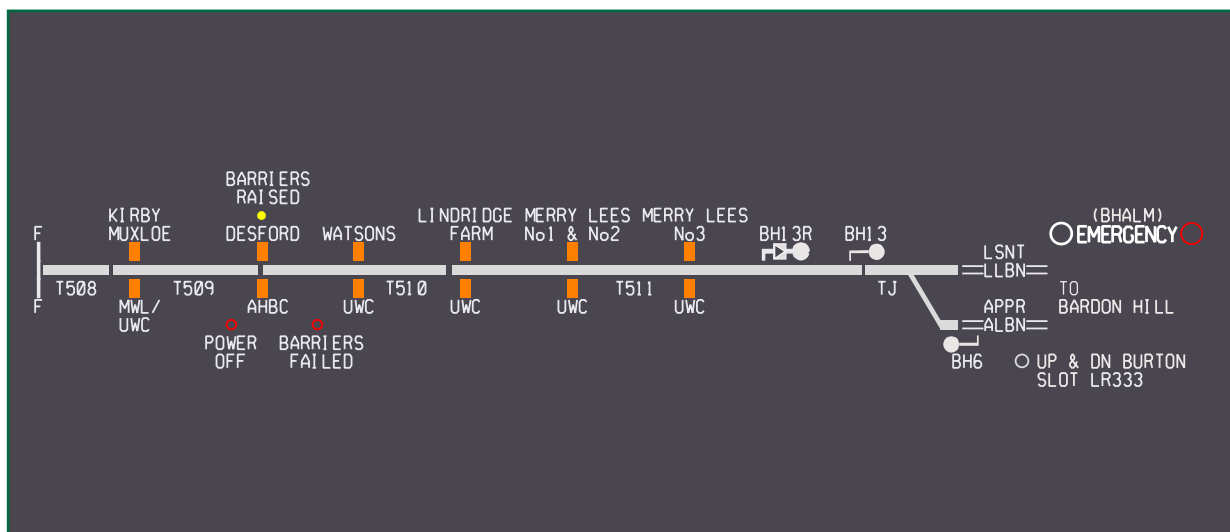
Figure 8: Track sections T510 and T511 as displayed on the Leicester workstation view at EMCC before the incident

- 35 Network Rail's technical and operations staff investigated and by 10:30 hrs they had found that Lindridge Farm user worked crossing and also Merry Lees No.1 & No.2 and Merry Lees No.3 user worked crossings were all shown in the wrong place on the signaller's workstation view. They identified that these crossings were shown on track section T511 when they should have been shown on track section T510 (figure 8).

- 55 **The immediate cause of the incident was that the signaller believed that train 6Z75 had already passed Lindridge Farm user worked crossing when he gave the motorist permission to cross, because his workstation view showed the level crossing on track section T511 and the train on track section T510.**
- 56 When the Leicester workstation was commissioned, it included an error on one of its views. This showed Lindridge Farm user worked crossing on track section T511 (figure 8) when it should have been shown on track section T510 (figure 9).

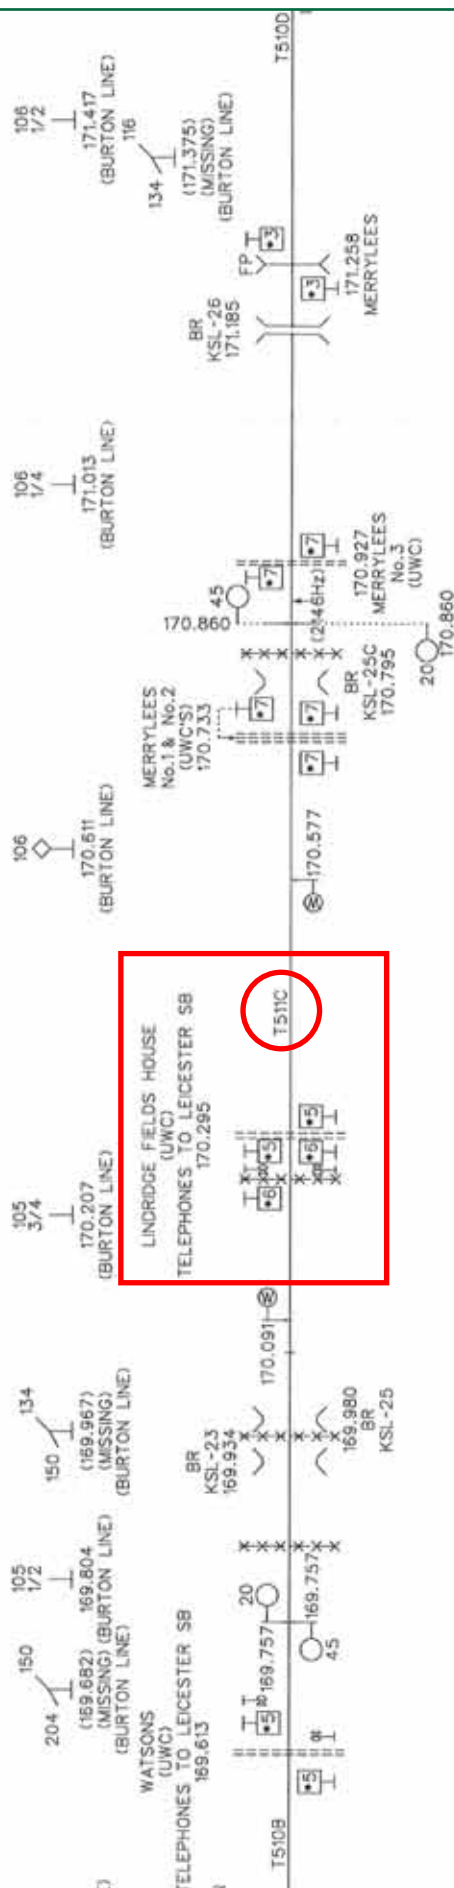
Figure 13: The error on the approved signalling plan for the Leicester area

Note: Lindridge Farm user worked crossing is incorrectly named as Lindridge Fields House user worked on this plan

- b. The signalling plan for the Leicester interlocking renewal, which was redrawn by Network Rail SDG, contained an error that incorrectly named track circuit T510C as T511C (**paragraph 67, Recommendation 2**).

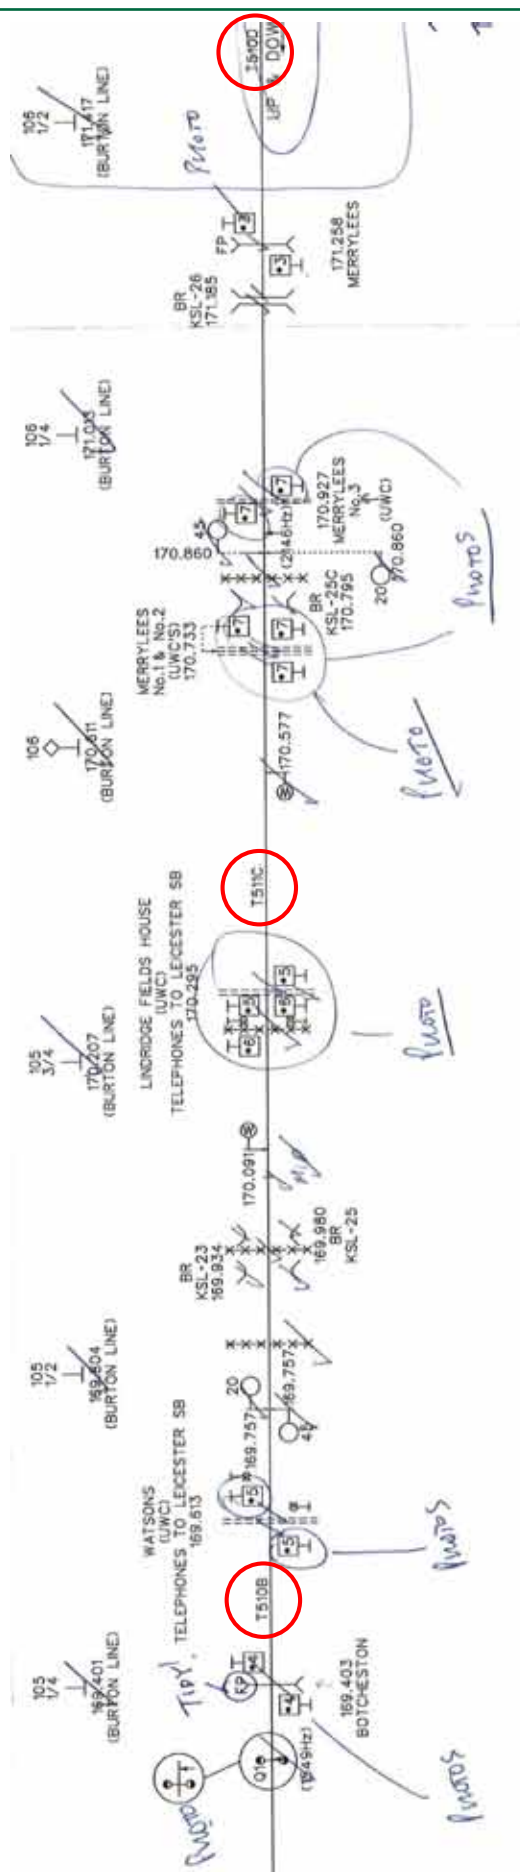
Figure 14: The tick marks and error on the copy of the signalling plan looked at by the checker

- Network Rail SDG used the signalling plan it had produced for the Leicester interlocking renewal work as a base for the new Leicester scheme plan. In doing this, it copied an error in the signalling plan across into the new scheme plan (paragraphs 97 to 99).

Note: Lindridge Farm user worked crossing is incorrectly named as Lindridge Fields House user worked crossing on this plan

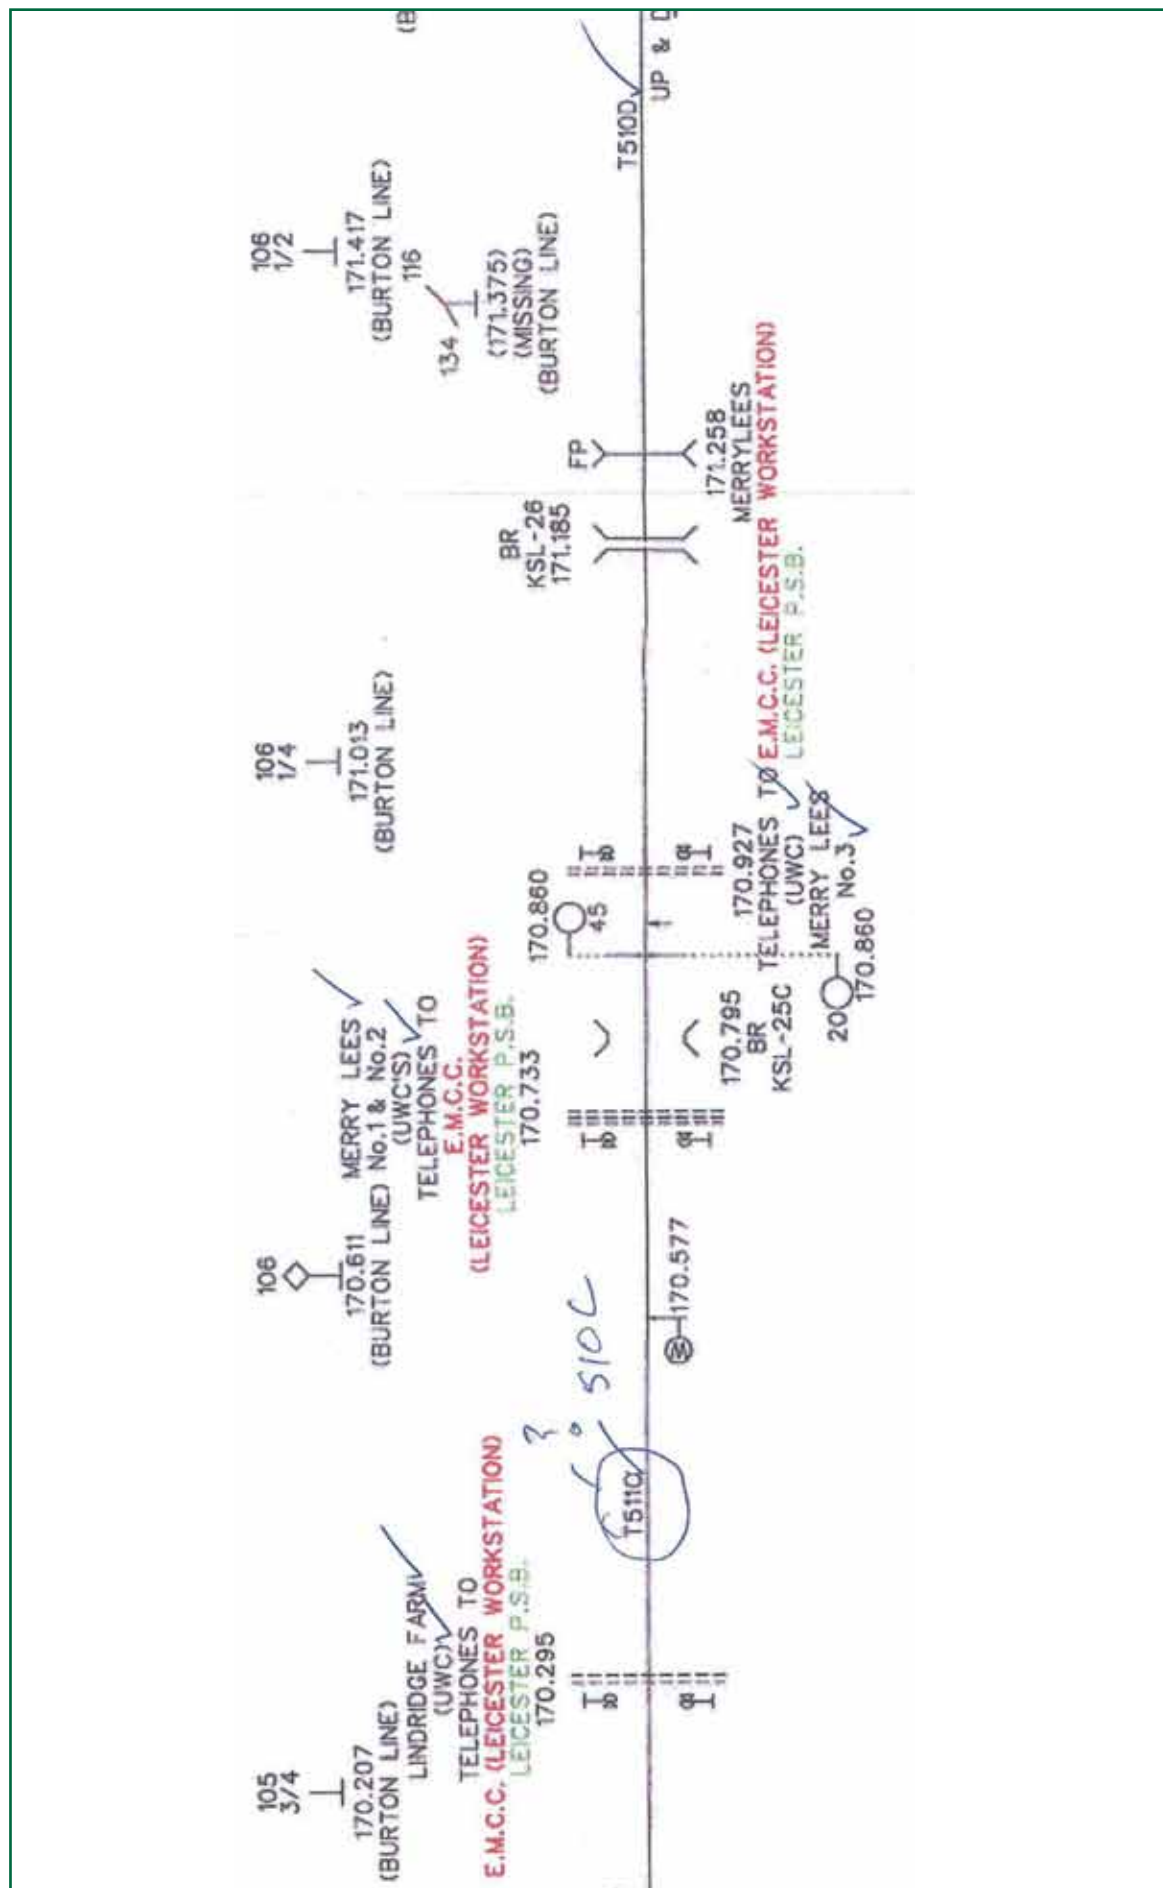
Figure 17: The tester's marks identifying the error on his copy of the re-control scheme plan for Leicester

- 120 Later on during 6 December, the tester noticed the error on the scheme plan when he logged that track circuit name T511C was shown twice on the scheme plan (figure 17). The tester recorded the error on a *test log*. It was the last item in a list of six scheme plan errors that the testers had noted during their checks that day.

- i. The error on the re-control scheme plan for Leicester was found during testing but no one assessed the impact of this error on the Leicester workstation view design (**paragraph 119, Recommendation 4**).

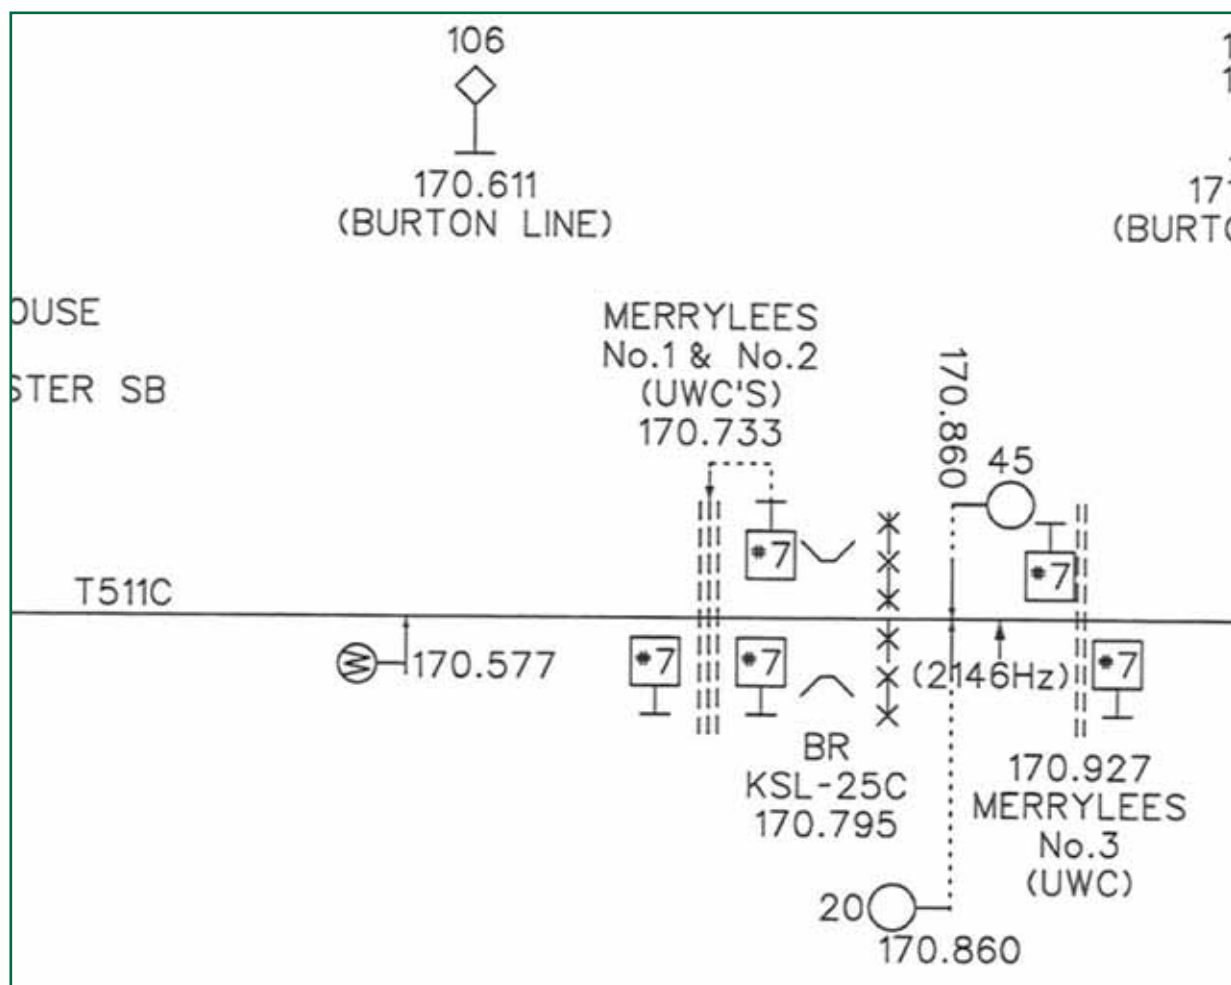
Figure 18: Snapshot of the signalling plan for the Leicester interlocking renewal

131 The only track circuit name shown on this snapshot was T511C, so on 28 April, the Local Operations Manager marked the signaller's panel up with the Merry Lees crossings shown on track section T511 (figure 19). As explained earlier (paragraph 67), the signalling plan for the Leicester interlocking renewal contained an error with track circuit T510C incorrectly named as T511C. This led him to incorrectly mark the Merry Lees crossings on track section T511 instead of T510. The signaller's panel at Leicester signal box remained like this until it was decommissioned on 31 December.

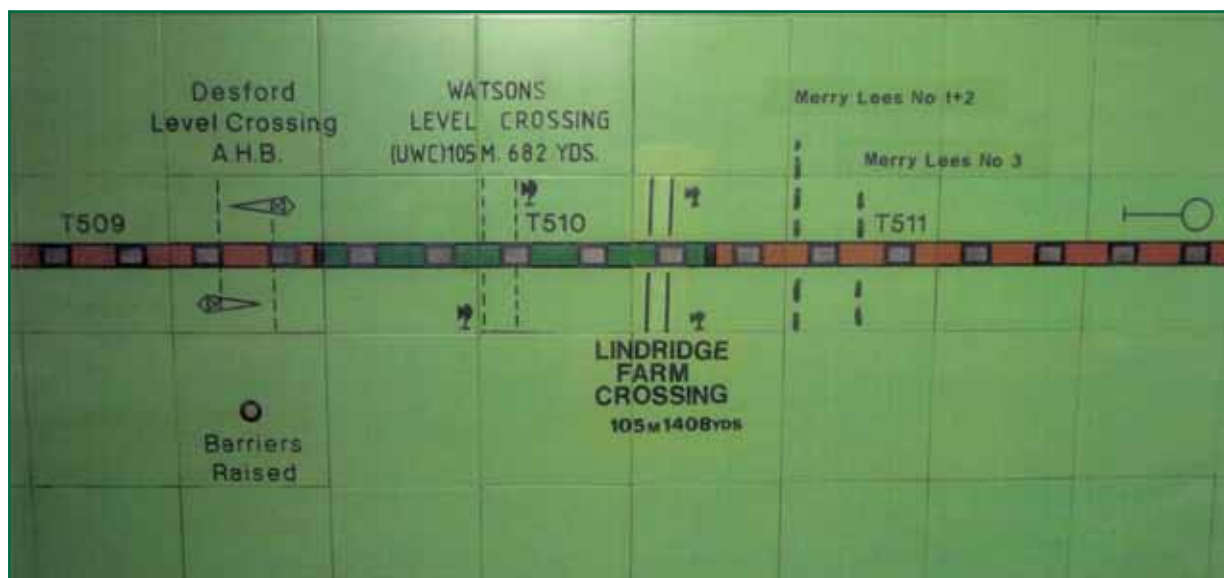
Figure 19: The signaller's panel at Leicester signal box with the Merry Lees user worked crossings incorrectly marked up on track section T511

- 146 Although not linked to the incident on 22 March 2012, the RAIB observes that:
- a. Merry Lees No.1 & No.2 and Merry Lees No.3 user worked crossings were incorrectly marked up on track section T511 on the signaller's panel at Leicester signal box from April 2011 (**paragraph 127, Recommendation 5**).
 - b. Merry Lees No.1 & No.2 and Merry Lees No.3 user worked crossings were incorrectly placed on track section T511 at a meeting held by the re-control project in March 2011 (**paragraph 133, Recommendation 3**).
 - c. The signaller did not report the incident straight away (**paragraph 138, Learning point 1**).
