TEM analysis GaAs

12-02-2020

GaAs

Samples analyzed by STEM, STEM-EDX (and BF-TEM)

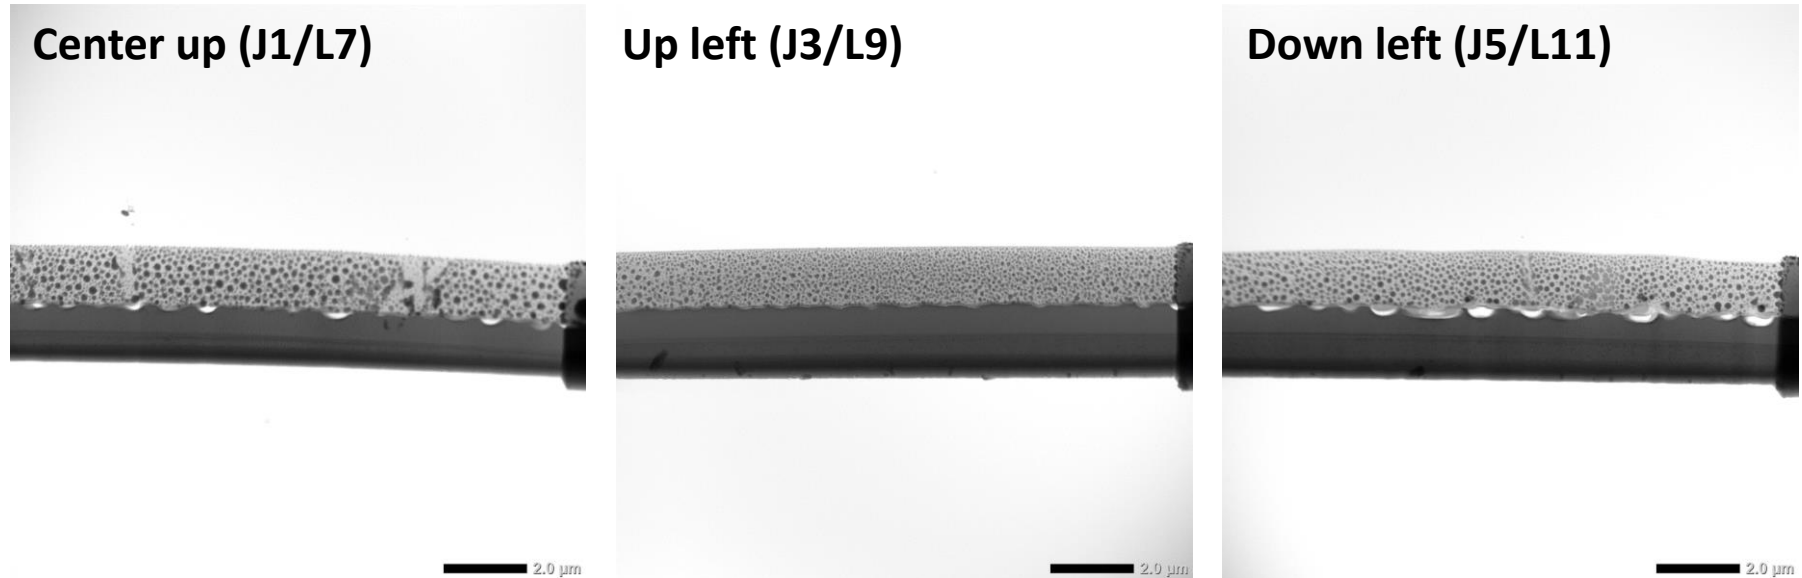
Overview of 3 lamella analyzed

- Note: due to technical issues we seem to have deposited a lot of Ga “droplets” on top of the carbon layer, they reside on the surface as confirmed by secondary electron imaging:
-

- Lamella taken from different regions of the wafer show somewhat different surface roughness (from 30 to 150 nm depth of surface ridges)
 - Aluminum-oxide layer seems to vary in thickness from 30 nm up to even 150 nm patches, also it seems to be broken, and in some places lifted up from GaAs to form pores beneath (see next slide and EDX)

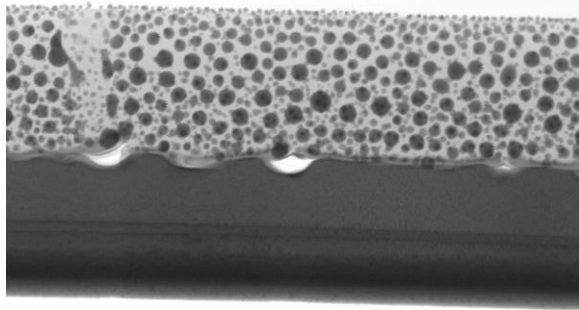
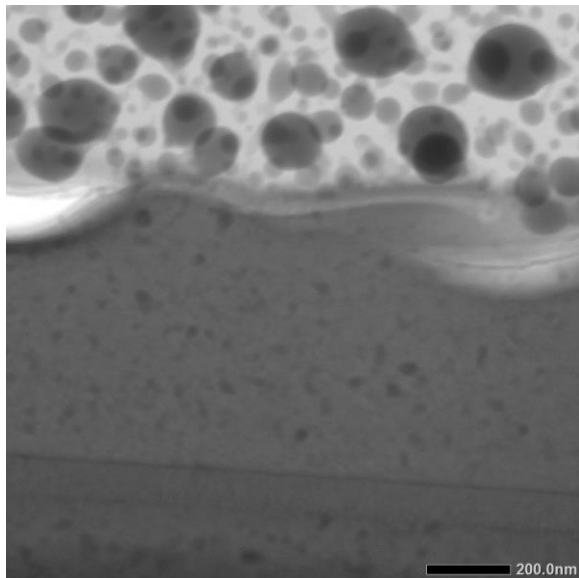
Center up (J1/L7)

- Varying thickness of alumina layer, fills up some ridges to form 150 nm layer while occasionally it remains thin ~50 nm and “lifted up” forming a pore beneath (see arrows)

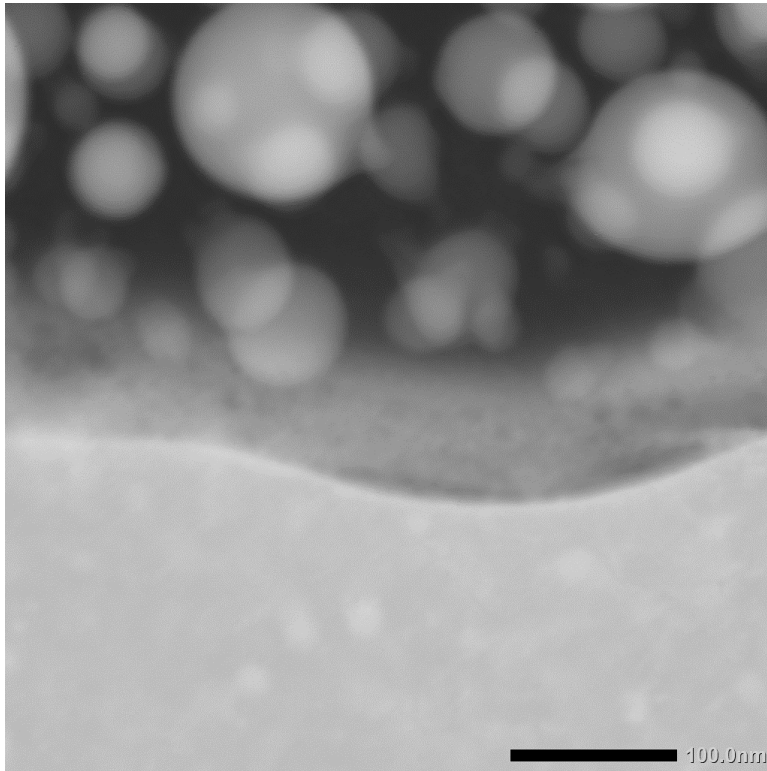
Center up (J1/L7)

- High magnification images reveal that alumina layer, at least in part, shows pore-like structure with pores of about 5 nm.
- Unfortunately the presence of Ga deposits (technical issue) obstructs in part the view on top alumina layer.

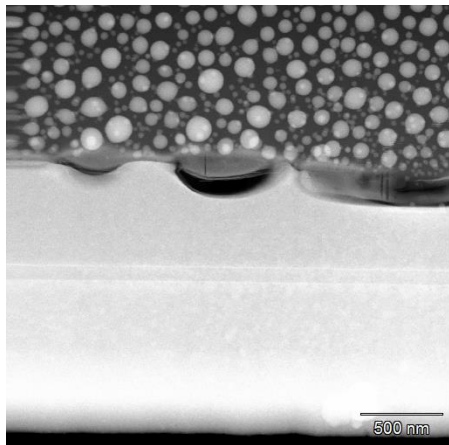
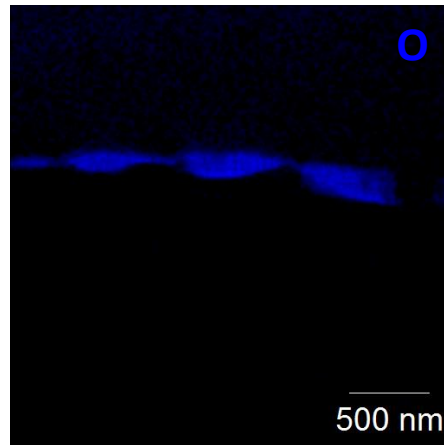
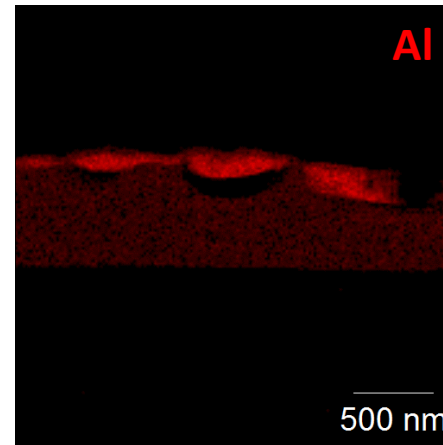
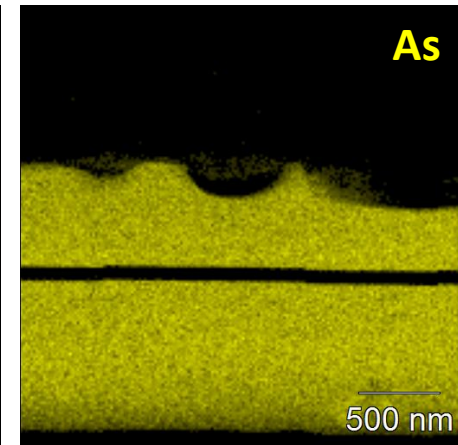
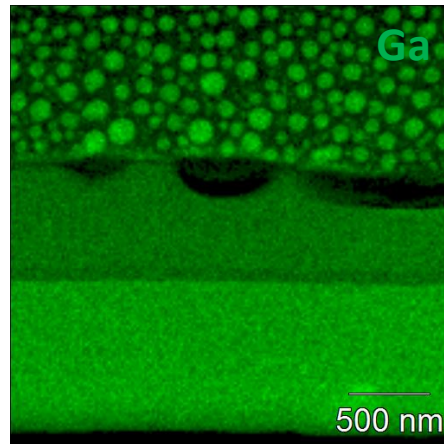
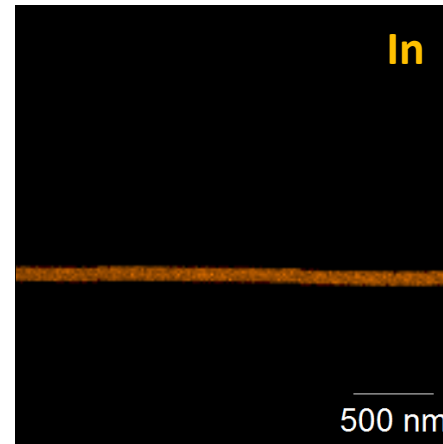
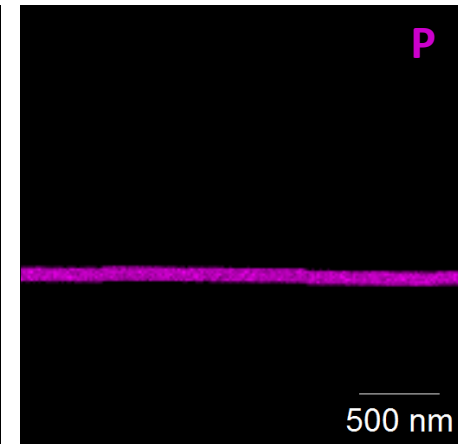
Down left (J5/L11)

- EDX maps confirm that presence of O is associated with Al signal, indicating alumina layer.
- Alumina layer seems to be patchy and broken
- A very well defined layer of Ga/In/P has been observed in the wafer separating Al-present and Ga-poor (top) from Al-absent and Ga-rich regions.

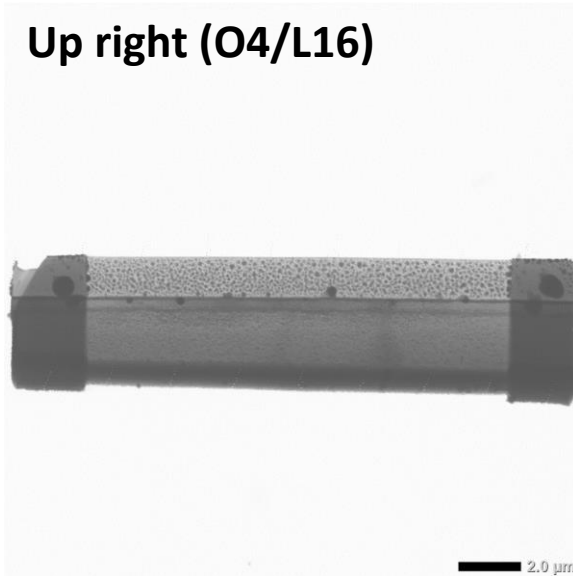
Up right (O4/L16)

- Note: due to technical issues we seem to have deposited a lot of Ga “droplets” on top of the carbon layer, they reside on the surface as confirmed by secondary electron imaging.
- Lamella taken from different regions of the wafer show somewhat different surface roughness – from left-most lamella being nearly flat to the right-most having about 100 nm deep surface ridges.
- In case of rough wafer surface, aluminum-oxide layer seems to vary in thickness from 30 nm up to even 150 nm patches, also it seems to be broken, and in some places lifted up from GaAs to form pores beneath (see next slide and EDX). In case of flat wafer, thin (~50nm) and continuous alumina layer is seen.

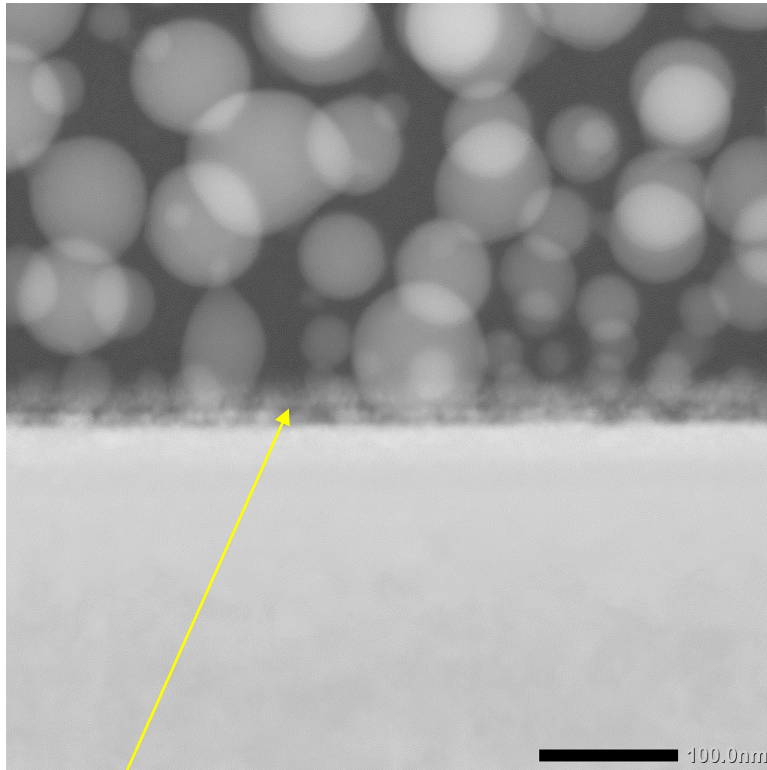
Up right (O4/L16)

- Very thin alumina layer, porosity unclear
- Presence of pores in the ridges, with either absent or lifted alumina layer
- Unfortunately the presence of Ga deposits (technical issue) obstructs in part the view on top alumina layer.

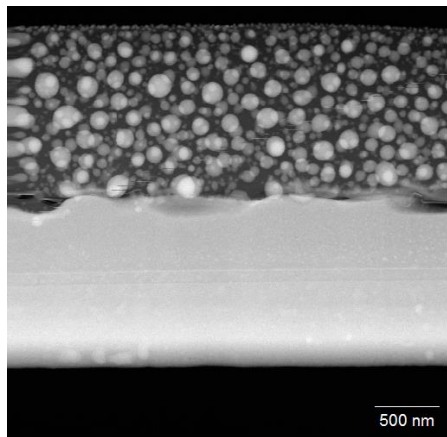
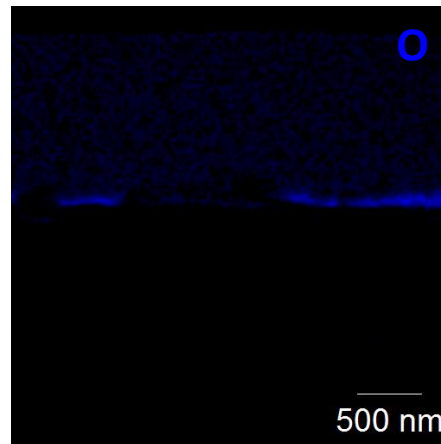
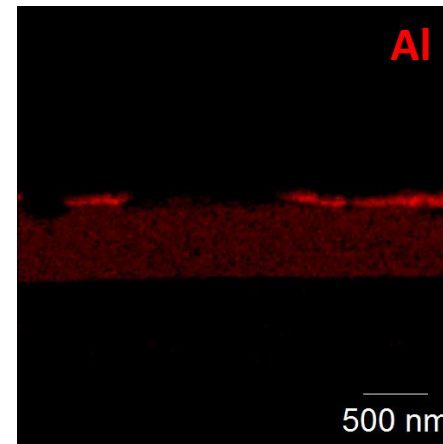
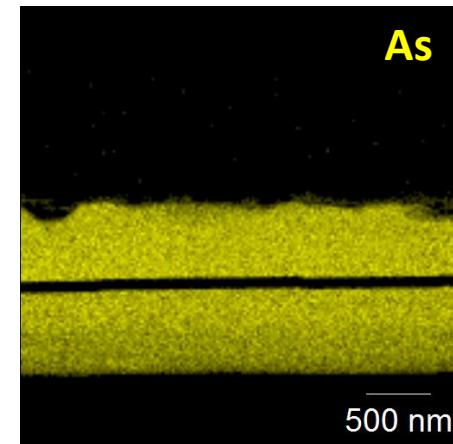
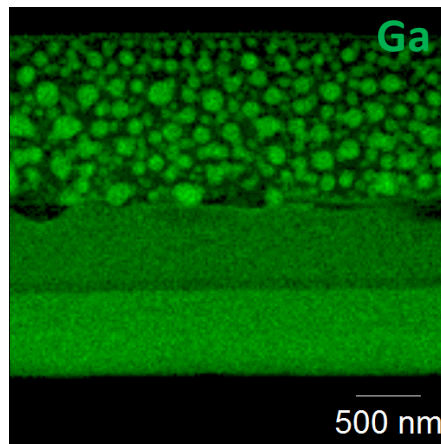
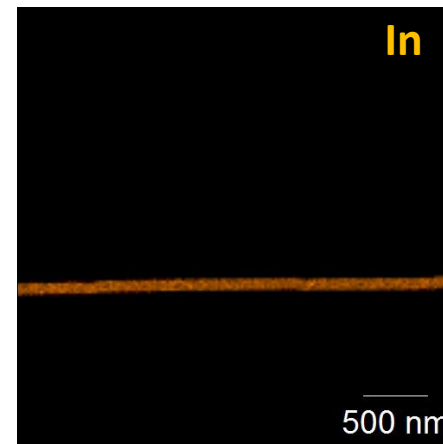
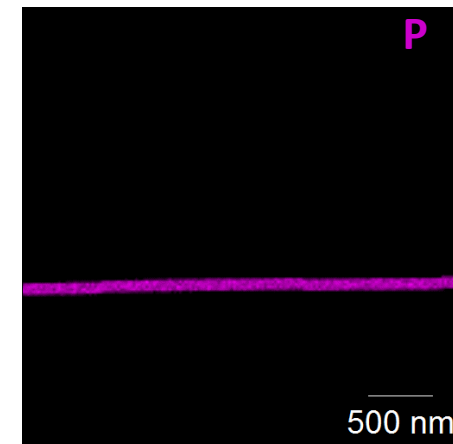
Down right (O6/L18)

- Very thin alumina layer, broken in patches
- A very well defined layer of Ga/In/P has been observed in the wafer separating Al-present and Ga-poor (top) from Al-absent and Ga-rich regions

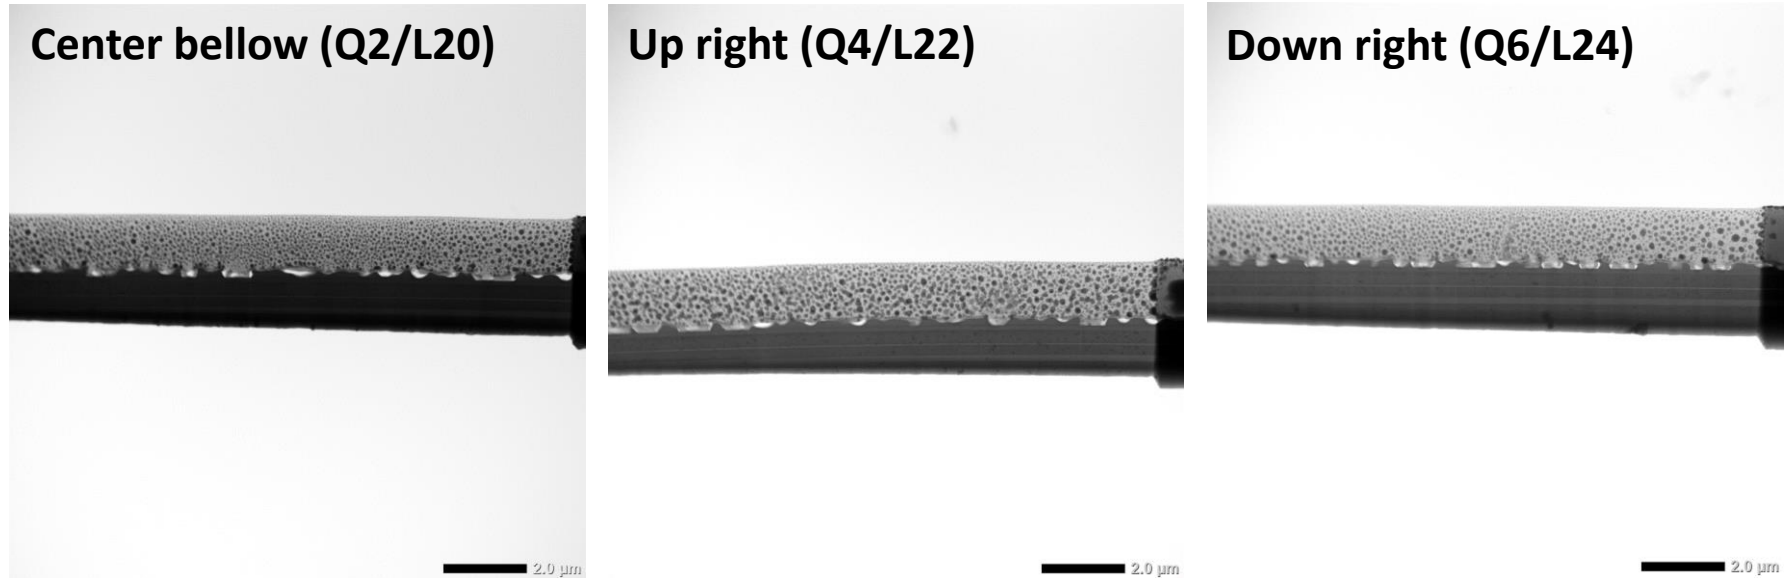
Overview of 3 lamella analyzed

- Note: due to technical issues we seem to have deposited a lot of Ga “droplets” on top of the carbon layer, they reside on the surface as confirmed by secondary electron imaging.
- All lamella show similar surface roughness with depth of the ridges of ~30 to 150 nm.
- Aluminum-oxide layer seems to vary in thickness from 30 nm up to even 150 nm patches (filling up some ridges), also it seems to be broken, and in some places lifted up from GaAs to form pores beneath.

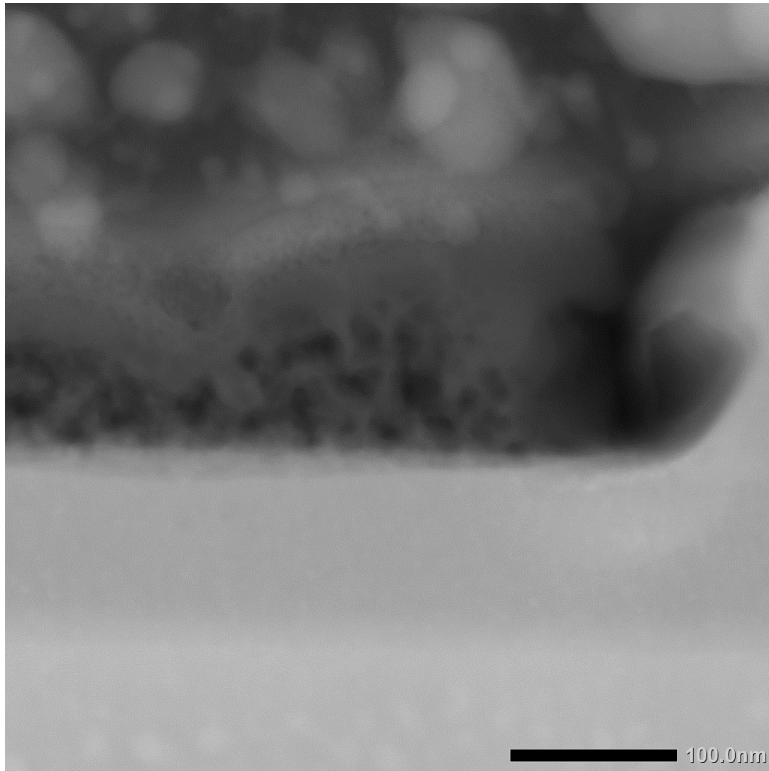
Center bellow (Q2/L20)

- High magnification images reveal that alumina layer shows pore-like structure with pores of about 5-10 nm.

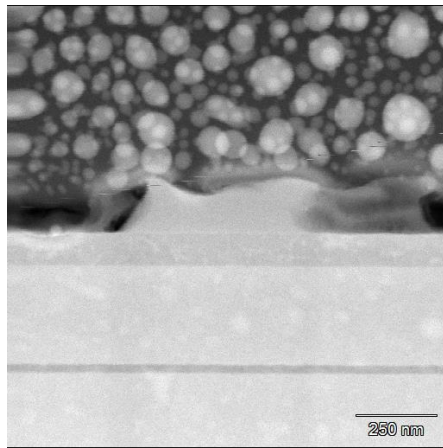
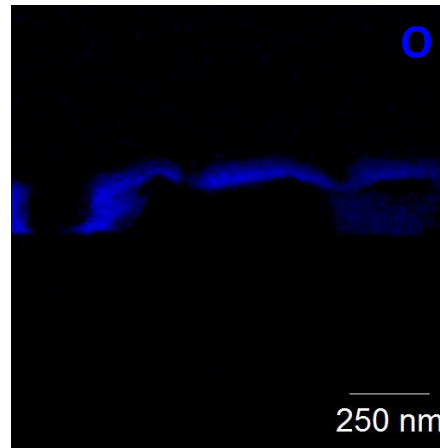
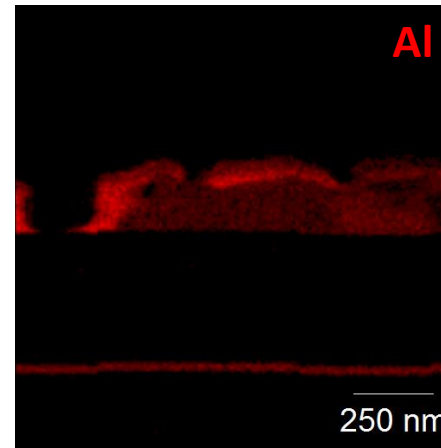
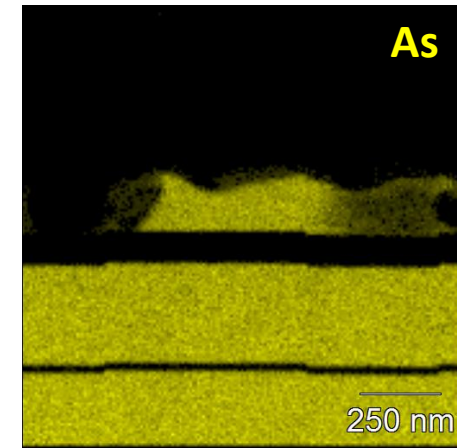
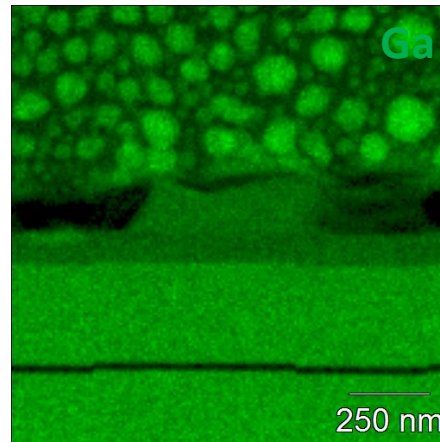
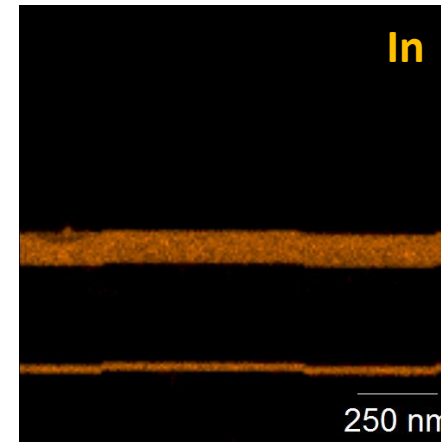
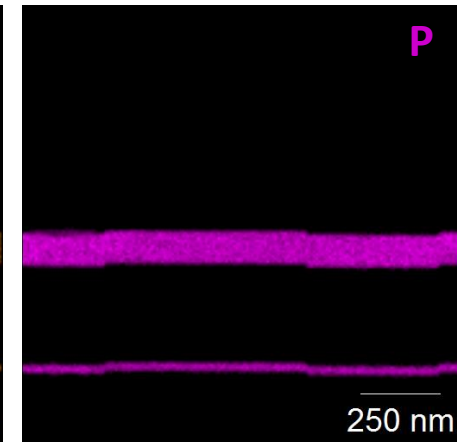
Down right (Q6/L24)

- A very well defined (and thicker) layer of Ga/In/P has been observed in the wafer, separating Al-present and Ga-poor (top) from Al-absent and Ga-rich regions, following is another In/P/Al thin layer
- Aluminum oxide region clearly defined with enriched Al and O signal

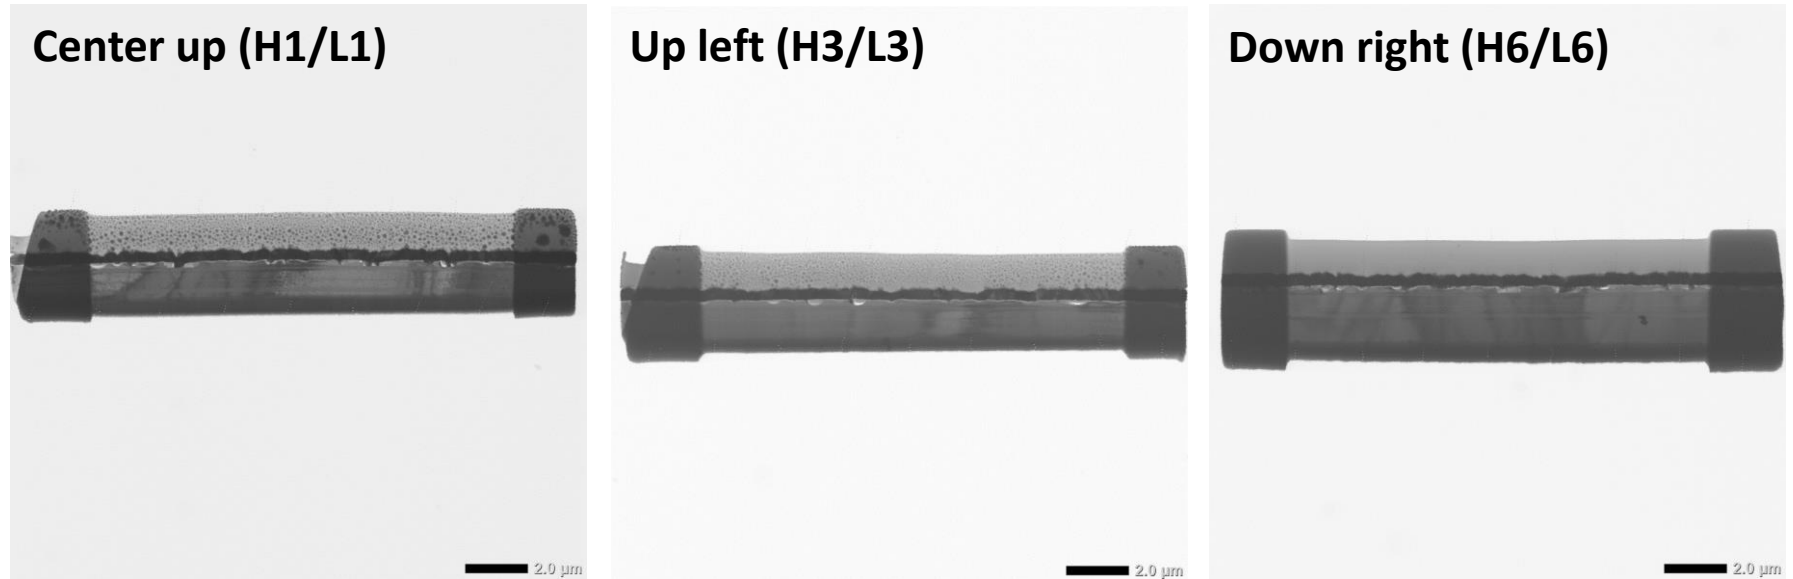
Overview of 3 lamella analyzed

- Note: due to technical issues we seem to have deposited a lot of Ga “droplets” on top of the carbon layer, they reside on the surface as confirmed by secondary electron imaging. Interestingly right-most lamella seem to be free of this artefact.
- All lamella show similar Ag and GaAs wafer surface roughness with depth of the ridges of ~30 to 150 nm.
- Aluminum-oxide layer seems to vary in thickness from 50 nm to 150 nm patches (filling up ridges), also it seems to more continuous and less broken that in previous 3 samples.

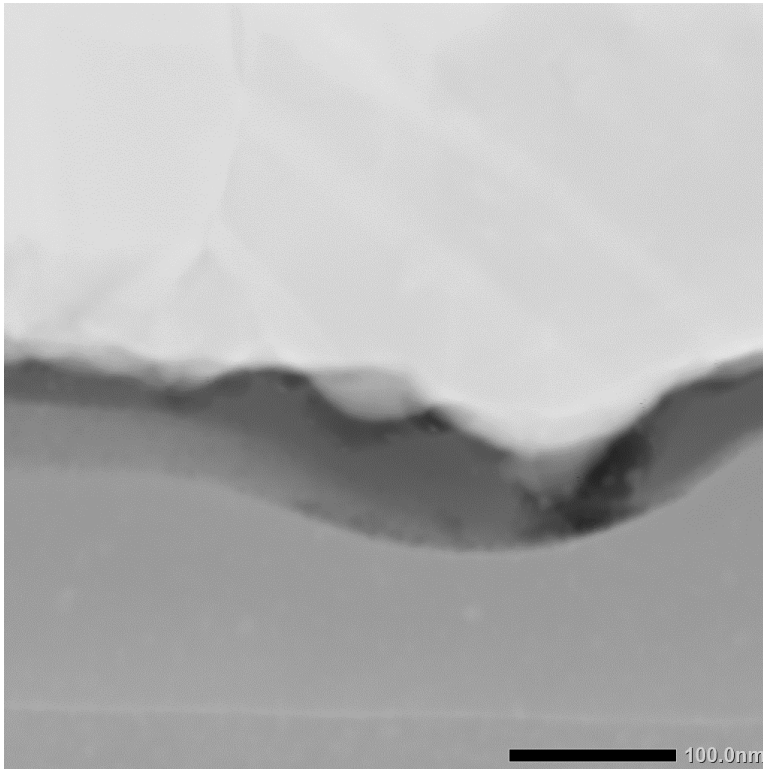
Up left (H3/L3)

- High magnification images do not show as clearly the presence of pores in alumina.
- Protrusion of Ag through alumina is observed in several places.

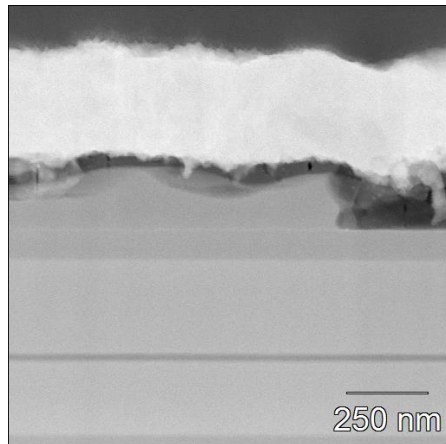
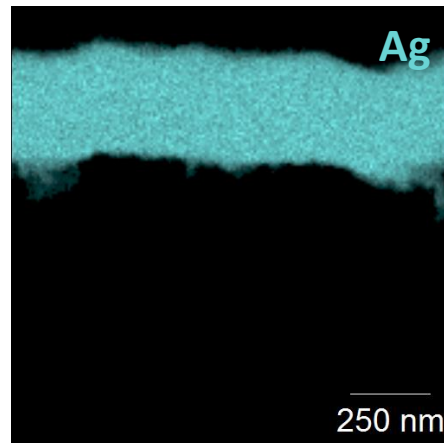
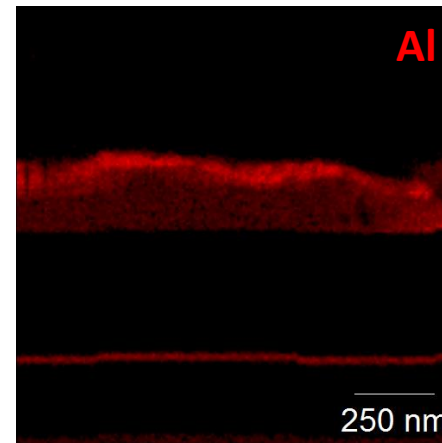
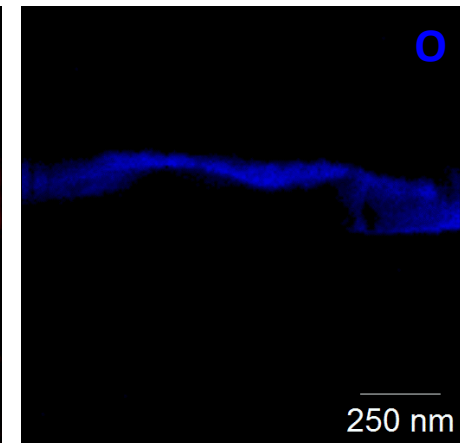
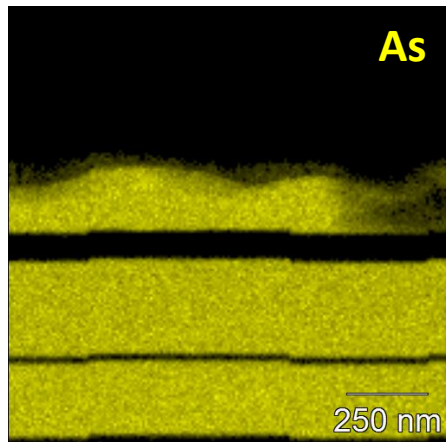
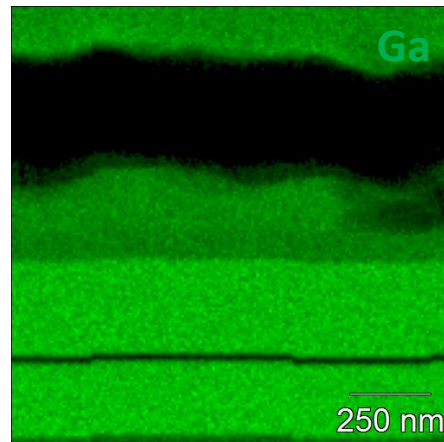
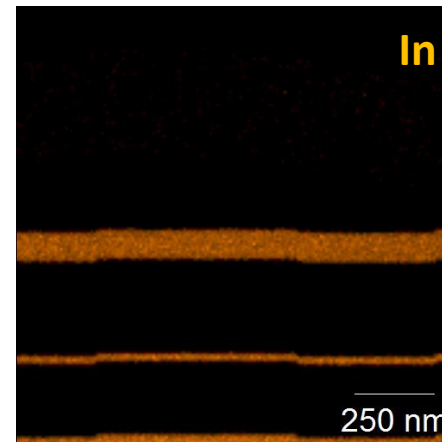
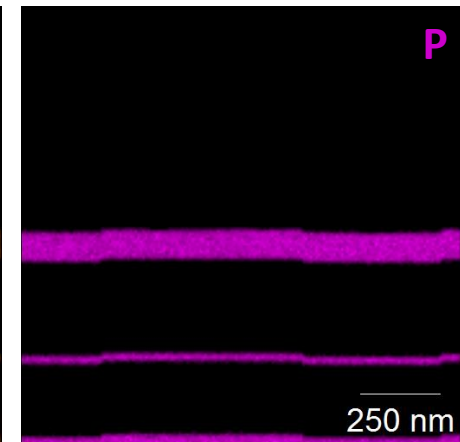
- A very well defined (and thicker) layer of Ga/In/P has been observed in the wafer, separating Al-present and Ga-poor (top) from Al-absent and Ga-rich regions, following is another thinner In/P/Al layer
- Alumina layer clearly defined with enriched Al and O signals
- Alumina layer appears more intact and continuous.
