CTT/300/04/04/TECH

15 नवम्बर २३/Nov 23

### **HIGH VIBRATION ON PORT DA - INS KARMUK**

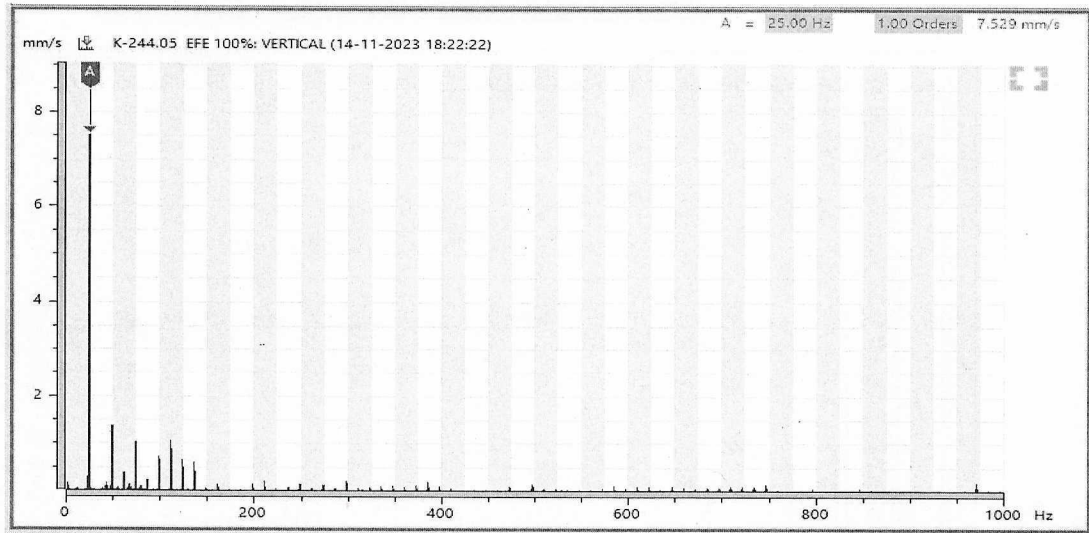
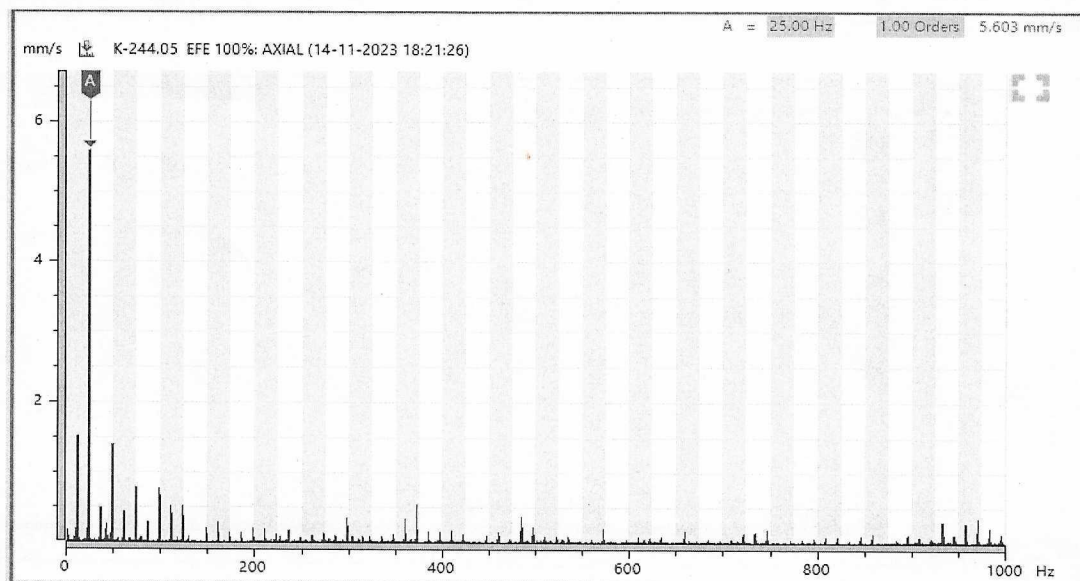
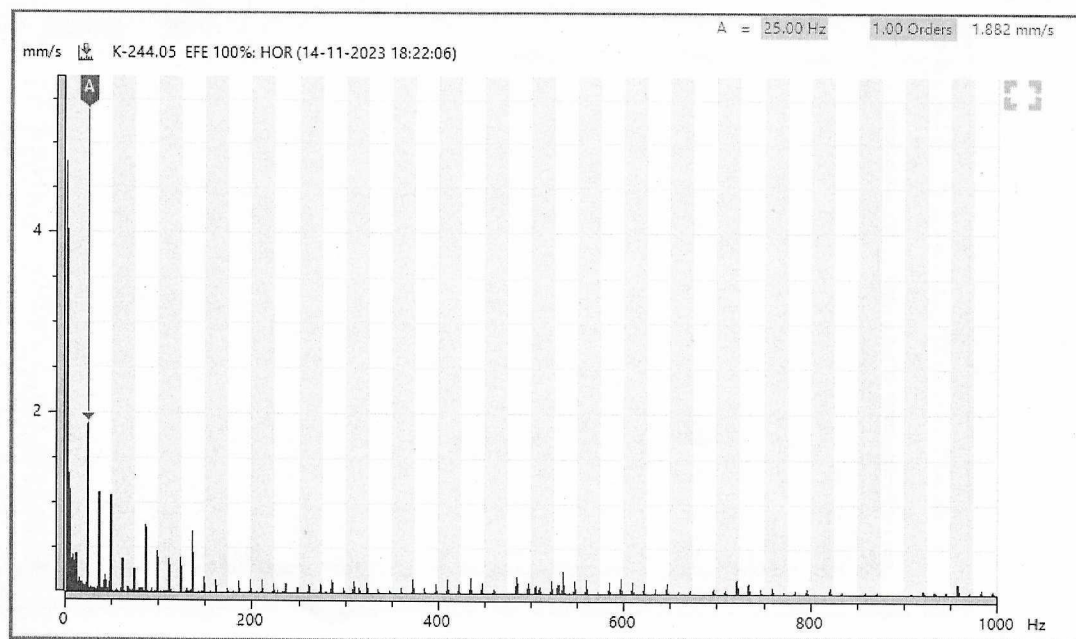
**INS KARMUK PORT DA EFE at 25% (load)**

Ser.	Measuring Points	At 25% (87 kW) load			Remarks
		V	A	H	
(a)	Engine free end	8.17	6.61	6.54	Sat
(b)	Engine drive end	7.60	5.46	7.16	Sat
(c)	Alternator drive end	18.20	8.91	<b>28.82</b>	<b>UNSAT</b>
(d)	Alternator free end	<b>33.16</b>	4.81	<b>39.54</b>	<b>UNSAT</b>

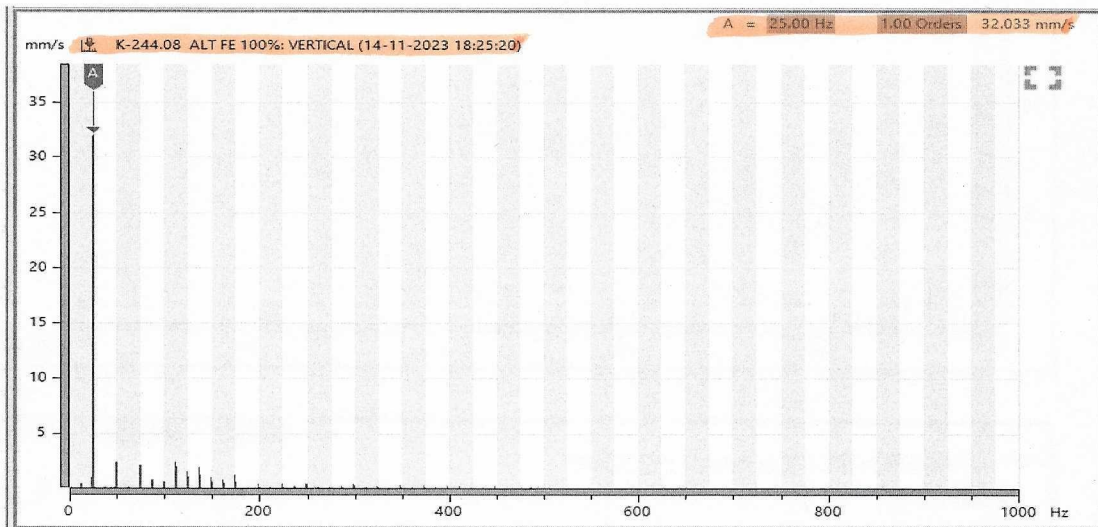
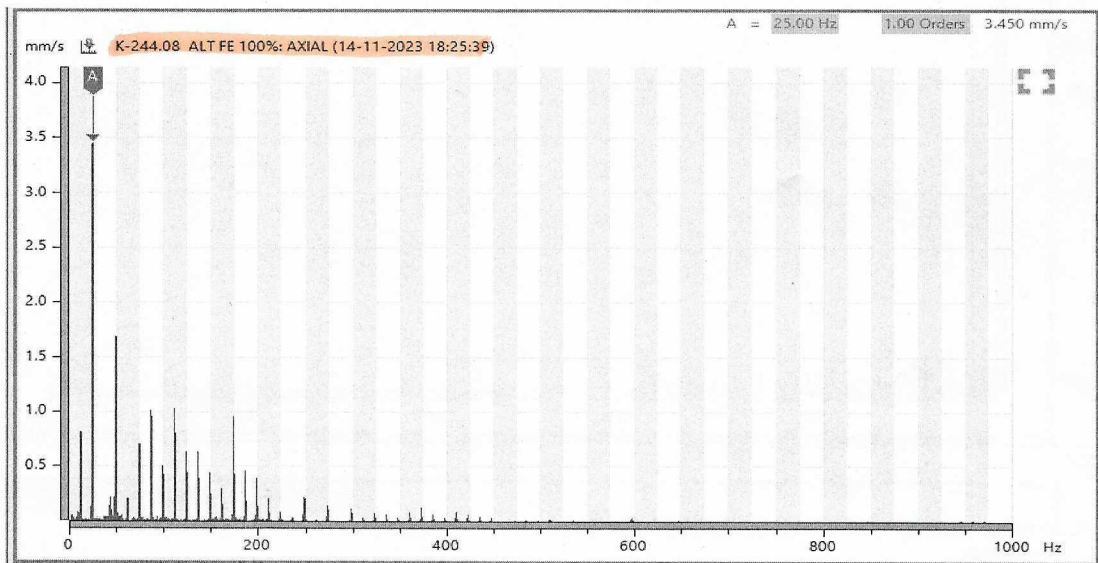
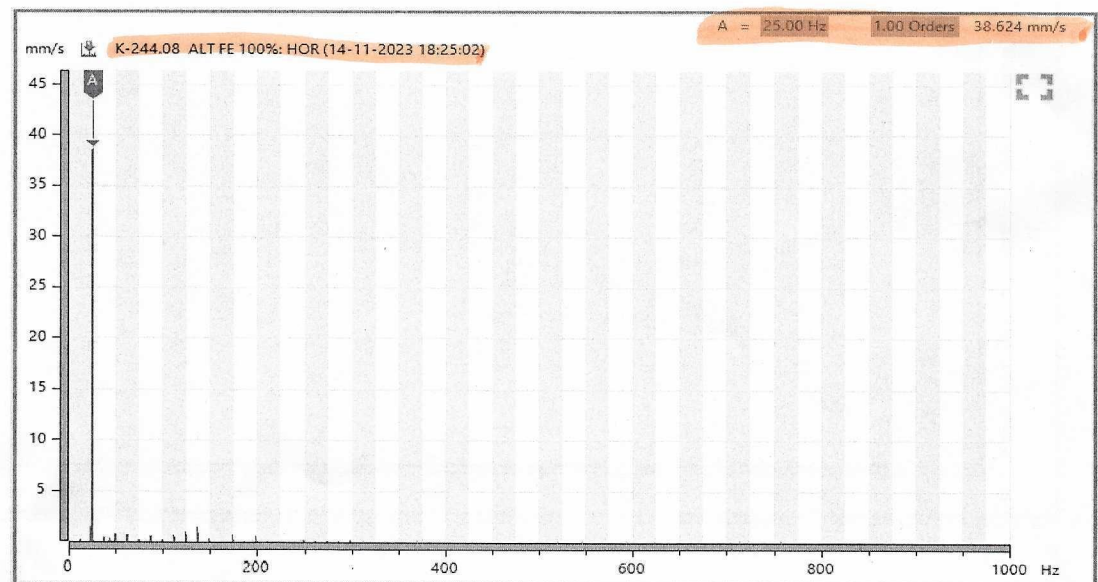
# INS KARMUK PORT DA AFE at 25% (load)

4. **Spectrum Analysis.** Narrow band/ Spectrum analysis of PDA was carried out at 25% load. The FFT spectrum indicates a prominent 1x peak on alternator free end (Horizontal & Vertical directions) and low amplitude in axial direction with a **maximum amplitude of 38.62 mm/s at AFE(H)**. Further, no side bands/ harmonics were observed, indicating the possible presence of **dynamic unbalance of rotor**.

- Dynamic balancing of Rotor.
- Replacement of all bolts in bearing hub as per specification.
- Provisioning of greasing pipes on **Alternator NDE for all DAs**.
- Replacement of alternator cooler rubber beading.
- Replacement of all rusted bolts in alternator and engine foundation.
- Details of mounts viz. date of manufacture, deflection readings etc to be forwarded to CTT(Pbr).
- Loosening of all jacking and aligning bolts as per laid down procedures.
