**Sub: Verification of compliance of the direction issued u/s 5 of E(P) Act 1986 to M/s. Astik Dyestuff Pvt Ltd., B-C, Plot # 707, B & C, GIDC Ankleshwar, Estate Panoli, Dist. Bharuch, Gujarat 393 002- Reg.**

# ASTIK DYESTUFF PVT. LTD.

| Subject | : | Revocation of Closure directions under Section-5 of the Environment ( Protection ) Act, 1986 – reg. |

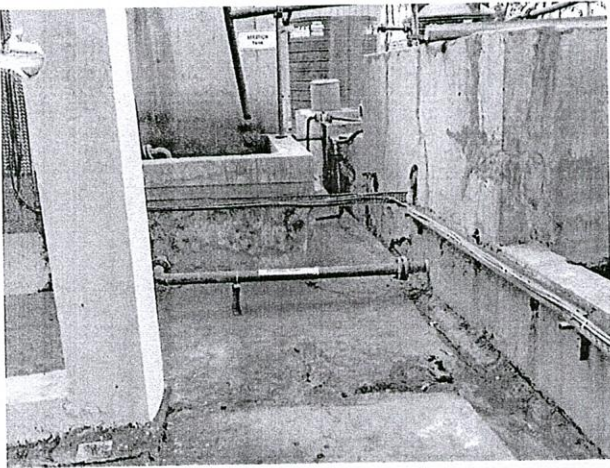
During CPCB officer visit, they have observed that collection tank one line directly connected to final treated effluent storage tank.

**Photo 5: After removal of pipeline**

And, after visit unit has taken initiative and remove all the extra line so that in future no confusion can occur.

As suggested by the board officials we have redesigned the pipeline flow in a totally linear manner with proper labelling and removed any suspect pipes which have raised concerns. Removed pipelines-Annexure 1a and ETP pipeline flow-Annexure 1b is shown. Further, additional PTZ camera with view of ETP area has been installed and connected to PCB server.

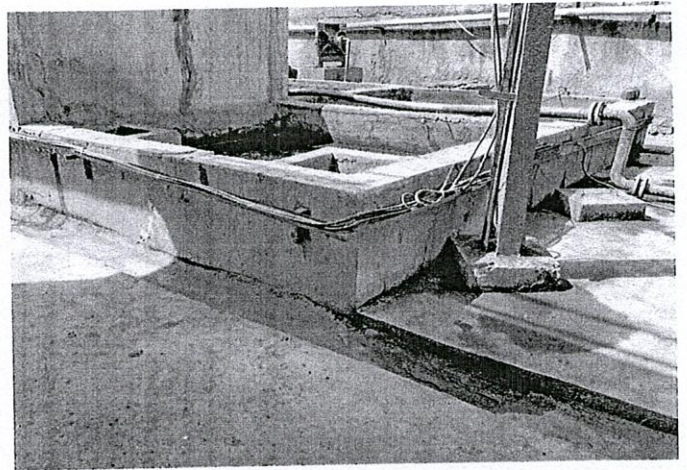
**Photo 6: After removal of pipeline**

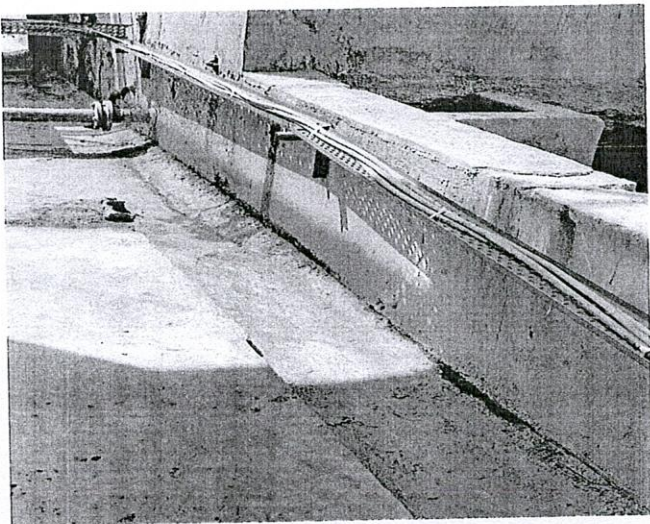
**Photo 7: After removal of T Junction with valve**

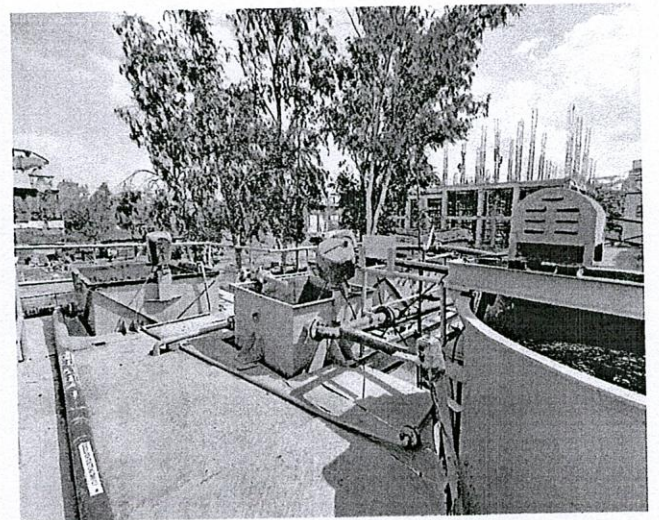
**Photo 10: After maintenance of MS structure**

| 7 | <b>The structure of Effluent Treatment Plant was observed in rusted and dilapidated state.</b> | <b>Fully Complied</b><br>All ETP components have been repaired with fresh maintenance to take care of any rust. Entire ETP pipeline network made into linear direction and proper labelling is done in ETP area. ETP is functioning with high degree of efficiency, and always been maintaining effluent norms well within prescribed limits.<br>A photograph for the ETP structure after maintenance is attached as Annexure-VIII |
