General Summary

Customer
 Ministry of Transportation and Infrastructure

Property Address
 111 Old Hope Princeton Way
 Hope, BC V0X 1L4

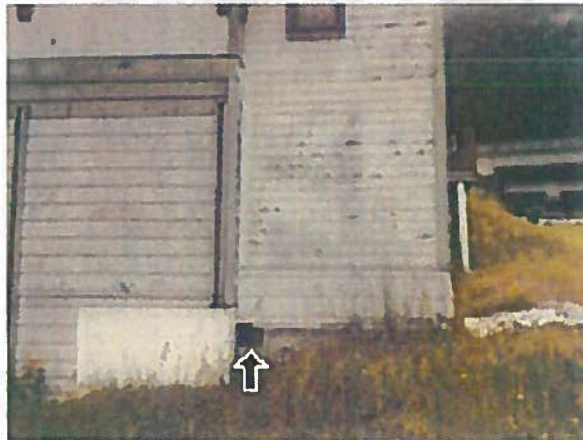
2.0 Picture 4

Water leaking damage was noted in locations around the exterior of the building. Upon further evaluation it was determined that the water source is the hydronic heating system from within the building.

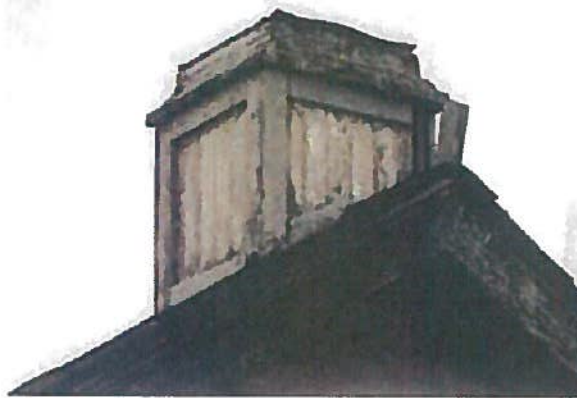
2.0 Picture 8

Where two brick chimneys once exited the roof for the old pot-bellied stoves, there are now two structures which are falling apart, requiring extensive repair. They are not large, and subsequent repair costs would probably be not much more than to have a Roofer remove them and sheet & shingle the void spaces they would leave behind. For the charm they add to the building, I would

recommend repairing and retaining them.

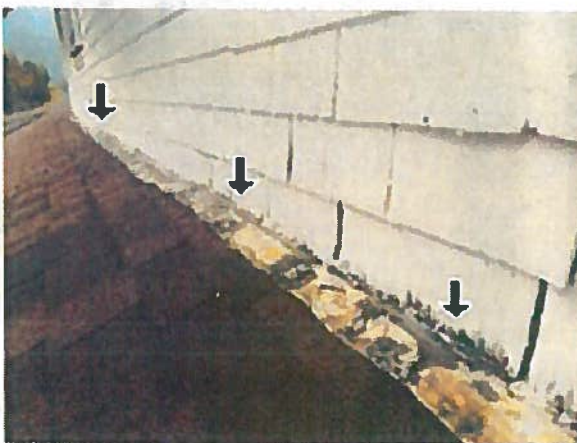
2.0 Picture 12

The lower course of exterior wood shingles at the front 2nd Storey (Picture 12) and West end of the building (Picture 13) requires repair/replacement due to exposure to the elements, and a few pieces of exterior trim require replacing (Picture 14).

Cost Estimate for Exterior Wood Siding/Trim repairs: \$2,000 - \$2,500.

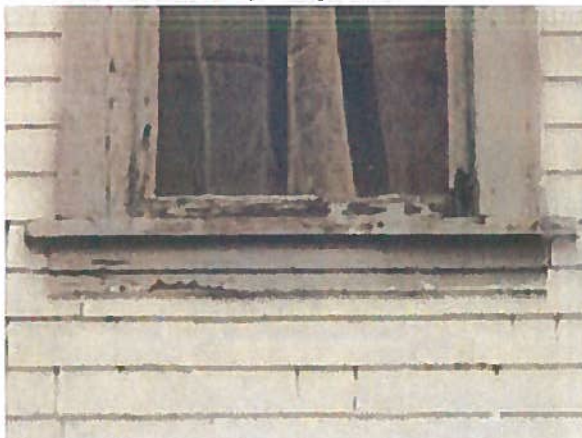
2.2 Picture 1

All the woodwork, sills and trim at the 2nd Storey wood-framed windows require repairs and paint. The ground level window frames are in much better condition as they have been protected from the elements by the porch.

Cost Estimate for Window Repairs: \$1,000 - \$1,500

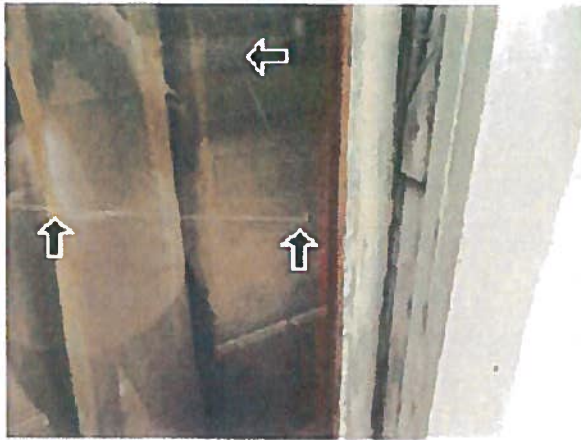
2.2 Picture 3

A couple windows are broken, requiring glass replacement.

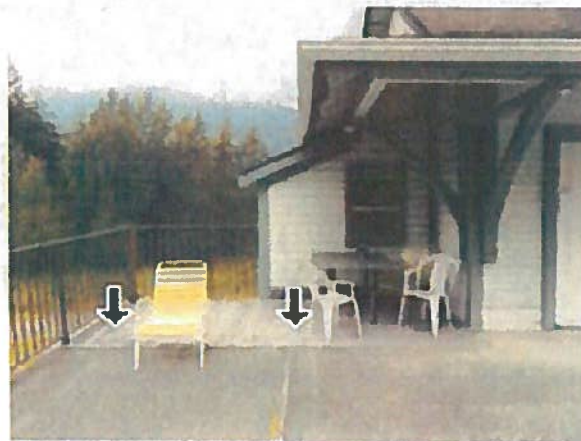
2.3 Picture 1

The surface is painted plywood, which is not sufficient. The decks need to be covered with some sort of waterproof membrane to protect the structure.

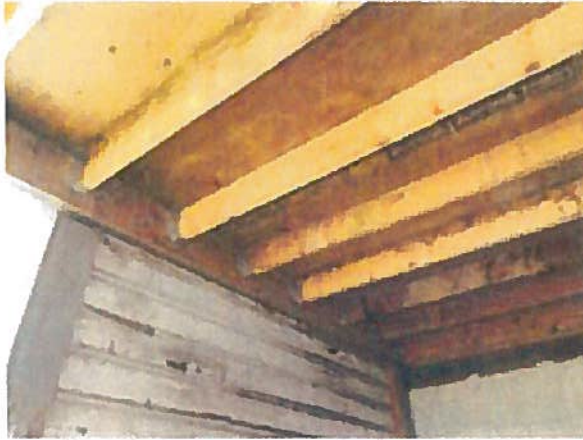
2.3 Picture 3

Additionally, the deck at the West end is under-built, with 2x6 joists spanned at 16" on center. These should be 2x8 joists (minimum).

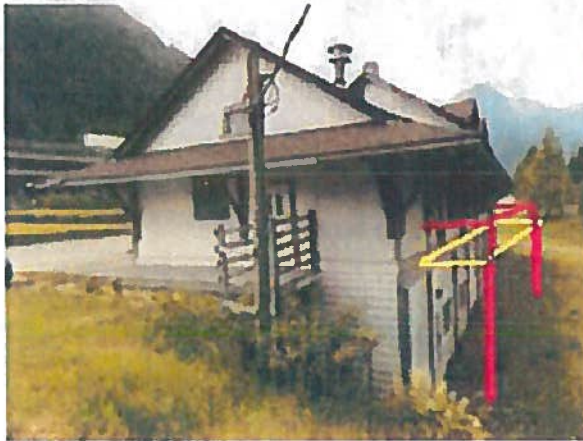
2.3 Picture 5

The rear of the building requires a large deck (or at the very least, multiple staircases) where the four exterior doors lead used to exit to the station platform, but now lead to a fall of approximately 13 feet. Ideally, I would suggest wrapping the rear deck around to connect to the East side deck.

** The other alternative is to permanently seal/secure the rear exit doors **

Cost Estimate for Existing Deck Repairs and new Rear Deck: \$4,000 - \$15,000

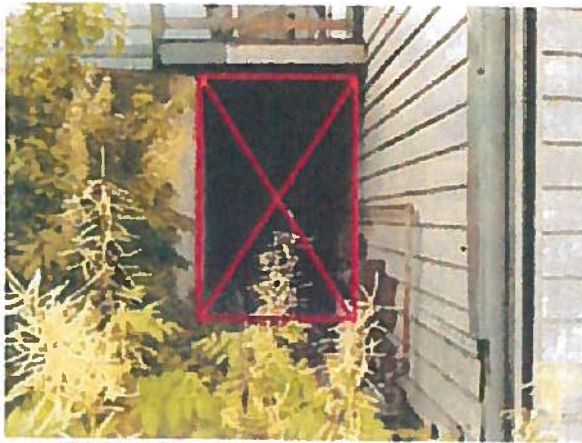
2.3 Picture 7

As a precautionary measure, I recommend enclosing the underside of the deck at the East end of the building to keep people out of this area.

Estimated Cost to Construct Steel Gate: \$800

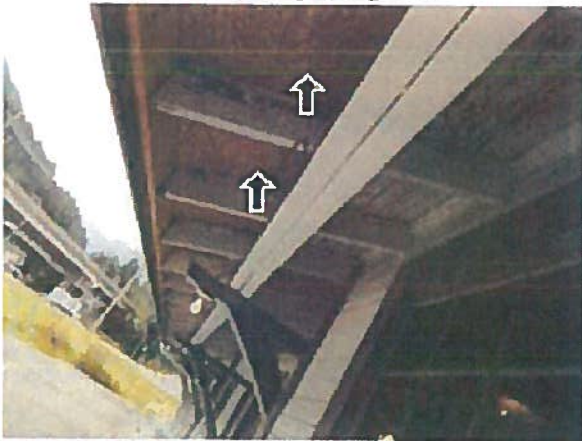
2.5 Picture 1

Repairs required under the Eaves where original cladding has been removed. For aesthetic reasons I recommend repairing this.

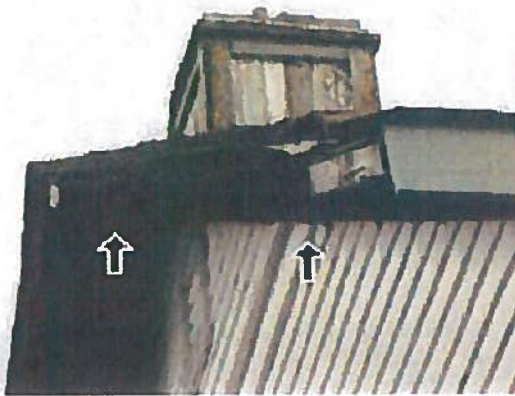
2.5 Picture 3

Fascia board is missing in locations. This is a project that is "in-progress", with volunteers doing what they can with limited resources. The material to finish the work is on-site in the basement.

Cost Estimate to Repair Fascia and Eaves: \$3,000

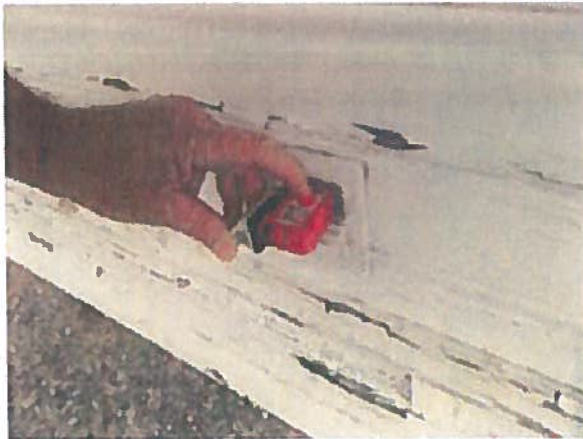
2.6 Picture 1

Any ground-level Receptacles should be converted to Exterior GFCI receptacles for safety Reasons.

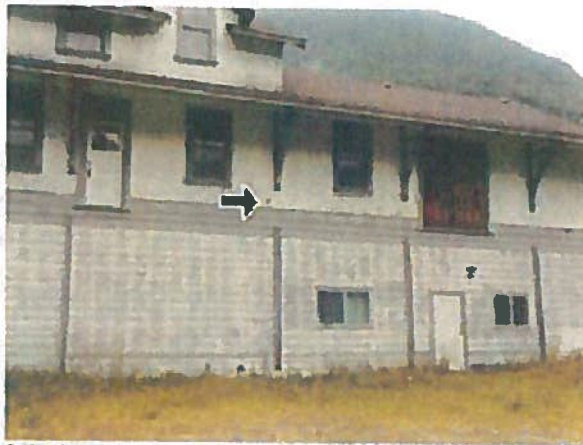
2.6 Picture 2

Elevated exterior receptacles should have cover plates and be weather protected with a hinged cover.

Cost Estimate for Exterior Receptacles: \$100

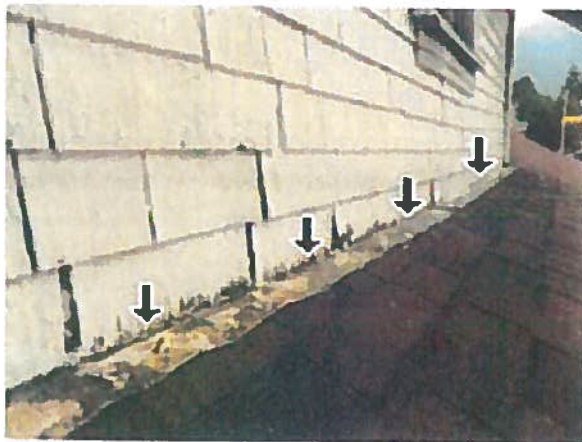
3.1 Picture 1

The flashing has been damaged. It looks as though it was bent up and out of the way when the Roofers installed the new shingles, then hammered back into place. The issue is that the downward slope "angle" has been lost, and water will now pool and run back into the building.

I recommend a Roofer install new flashing where necessary.

Cost Estimate for Flashing: \$500

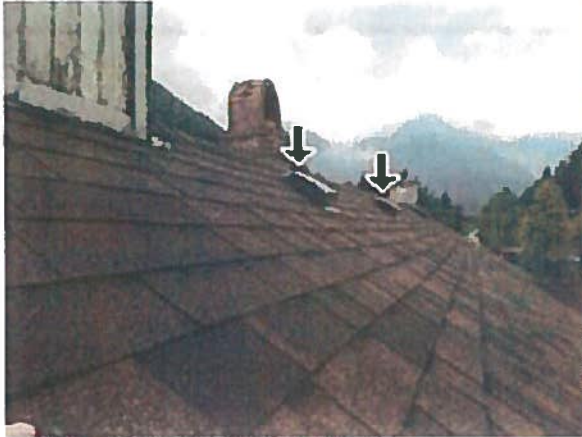
3.3 Picture 1

Roof vents (for exhaust) were installed along the back ridge of the roof (Picture 1), however the soffit/eaves are not vented to allow for air intake (Picture 2). As such, natural convection and air exchange can not happen. I recommend a Roofer install soffit venting and baffling.

Cost Estimate for Venting Soffit and Installing Baffles between Rafter Bays: \$1,000

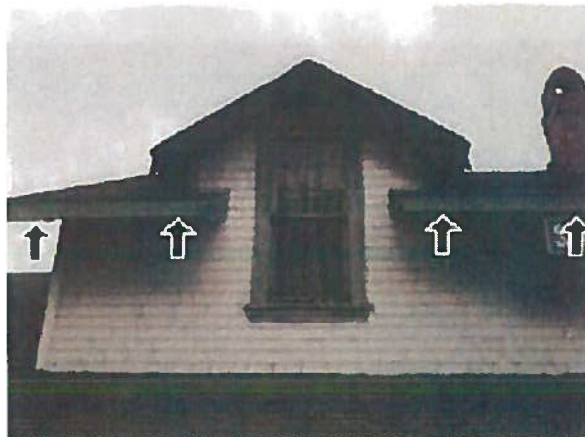
3.4 Picture 1

The edges of all the roof lines where there is water run-off require gutters to protect the fascia.

Cost Estimate to Install Gutter(s): \$1,500 - \$2,500

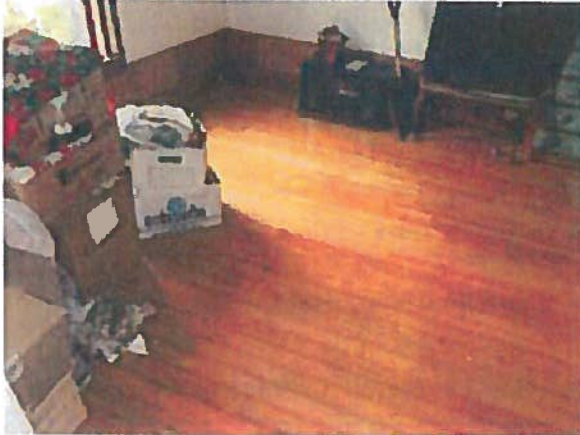
4.0 Picture 1

The hardwood flooring in the 2nd Storey Stationmaster's Apartment has been water damaged and requires refinishing.

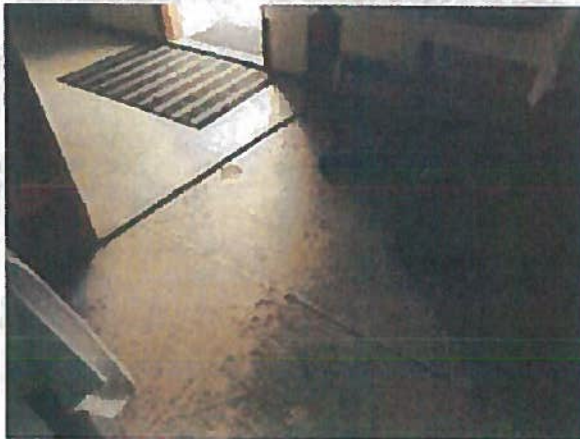
4.0 Picture 3

Much of the flooring on the main floor is unfinished K3 Particle Board, which does not do well when exposed to water and heavy foot traffic. I recommend a durable flooring be installed over the Particle Board.

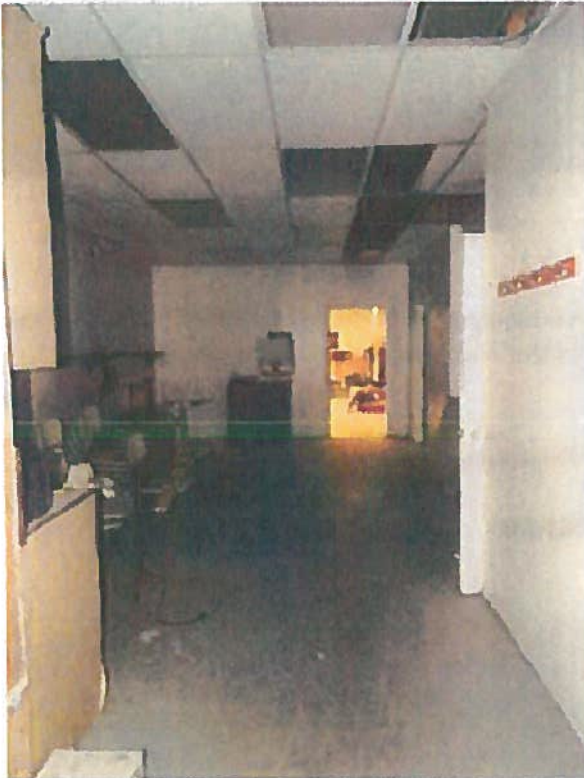
4.0 Picture 10

The flooring in the basement is unfinished and/or painted concrete.

Cost Estimate for Flooring (depending on type and how far you choose to go with it - i.e. installing floor coverings in the unfinished basement or not): **\$5,000 - \$10,000**

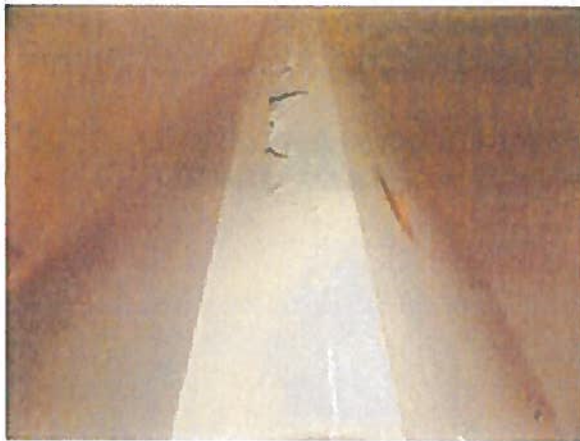
4.1 Picture 1

For the most part the walls are in fair condition, however there are a couple areas which require minor repairs and paint, particularly upstairs on the 2nd Storey where an old roof leak caused the paint to bubble and peel.

Cost Estimate for Wall Repair and Paint: \$500 - \$1,500

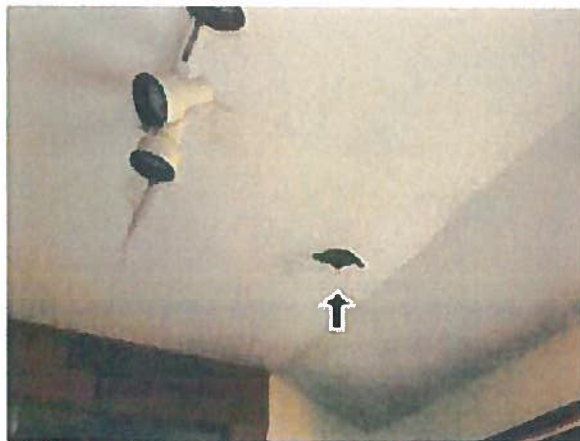
4.2 Picture 1

Water leaking prior to the Roof replacement has damaged the ceilings in a few locations, namely near the main floor entry (Pictures 1 & 2) and in the 2nd Storey apartment (Pictures 3, 4, 5, 6). Repairs are necessary.

I recommend repairs by a qualified Drywaller/Contractor.

Cost Estimate for Ceiling Repairs: \$1,200 - \$1,800

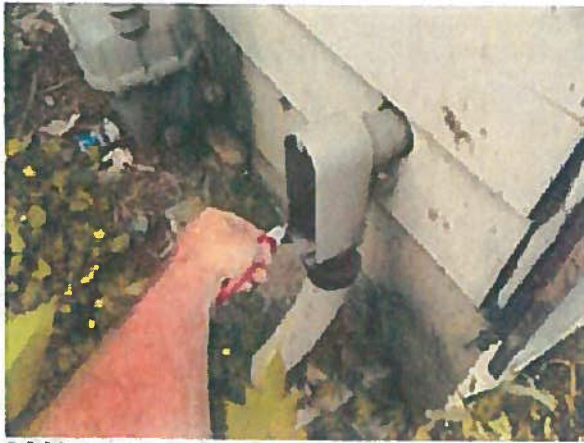
5.0 Picture 1

Someone has attempted to gain access to the service entrance at the exterior of the building. No damage was done so perhaps they thought better of it. regardless, I recommend having a steel lockable cage fabricated for security reasons.

Cost Estimate to construct: \$500

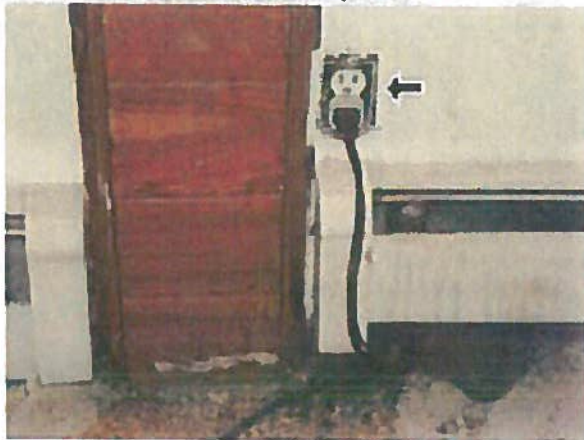
5.4 Picture 1

Replace any missing cover plates...

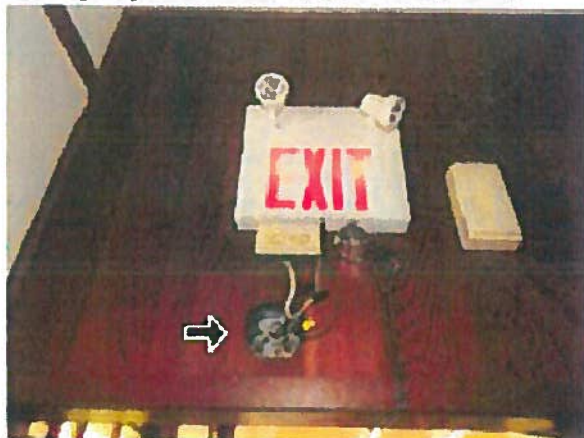
5.4 Picture 2

This open junction box should be closed...

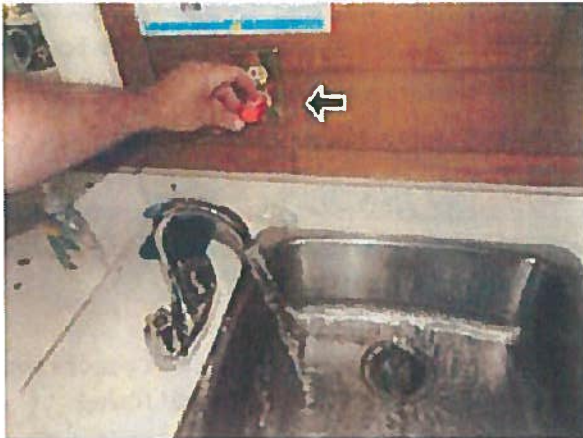
5.4 Picture 3

Replace this standard receptacle with a GFCI as it is near a water source...

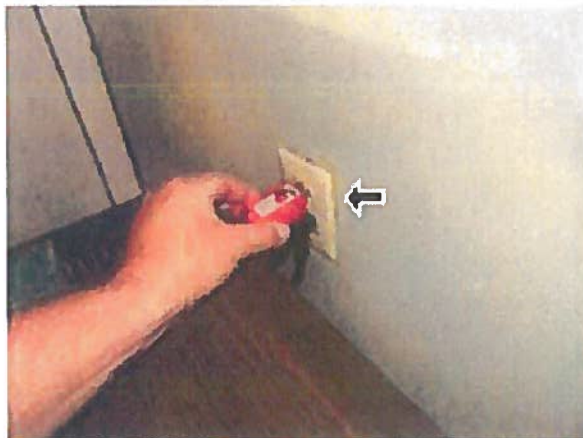
5.4 Picture 4

Check the connections and secure this loose receptacles in the Kitchen...

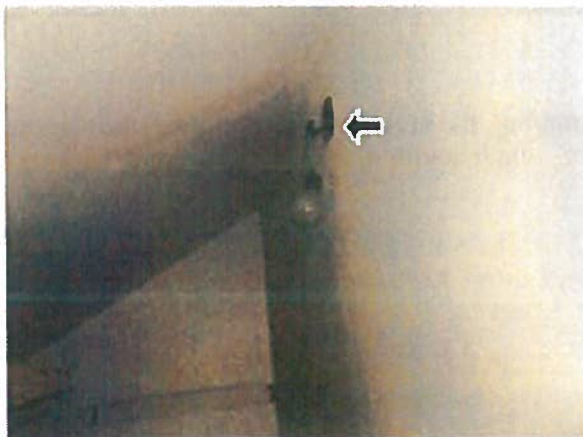
5.4 Picture 5

And install a proper fixture in the 2nd Storey closet.

Cost Estimate for Electrical Repairs: \$300 - \$500

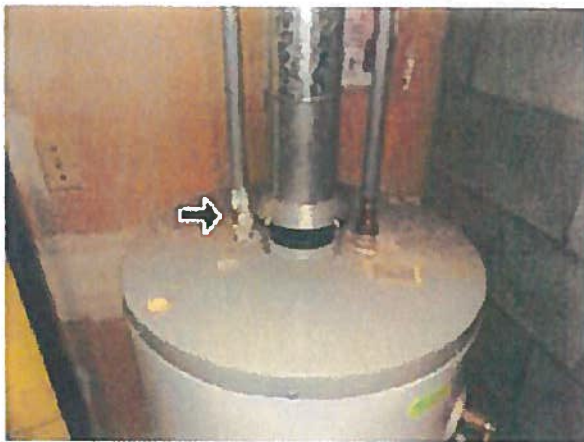
6.2 Picture 1

Heavy corrosion noted at the connections above the hot water tank, as well as in a couple other locations, possible due to minerals in the water adversely reacting with the metal fittings. I recommend a Plumber replace the corroded fittings throughout the building. Otherwise, no distribution line issues noted.

Cost Estimate: \$400

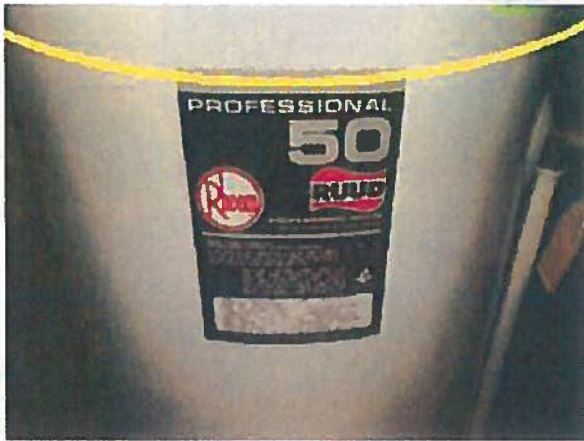
7.5 Picture 1

No seismic restraints installed. Recommend strapping the tank down to minimize the chance of the tank movement in the event of an earthquake, which could invariably cause pipe breakage and flooding.

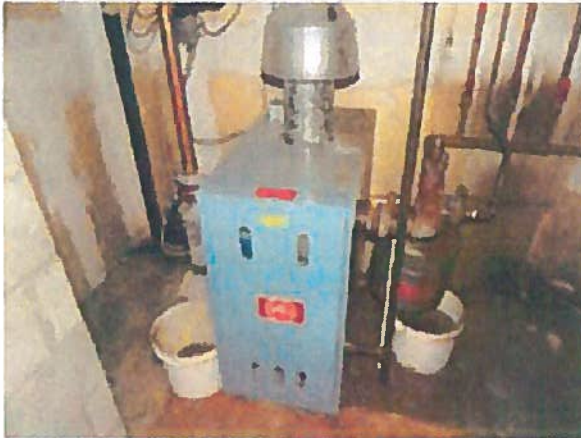
8.0 Picture 1

The Boiler is in decent shape, with a new motor and pump having been installed less than 3 years ago. Each zone is also properly manifolded.

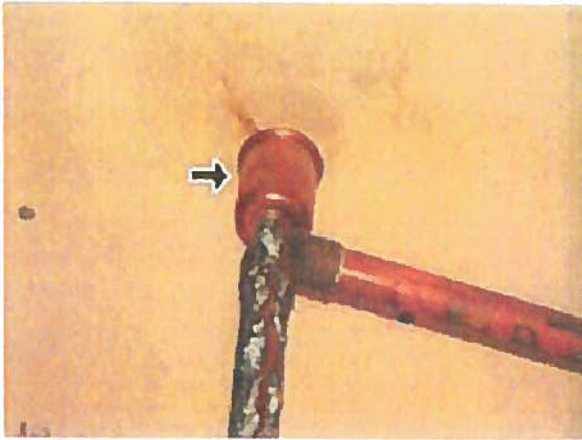
8.0 Picture 3

The main repair issue is that a few of the bleeder valves on the actual radiator units are leaking. A few have been replaced (Pictures 3 & 4) but many have gone unchecked, particularly at the East end of the building where long-time leaks (Pictures 5, 6, 7 & 8) have subsequently damaged exterior walls beneath them (Picture 9), as previously mentioned in the Exterior section of the report.

I recommend a qualified Contractor evaluate all the hydronic baseboard, and repair as necessary.

Estimated Cost for Evaluation and Repairs: \$1,500 - \$2,000

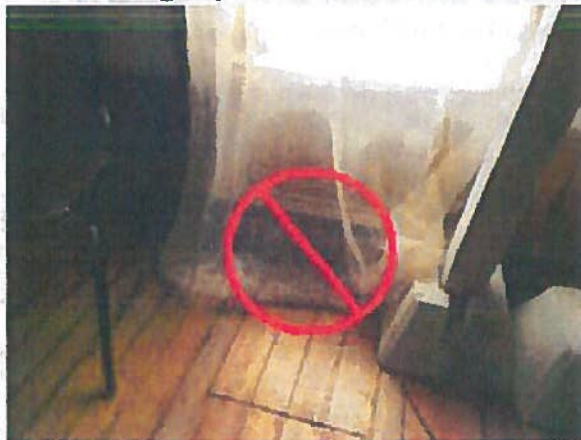
8.2 Picture 1

It is a FIRE HAZARD to have drapes, electric cords, or any other combustible material come into contact with an electric baseboard. I strongly recommend shortening any drapes or re-routing any cords which come into contact (or near) any electric baseboards.

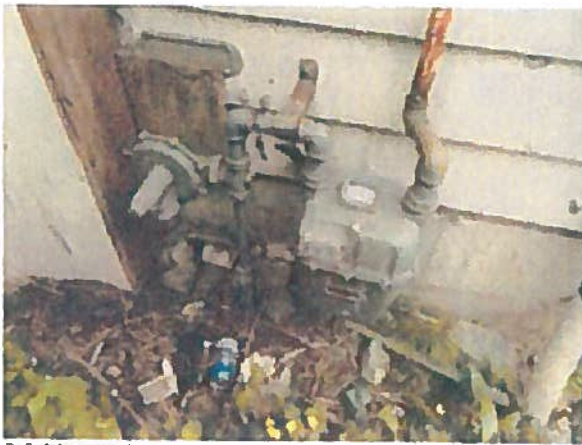
8.8 Picture 1

The Main Gas shutoff is located at the exterior of the building. This is something that, as a homeowner, you would generally not touch. The repair notice is because, like the electrical service entrance, I recommend that (providing it is permitted) a lockable enclosure be fabricated to protect the meter and shut-off from vandalism.

Estimated Cost to construct: \$500

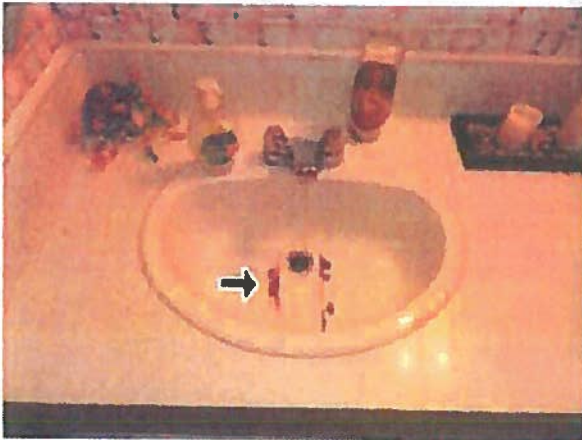
9.0 Picture 1

In total there are 4 bathrooms (three on the main floor with one upstairs), with a total of 5 bathroom sinks. Except for the one upstairs, the main floor bathroom sinks are rusted extensively and require replacement.

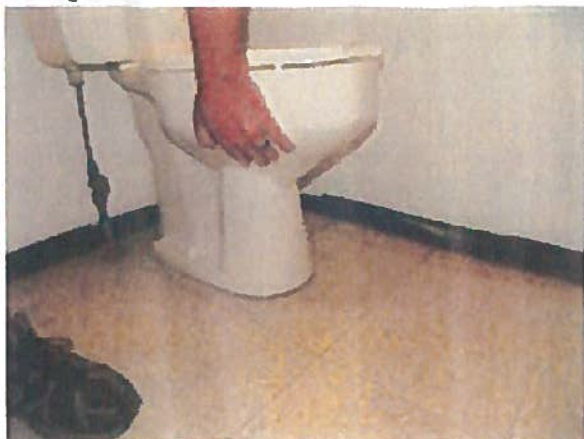
9.1 Picture 1

There are 7 toilets, none of which showed evidence of moisture/leaking. One toilet was loose (in the women's washroom). I recommend securing before it starts to leak and causes substrate damage.

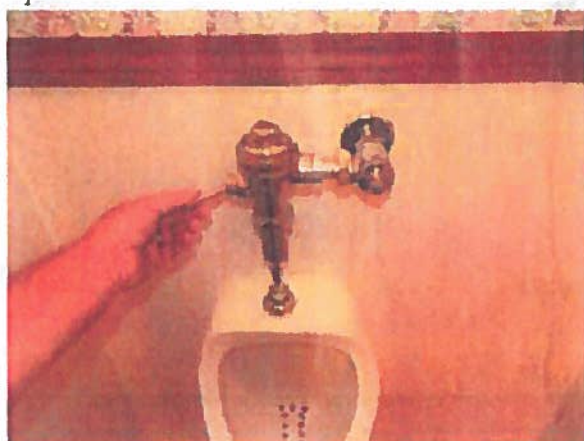
9.1 Picture 2

The fixture/flush mechanism for the urinal in the men's washroom does not work. I recommend repairs.

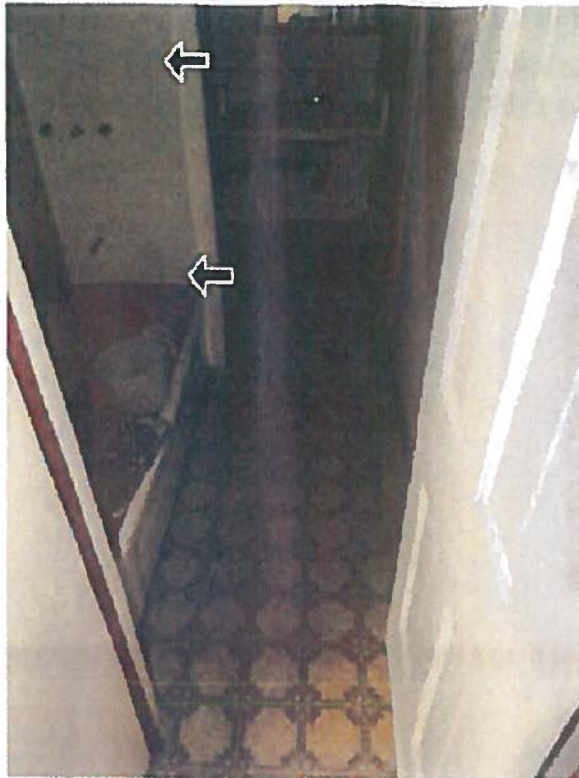
9.2 Picture 1

There is no proper surround in the 2nd Storey bathroom.

Estimated Costs for Bathroom Repairs: \$1,500

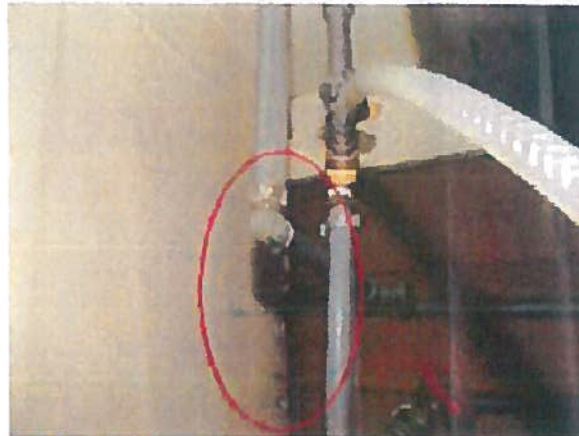
10.0 Picture 1

The sink at the front kitchen service counter leaks extensively at the faucet fitting(s). I recommend repairs/replacement of the faucet.

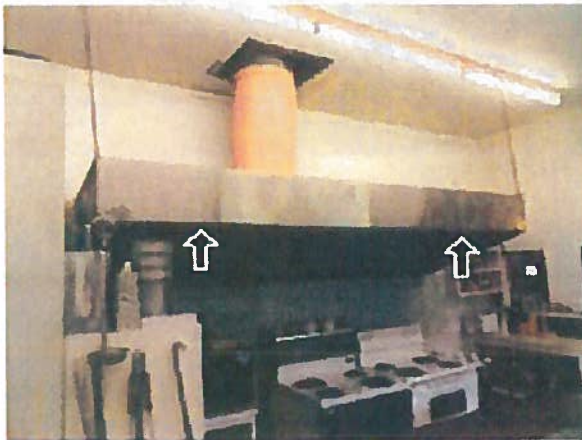
10.3 Picture 1

The kitchen has a large, non-operational vent hood. Depending on how you intend to use the space, you could repair it or remove it. Repairing would require the installation of the entire fan and motor assembly.

Cost Estimate to Remove or Repair: \$300 - \$2,500

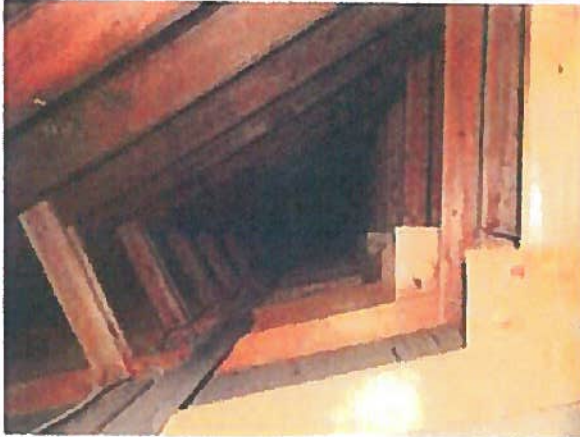
11.3 Picture 1

Above the main hall there is no insulation in the ceiling. Heat loss in this area will be exceptional. I recommend insulation be installed by a qualified contractor.

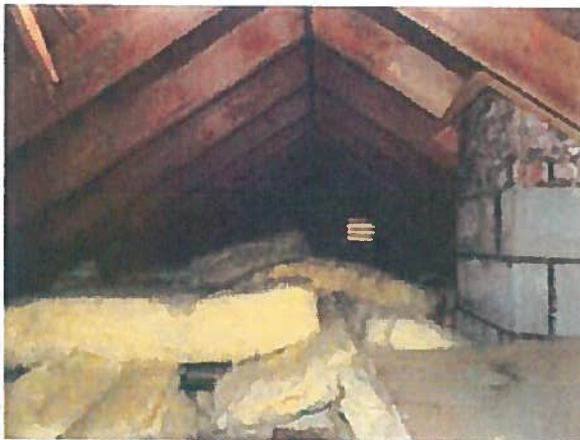
11.3 Picture 3

Fiberglass batt insulation has been installed above the 2nd Storey apartment, however it is not layed evenly, and some areas have been exposed to water leaks from the roof. I recommend the batt insulation be re-distributed properly, with any damaged pieces removed.

Cost Estimate to Insulate: \$5,000

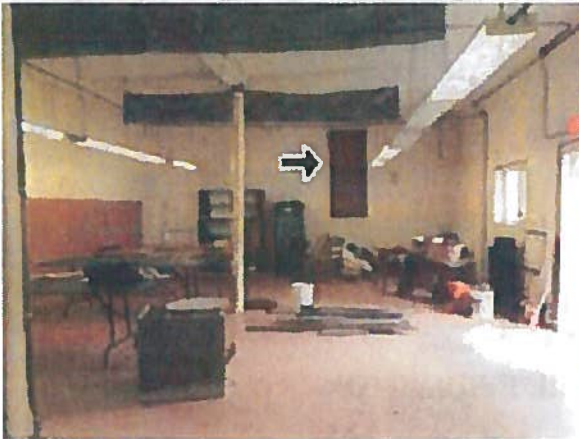
12.1 Picture 1

In the basement is a door that is 4 feet off the floor. This is the interior access to the lower floor of the addition at the East end of the building.

As previously mentioned, water has been penetrating this structure... not from the exterior, rather from the hydronic heating system above.

Other than ensuring that the structure of the wall is dry, structural repairs may not be necessary. This can only be determined by removal of the insulation and vapour barrier.

Cost Estimate (vary's depending on damage, if any): **\$100 - \$500**

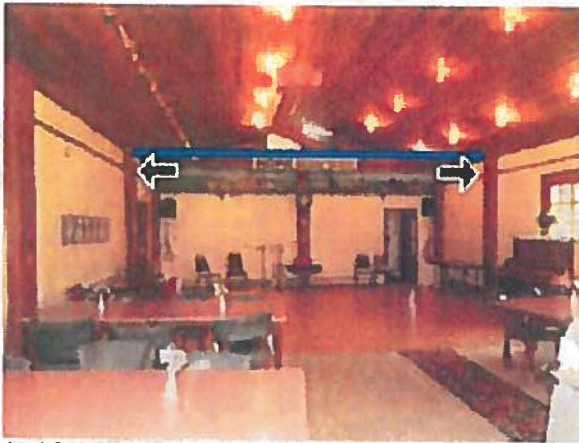
12.1 Picture 4

The walls at the East end of the main floor have splayed out and are no longer plumb (Picture 4). I suspect that while the built-on-site truss system that ties into the original rafters are very beefy and does an adequate job of supporting the roof (Picture 5), it has not served to prevent the walls from separating since the building was moved to this location in the mid-80's.

As indicated by the **BLUE LINE** in Picture 4, I recommend the installation of long steel rods (or cable), installed at regular intervals and anchored to the exteriors of the North and South walls. You probably won't be able to bring the walls back together, but you can prevent them from further movement.

I recommend consulting a structural engineer to determine the gauge of rod/cable, the spacing interval, and manner of exterior attachment.

Cost Estimate: \$5,000

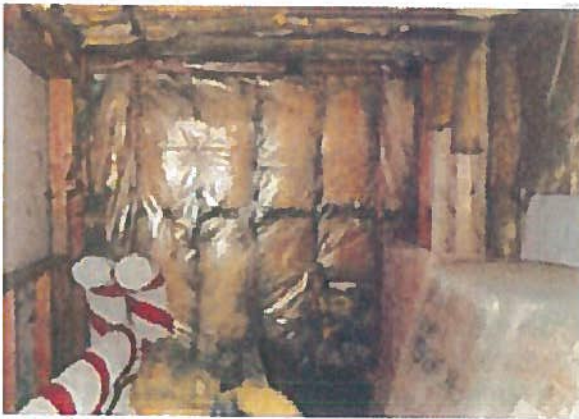
12.5 Picture 1

I recommend removal and replacement of this insulation and vapour barrier in the basement as it is saturated.

Cost Estimate: \$350

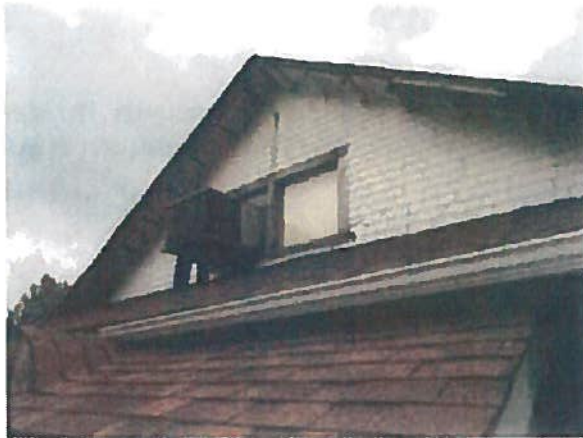
13.0 Picture 1

There is a large A/C unit that has been installed in a window (despite the fact that it is technically not a window-mount unit). It is not level and the condensate drip line runs back into the hall (Picture 3), to drip on whomever is standing below it.

I recommend installing it on a secure and LEVEL platform, and unless you decide to create a dedicated location and run it through a newly-created opening in the wall, properly enclosing and framing the window shut, and diverting the condensate drip line to the exterior of the building.

Cost Estimate: \$500 - \$1,000
