PROPERTY INSPECTION REPORT

251 N Bristol Ave, Los Angeles, CA 90049

2025-08-13 06:00:00

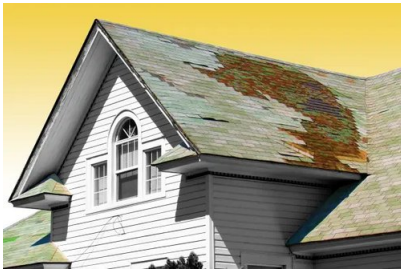
Several roof shingles were observed to be broken. This condition may lead to water intrusion and should be addressed promptly to maintain the roof's integrity.

Based on the age and type of shingle, the roof has exceeded its expected service life. Even with current repairs, the design of the shingle is beyond its intended lifespan. It is recommended to consult a qualified roofing professional for suggestions and quotes regarding roof replacement.

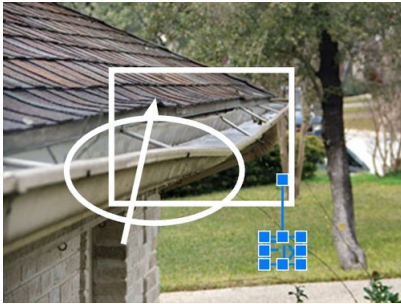
One of the gutters was observed to be improperly installed and hanging off the structure. This can lead to ineffective drainage and potential water damage to the property.

A gutter hanger was observed to be missing or damaged. It is recommended to properly secure or replace the gutter hangers to ensure the intended stability and proper alignment of the gutter system.

The inspector recommends that gutter replacement/repair be performed by a licensed contractor to ensure proper attachment, flashing, and drainage performance. Obtain quotes and confirm contractor licensing and insurance prior to work.

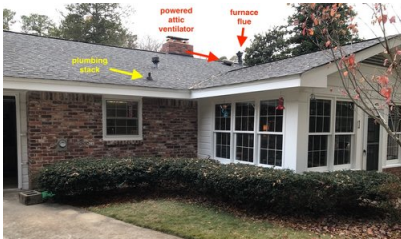
The plumbing vent displayed insufficient clearance from a rooftop deck. For proper ventilation and to prevent sewer gases from entering recreational areas, vents should typically extend at least 6 feet above a rooftop deck. It is recommended to consult with a licensed professional to ensure appropriate vent height and mitigate potential health concerns.

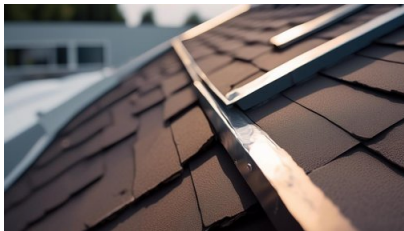
Comment:
Observations indicate the presence of openings or gaps within the flashing or sealant materials. Such breaches can compromise the water-resistant barrier of the roof, potentially leading to water penetration. It is recommended to engage a certified roofing contractor to address and repair these areas to prevent future moisture intrusion.

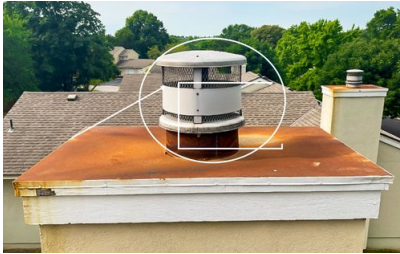
A damaged or missing vent cover could allow debris and small pests to enter. It is recommended to repair or replace the vent cover to ensure proper operation.
