SBG O & M

ACCIDENT, INCIDENT REPORTS AND RISK ASSESSMENT

ACCIDENTS, INCIDENTS, RISK ASSESSMENT

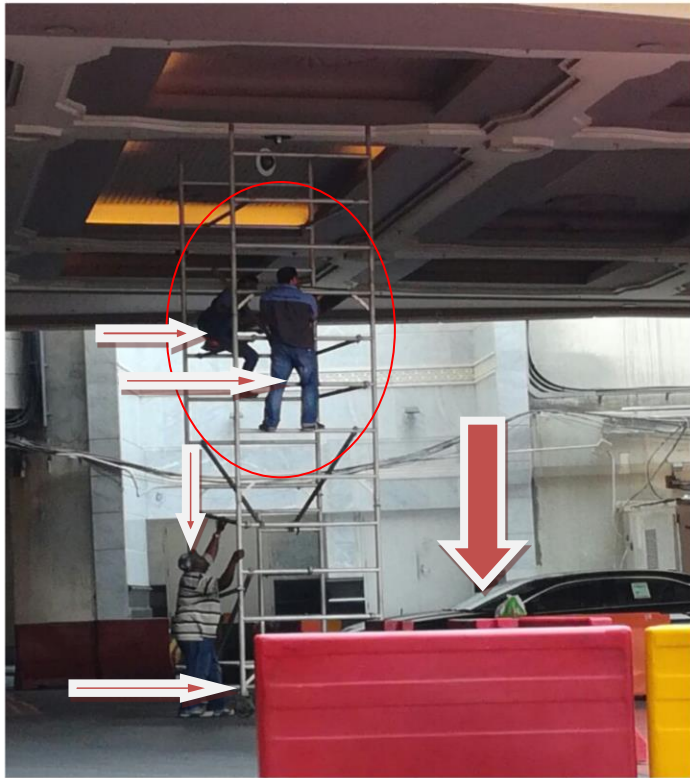
Several violations can be observed in the given picture, fall of person hazard, fall of material, inadequate type of scaffold, no use of ladder for access and egress to the scaffold, inappropriate mid-rail, in appropriate working platform, no use of safety harness, no barricading of the work area.

1. The worker is accessing the platform without any ladder and it is a severe safety violation.
2. One worker was climbing and standing on the mobile rolling scaffold and it has severe potential of fall of worker and material hazard in the car parked near the scaffold or on the floor and it can cause broken bones to worker and property/.vehicle damage.
3. The workers are not wearing safety vests and not visible to the people nearby the location and the worker standing nearby was not also wearing personal protective equipment.
4. The scaffold was not built properly and the rails, including mid-rail and mid-rail was not of minimum standards.
5. Poor safety culture observed in all this activity and severe negligence was observed from the HSE Policy of project, Standard operating procedures and safe system of work

- There must be adequate ladder inside the scaffold for the safe access and egress of worker during the maintenance work
- The **Lock of the scaffold** must be adequate so that the toppling-over of the scaffold must be avoided and also the risk of fall hazard.

- For **work above 6 feet safety harness** must be mandatory for the effectiveness of the fall arrest system to avoid the consequences generated from the fall of person hazard

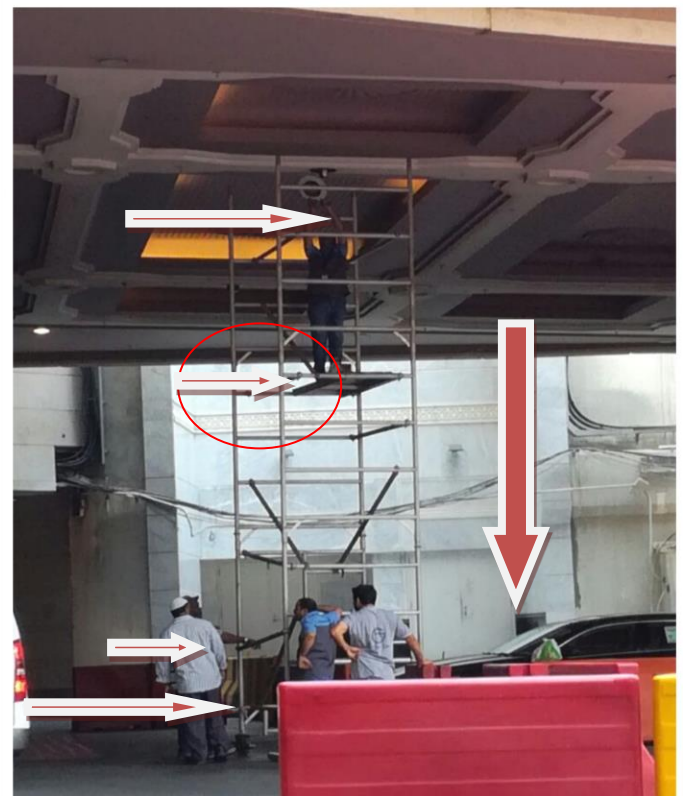
Several violations can be observed in the given picture, fall of person hazard, inadequate type of scaffold, no use of ladder for access and egress to the scaffold, inappropriate mid-rail, in appropriate working platform, no use of safety harness, no barricading of the work area.

1. The worker is working electrical work without using any suitable gloves, safety shoes.
2. The worker is not wearing safety harness and it is a severe deviation.
3. The platform is not complete and appropriate and it increases the potential of fall hazard
4. No barricading for the activity and the workers are not even wearing the safety vests.
5. The locks of the mobile scaffolds are not properly utilized and unbalance scaffold can be the reason of the fall of person and scaffold hazard.
6. The car is parked near the activity and the inappropriate scaffold and even the person is such conditions can topple over.

- No electrical work must be allowed without the appropriate use of the **insulating gloves** to avoid the consequences which can be generated due to the electrical hazards associated, so before analyzing the safety requirements of the activities it must be ensured by the safety officers to evaluate the pre-cautions and effectiveness of PPE'S.

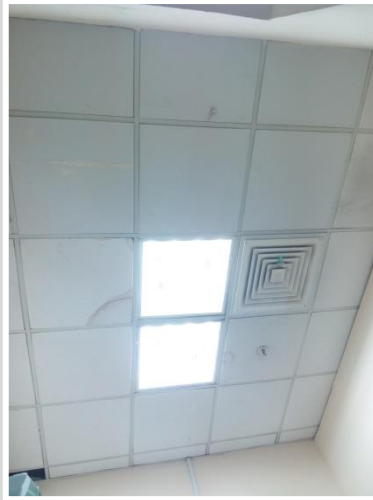
Figure 2 :No Detector at Office

- Exposed Live Electrical Parts can cause Shocking. So we recommend to rectify the drawback immediately.
- Fire Prevention System, Smoke Detector must be provided in corridor as well as Office cabin according to **NFPA 72, National Fire Alarm Code**.

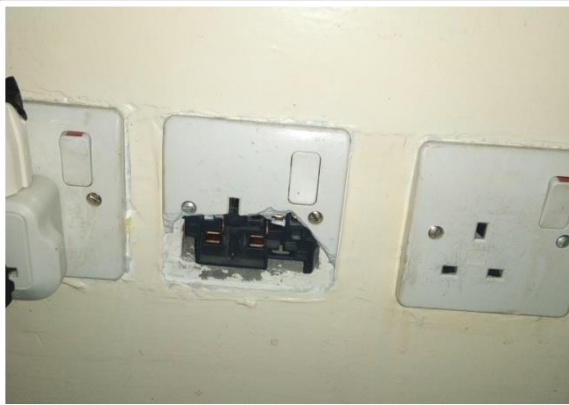
Fig.1 : Exposed Electrical Live Part

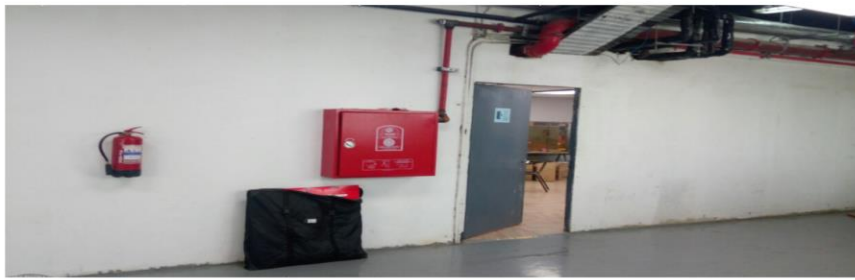
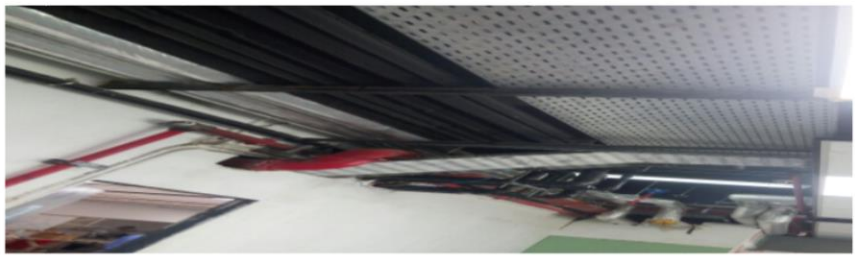
Description of incident	RESPONSIBLE DEPARTMENT
<p>7. It was observed by the SSCL safety staff that there was water leakage in the cooling pipelines</p> <p>8. The root cause seems to be the leakage from the cooling supply</p>	Shop owner

<p><i>lines i.e. due to the rusting of pipeline, damaged surface of the pipeline</i></p> <p><i>9. The water was leaking and SSCL safety informed the shop owner about the incident to avoid the consequences in case of slipping and tripping.</i></p> <p><i>10. Although there was no loss or damage to property or injury.</i></p>	
--	--

The water leakage from cooling supply line in the shop can be seen in the given location

RECOMMENDATIONS	STATUS
<p><i>11. The leakage must be immediately rectified in short span of time to avoid the consequences of hazards generated.</i></p> <p><i>12. LOTO must be applied before any maintenance work so that all the energies must be removed i.e. potential energy and electricity.</i></p> <p><i>13. All the Cooling supply lines, drainage, sprinkler lines and systems should be properly checked and repaired.</i></p> <p><i>14. In case of water leakage there must be quick response action by the maintenance department</i></p> <p><i>15. The shop workers must know have the awareness regarding the hazards associated with water leakage and the floor must be immediately cleaned.</i></p>	<p><i>SSCL safety team informed the shop owner to immediately resolve this leakage issue</i></p>

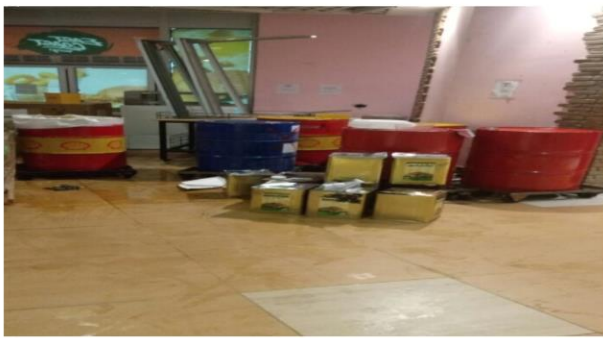
DESCRIPTIONS OF HAZARD	RISK LEVEL	TIME SCALE
11. It was observed by the SSCL safety team that there was some severe negligence executed By the management of Musbah as they placed flammable material, combustible material in an undesignated area.	HIGH	IMMEDIATE

Placing the unwanted flammable and combustible material in an undesignated area in commerical by Musbah management

RECOMMENDATIONS
<ul style="list-style-type: none"> All the activities executed in the project must not deviate from the HSE Policy of the project. All the unwanted flammable and combustible material must be immediately removed from the location to avoid the consequences which can take place due to the hazards associated. Such materials by the shop owners must be stored only in the designated location as per NFPA standards. The material must not be transferred from one area to another from the crowded areas and only service lift lobbies must be used. No one must be allowed to smoke cigarette in the project in such areas as it's a safety violation and it can lead to some unbearable consequences as mostly such negligence as a small source of ignition can lead to a huge fire

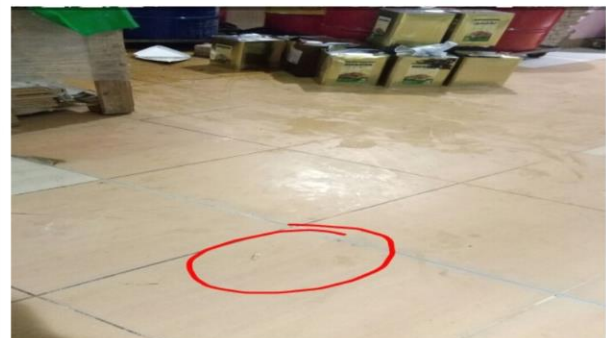
SAFETY VIOLATIONS	Risk level	Rectification time
16. Unawareness from the HSE policy of the project	High	Immediately
17. The administrative actions were found not in-line as traces of ash from the smoking of cigarette was also observed near the risk area and even this can be the source of ignition which could result in a fire incident having unbearable consequences

Traces of ash observed in the location due to smoking of cigarette in the locdation which shows that administrative actions are not followed and in line

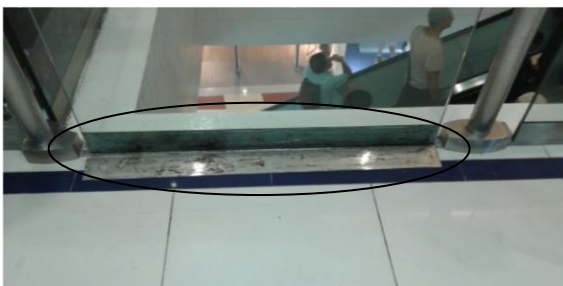
DESCRIPTIONS OF HAZARD	RISK LEVEL	TIME SCALE
18. It was observed by the SSCL safety team that the support of the glass in the given location was not fixed and it has the potential of causing any injury to the visitors passing nearby.	HIGH	IMMEDIATE
19. As the picture shows that the support was not properly fixed and its sharp edges can be visually seen.	RESPONSIBLE SSCL CIVIL DEPARTMENT	
20. All there was no injury or property damage but the support must be immediately rectified.		
21. As it could have the consequences in the form of any personal injury and cuts to the visitors

RECOMMENDATIONS
<ul style="list-style-type: none"> All the activities executed in the project must not deviate from the HSE Policy of the project. The support of the glass must be immediately fixed in short span of time to avoid any consequences generated from the hazards associated. No one must be allowed to work without adequate PPE'S, safety shoes, dust mask, ladder and suitable gloves. The area must be properly barricaded before the maintenance work. All the safety precautions must be evaluated and implemented for the safe system of work and implementation of the HSE policy of the project All the supports to the glass nearby must also be checked routinely.

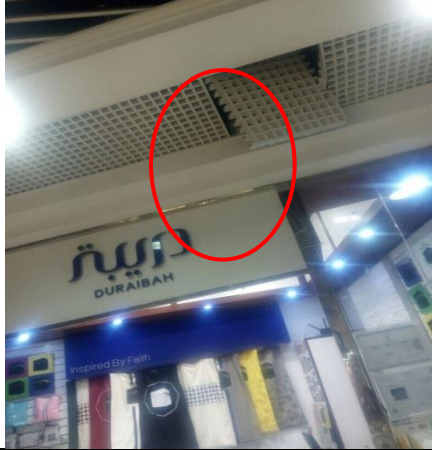
DESCRIPTIONS OF HAZARD & INVESTIGATION	RISK LEVEL	TIME SCALE
22. It was observed by the SSCL safety team that there was some the ceiling on the given location was found damaged and it was hanging	HIGH	IMMEDIATE
23. At the location lot of visitors pas nearby to it as the ceiling part is hanging as it has the potential of fall of material hazard		
24. It has also can cause damage to the property as the weight of the ceiling material is quite heavy so it can have some severe consequences.	RESPONSIBLE	
25. SSCL Safety barricaded the location below the hanging tile to avoid the access of visitors to the risk area.	SSCL Civil Department	
26. Root cause seems to be either it has damaged due to its weak strength or someone has performed some maintenance work above the ceiling and do not fixed that but it has to be fixed in short span of time.

Ceiling material is damaged and hanging in the location as the location is at risk

RECOMMENDATIONS	STATUS
18. The damaged hanging part of the ceiling material must be immediately fixed by SSCL Civil department	The ceiling material is still hanging and damaged
19. The concerned department must utilize an adequate mobile scaffold to carry out this maintenance work with proper guard rail, bracing and transom.	
20. There must be use of safety harness for maintenance work at such height.	
21. LOTO must be applied before any maintenance activity for the effectiveness of safe system of work.	
22. No one must remove the barricading on the location before the hanging ceiling material is being fixed	
23. Adequate permit to work and suitable PPE'S must be utilized by the workers to perform this activity.

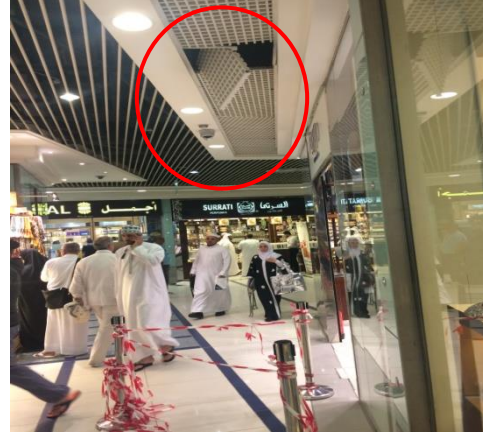
SSCL safety staff barricaded the location to prevent access of visitors from the risk area

CORRECTIVE ACTION
SSCL Safety Department immediately barricaded the location below the hanging ceiling to avoid the consequences from the hazards generated as short time solution but it must be fixed immediately and we reported the maintenance department SSCL Civil department in short span of time.

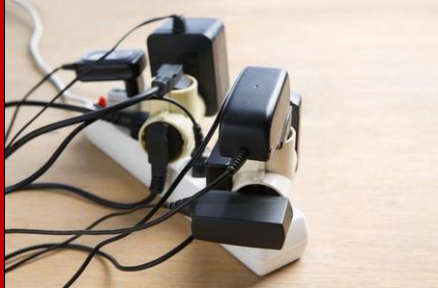
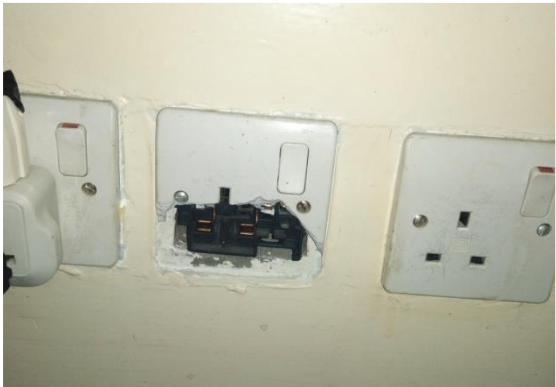
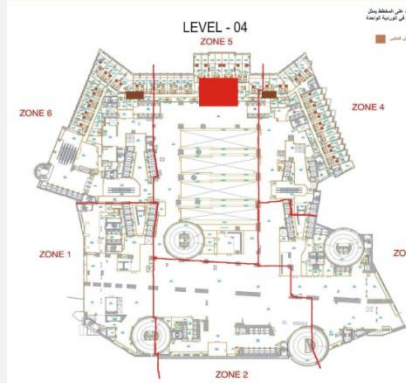
<p><i>P4Mech, CP, Z5</i></p>	<p><i>Occupant : SSCL – Mechanical</i></p>

Hazard	Exposed Live Electrical Part
Risk	When a person touches the live electrical part he may receives an electrical shock, sometimes the electrical stimulation causes the muscles to contract. This "freezing" effect makes the person unable to pull free of the circuit. It is extremely dangerous because it increases the length of exposure to electricity and because the current causes blisters, which reduce the body's resistance and increases the current.
Recommendation	Damaged Electrical Socket must be replaced with new and standard socket.
STATUS	NOT RECTIFIED

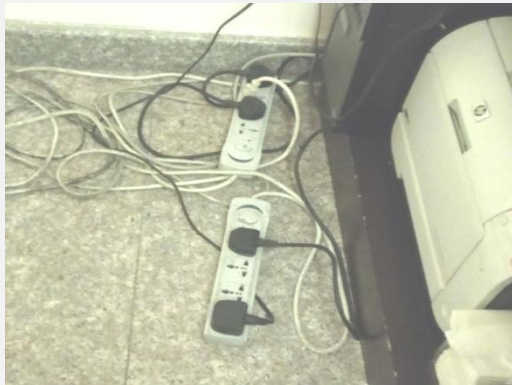
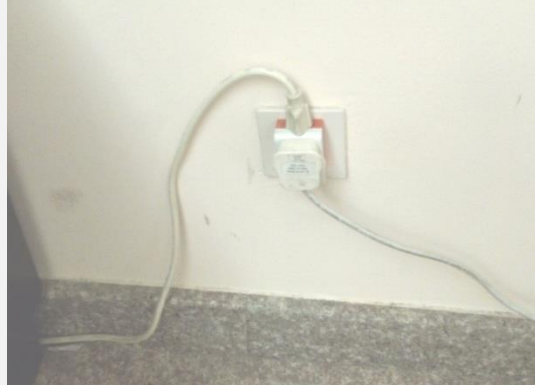
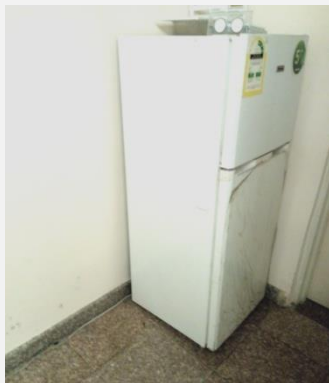
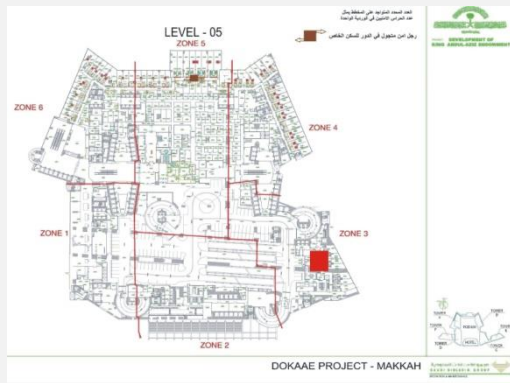
P5, Tower C, Zone - 03		Occupant : SSCL-fm-200 – Engineer Rahan Office

Electrical Connection for Monitor, CPU, Printer, Copier Machine and Fridge are taken from only one Electrical Socket (Over Loaded).			
Hazard	Electrical Circuit Overload – Fire Hazard		
Risk	Likelihood of short circuit due to over load. This may result in electrical spark and which in turn can cause fire hazard.		
Recommendation	<ul style="list-style-type: none">Separate Electrical Socket must be installed for the use of electrical appliances.Instruction and information must be given to the office staff regarding risk associated with overloading electrical circuit.		
STATUS	RECTIFIED

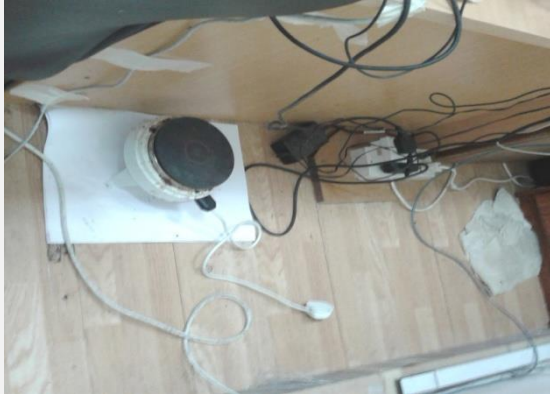
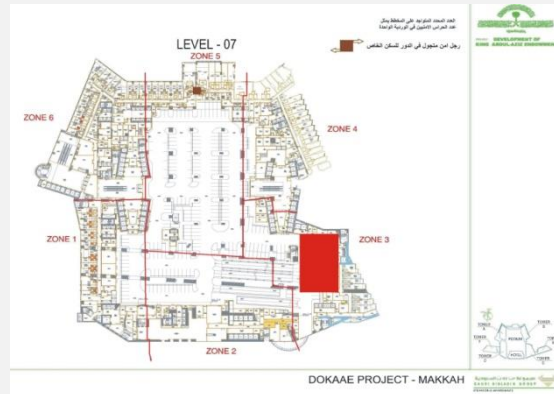
P7, Tower -C, Zone - 03

Heater is used near cumbustable material and Extension Box Over Loaded

Fire Hazard

- Likelihood of short circuit due to over load. This may result in electrical spark and which in turn can cause fire hazard.
- Sources of ignition (Heater) must be kept away from the combustible material.

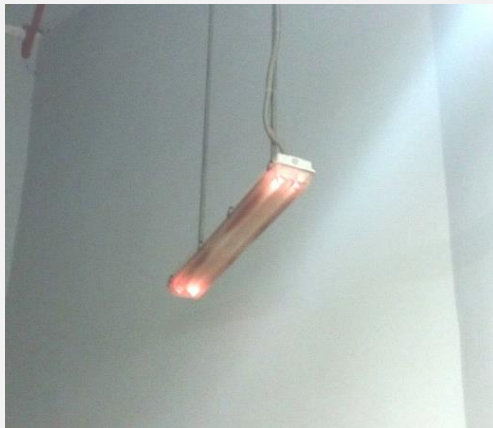
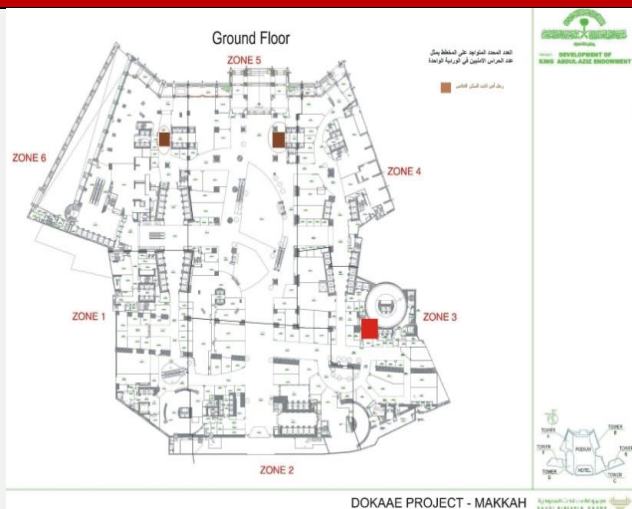
GF, Tower -C, Zone - 03

Poor Lighting

Risk	<ul style="list-style-type: none"> Poor Lighting can decrease the visibility. It will be difficult to identify any slip, trip and electrical related hazards in the office.
Recommendation	<ul style="list-style-type: none"> Faulty light must replaced immediately. Standard light must be used.
	NOT RECTIFIED

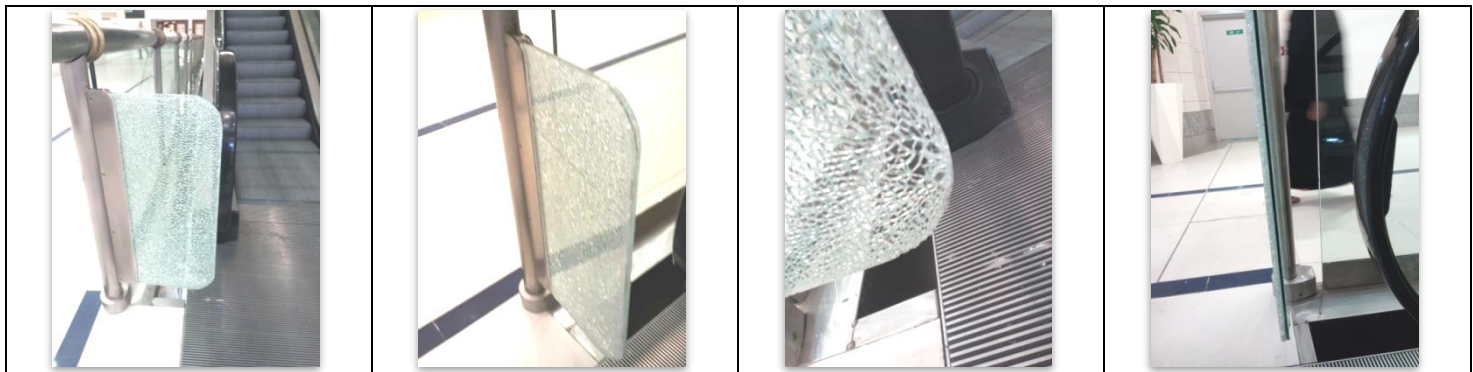
DESCRIPTIONS OF HAZARD	Responsible Department
<ul style="list-style-type: none"> It is observed that the glass guard rail of the escalator (No.40, 39) is broken. Root cause for is found to be that someone hit the bottom left side corner of the glass guard rail with some material like trolley. This cause the glass guard rail to broken. 	SSCL CIVIL

RECOMMENDATIONS	TIMESCALE	Risk Level
<ul style="list-style-type: none"> Broken glass guard rail must be fixed. It found that most of the trolleys are used by the staff from Hotel Swissotel AL Maqam. So Instruction must be given to the staff of the Hotel Swissotel AL Maqam regarding safe movement of trolleys near to the escalator glass guard rail and ask them to take extra care. All the glass near escalators must be properly checked and inspected 	Immediate	High

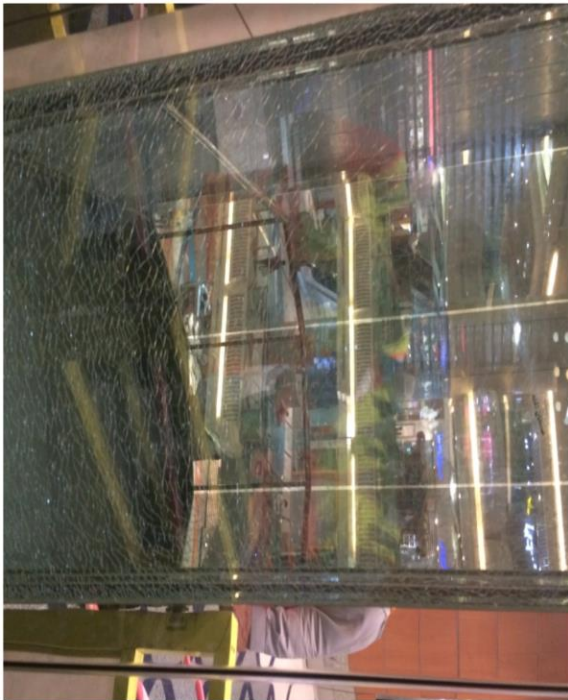
Lift door glass damaged and cracks can be observed from the picture

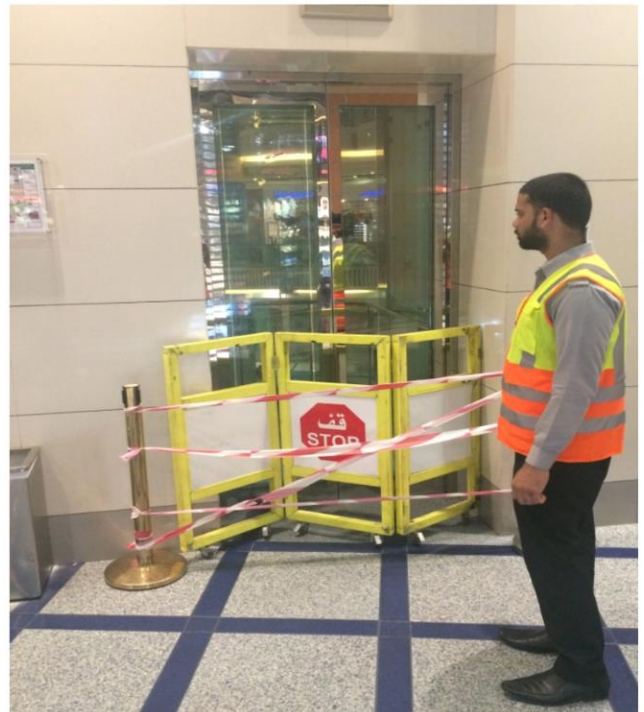
SSCL safety staff barricaded the location to avoid any severe consequences

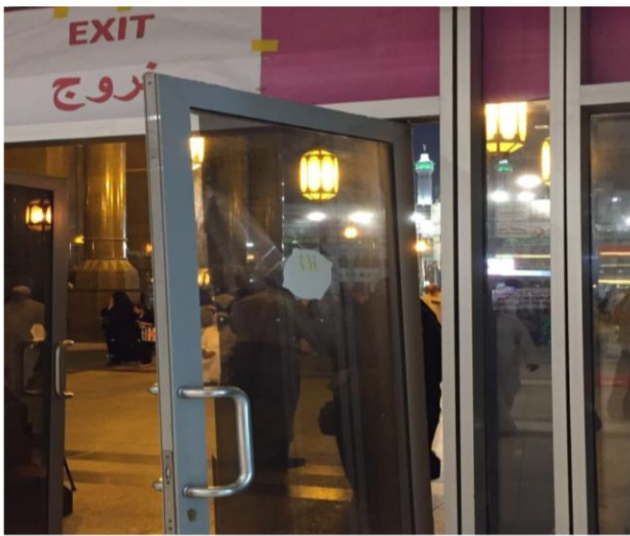
Main door hinge is broken and it can fall

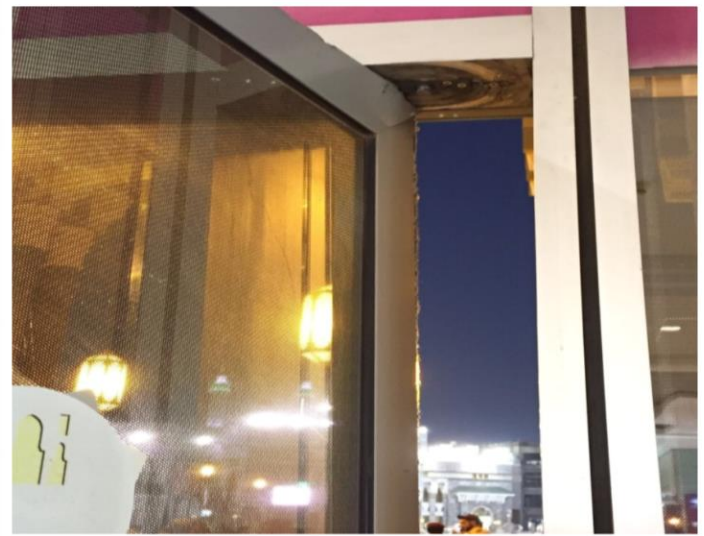
The hinge is damaged and the door can fall down having severe consequences
