DOCUMENT NUMBER: 17-00152
ISSUE NUMBER: 2
ISSUE DATE: March, 97

Premature Termination of Fax/Data Links with 9323/9360 Transceiver

9323/9360/9780/9390 Software Compatibility Summary

9323/9360/9390 Loss of Channels, Scan and Selcall parameters during power up OR when used with 9300 ALE controller.

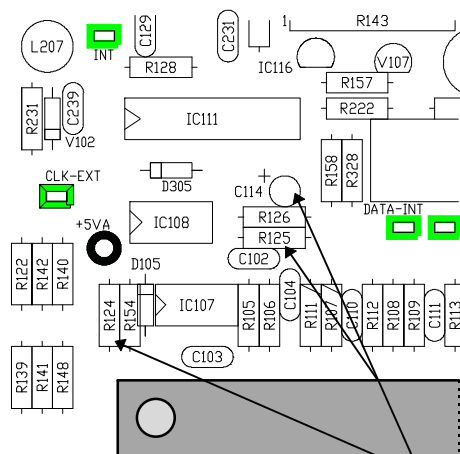
Figure 1: Location of components

R124, R125, R126, C114

- ☐ Remove the transceiver (including the control head where applicable) from the installation.
- ☐ Remove the two screws securing the bottom cover and remove the cover.
- ☐ Locate the Microprocessor and Audio Assembly PCB (Printed Circuit Board), 08-04966-001.
- ☐ Disconnect all the ribbon cables from the PCB taking careful note of the orientation of the connectors on P103 and P302.
- ☐ Remove the eight screws securing the PCB.
- ☐ Withdraw the PCB from the chassis.
- ☐ Locate and remove R124, R125, R126, and C114. Refer to Figures 1 and 2.

- ☐ Remove R161 and D111 if fitted. Refer to Figures 1 and 2.
- ☐ Locate IC107 (LM358). Refer to Figure 3.

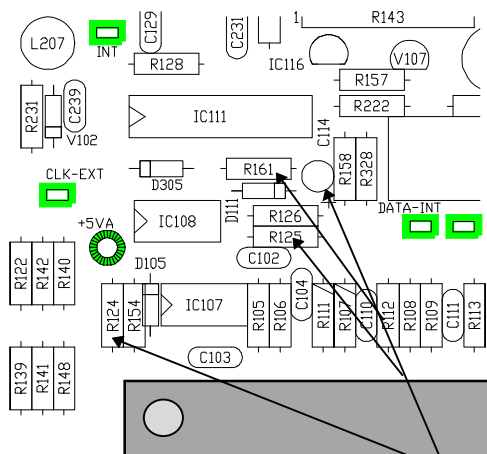
Figure 2: Location of components

R124, R125, R126, R161, D111, C114

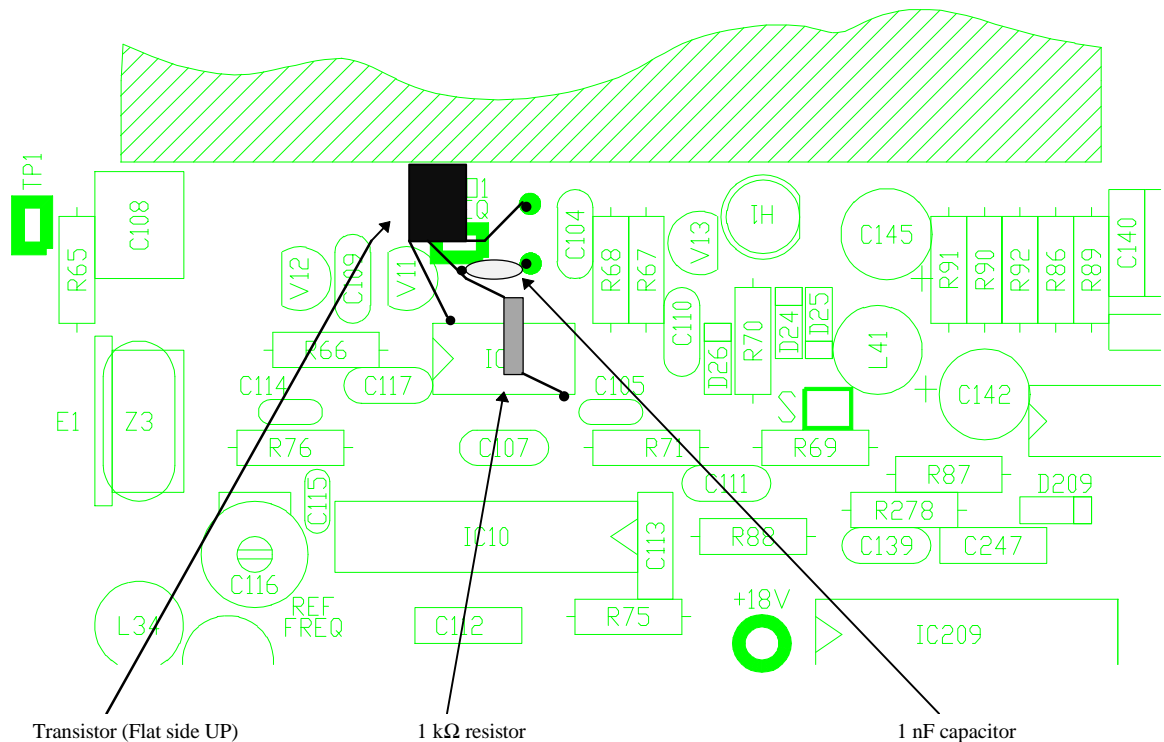
Figure 2 Diagram of modification

The unlock error is caused by the RF energy from the VHF/UHF transmitter disturbing the normal operation of the VCO1 control circuit.

- ☐ Trim and solder one lead of the 1 k Ω resistor to IC9 pin 4. Refer to Figure 2.

- ☐ Fit one lead of the capacitor into the bottom hole for C103. Trim and solder.
- ☐ Solder the remaining leads of the capacitor and the resistor together.
- ☐ With the transistor flat side up, solder the centre lead to the leads of the capacitor and resistor. Trim any excess lead.
- ☐ Trim and solder the Collector of the transistor to IC9 pin 8.
- ☐ Fit the Base of the transistor into the upper most hole for C103. Trim and solder.
- ☐ Ensure there is no possibility of a short circuit occurring particularly to the test point labelled VCO1 FREQ.
- ☐ Secure the transistor with some silicon sealant if necessary.
- ☐ Secure the PCB into the chassis with the seven screws.
- ☐ Replace all connectors.
- ☐ Refit and secure the top cover.
- ☐ Return the transceiver to the installation.

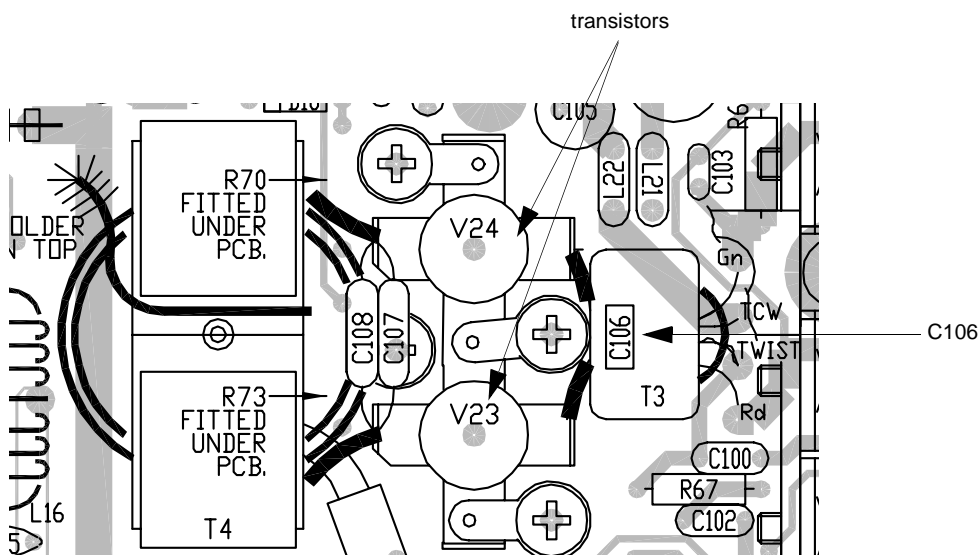
Figure 1: Power amplifier PCB for the 93xx series/9780 and LP transceivers

The transistors SRFH1008 and MRF455 are obsolete. The replacement transistor is MS1253-CDN.

- ☐ Remove the two faulty transistors from the PA PCB (see Figure 1).

- ☐ Replace C106 with a capacitor that has a value of 470 pf.

- ☐ Replace the transistors with MS1253-CDN.
- ☐ Continue from [page 3, Adjusting the driver bias for power amplifiers in 93xx series/9780 and LP transceivers.](#)

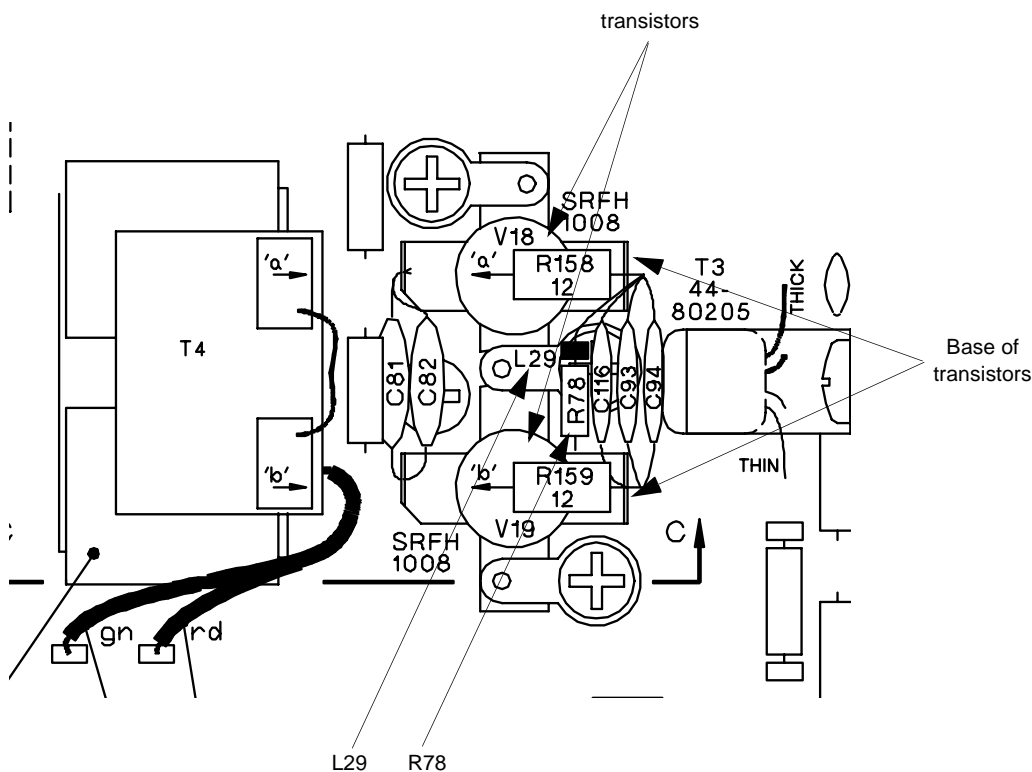
Figure 2: Power amplifier PCB for the 85xx series/9313/9480 transceivers

If R78/L29 is not present, it must be fitted.

Without the resistor/choke in place, spurious oscillations at approximately 4 MHz occur. The resistor/choke network consists of a:

- ☐ Check if there is a resistor/choke (R78/L29) across the base of both transistors on the PA PCB (Codan part number 08-03743-xxx) (see Figure 2).

- ☐ Replace the transistors with MS1253-CDN (see Figure 2).
- ☐ Continue from [page 5, Adjusting the output bias in all transceivers](#).

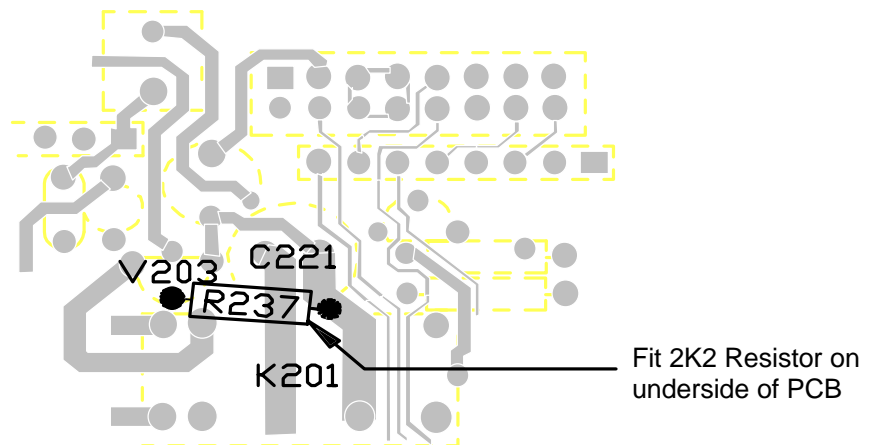
08-04966-001
Bottom View

The transceiver turns itself ON and then may or may not be able to be turned OFF. This is caused by leakage in the power-on circuit and can be overcome by biasing V203 (the power-on transistor) off slightly so that it requires a greater base current to turn the transceiver ON.

The remedy requires the addition of a resistor on the Microprocessor & Audio PCB assembly, 08-04966-001. With the transceiver disconnected and removed from the installation, remove the bottom cover. Disconnect all the ribbon cables from the PCB taking careful note of the orientation of the connectors on P103 and P302. Remove the 7 cross head screws securing the PCB in place and withdraw the PCB. Identify V203, which is located at the right rear corner of the PCB (with the front panel towards you) adjacent to the relay K201. Fit a 2K2 resistor between the Base of V203 and relay K201, (Base-Emitter junction of V203), as shown below. This resistor can be added to any circuit diagrams that you may have, and be designated R237.

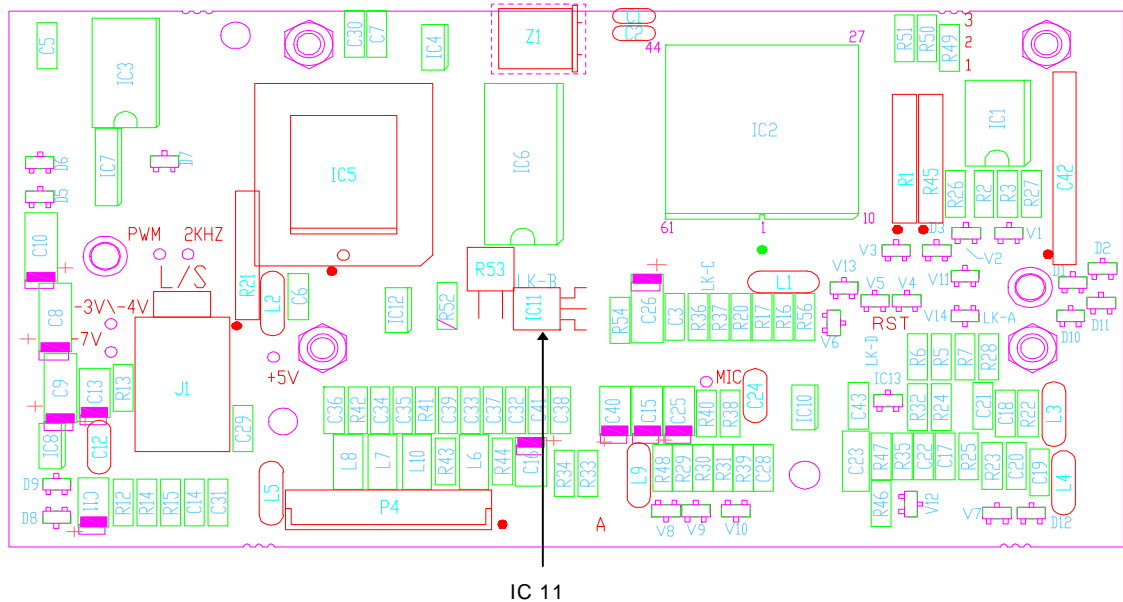
**Figure 1: Location of IC11**

The problems are caused by the use of non brand-name, generic voltage regulators.

- ☐ Locate IC11. Refer to Figure 1.

- ☐ Carefully lift IC11 up off the board so that the identifying markings on its flat side may be read.
- ☐ Check that the regulator has a manufacturer's marking such as a **trademark** or a **name**.
- ☐ If IC11 does not have a manufacturer's trademark or name it will need replacing. Continue at *Procedure: changing the regulator*. Otherwise, continue at *Reassembly*.

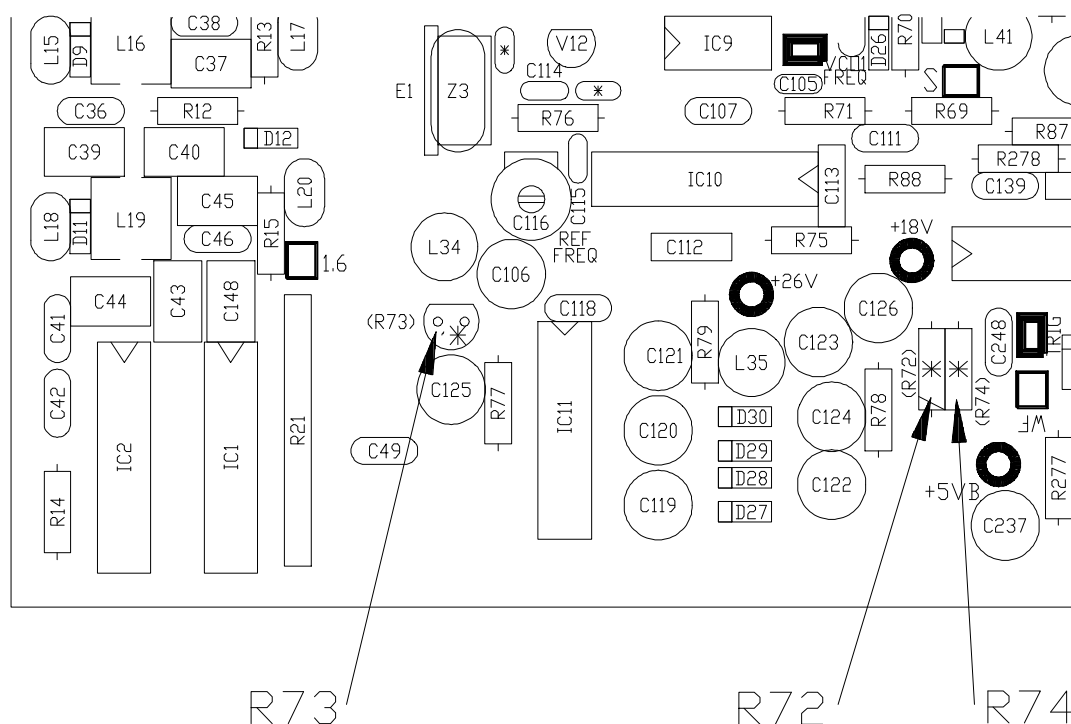
Figure 1: Position of R73 and R74 (Bottom Left Hand Corner of 08-04962)

9323, 9360 and 9360-30 transceivers fitted with version 4.10 software are likely to suffer VCO2 (Voltage Controlled Oscillator) unlock problems under certain conditions. The modification described in this Service Bulletin overcomes this.

The VCO unlock condition will occur under one or more of the following conditions,

- Power Up
- An interruption to the power supply causing the transceiver to reset (such as cranking of a motor)
- High Humidity

1. Disconnect power from the transceiver and remove from the installation.
2. Remove the top cover.
3. Referring to the diagram, locate the position of R73 and R74. (Neither of these resistors are fitted).

4. Remove the Receiver Exciter assembly from the chassis.
5. Using tinned Copper Wire (TCW), fit and solder a link into the holes marked R73. Trim excess lead length.
6. Fit and solder the $1K\Omega$ resistor into the holes marked R74. Trim excess lead length.
7. Fit and secure the Receiver Exciter assembly into chassis.
8. Refit plugs ensuring correct placement and orientation.
9. Fit top cover
10. Reinstall
11. Connect power.
