Europe/Middle East**Bulletin N°:****KDM 48/22****Product Support Program: Mandatory****Section:****Engine****Date of completion: April 30, 2024****Issue:****Revision A****Date:****April / 2023**

PSP 202259 - Retrofit the turbocharger support bracket conversion kit

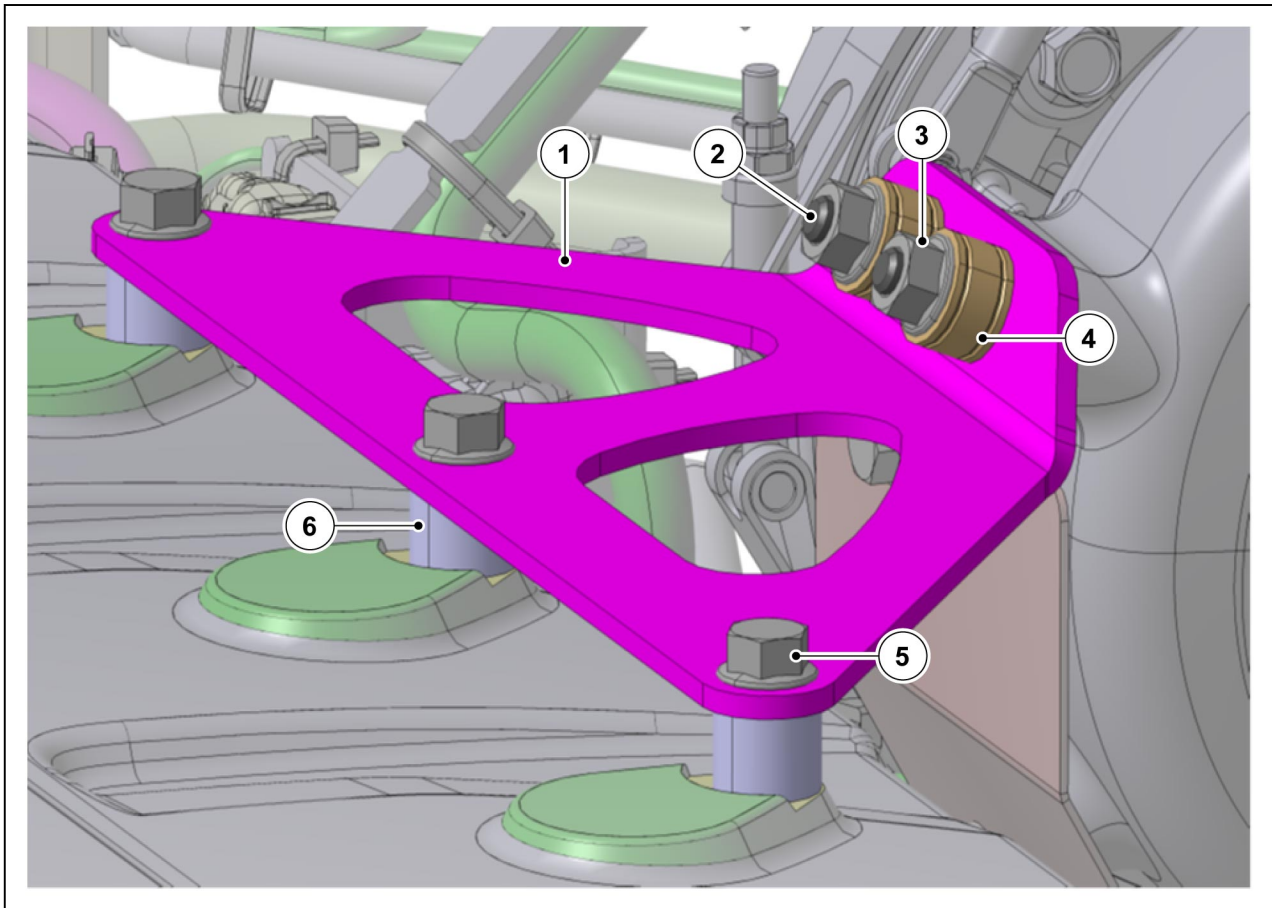
Fig. 1

Increased vibrations can cause the turbocharger fasteners to break.

Install the support bracket conversion kit U972200100000 as shown in (Fig.1).

1. If equipped, remove the air accumulator, access through the left side of the machine.
2. Remove the paint from the contact points.
3. Clean and re-cut the threads if necessary.
4. Install the support bracket conversion kit as shown in (Fig.1). Torque values can be found in the table above.

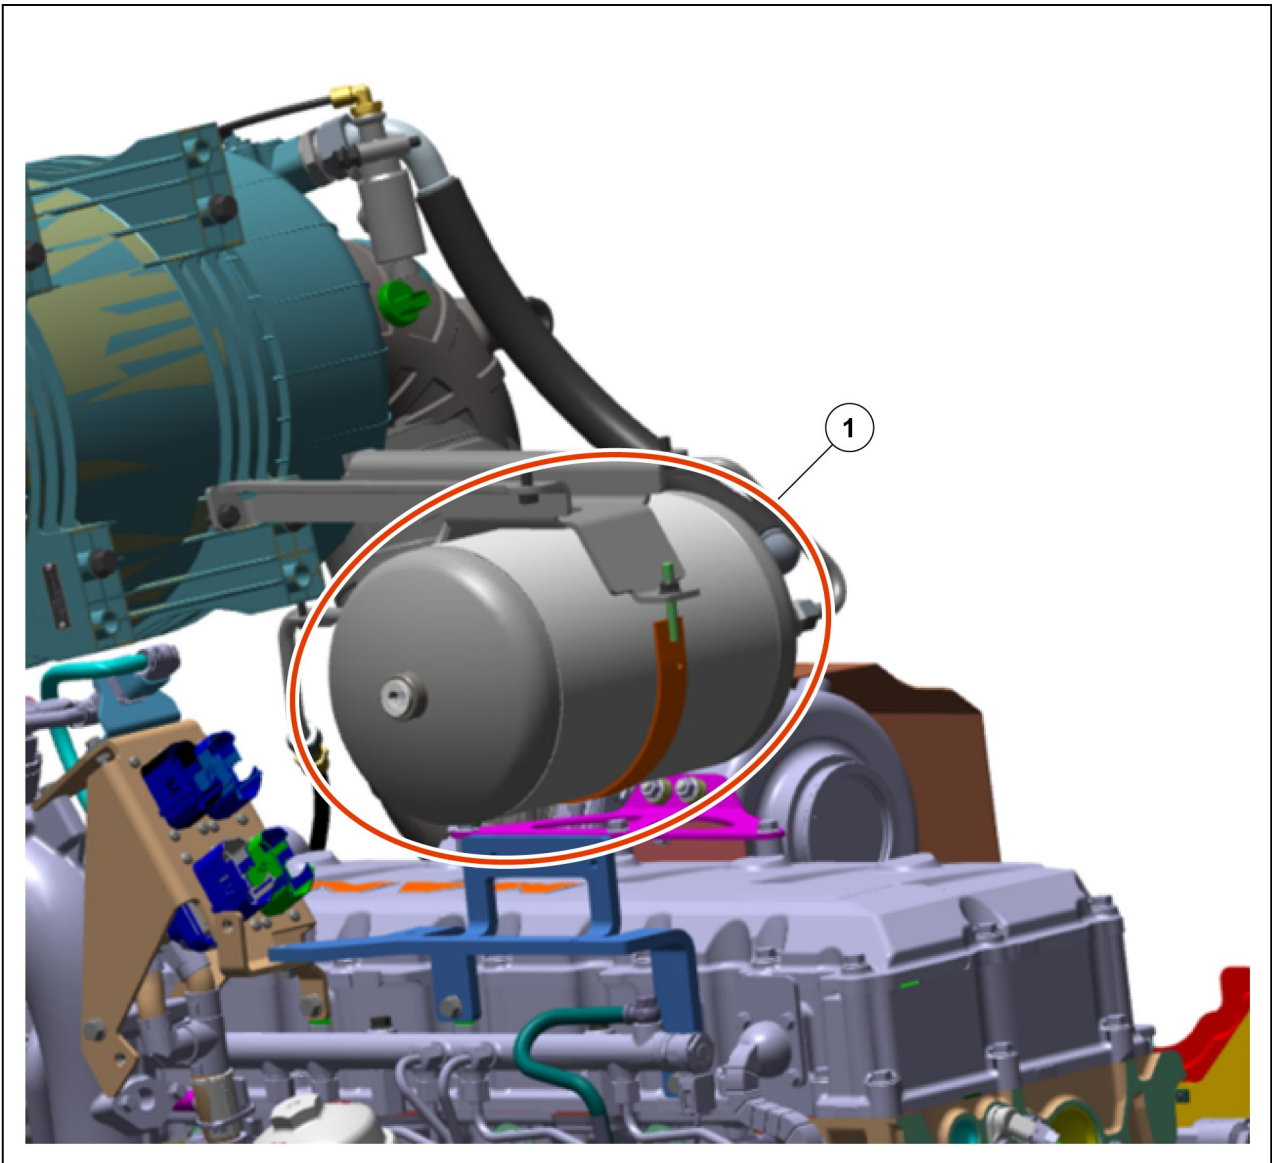
Fig. 2

NOTE: For machines equipped with self-cleaning air filters, an additional 0.5 hour labor time is permitted. These machines can be recognised by the air accumulator (1) above the valve cover as shown in (Fig. 2).
