**20:20 House (Residential management)
Limited C/o Cardoe Martin –
20:20 Building, Skinner Lane, Leeds**

**Fire Safety Review of External Walls and
Attachments**

IFC Report FSA/21183/01

23th November 2021

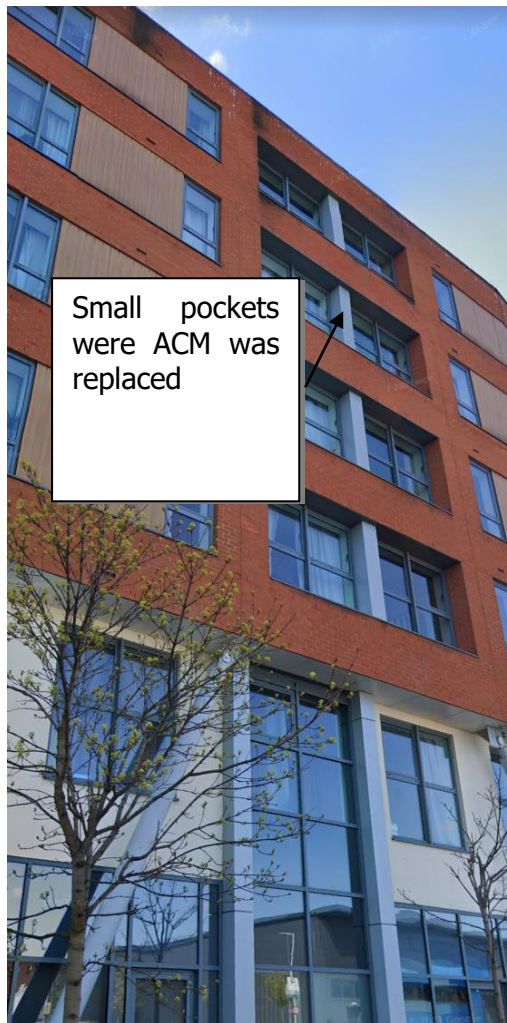
In addition, there have been recent concerns regarding the fire performance of materials such as ACM panels with combustible cores. It should be noted that remediation work was undertaken by Ballymore to replace the ACM panels and IFC understand this work is complete. The ACM was predominantly on the uppermost floor with ACM being in isolated areas provided around the pillars from ground to fifth floors. IFC understand all ACM was replaced on the building.

Figure 1 Area showing example of isolated pockets where the ACM was replaced by Ballymore

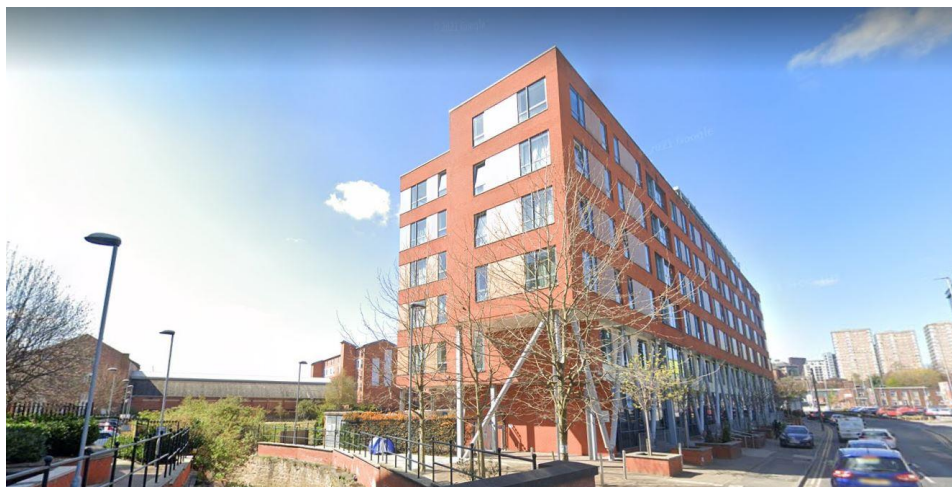
Figure 4 - Image showing the North/East Elevations

This wall type is provided on levels 2-5 but also on level 1 in some areas of the façade as shown in Figure 4 below. This wall type makes up the majority of the external wall.

- The external walls are kiln fired clay bricks and masonry blockwork inner leaf, which are inherently non-combustible.
- The insulation is a mixture of non-combustible and combustible insulation. The insulation is sandwiched between inherently non-combustible inner and outer leaf's.
- Cavity barriers appear to be in place in some locations. However following guidance in ADB, it is acknowledged that cavity barriers can be omitted with this type of wall, therefore IFC consider that even without cavity barriers, this is acceptable.
- Overall, the fire risk in this wall type is therefore considered to be **Trivial**.

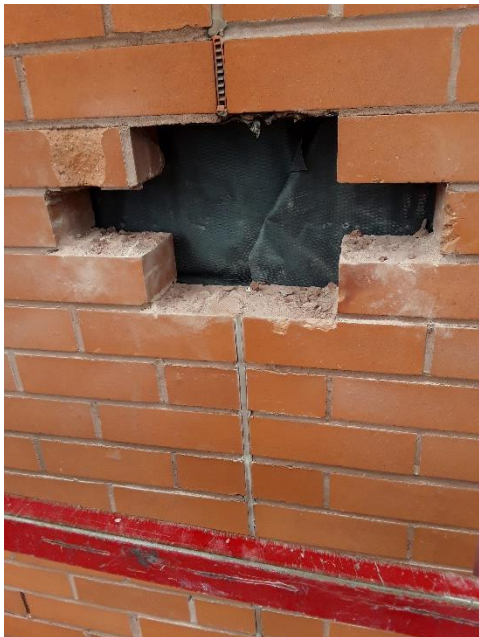
However, Ballymore and IFC inspected this wall type in a small number of areas and there appeared to be a polythene-sleeved mineral wool cavity barrier horizontally at floor level.

Figure 5 – Intrusion into Brick Façade

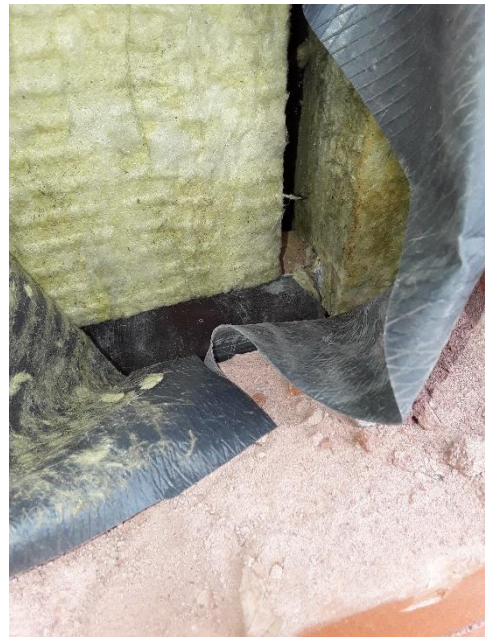
Figure 6 – Cavity within Brick Façade

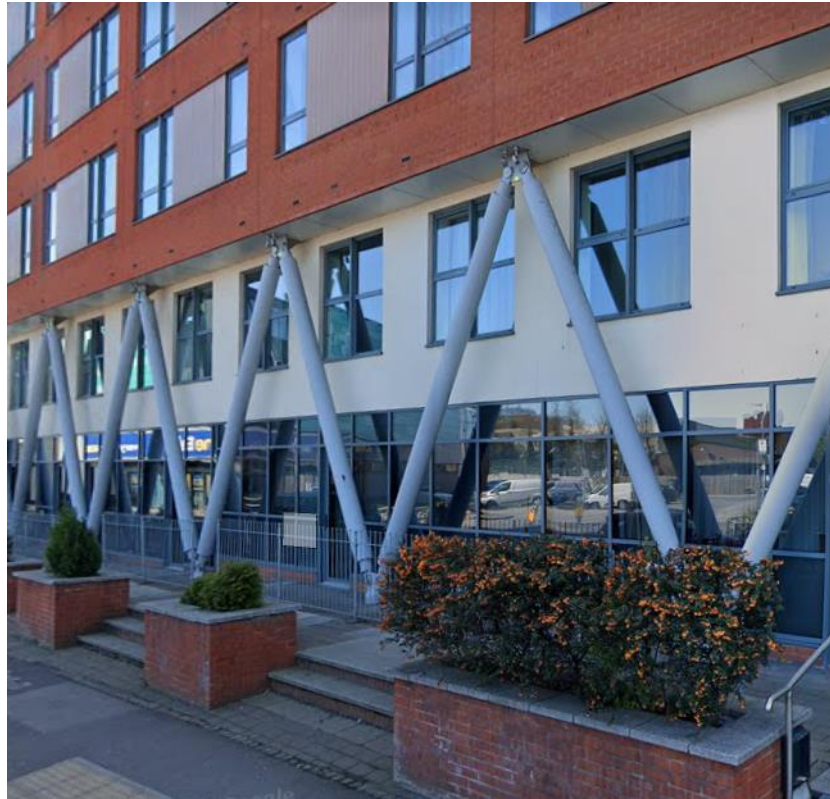
Figure 7 – Example of the Aluminium Curtain Walling System

- a) Curtain walling with aluminium and glazing.
- b) At the interfaces with the internal compartment walls there were small strips of ACM that were replaced with new 3mm thick aluminium panels. This is covered fully below in wall type 5 (section 4.7).

- The external wall is considered non-combustible.
- The interface with the internal compartment walls and external wall requires further investigation to confirm the internal walls about the curtain wall.
- Overall, the fire risk in this wall type is therefore considered to be **Trivial**.

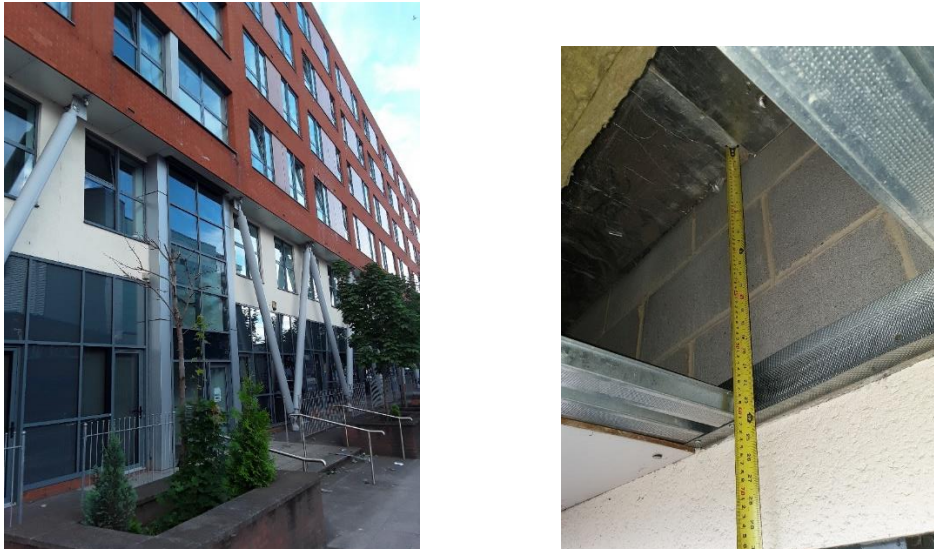
Figure 8 – Example of the Render Coated System

- a) Concrete block circa. 100mm thick
- b) Render coating. The type of render used is unknown

- The render coated system to the external wall is considered non-combustible.
- Overall, the fire risk in this wall type is therefore considered to be **Trivial** if the remainder of this wall type is render on blockwork. We suggest a wider sample along this wall type is undertaken as part of due diligence.

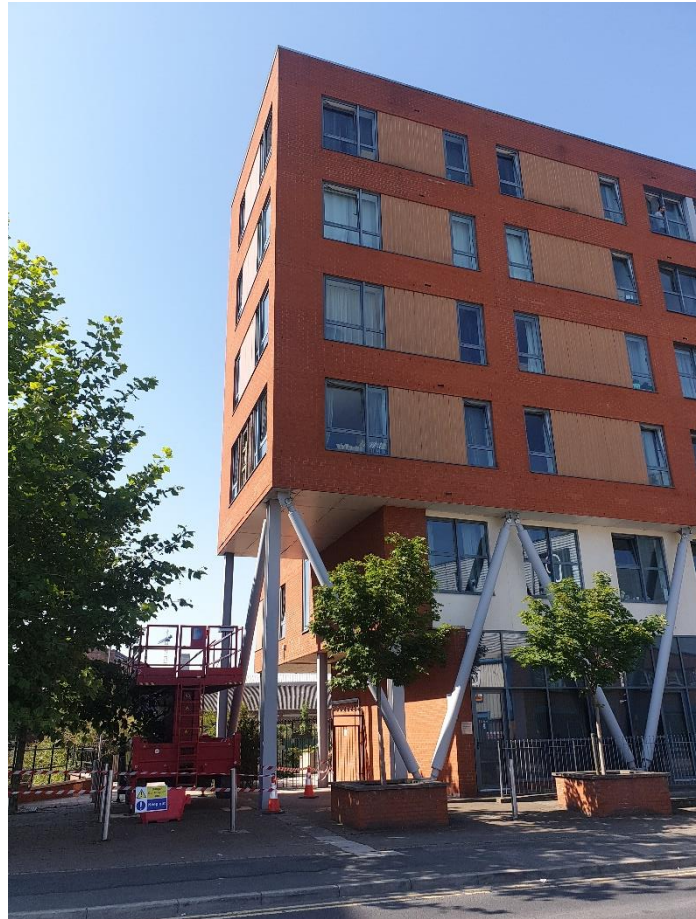
Figure 9 – Example of the Trespa Cladding on the North Elevation

On the North and East facing elevations the timber cladding has been replaced with Trespa panels.

- The Trespa panel is a standard panel with reaction to fire properties of D-s2, d0 and timber panels to the external walls generally will have reaction to fire classification of D when tested to BSEN 13501. This façade is therefore considered combustible. This wall type presents the potential for fire spread over the external wall, particularly vertical fire spread as the panels are constructed in a line in the vertically orientation. IFC consider that this wall type did not meet the functional requirements of the Buildings Regulations when the building was constructed in circa 2008.

- The insulation is mineral wool/earthwool and non-combustible.
- At the interface where the wall type changes or at the internal compartment line, no cavity barriers are provided. IFC expect to see cavity barriers in these locations, specifically around all four sides creating a picture frame and where the internal compartment walls meet the external wall.

- Overall, the fire risk in this wall type is therefore considered to be **Moderate**.

- a) Replace the Trespa and timber panels on all elevations while providing cavity barriers where this wall type meets another wall type or window i.e. like a picture frame. Cavity barriers are also advised to be provided where an internal compartment wall/fire resistant wall meets the external wall.
- b) Replace the timber cladding that connects the balconies that are shown in attachment type 2.

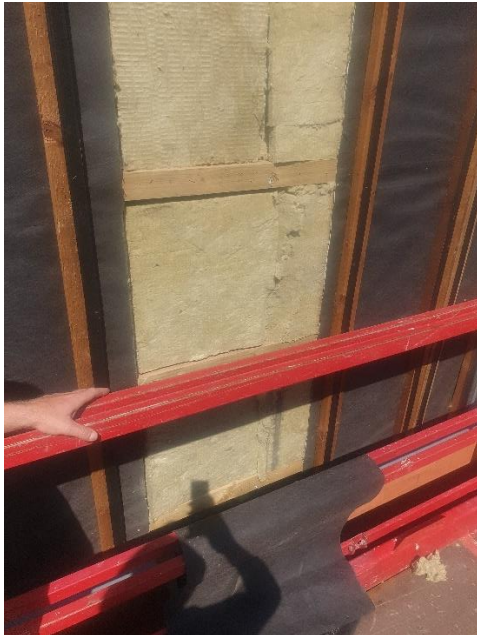
IFC were not provided with drawings to show cavity barriers within this external wall type on the 20:20 Building.

Figure 10 – Intrusion into Timber Cladded Façade

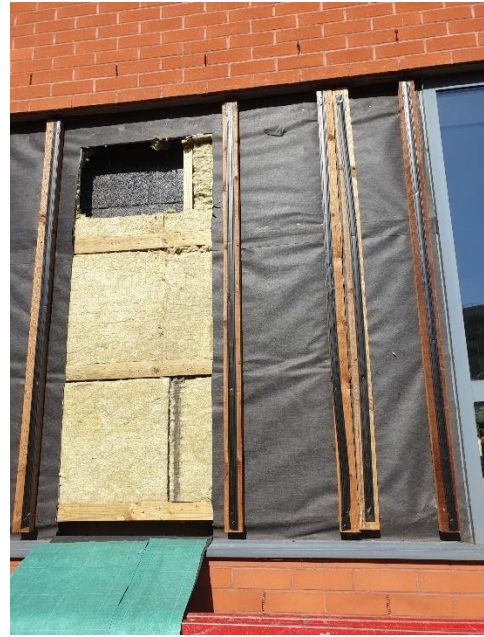
Figure 11 – Intrusion into Timber Cladded Façade

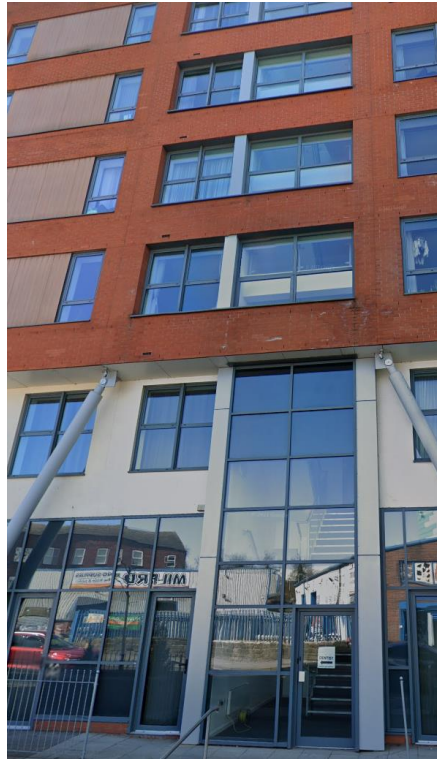
Figure 12 – Example of the Rainscreen Cladding Found in Small Sections Across the Building

The small sections of ACM cladding found at ground/1st and in a few strips up the building were replaced by Ballymore with 3mm thick aluminium rainscreen panels.

- The external wall is non-combustible.
- The insulation is non-combustible.
- Overall, the fire risk in this wall type is therefore considered to be **Trivial**.

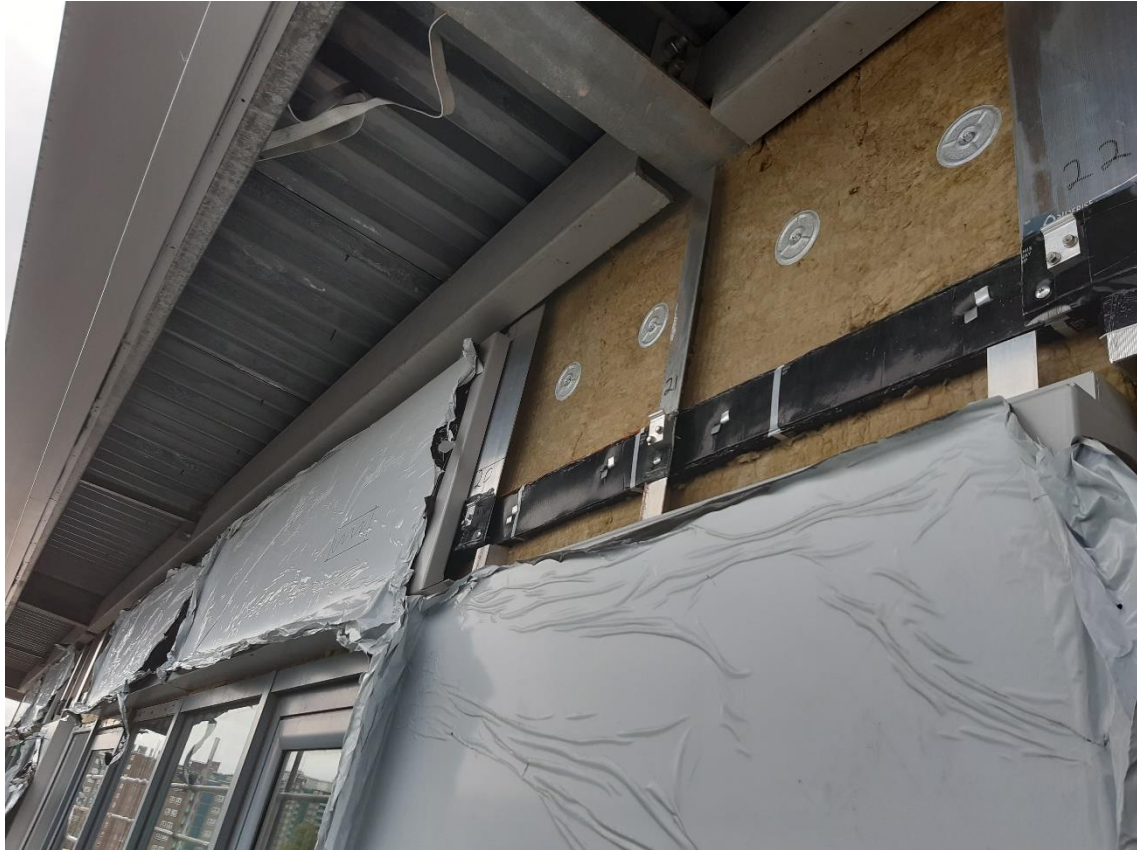
Figure 13 - Example New Rainscreen Cladding Being Fitted to the Sixth Floor

- The external wall is non- combustible.
- The insulation is non- combustible.
- Cavity barriers and fire stopping are provided at interfaces with internal compartment walls
- Overall, the fire risk in this wall type is therefore considered to be **Trivial**.

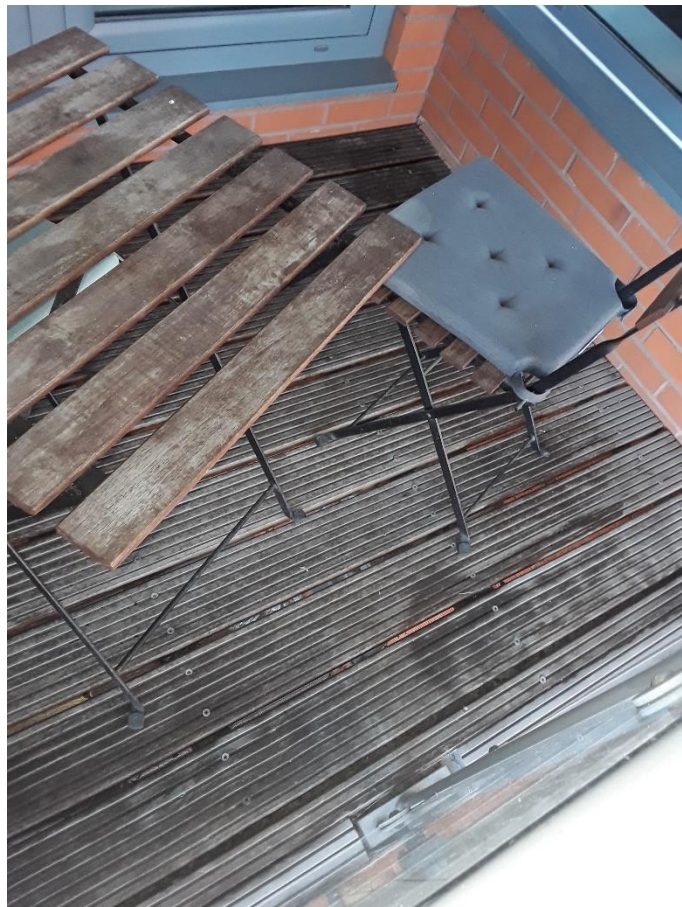
Figure 16 – Example Timber Inset Balcony

This balcony is formed from the extension of the concrete floor slab. The balcony is then recessed as it is surrounded on two sides by the brickwork façade on 1-5th floors. The surface of the balcony is then finished with a timber decking.

- The timber decking to the balcony will likely have a reaction to fire classification D, therefore combustible. However, the balconies are only accessed from the individual apartment and are located separately from one another.
There is no concrete separating one balcony from the one above, the floor of the balcony is timber (1-5th floors). The 6th floor has concrete under the timber decking. In all cases, the timber is laid horizontally. This is significant as the likelihood of fire spread is reduced because of this.
- The glass balustrade is generally non-combustible.
- There is a tenancy policy regarding the use and storage of materials on balconies to limit the risk of fire occurring.
- Overall, the fire risk in this type of attachment is **Tolerable** once the ignition and fuel sources are controlled by the management and tenants.

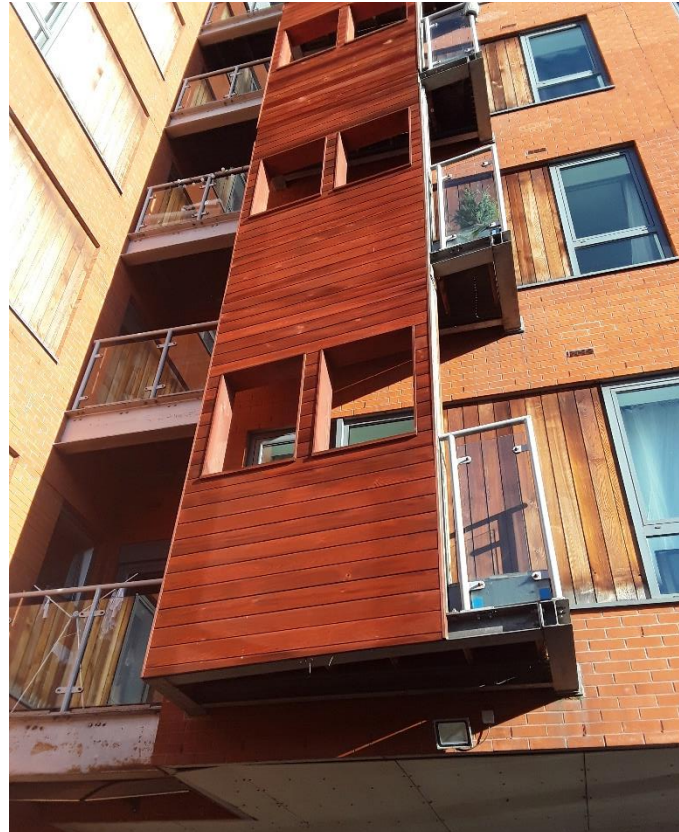
Figure 17 – Example Cantilever Balcony

This balcony is formed from a steel cantilever design at floor level. The balcony has a glass balustrade to one side and timber cladding panel to the others. This timber cladding runs the length of the balconies from 1st-5th floor connecting them all.

- The timber decking to the balcony will generally have a reaction to fire classification D, therefore combustible.
- The timber cladding panels connecting floors equally will have reaction to fire classification of D when tested to BSEN 13501. This balcony façade is therefore considered combustible. There is a potential risk of fire spread over the timber panels connecting floors. Timber such as this constructed vertically presents a risk of fire spread.
- The glass balustrade is non-combustible.
- Overall, the fire risk in this type of attachment is **Moderate**.
