20:20 HOUSE, LEEDS

Site Monitoring Report No. 22

Date of visit: 11th October 2021

Document reference: 05218/HB/LEK/53621/WL/01

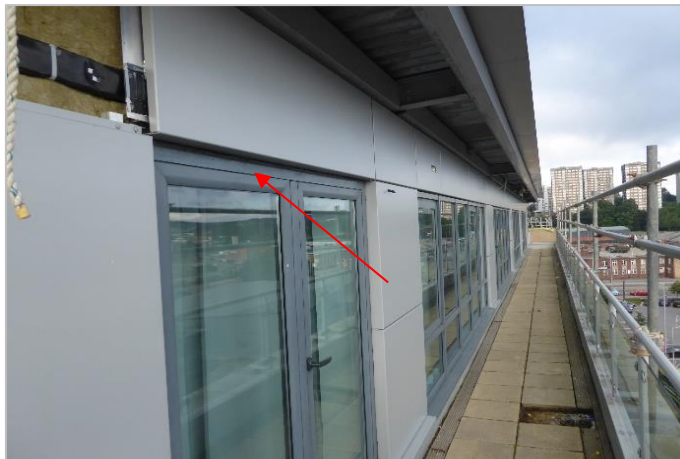
Photograph No. 7 – Elevation No. 7 (no access at time of visit)

Aluminium panels have now been installed to all areas of Penthouse 1. Along elevation 7, a flashing is to be installed to cover the exposed insulation at the curtain wall head, indicated by an arrow on photograph No. 7. Elevation 10 also displays exposed insulation and should be sealed in a similar fashion to elevation 7 indicated by an arrow on photograph No. 10.

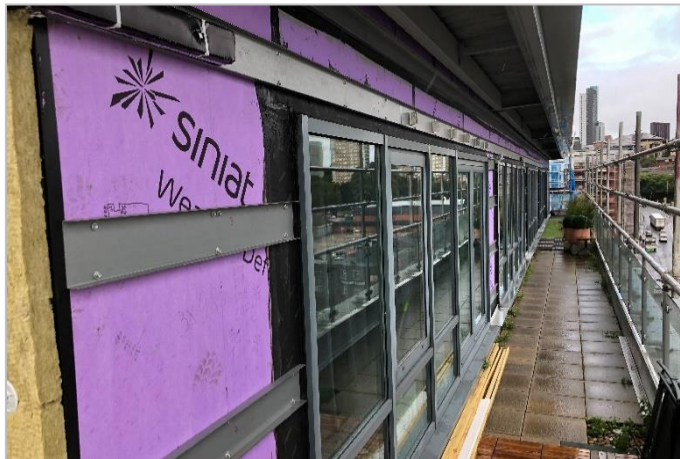
Photograph No. 17 – Elevation No. 17

A number of elevations have progressed to a stage for the installation of the cladding panels to commence. Elevation 17 has 10% helping hand brackets installed but no vertical rails or insulation installed to date.

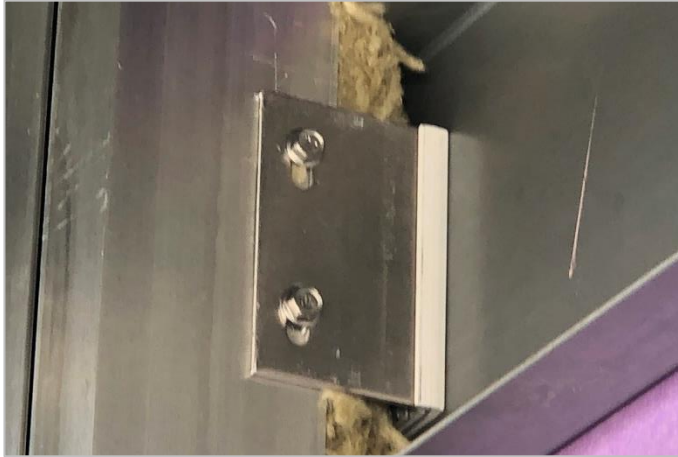
4.1.1 Dead fix Elevation 11

A bracket located at the top of elevation 11 displayed a dead fixed bracket instead of a sliding fixed bracket. This is not with due regard to the subframe drawings issued to date.

Photograph No. 21 – Bracket installed as dead fixed instead of sliding fixed

Action: Ballymore to ensure that all brackets are dead fixed and sliding as per subframe drawings and if new fixing holes are required, the vertical should be moved down to allow new fixing holes into the material.

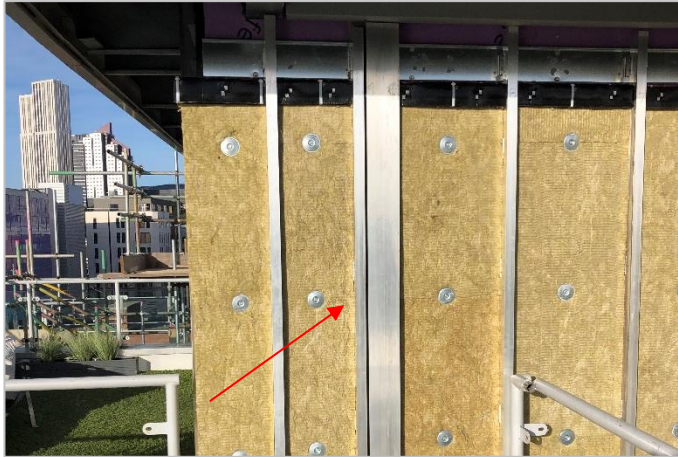
4.1.2 Additional 'L' rail to elevation 12

An additional 'L' rail was observed on elevation 12. The additional rail was not illustrated on the updated subframe drawings. Therefore, a panel was temporarily installed to understand the rationale of the additional rail. It was concluded to be necessary in order to pick the fixing clips.

Photograph No. 22 – Additional rail added to elevation on site

Action: Ballymore to update elevation 12 subframe drawing with additional rail.

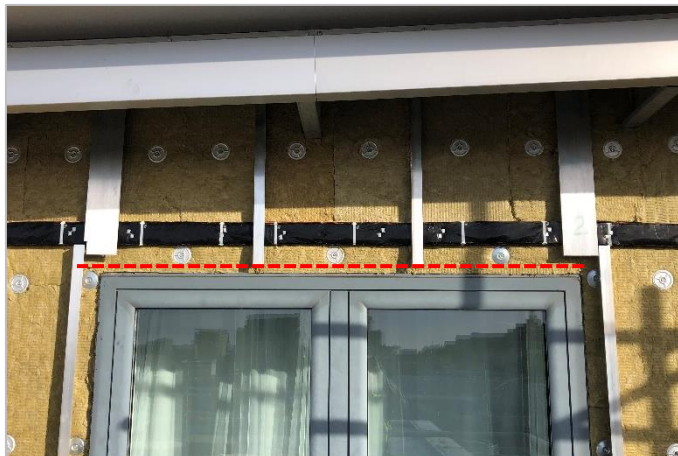
4.1.3 Rails on elevation 13 don't align

The 2 vertical 'T' rails installed at the door head to elevation 13 were not aligned with the 2 vertical 'L' rails above the door head. The author is unsure if the vertical rail will support the panel appropriately as the fixing clips may need to be adjusted to suit.

Photograph No. 23 – Four rails above door are not aligned

Action: Ballymore to ensure that the vertical rails above the door head for elevation 13 are aligned and follow suit with the subframe drawings issued.

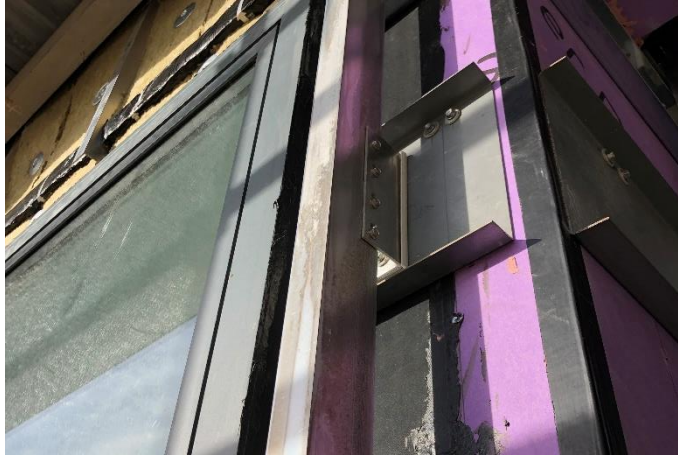
4.1.4 Double bracket on elevation 14

A double bracket was observed to the external corner of elevation 14 leading into the recessed balcony area. Subframe drawings indicate that a single sliding bracket should be installed in this area.

Photograph No. 24 – Double bracket installed in wrong location

Action: Ballymore to ensure that the double bracket installed to the external corner leading to the recessed balcony is correctly installed. If so, the sub-frame drawings should be updated to reflect this.
