# 20:20 Building, Skinner Lane, Leeds

## Intrusive Survey of ACM Cladding Report

05218/JY/XX/50316/WL/01

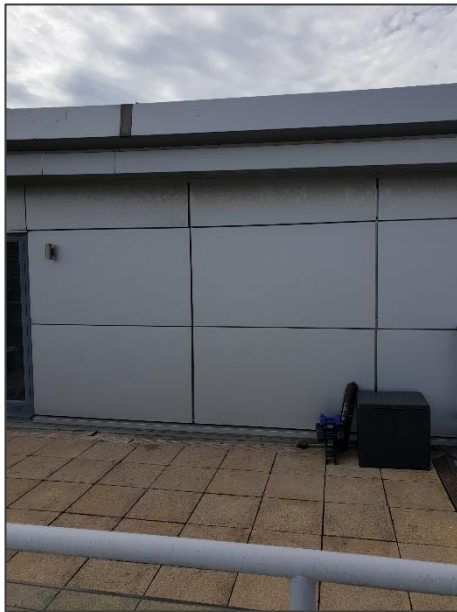
- 5.1.1 The ACM cladding was observed to comprise of 0.5mm thick front and rear aluminium facing with a 3mm black polyethylene core and formed into a cassette panel 30mm deep. The vertical sides are supported by a 38mm 'U' channel. Horizontally, aluminium profiles are secured to the top and bottom of the cassette panel to allow it to hook onto the support structure and be secured in place.

*Photograph No. 10 - ACM panels of Area 1*

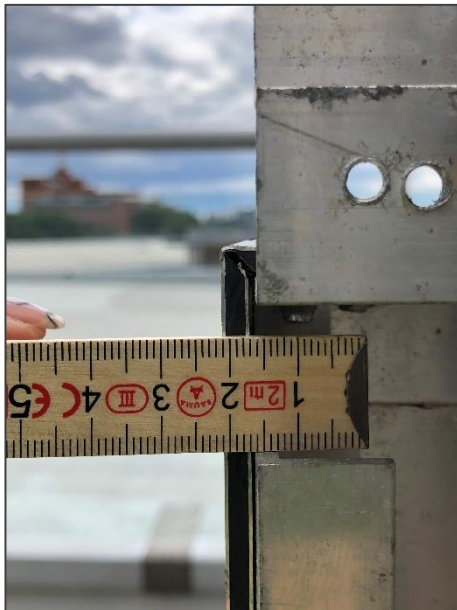
*Photograph No. 11 - Edge of ACM panel*

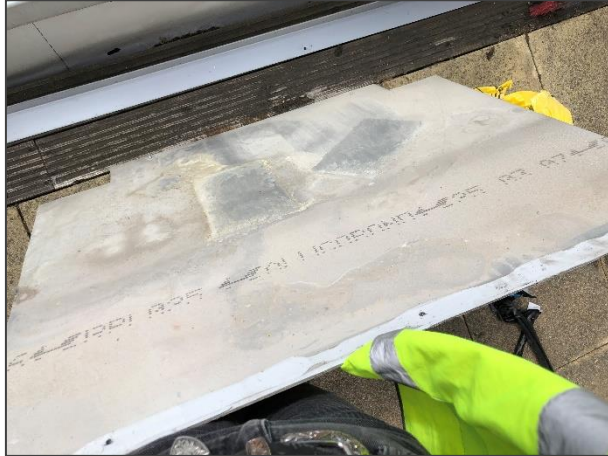
- 5.1.2 Based on the panels observed and markings to the rear face, these are understood to be Alucobond panels.

*Photograph No. 12 - Soffit ACM panel showing markings and where cavity barriers were sat prior to removal*

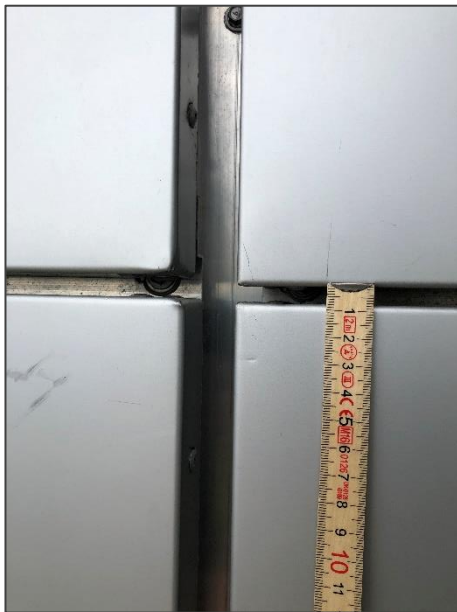
- 5.1.3 Vertically, there is a nominal 20mm joint between panels; horizontally, this is 8-10mm.

*Photograph No. 13 - Horizontal joint - 8-10mm, depending on where measurement was taken*

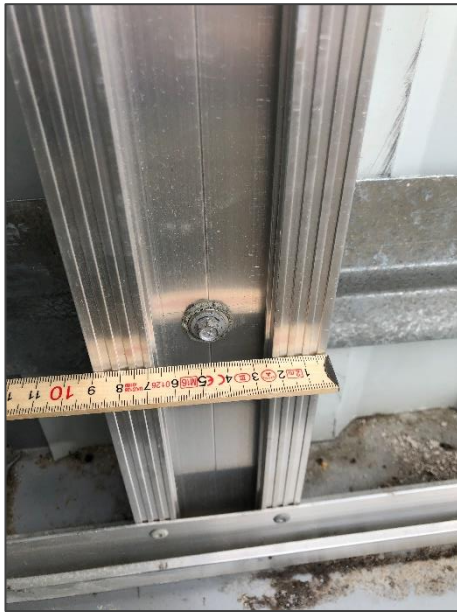
The supporting structure is comprised of vertical aluminium 'top hat' rails that are 90mm wide and 60mm deep (overall) and positioned to support each panel. These are secured to galvanised steel 'z' angles which are fixed, in turn, to the corrugated trapezoidal sheet beginning 110mm up from the base aluminium flashing and spaced 960mm-1000mm apart approximately.

*Photograph No. 14 - Supporting structure,  
vertical top hat rail*

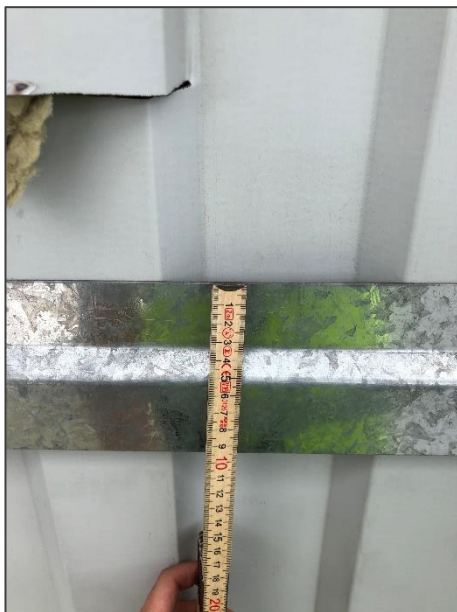
*Photograph No. 15 - Supporting structure –  
galvanised steel rail*

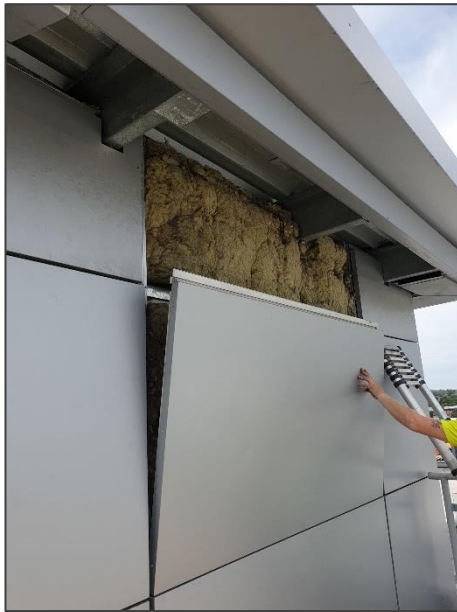
Mineral wool insulation has been observed fully filling the cavity between the rear of the panel and the galvanised sheet. The cavity is 70mm-90mm depending on the plane of the sheet that is being measured from.

*Photograph No. 16 - Insulation installation observed during removal of exterior ACM panels to Area 2*

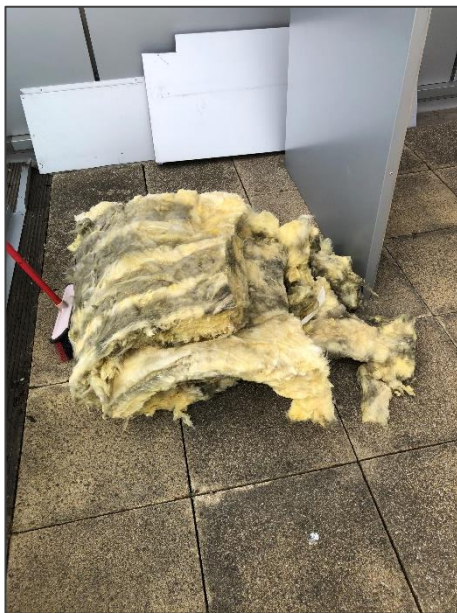
*Photograph No. 17 - Mineral wool insulation removed from Area 1 in advance of façade review*

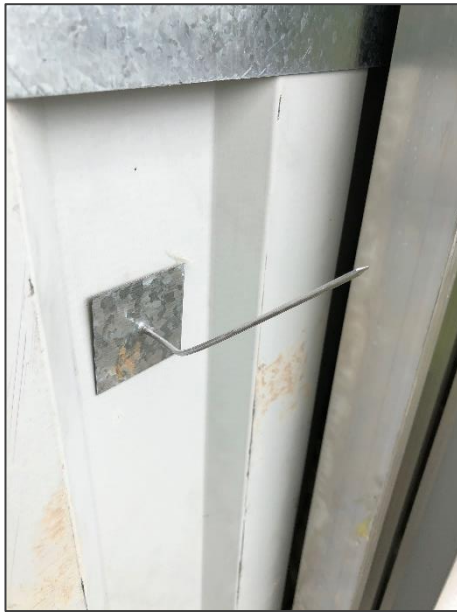
*Photograph No. 18 - Insulation fixing*

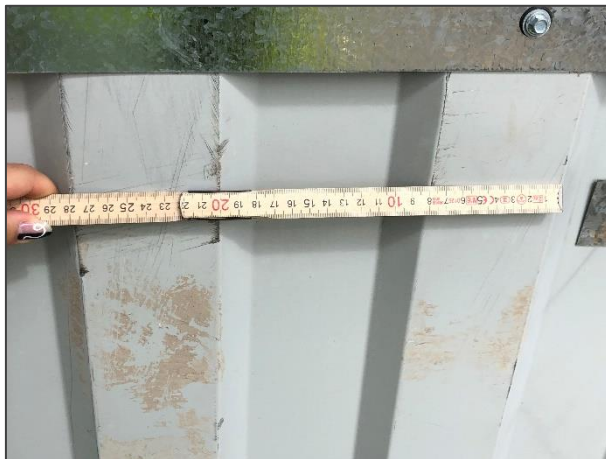
A trapezoidal corrugated sheet (thought to be galvanised steel) provides an element of rigid support for the insulation with fixings adhered to the face periodically. The width of each segment is circa 80mm.

*Photograph No. 19 - Corrugated trapezoidal sheet*

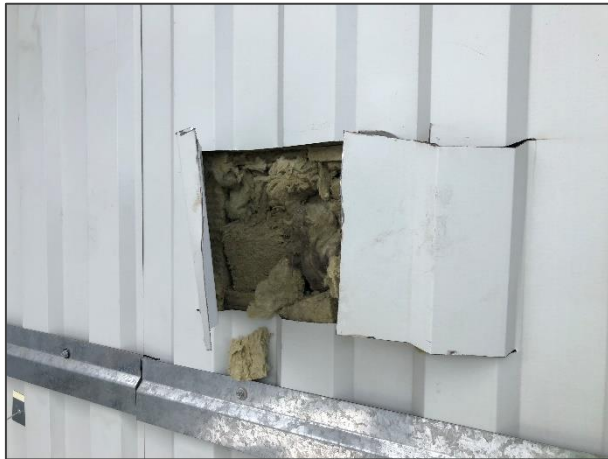
Behind the sheet, mineral wool insulation was observed. This appeared to be 150mm in depth within a 200mm cavity.

*Photograph No. 20 - Mineral wool insulation observed to the interior cavity - Area 2*

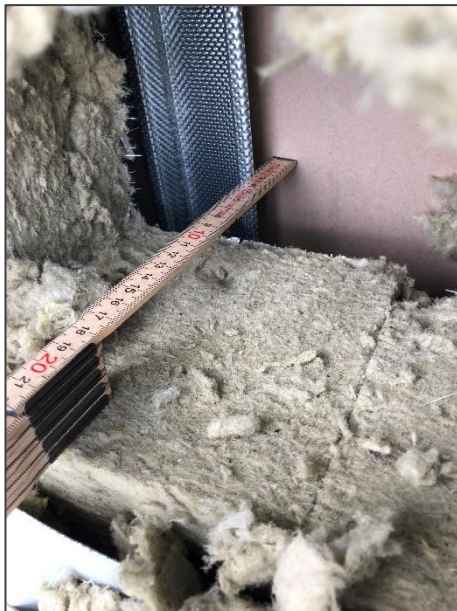
*Photograph No. 21 - Overall internal cavity dimension – 200mm*

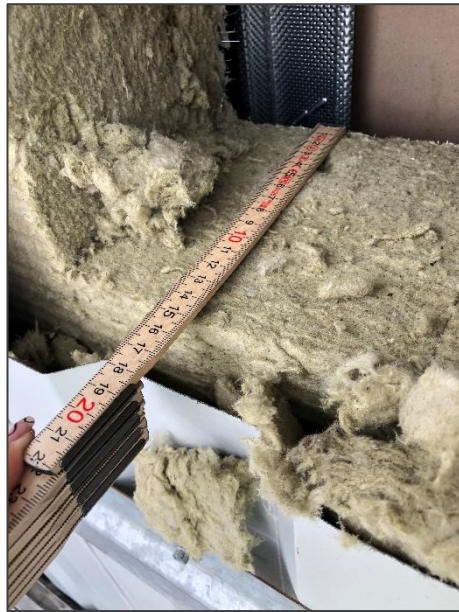
*Photograph No. 22 - 150mm of mineral wool insulation to the interior cavity*

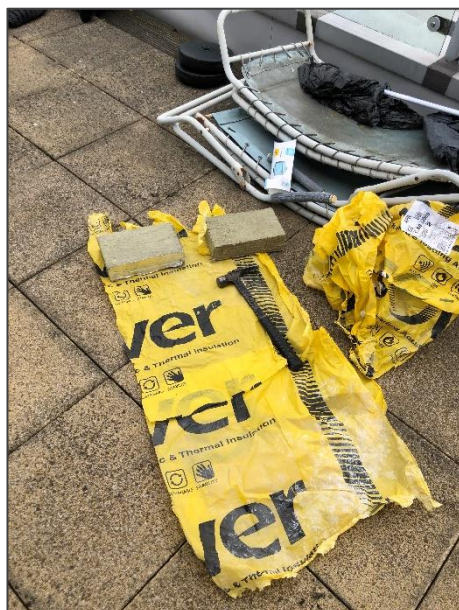
Cavity barriers were not observed at the edge of the cavity or at the jamb of the smoke vent opening/window. At the top of the smoke vent opening/window, the aluminium soffit panel was pulled away to reveal cavity barriers had been placed in the cavity above and were sat on the soffit panel, subsequently, these fell to the ground as they were not mechanically fixed as required by Approved Document B. These were observed to be a sleeved Isover product; however the sleeving was damaged and torn which may affect its performance and durability.

*Photograph No. 23 - Fallen cavity barriers from soffit above smoke vent/window*

Where the soffit met the smoke vent/window that was observed during the survey, cavity barriers were observed and fell out of the cavity upon soffit removal. Based on the imprint on the back of the soffit panel, were thought to just be sat in the cavity rather than mechanically fixed which would have secured them in place and prevent their displacement over time. This is not installed in accordance with ADB requirements or manufacturer recommendations to be considered compliant.

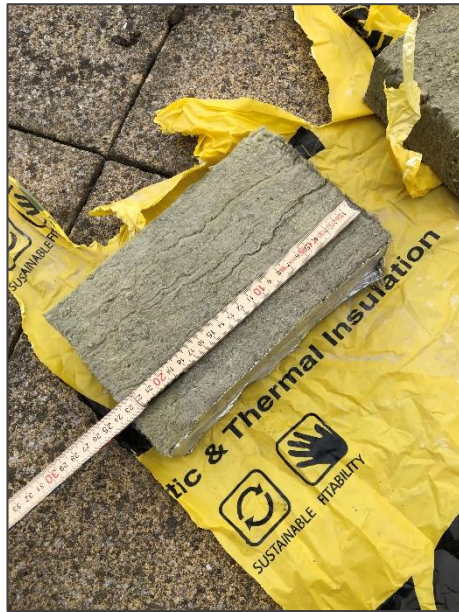
Photograph No. 24 - Individual cavity barrier  
- 230mm wide

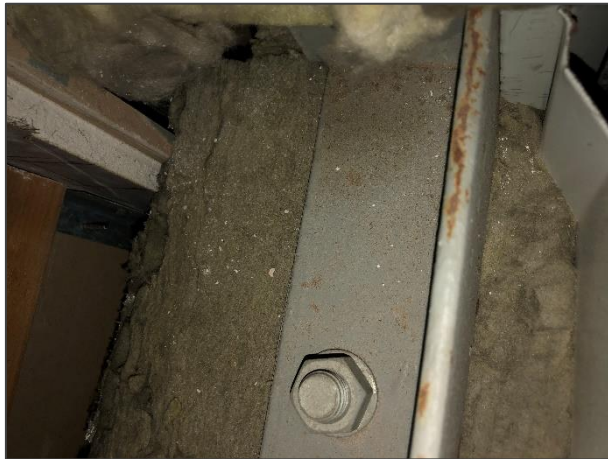
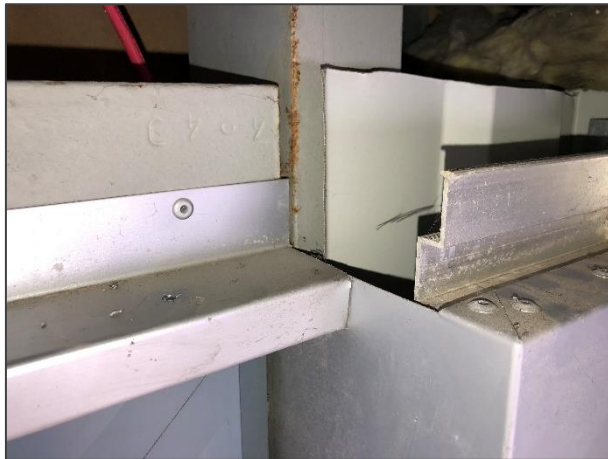
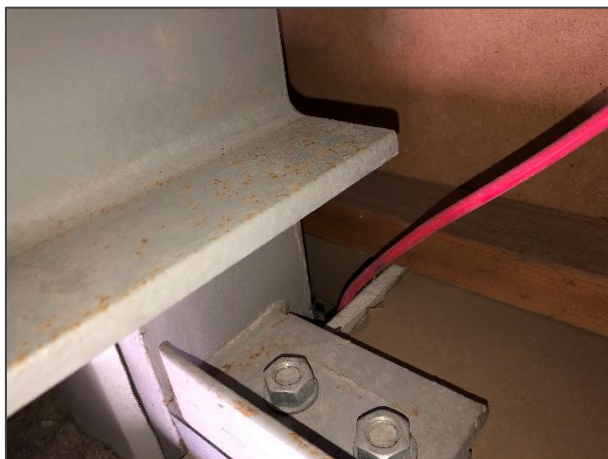
- 9.3.1 The primary structure has not been fully investigated beyond the corrugated trapezoidal sheet however portions of it were exposed during the survey. The portions seen were observed to be painted steel and in all instances observed, the paint coating was observed to be degrading and the surface of the structural elements was corroding.
- 9.3.2 This is likely due to the lack of membranes or sealed interface detail at the top of the construction allowing moisture into areas which are usually face sealed and therefore dry.
- 9.3.3 The primary structure should be assessed and evaluated by an independent and suitably qualified structural engineer. This will likely result in the requirement for the corrugated trapezoidal sheet coming off and the inner façade construction being open to the elements.

*Photograph No. 25 - Section of primary structure observed*

- An independent and suitably qualified structural engineer should assess the primary structure to determine how the corrosion observed will affect the structure's service life and any remedial works to rectify the coating and corrosion.
- The corrugated trapezoidal sheet should be assessed for its condition (particularly to the rear face), load bearing capacity and service life.
- The junction where the roof meets the vertical is specifically addressed for watertightness, thermal performance and acoustic performance.

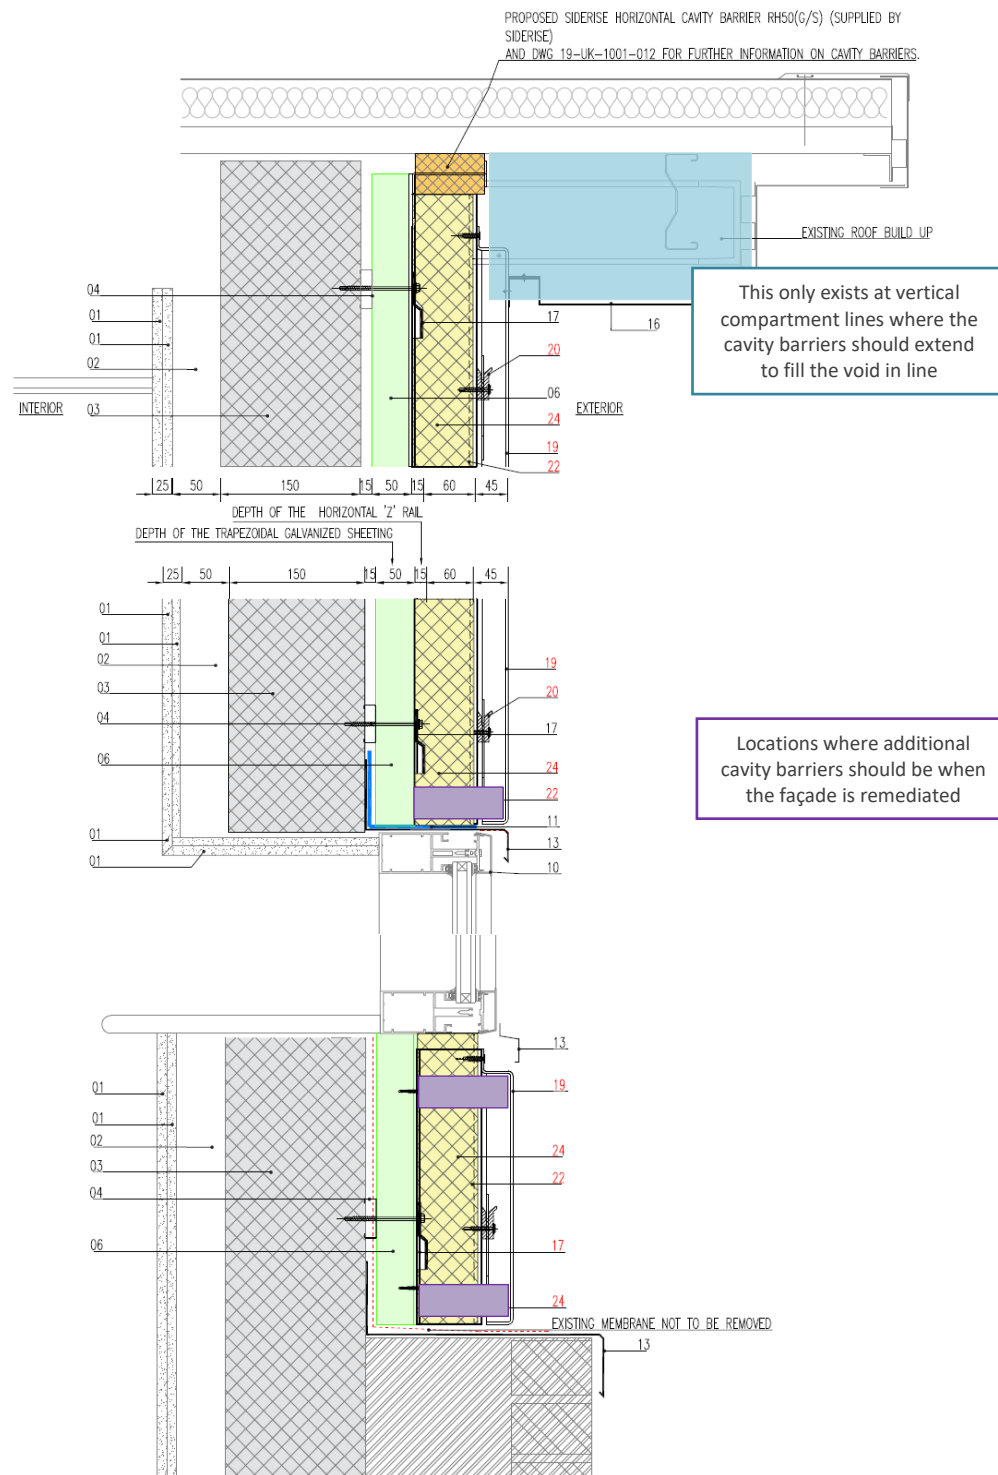
Figure 2- AOCA proposed detail

- 10.4.1 The drawing do not clearly define the primary and secondary wall construction; therefore, the elements which fasten to the sheet is not clear. This needs to be identified in order to determine the suitability of the existing construction.

- 10.4.3 The corrugated trapezoidal sheet stops short at the top of the detail where it interfaces with the roof and at the bottom which means this may not perform a number of functions relating to acoustic performance, thermal/condensation performance and fire performance. A strategy for sealing these areas to meet the necessary performance should be devised if the sheet is to remain part of the construction.

- 10.4.4 A cavity barrier is shown at the top of the proposed detail. Whilst a cavity barrier should be provided at edges of compartments, further cavity barriers may be required above and below the window and at the edge of the cavity. Vertically, full fill cavity barriers should be used; horizontally, open state cavity barriers with an intumescent face that will expand to the rear face of the aluminium panel when activated should be used or a sleeved, full fill cavity barrier whose durability has been proven to not be compromised by the presence of water. Given the shape of the trapezoidal corrugated sheet, assistance from the manufacturer in relation to the installation of the barriers with this form of sheet should be sought. Refer to Figure 1 below.
