# ***Digital Diagnostics Report***

## **Infrared Thermography Report**

**June 26-28, 2013**

Re: Thermography Report

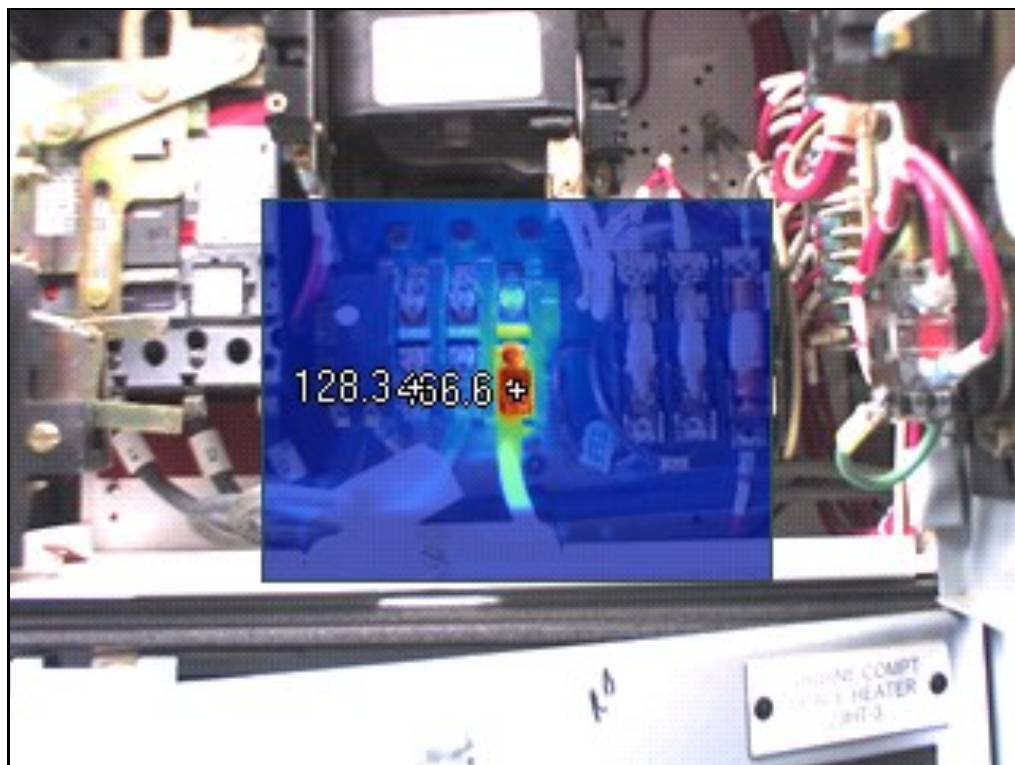
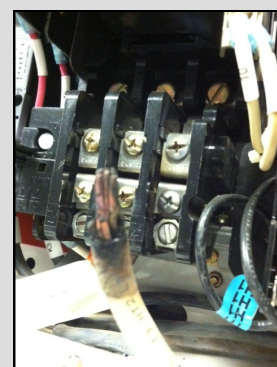
PECC 2 Turbine Compt Heater

**HIGH**

C Phase on overload component is 358F hotter than A and B Phases.  
Evaluate overload for replacement. Prep conductor and re-terminate.

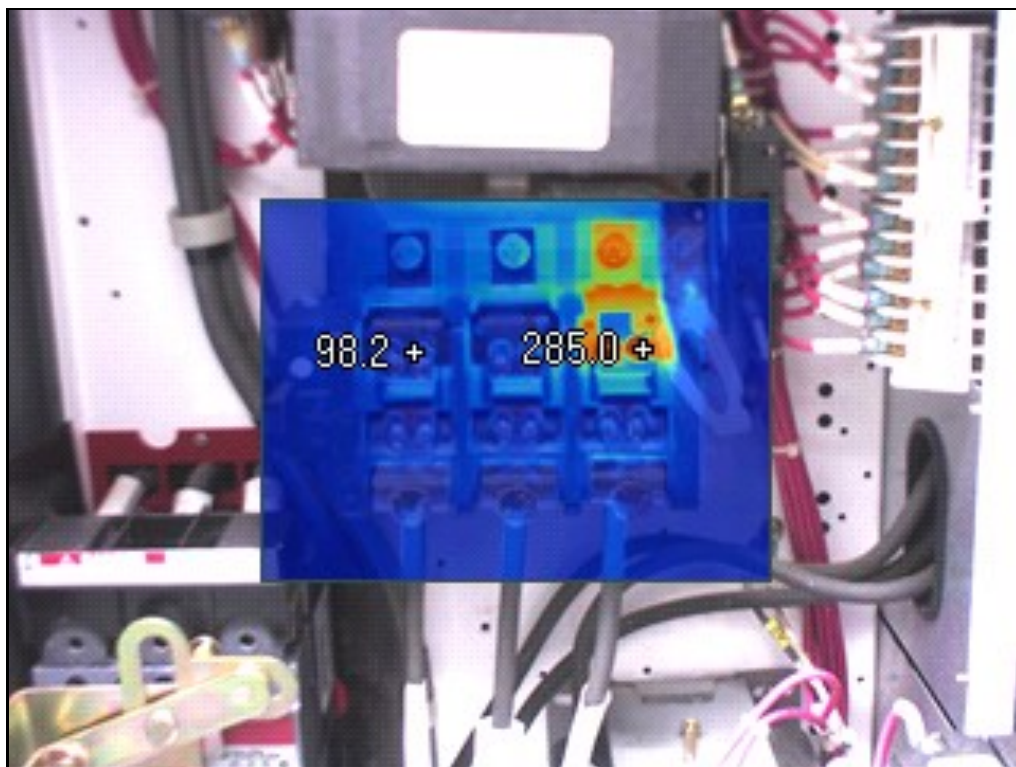
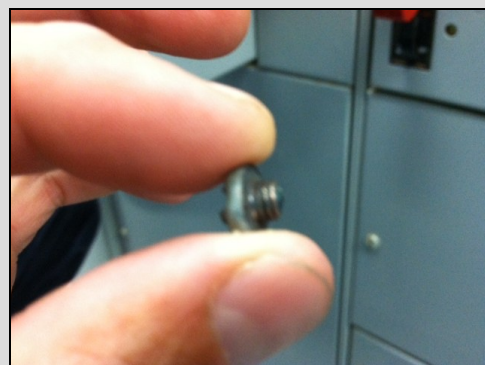
PECC 3 Cooling Water Fan  
Motor 88FC-4

**MEDIUM**

Problem corrected in the field. Had a very short screw holding the component in place. Replaced with longer screw and tightened.
