Bsides 2025 Badge

Preliminary Hardware Failure Analysis Report

Focus: Analysis of IC (IP5305T / U2) and Power Stage Failures

Report Type: Preliminary

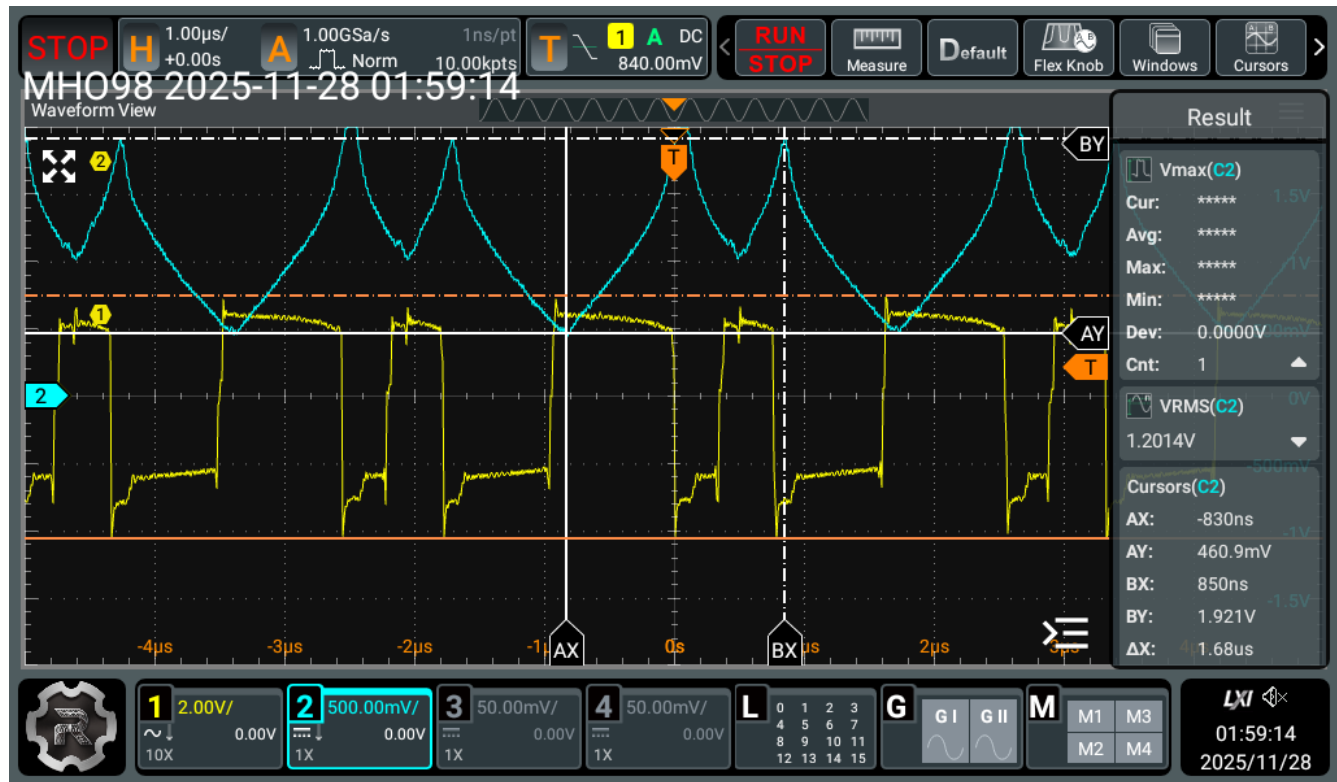
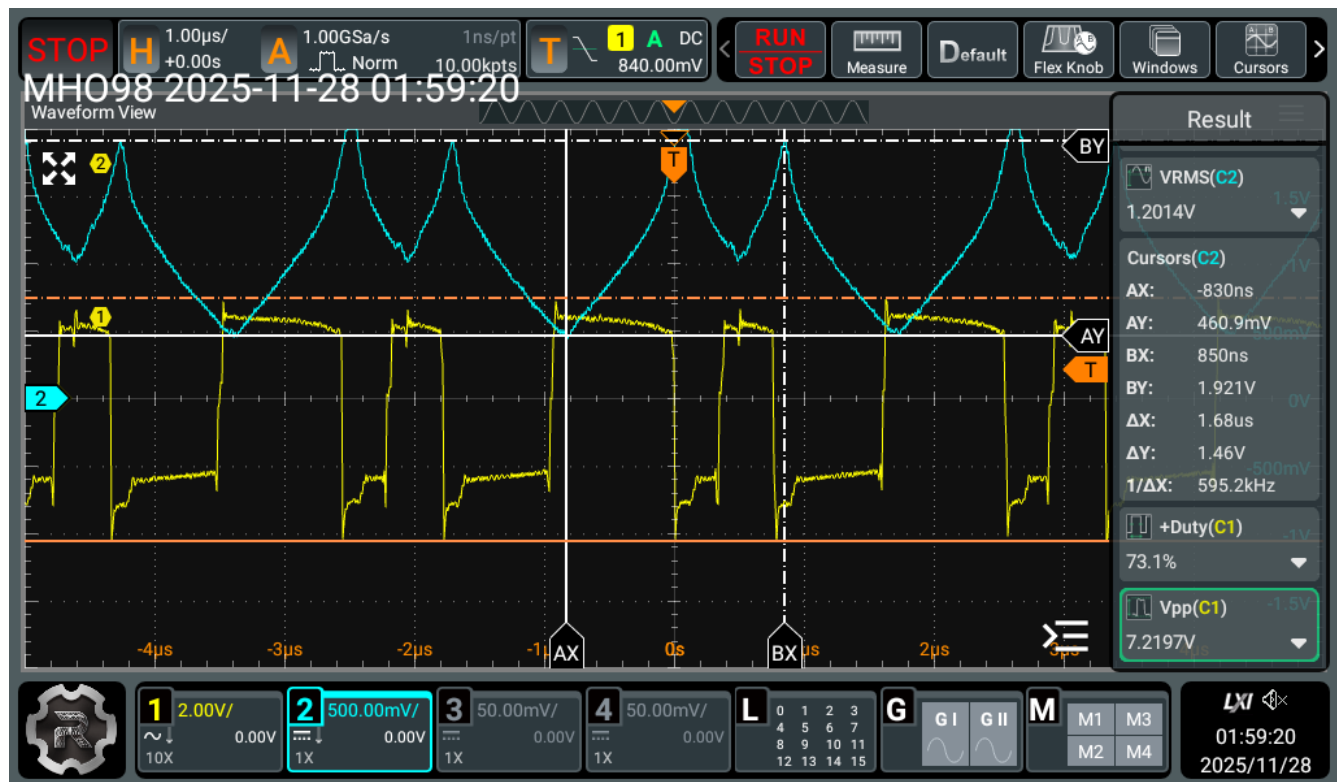
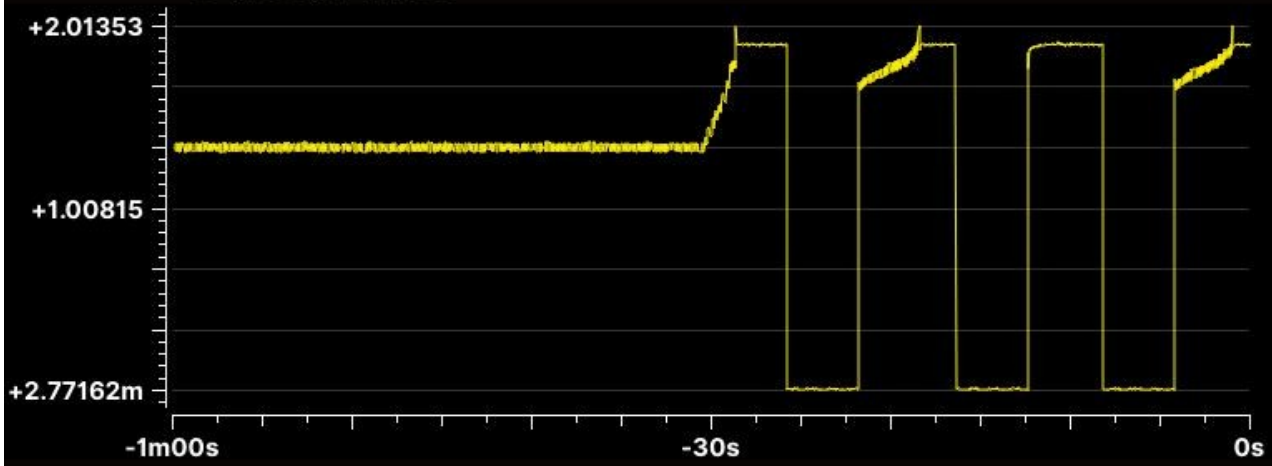
5.4. Inductor Vpp and Current @ Isat (Iload: 680mA – Device shuts down):

- When the inductor core saturates (5.4), excessive* current may flow through the U2 FET and the switching node.
- Excessive* current may flow through the U2 internal FET during Wi-Fi transmissions from the ESP MCU (U1), as short, high di/dt pulses draw current from the power source and through the boost stage.

- Repetitive pulsed operation may gradually degrade the IC (U2) and/or inductor (L1), particularly when current the peaks approach the inductor (L1) saturation current (I_{sat} , 5.4).

- Select an inductor (L1) with a higher current saturation margin (I_{sat}).
- Include a snubber network between the switching node and a low-impedance reference node to limit the peak amplitude of voltage overshoot during FET turn-off.

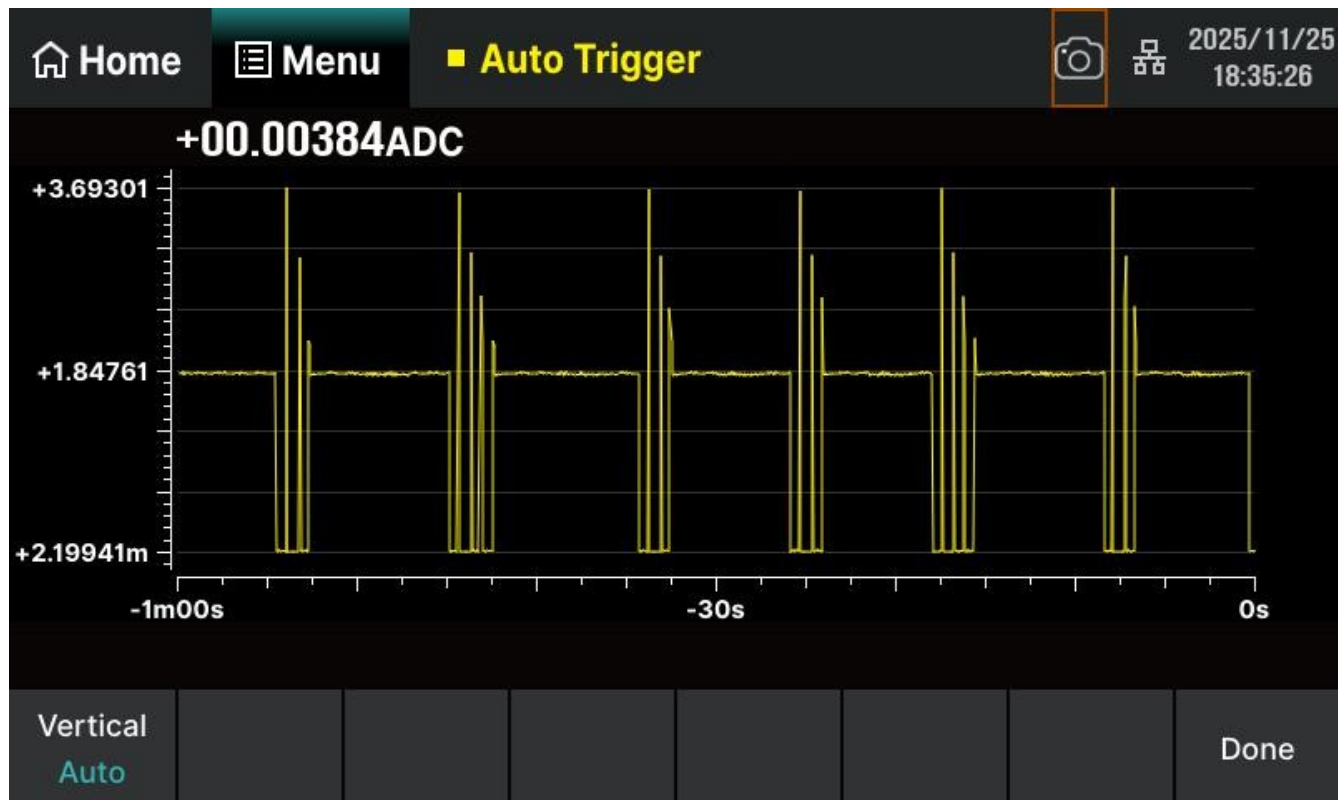
5.5. Current transients @ 800mA Iload power cycles (note the ~3.7A peaks):

The IC (U2) and inductor (L1) combination in the DUT was subjected to large current peaks (3.7A) during the tests (5.5), which may have contributed to the degradation of the IC (U2), as seen in (5.9).

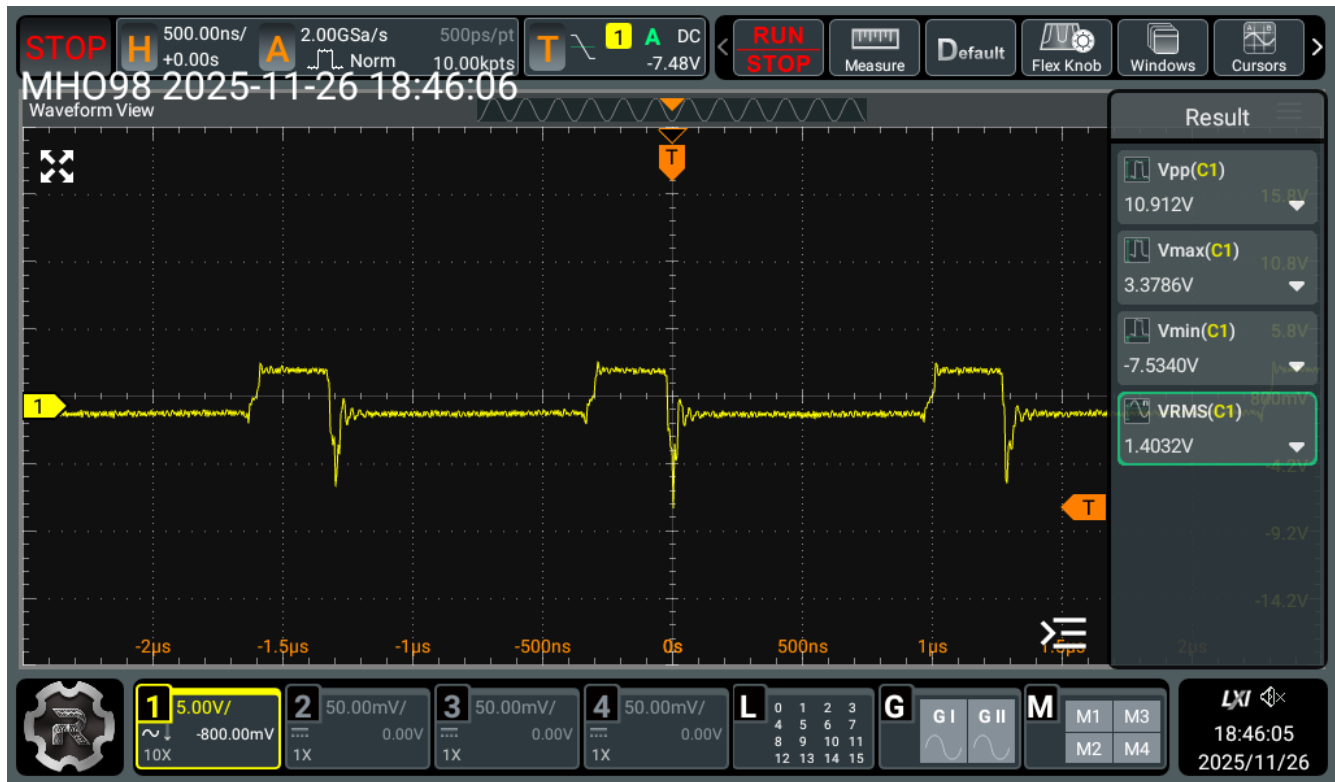
5.6. Switching-node ringing @ 800mA Iload power cycles (note the $V_{pp} \sim 11V$):

- Power cycling the device with the DC electronic load set to 800mA causes large currents to flow through the IC (U2), leading to higher-than-expected peak voltage overshoot when the internal FET turns off. The highest measured V_{pp} was ~11V (5.6), which is unusual for an IC designed to operate at nominal 5V. Nevertheless, the absolute maximum ratings for the internal FET are not specified in the IC (U2) datasheet, so it might still be within tolerance.
- Higher switching transients might occur with different IC (U2) / Inductor (L1) combinations in different devices, potentially degrading the FET and subsequently causing them to fail shorted between drain and source, leading to a thermal runaway due to uncontrolled current flow.

The lack of a snubber network between the switching node and a low-impedance reference node contributes to higher-than-expected peak voltage overshoot during FET turn-off.

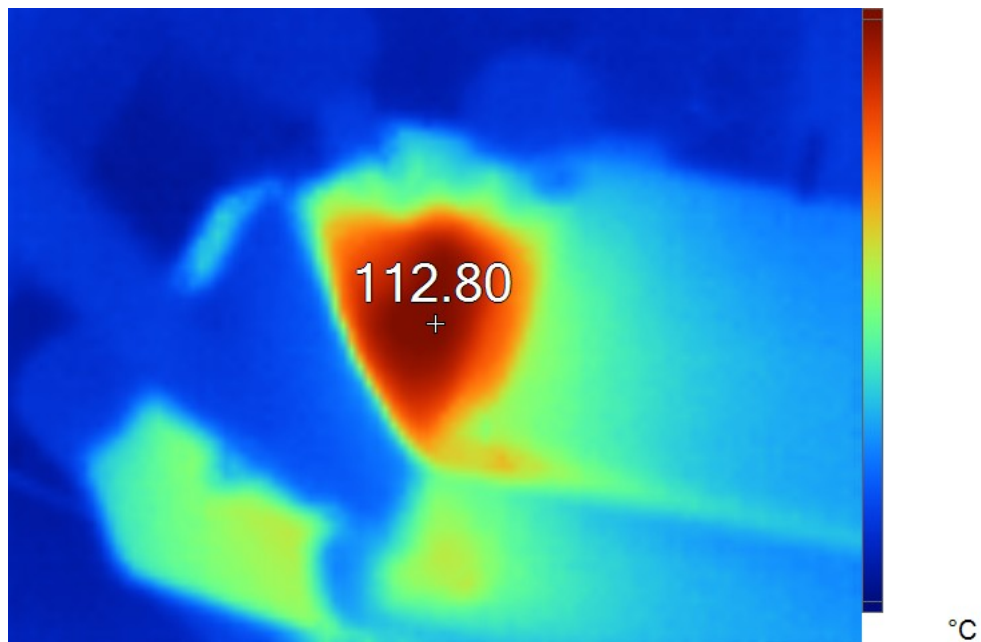
5.7. Peak Temperature observed @ 780mA Iload (pulsed, 10ms, 50% duty cycle):

- 112.8 Celsius (assumed junction temperature to be between 20 to 50 Celsius higher).

It is difficult at this stage to conclude which specific test contributed the most to this degradation, as the IC (U2) was traced after testing, rather than between each test. It is, however, suspected that the degradation occurred during the measurements shown in (5.6) and (5.7), which subjected the IC (U2) to the highest combined thermal and electrical stress.

- Bypass diode D2 is not required.
- Implement reversed-polarity detection or protection for the chemical power source.
- Include thermal vias in the PCB power pads to improve heat transfer.

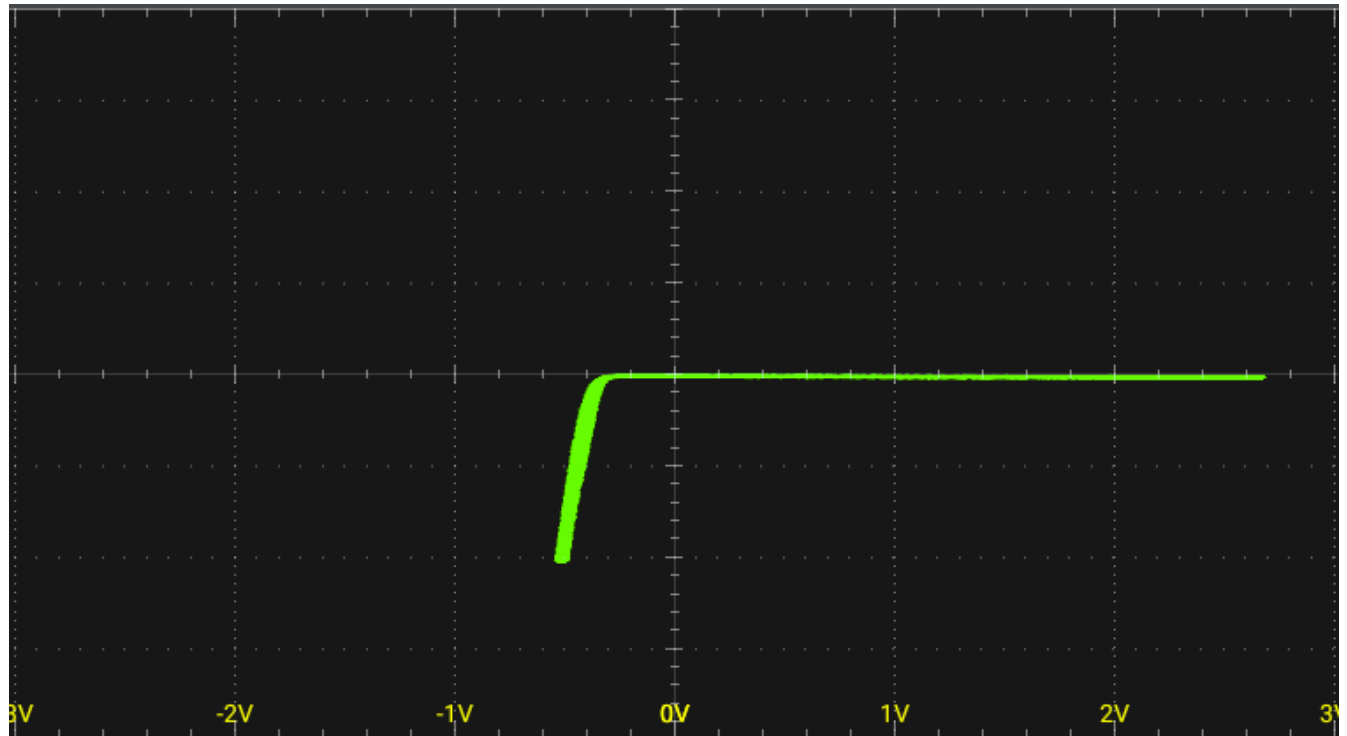
5.8. I-V Curve trace for a unused IP5305T (picked directly from a reel):

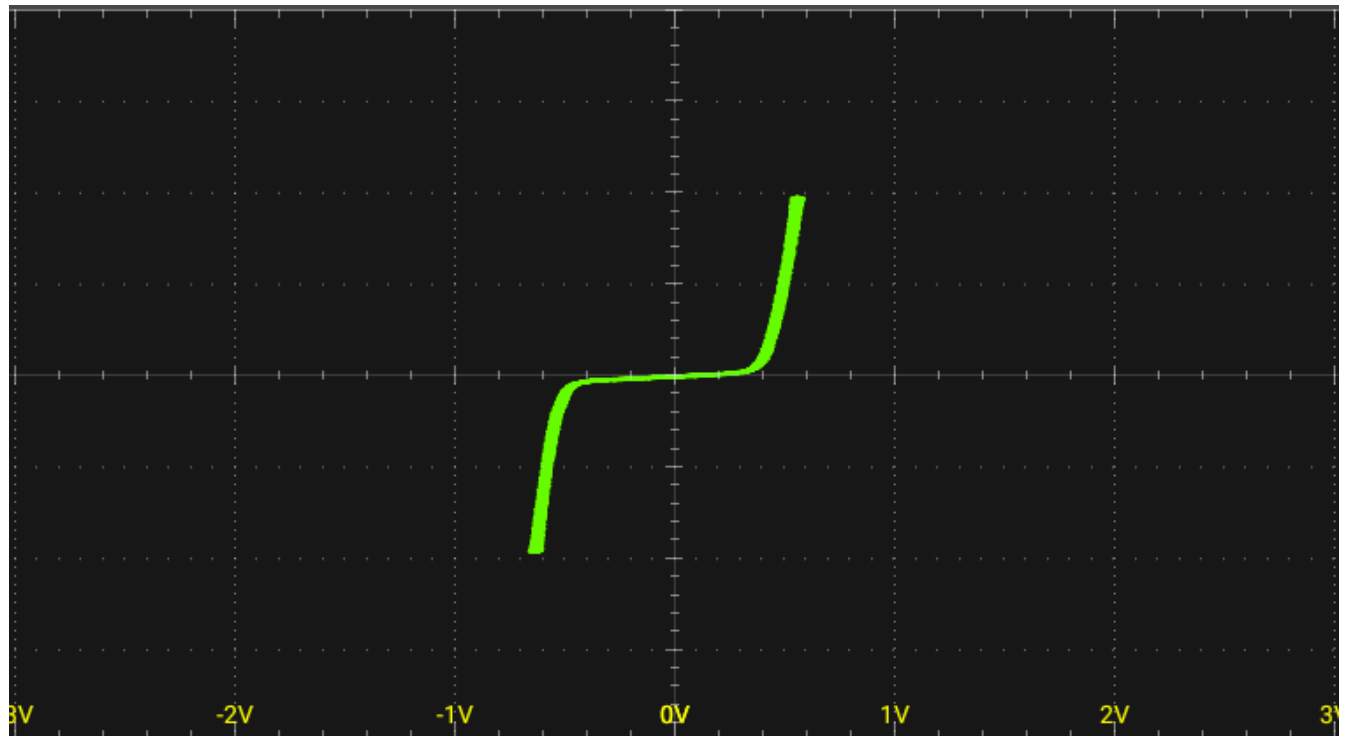
5.9. I-V Curve trace for a IP5305T after being subjected to the previous tests:

The IC (U2) was de-soldered from the DUT and an I-V curve trace was performed between the SW and PowerPAD connections. The resulting curve for the suspected degraded IC (U2) can be seen in (5.9) and compared with the I-V curve of an unused IC in (5.8).

These results indicate that, for the suspected IC (U2), a current conduction path exists between SW and PowerPAD when a positive voltage is applied across the terminals. Although the exact degradation mechanism cannot be determined from this measurement alone, the observed behavior is consistent with degradation of the internal silicon structures associated with the switching FET. As conduction begins at lower applied voltages, the effective resistance between SW and PowerPAD is reduced. This can lead to increased static current and higher power dissipation during operation, increasing the risk of thermally induced failure.
