HP L700/800 Printer Series

Substrate advance system errors 0065-0002-0059 and 0065-0002-0061

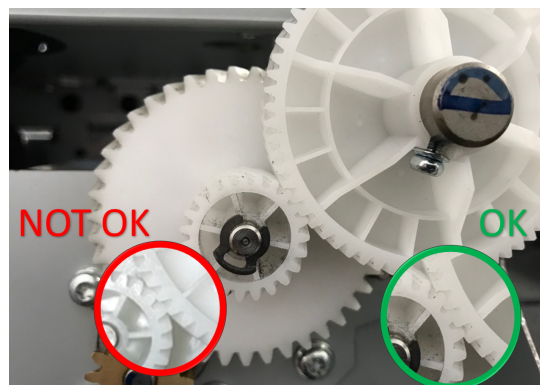
A proper gear meshing in the Substrate Advance Motor Assembly is crucial for optimal transmission performance, as poor meshing can result in unexpected substrate advance issues. Therefore, additional steps have been added to this document to inspect and replace the Substrate Advance Motor Assembly.

- Verify that the Substrate Advance Motor gears are meshing correctly to ensure the necessary accuracy during substrate advance movements. If there is a gap, as shown in the left zoom image circled in red, the technician should remove and reinstall the Substrate Advance Motor.

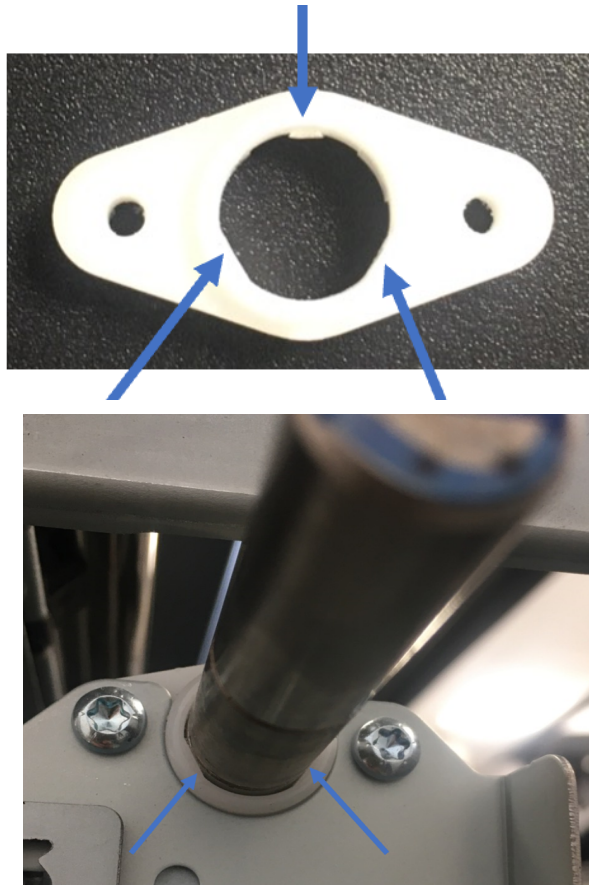
- Ensure that the flat part of the shaft matches the flat area of the bushing, as shown in the pictures below.

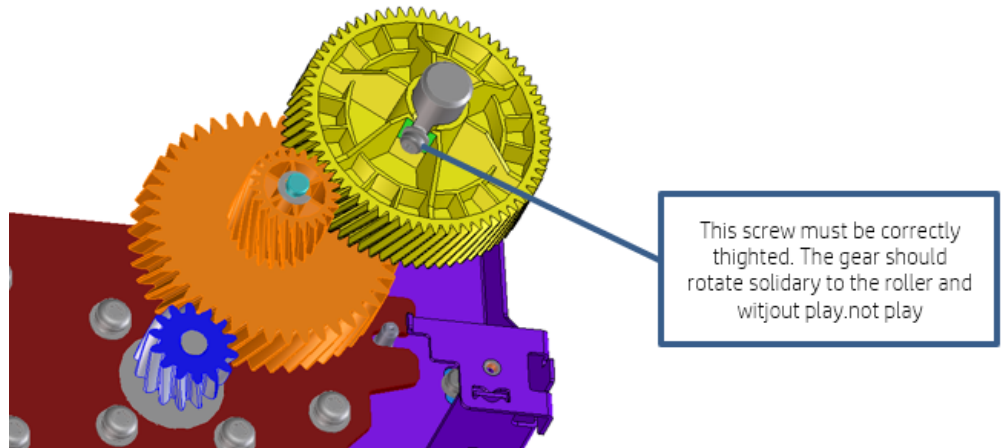
- Verify that the screw holding the Drive Roller's gear to the roller is correctly tightened after any operation requiring the disassembly of the roller's cogs. If necessary, tighten the screw. The cog should rotate with the roller.

- It is essential to check the status of this screw, as a loose screw can cause severe transmission backlash and result in printer failure.
