### Technical report by sample - Percentage of total photons:

Stalking Panther Large, Gilcrease Museum A,9

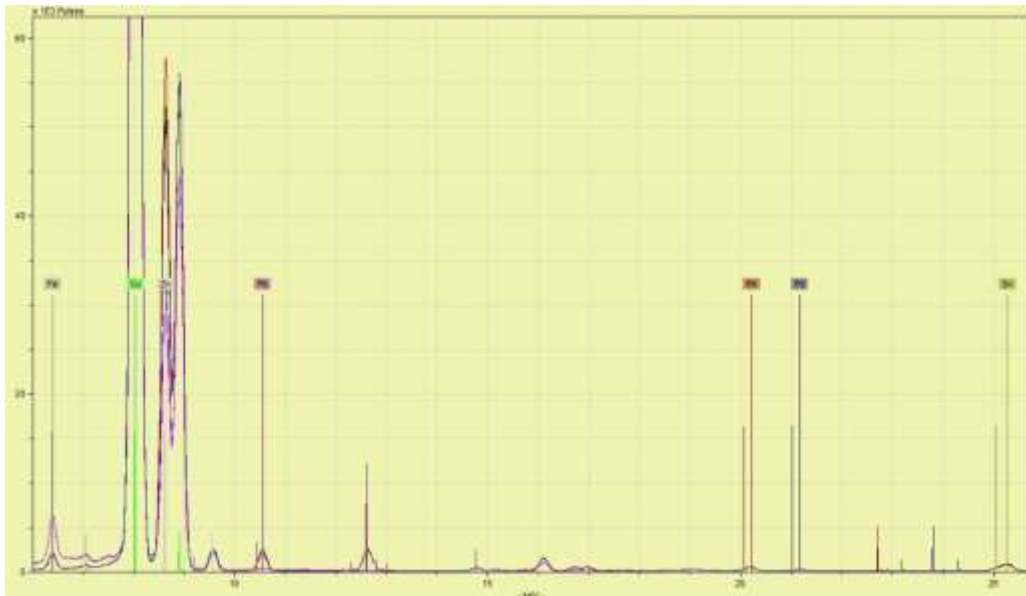
Stalking Panther Large, Gilcrease Museum A, 9; Spectrum Image

Trace amounts of iron, chlorine, potassium, sulfur, calcium, titanium, and silicon are present in all test spots. They are present in the greatest concentrations on the test spots "FRONT SHOULDER LEFT 15" and "NECK 15."

Copper-tin-zinc alloy. Patina has been eaten away so it is no longer present. The presence of chlorine and sulfur is a sign of ongoing damage and future potential damage.
