Damage Report for Household Residence in Seaford, NY

CE-GY 7823

November 18, 2015

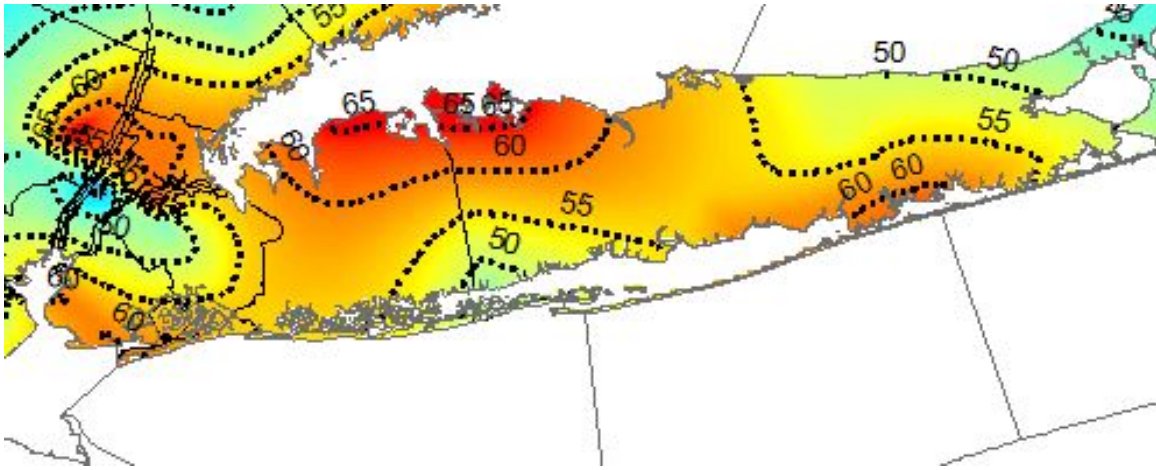
Weather data in the vicinity during Sandy were gathered from the National Oceanographic and Atmosphere Administration (NOAA) and the United States Geographical Survey (USGS). According to NOAA, the maximum sustained wind speeds around Seaford, NY are 50 mph to 55 mph (Figure 1)¹. Based on the data provided from USGS, the estimated waterline recorded around the vicinity is 3.3 ft to 3.5 ft above ground (Figure 2)².

Figure 1: Sustained wind speed in NY Area (from NOAA)

In addition, John Smith, PE claims that both flooding and high wind speeds contributed to shifting and racking of the house. We do not believe any wind damage is possible since the maximum sustained wind speed in the vicinity was about 55 mph (see Figure 1). Referring to the Saffir-Simpson Hurricane Wind Scale ³, the lowest wind speed in which damage due to hurricane winds will occur is about 75 mph (Category 1). Since the wind speed measured is lower than Category 1 wind speeds, any damage due to high winds is very unlikely.

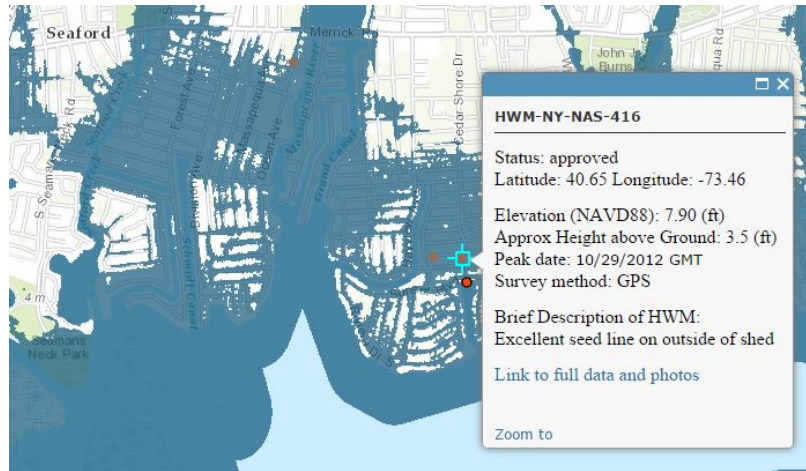
(a) Tide data around Seaford, NY

Figure 2: Estimated waterline around property vicinity (from USGS)

Since the waterline at the property was about 3.5 ft above ground, the exterior finishes and

interior finishes on the first floor would expect non-structural damage. As stated in both reports, the interior floor and drywall were damaged and removed for either drying or the possibility of mold growth.

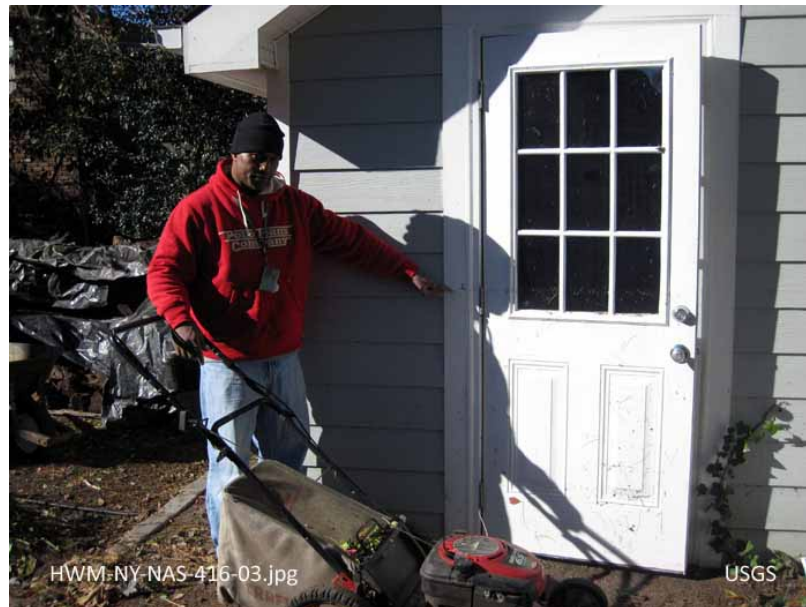
(b) Photo of marked waterline
