Oklahoma Murrah Federal Building Collapse

Sue Nopachinda

CE-GY 7823

December 16, 2015

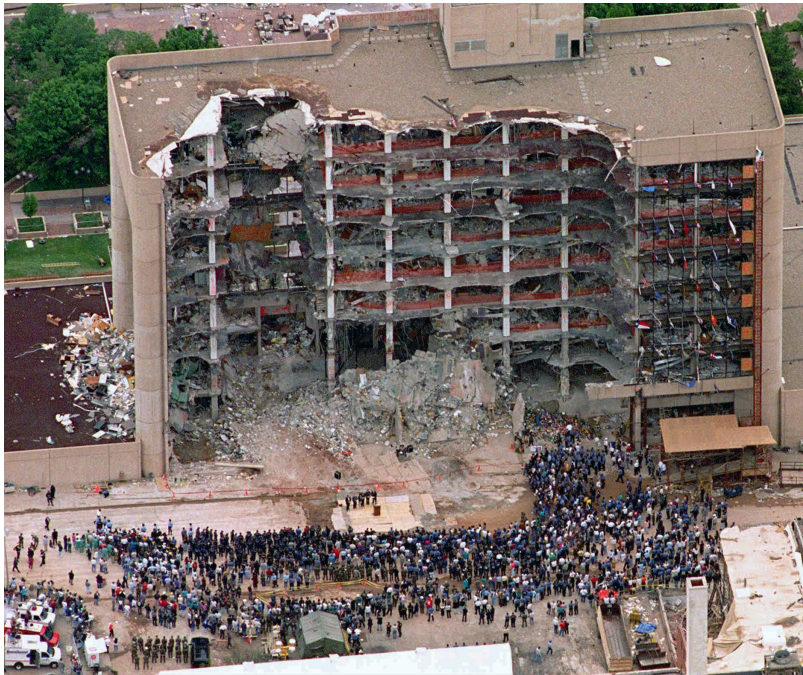
On April 19, 1995 at 9:02 AM, a bomb inside a 24 foot Ryder rental truck was detonated in front of the north side of the Murrah Building. The explosion caused all nine stories of the north face to collapse, effectively destroying a third of the building (Figure 2). During the time of the bombing, about 600 federal workers and 250 visitors were on site. The collapse caused 168 fatalities, including 9 children, and 426 injuries. About 90% of fatalities were due to falling debris while a majority of injuries stemmed from lacerations from airborne projectiles such as glass and debris. Additionally, the blast damaged numerous buildings in a 48 square block area including roof damage on a water resources building, masonry damage to a journal record building, and glazing destruction of a YMCA facility. Financial damage was estimated to be at least \$510 million. \$200 million was attributed to the damage on the Murrah building, \$28 million to rebuild the building (not including demolition costs), and at least \$50 million worth of damages to nearby buildings. Considered to be one of the biggest

Figure 2: Collapse of the north side of the Murrah building. (Source: www.ssa.gov)

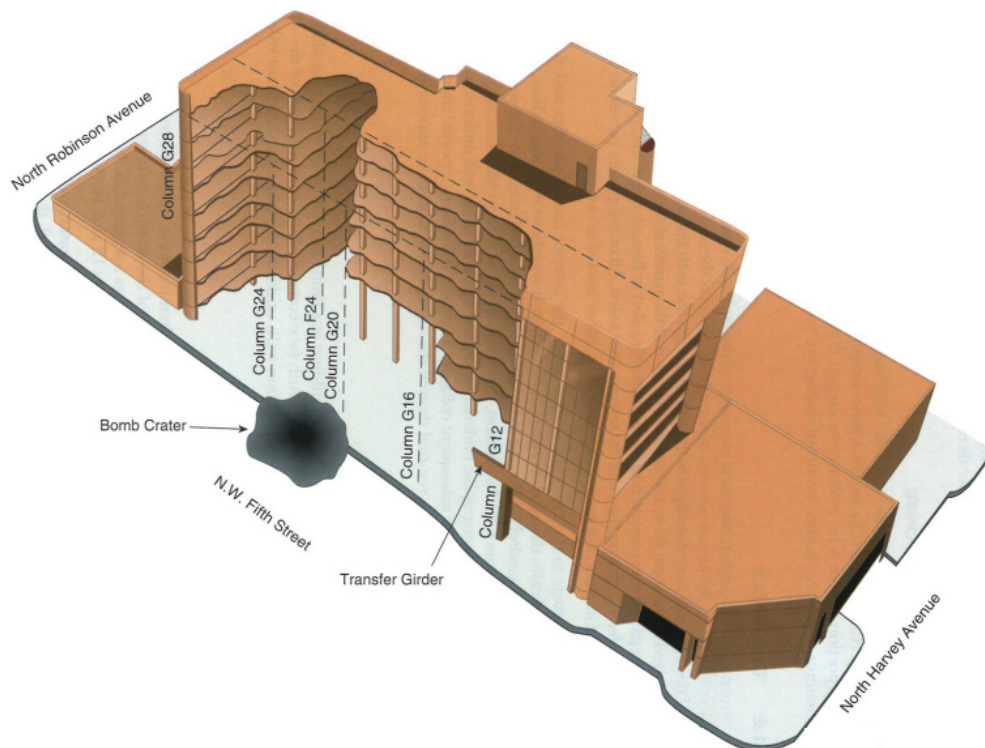
BPAT first investigated the damage caused by the blast. From Figure 3, damage from the blast mainly effected the north, west, and east faces of the building. Major wall damage was sustained on the east face including fractured granite panels failing in flexure and glazing failure. Collapse of the north face (column line G) were due to the blast force from the bomb except for a small piece of the transfer girder on the third floor. The south face did not sustain as much damage since it consisted of the core structure and concrete masonry partition walls. Interior damage included failure of floor slabs, roof slabs, and masonry walls between column lines G12 and G28. Referring to Figure 4, floor panels between column lines 22 and 26 and lines E and F were lost once column F24 was destroyed. In total, about 62% of all floor panels above the second floor were destroyed from the blast.

Figure 3: Failure due to blast (Source: www.fema.gov)

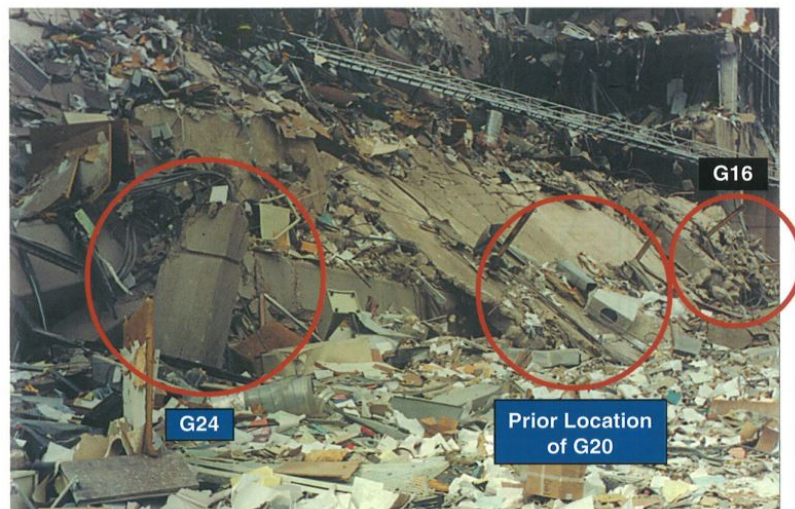
BPAT then proceeded to conduct analysis on blast loading and building's response. To determine the amount of explosives detonated, the team measured the depth and diameter of the crater that was left behind by the blast. With a diameter of 28 feet and depth of 2.8 feet, the estimated amount of detonated explosives was 4,000 pounds of TNT. From this, the blast response for Columns G20, 24, and 16 were analyzed. Based on the scaled distances for each column, only column G20 was completely obliterated by brisance effects. This is supported by the fact that no remnants of Column G20 were found at the site. Columns G24 and G16, however, experienced brittle failure. Since the direction of the blast impacted about 1400 psi of pressure on the column's weak axis, the shear at the supports exceeded the column's capacity of only 54 psi. As a result, these two columns failed at the top as the axial prestress and shear capacity was much greater on the first floor than at the third floor. Figure 5 shows the overall damage of Columns G20, 24, and 16 which are consistent with the analysis results.

Figure 5: Damage along Column Line G (Source: www.fema.gov)

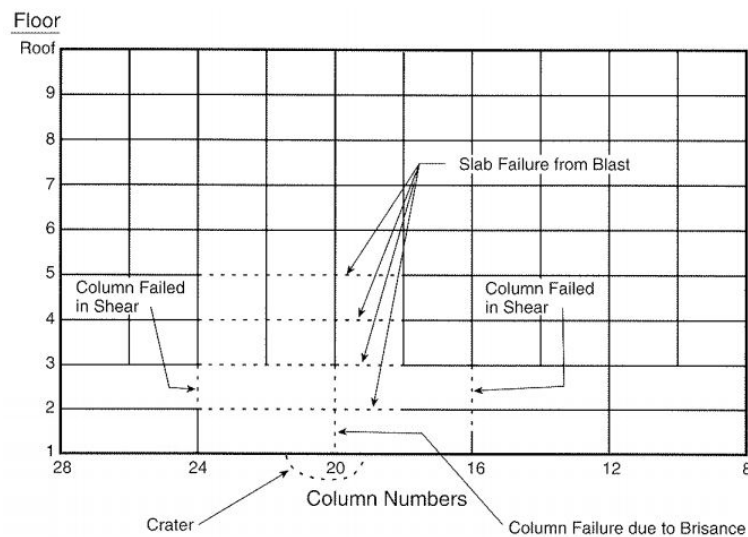
Similar analysis to investigate failure of the floor slabs revealed that the slabs from the first to fifth floor failed when the bomb detonated. Typical floor slab details revealed that reinforcement placed near the bottom, effectively reducing resistance against upward loading. About 163 psi of pressure was induced to the bottom of the floor slabs, causing the slabs to deflect 9.3 inches and exceeding their ultimate capacity. Figure 6 shows a schematic of the overall damage at the north face.

Figure 6: Damage on the north face (Source: www.fema.gov)

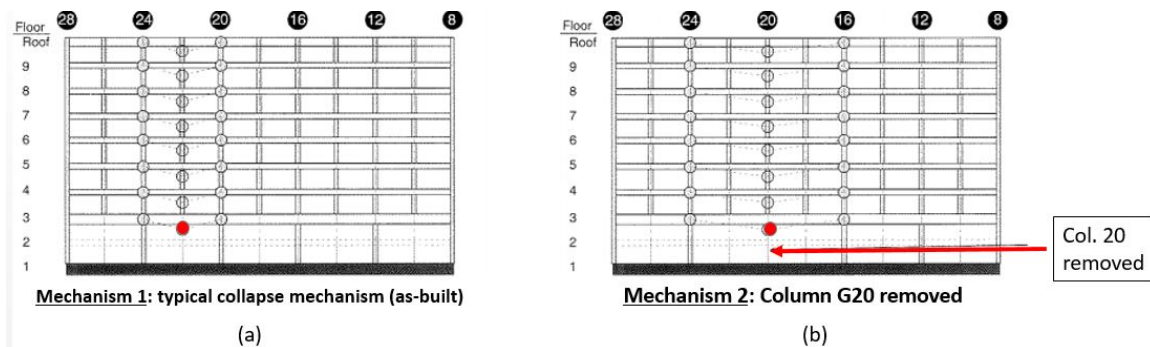
failure mechanisms. Mechanism 1 (Figure 7(a)) considers the typical collapse system in the as-built condition. It is assumed that the moment capacity at Column Line 22 is finite since bottom-flange reinforcement is continuous. The moment capacities of the girders on floors four through nine and the roof are zero since bottom-flange reinforcement stops at the support. Mechanism 2 (Figure 7(b)) considers Column G20 removed which is akin to the blast response. The positive moment capacity at the support is assumed to be zero at Column Line 20 since bottom-flange reinforcement terminates. Analysis was conducted on these two mechanisms to determine the unit strengths for Column Line G. Mechanism 1 had a unit strength of 490 to 530 psi while Mechanism 2 has a unit strength of 60 to 70. Knowing that the building unit

weight is about 150 to 200 psf from prior analysis, it is evident that Mechanism 1 was able to sustain this load while Mechanism 2 could not. Therefore, Column Line G cannot sustain its own tributary weight if any interior column is removed. Considering Columns G20, 24, and 16 were destroyed, there is no plausible way that the transfer girder on the third floor could sustain itself.

Figure 7: Two collapse mechanisms considered (Source: www.fema.gov)
