Multi-Point Vehicle Inspection

Thursday, June 15, 2023

Land Rover

Range Rover Velar

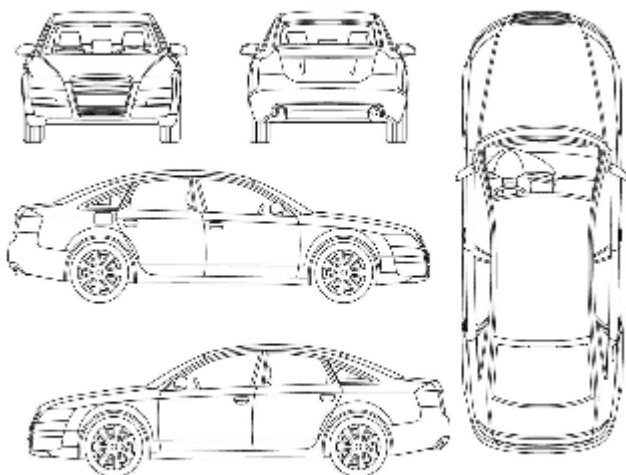
A2 -REAR DRIVER DOOR
U2-REAR DRIVER QUARTER

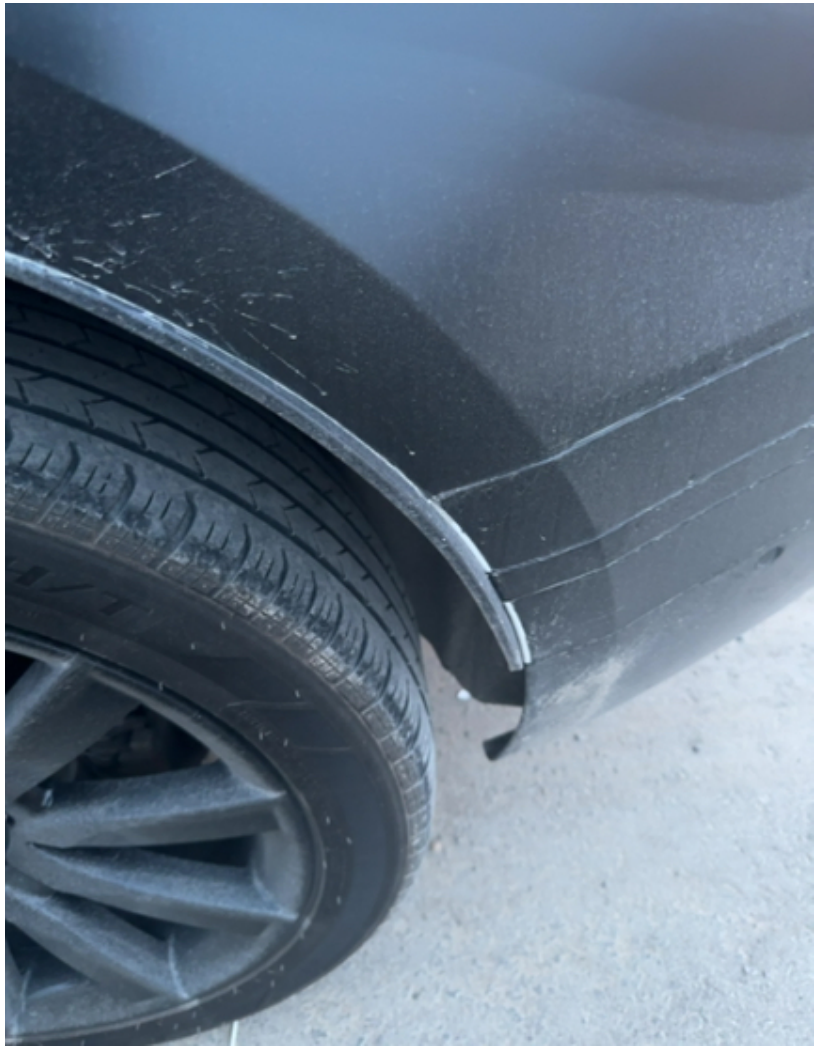
Additional Photos

Overall vehicle in good condition, damage to rear wrap as shown in photos below
