# CLAIM INSIGHT

## AI-Powered Insurance Claim Assessment Report

Claim Reference: CI-202512040910

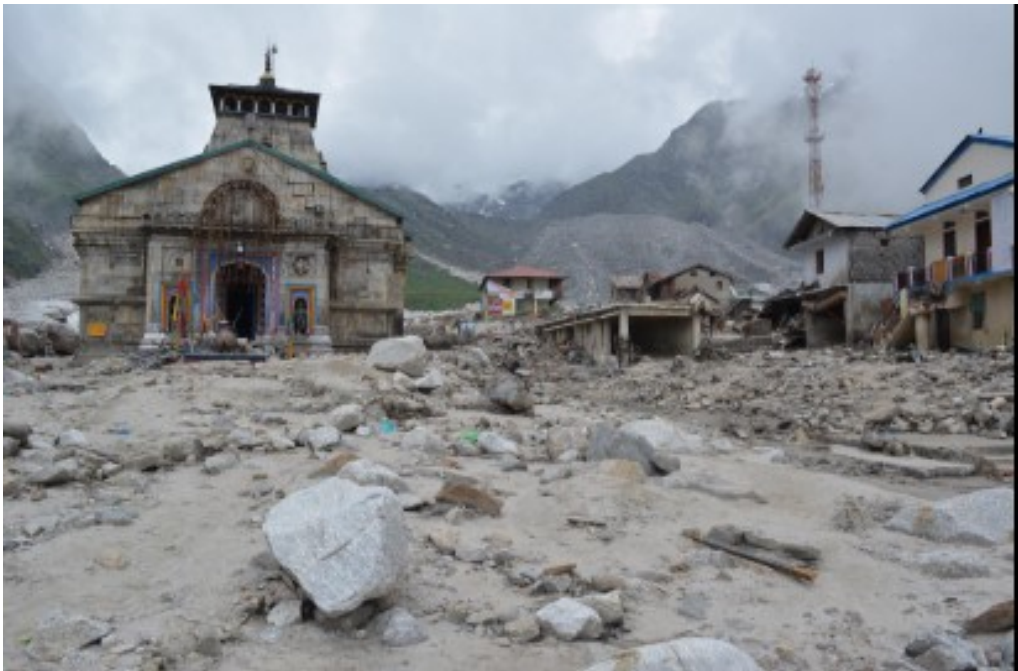
### DAMAGE IMAGE

**Damage Type:** Flood Damage  
**Severity Level:** SEVERE (84/100)  
**Estimated Cost Range:** 30,000 - 2,00,000  
**Report Status:** READY FOR CLAIM PROCESSING

Damage Type:	Flood Damage
Affected Components:	Water damage throughout vehicle, Moisture intrusion in interior, Electrical system damage, Engine compartment flooding, Upholstery and carpet water damage, Potential mold/mildew growth, Corroded metal components, Contaminated fluid systems
Repair Complexity:	High (structural/critical repair)
Estimated Cost Range:	30,000 - 2,00,000

Image Analysis: Image analysis indicates visible damage to property. External surfaces show signs of impact.

CRITICAL DAMAGE DETECTED (Score: 84/100) The damage assessment indicates extensive structural compromise requiring immediate attention. Multiple critical components are affected, posing safety risks if not addressed promptly.

IMMEDIATE PROFESSIONAL INTERVENTION REQUIRED - Contact repair services within 24 hours

- 1. IMMEDIATE ACTION REQUIRED:** Contact certified structural or auto-repair professionals within 24 hours to prevent further deterioration and ensure critical issues are addressed promptly.
- 2. SAFETY FIRST:** Do not enter, touch, or operate the affected area until a qualified technician performs a safety inspection to avoid injury or secondary damage.
- 3. THOROUGH DOCUMENTATION:** Capture high-quality photos and videos of all damaged surfaces from multiple angles, including close-ups, wide shots, and any visible structural impact.
- 4. PROFESSIONAL ASSESSMENT:** Arrange a full structural and functional evaluation to identify hidden issues such as internal cracks, compromised supports, or electrical hazards.
