# ***C. & D. Construction Consultants***

Inspector Name: Bob Reese; ASHI Member 205092  
Inspection No: 24100212  
Inspection Date: 10/2/2024  
Client: Robin Mennel & Sidney Rens  
Address: 5874 Birch Hollow  
St. Louis, MO 63129

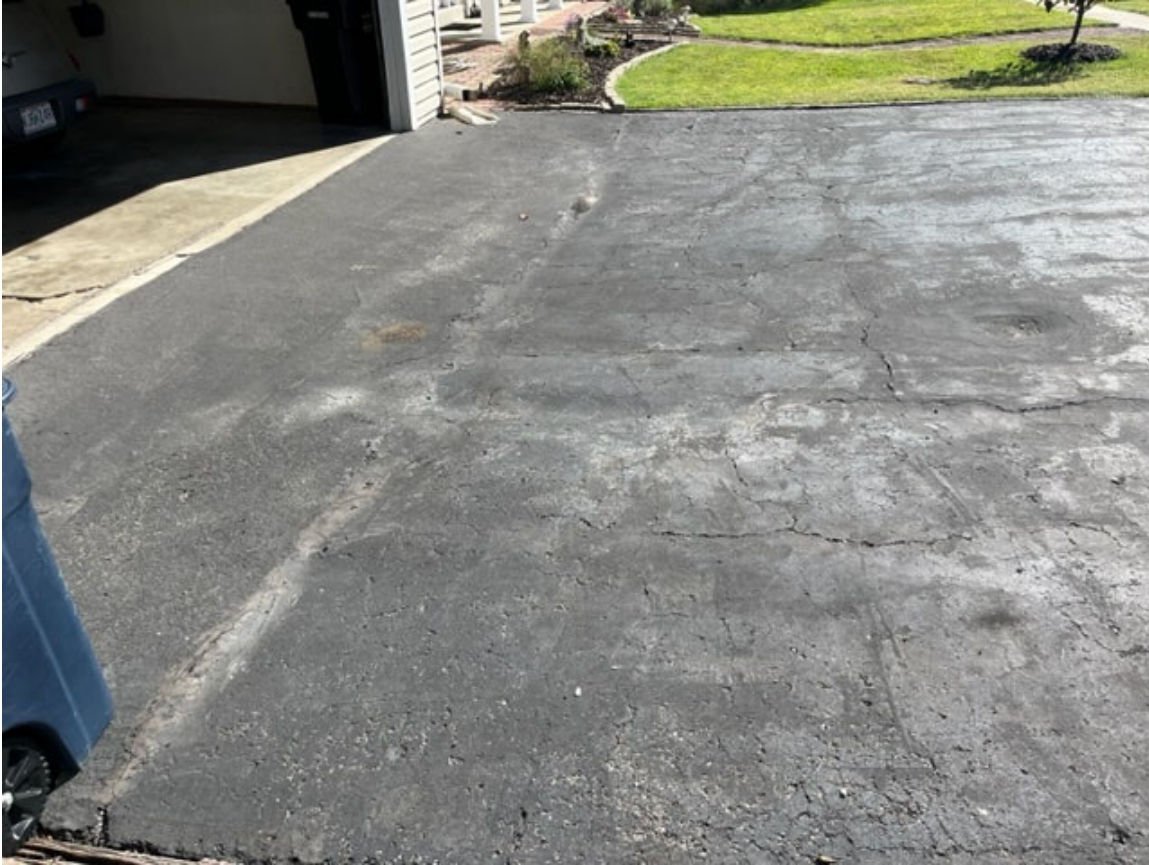
#### DRIVEWAY:

Asphalt requires periodic coating or sealing to prevent deterioration. Recommend sealing all cracks and voids and coating the driveway with the proper sealer.

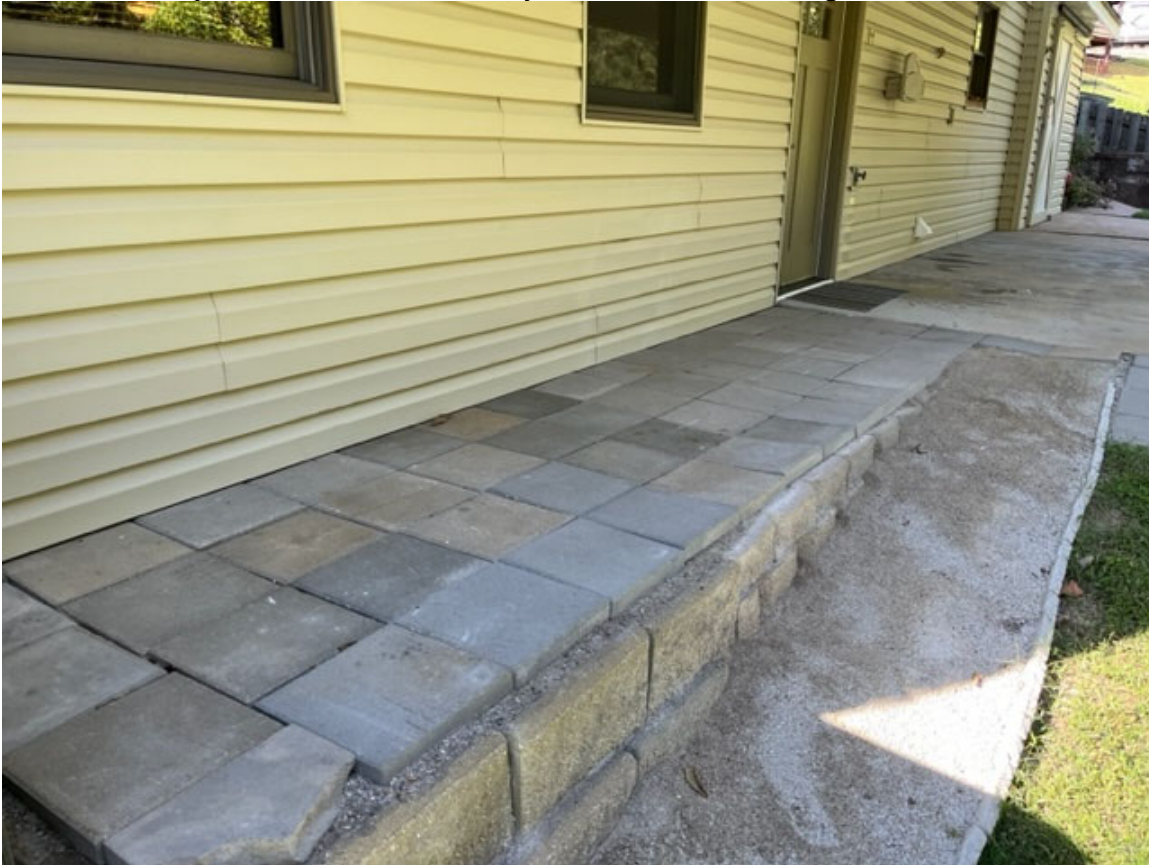
SIDING:

Cracking was noted at the rear patio. Recommend sealing cracks and voids to prevent damage from water penetration.

The siding is in contact with the concrete pad at the rear patio. This area may be prone to water or insect entry. Recommend monitoring this area.

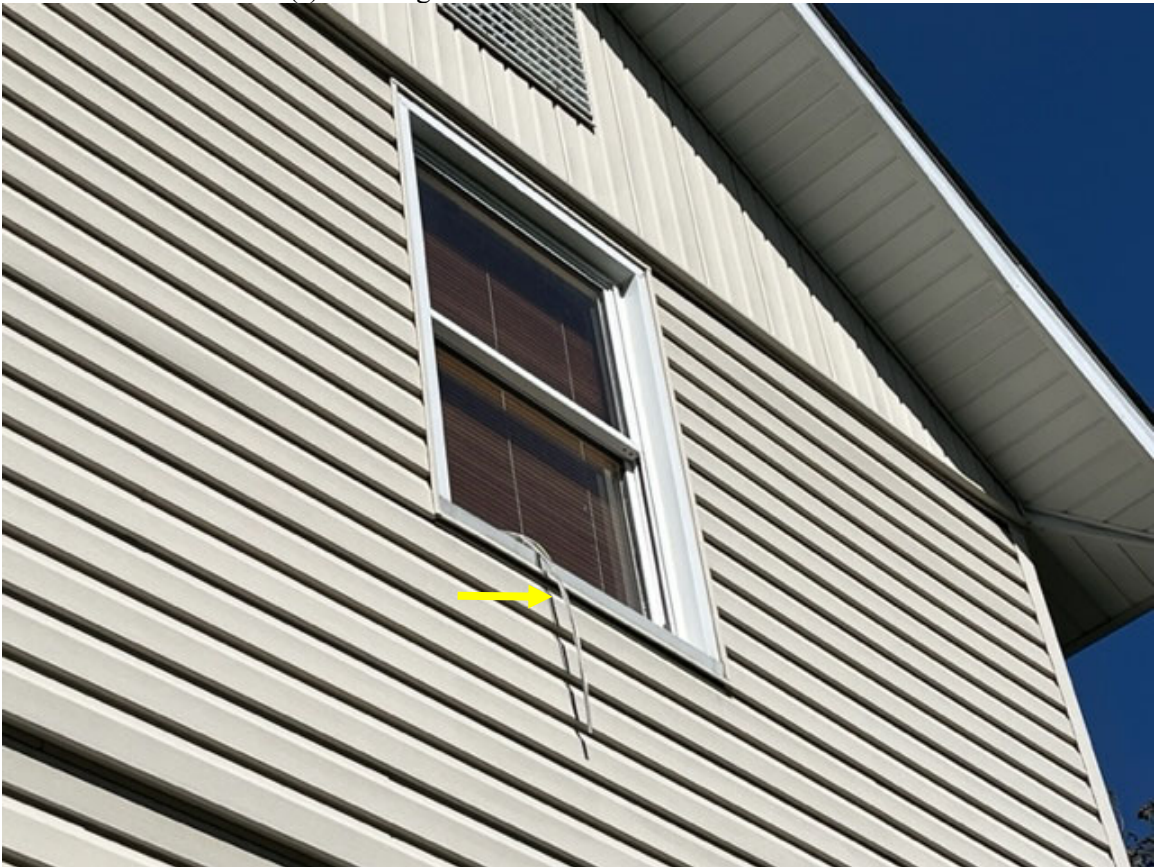
WINDOWS:

Missing screens noted. Damaged trim or frame was noted at the exterior of the window(s) at the right-side 2nd floor bedroom.

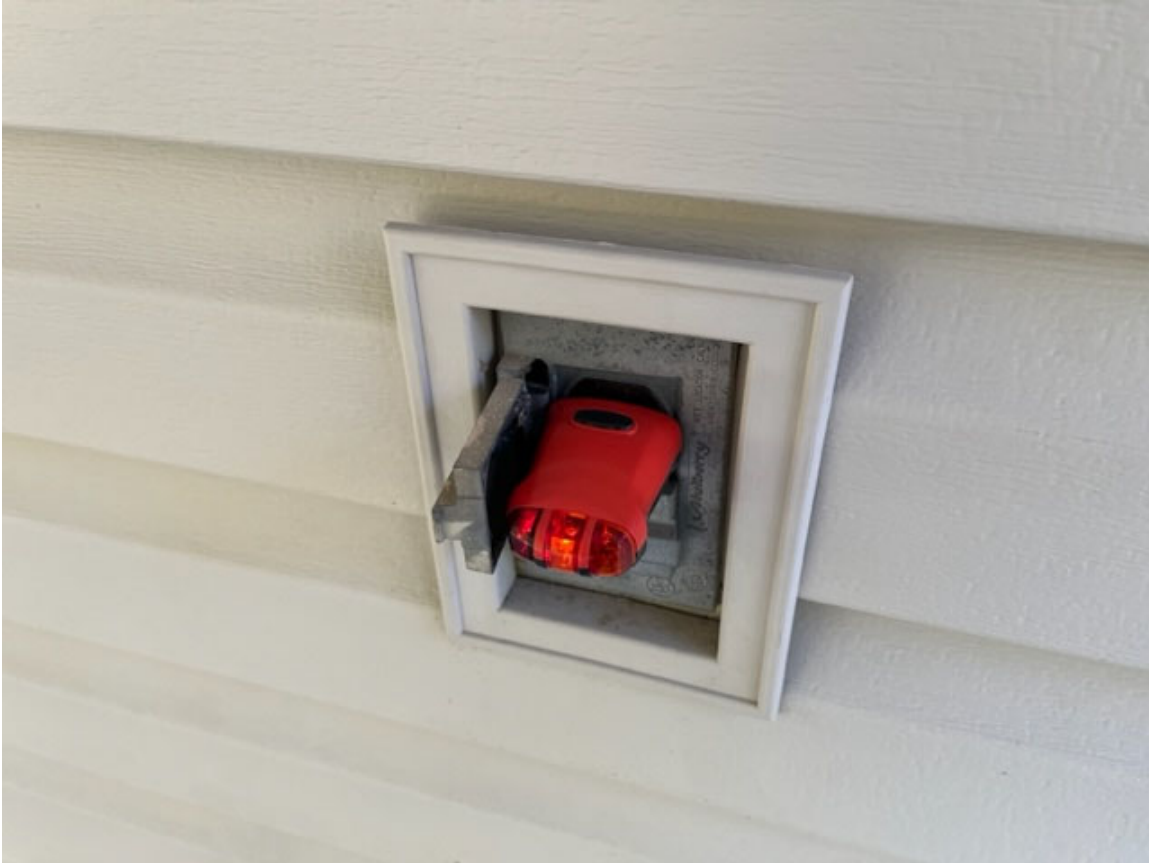
**ELECTRICAL:**

**DEFECT:** No GFCI protection noted at the rear patio. Recommend upgrading to GFCI near water sources. Reverse polarity noted rear patio outlet (hot and neutral wire reversed). Recommend review/repair as needed by a licensed electrician.

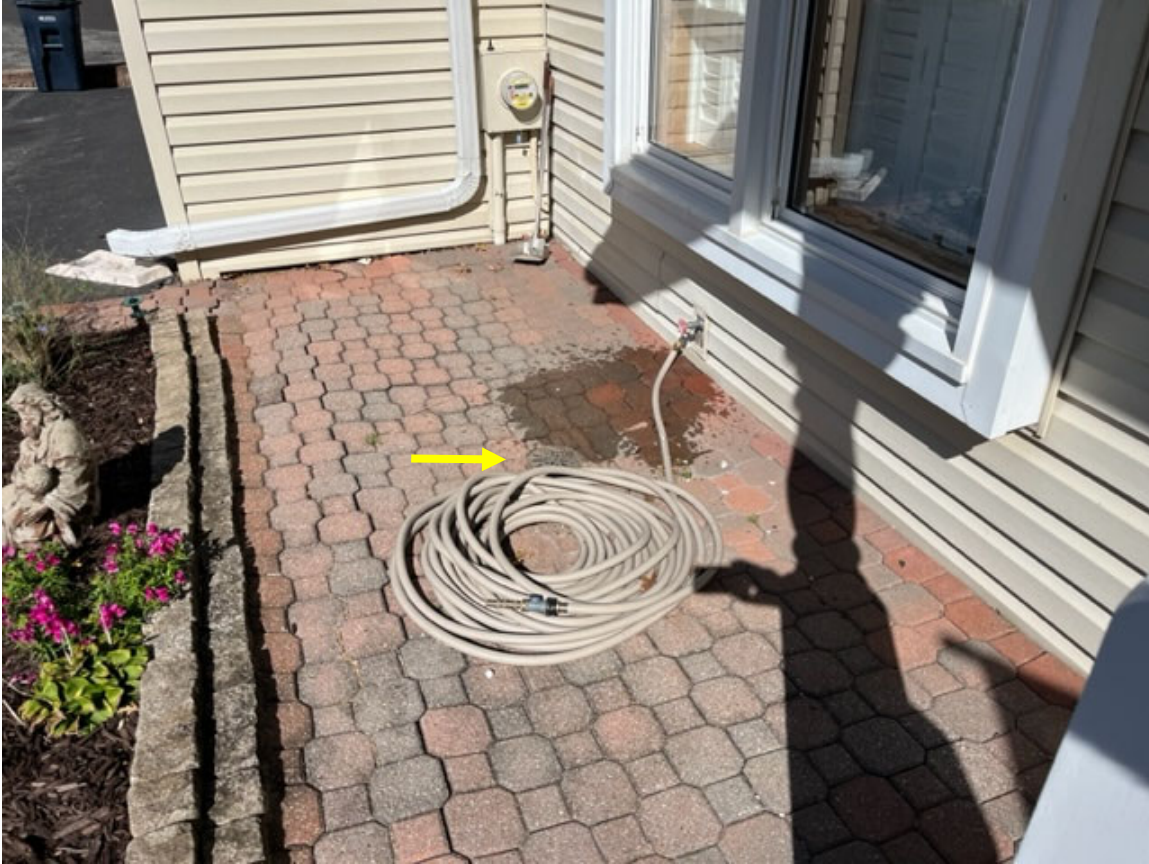
**GRADE/DRAINAGE:**

Downspouts drain into the ground. We are unable to determine if the drains are blocked since they are buried underground. We suggest monitoring for blockage.

The lot pitch will direct water towards the foundation at the front of the house. We recommend measures be taken to ensure water drains away from the home's foundation. A drain was noted, unable to determine effectiveness of drainage. Recommend keeping drain clear of debris.

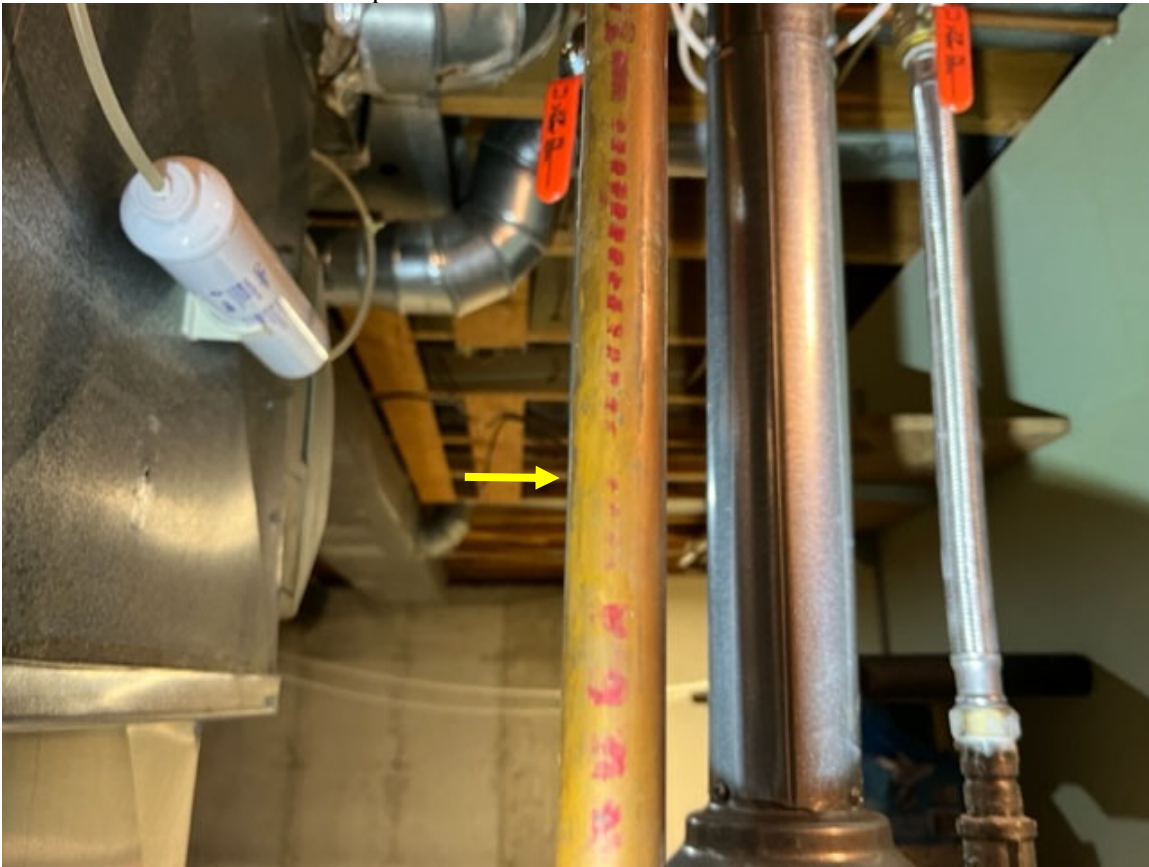
GAS METER:

**DEFECT:** Improper copper (water grade) pipe was used for the gas piping.  
Recommend replacement as needed.

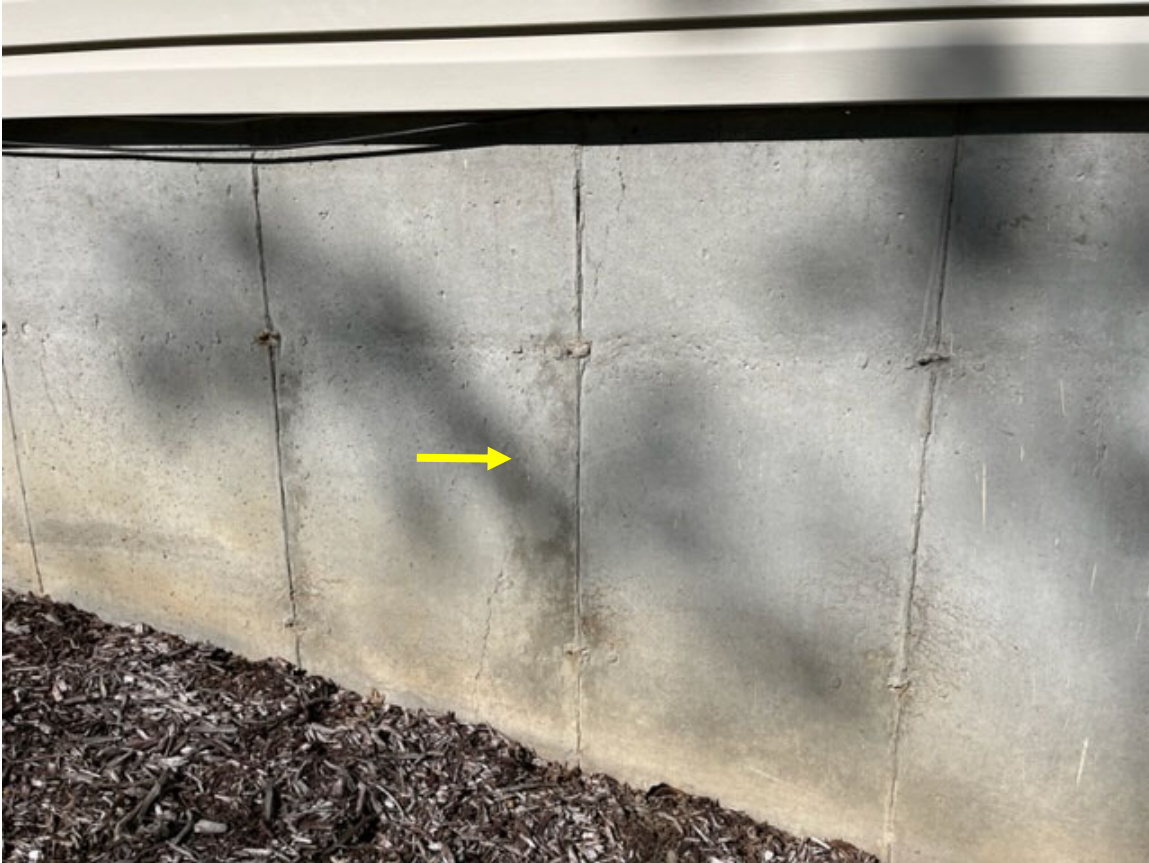
#### FOUNDATION:

Cracking was noted at the right side. Most foundations have some cracks. Vertical foundation cracks are common in concrete construction but are not usually considered structural significant. Cracks can be caulked from the exterior to prevent any water penetration. The area below grade however can be a source for moisture penetration. Recommend monitoring for future movement or leakage.

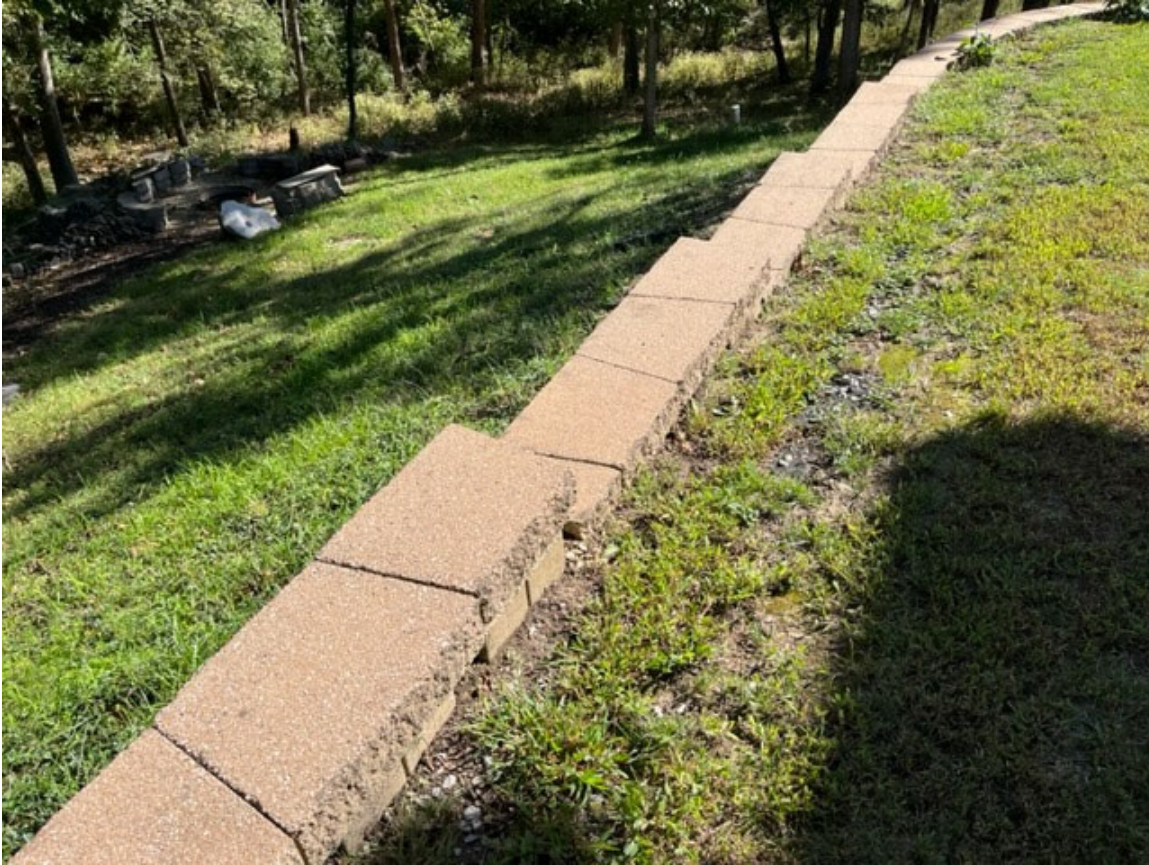
COMMENTS:

Portions of this property appear to be an addition to the original structure. Per our inspection agreement, we do not verify building permits. Although unable to verify, no drain tile was noted behind the retaining wall at the rear of the house. The retaining wall cap stones have not been properly glued or secured. Recommend review/repair as needed.

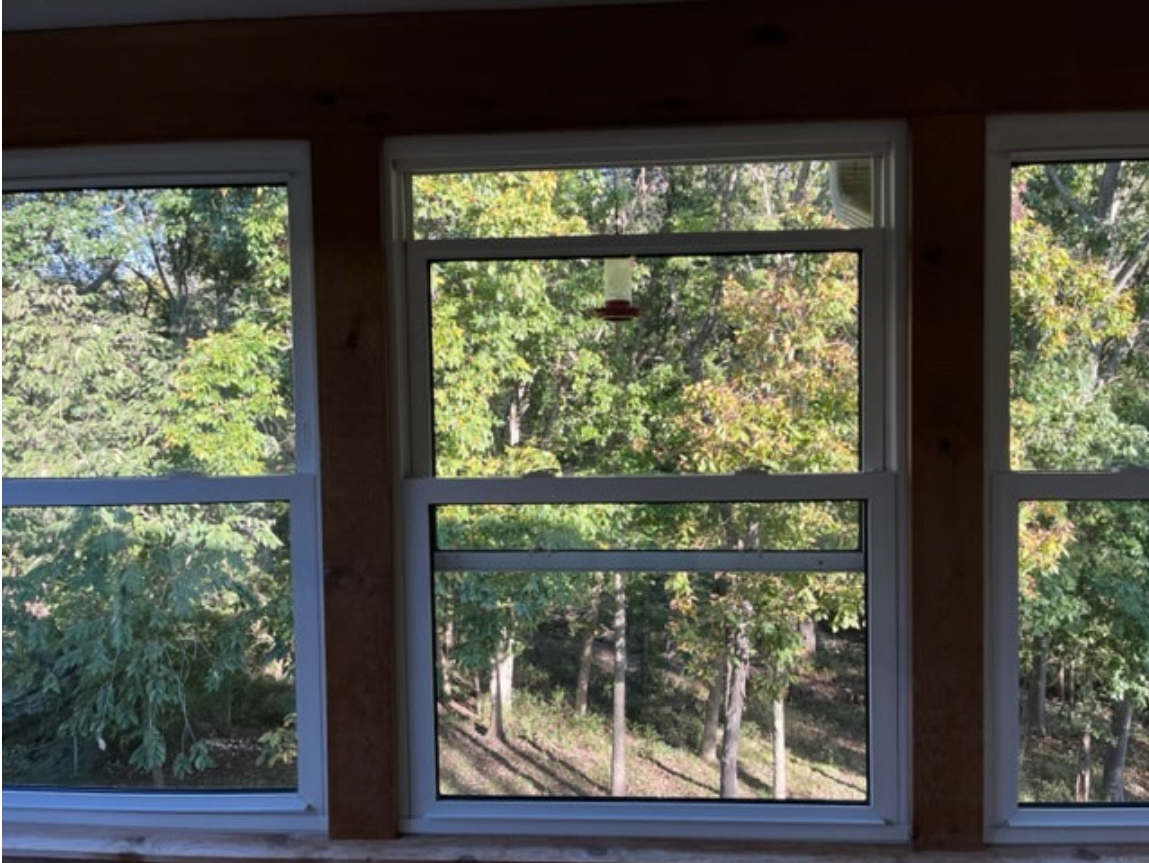
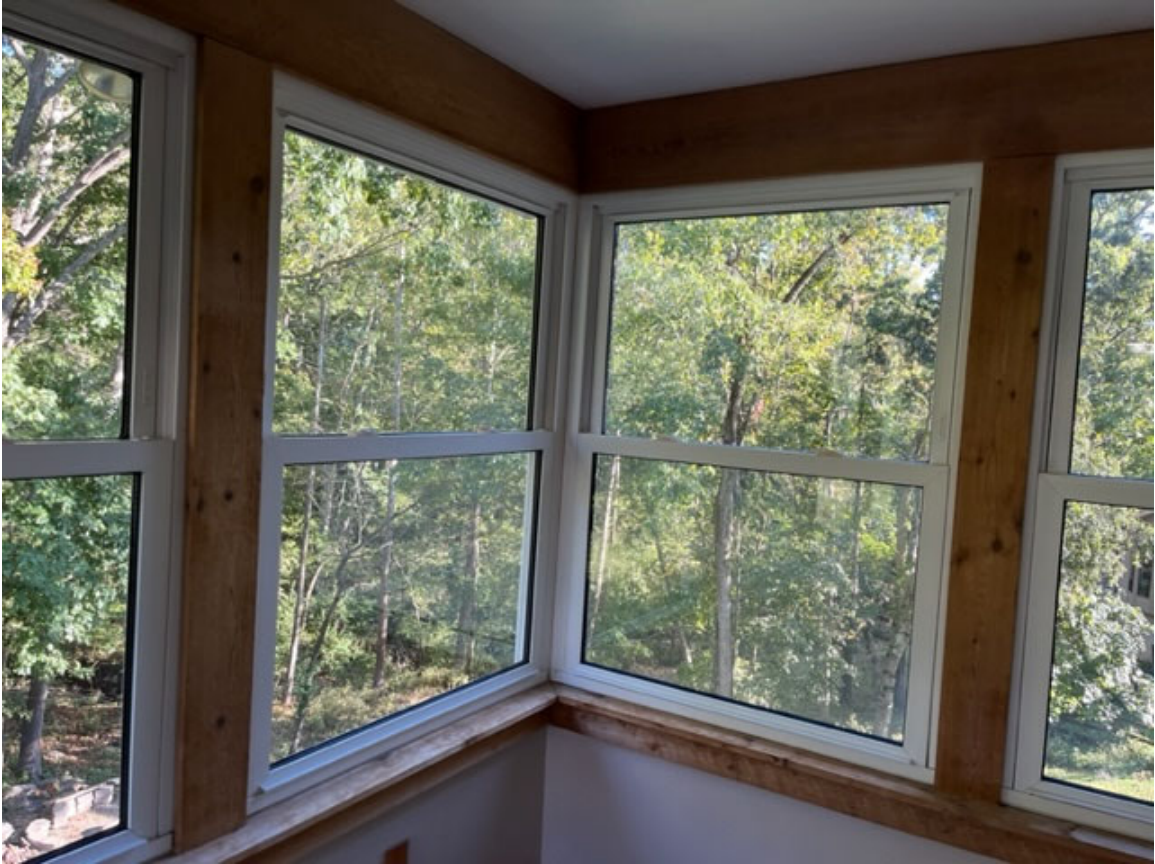
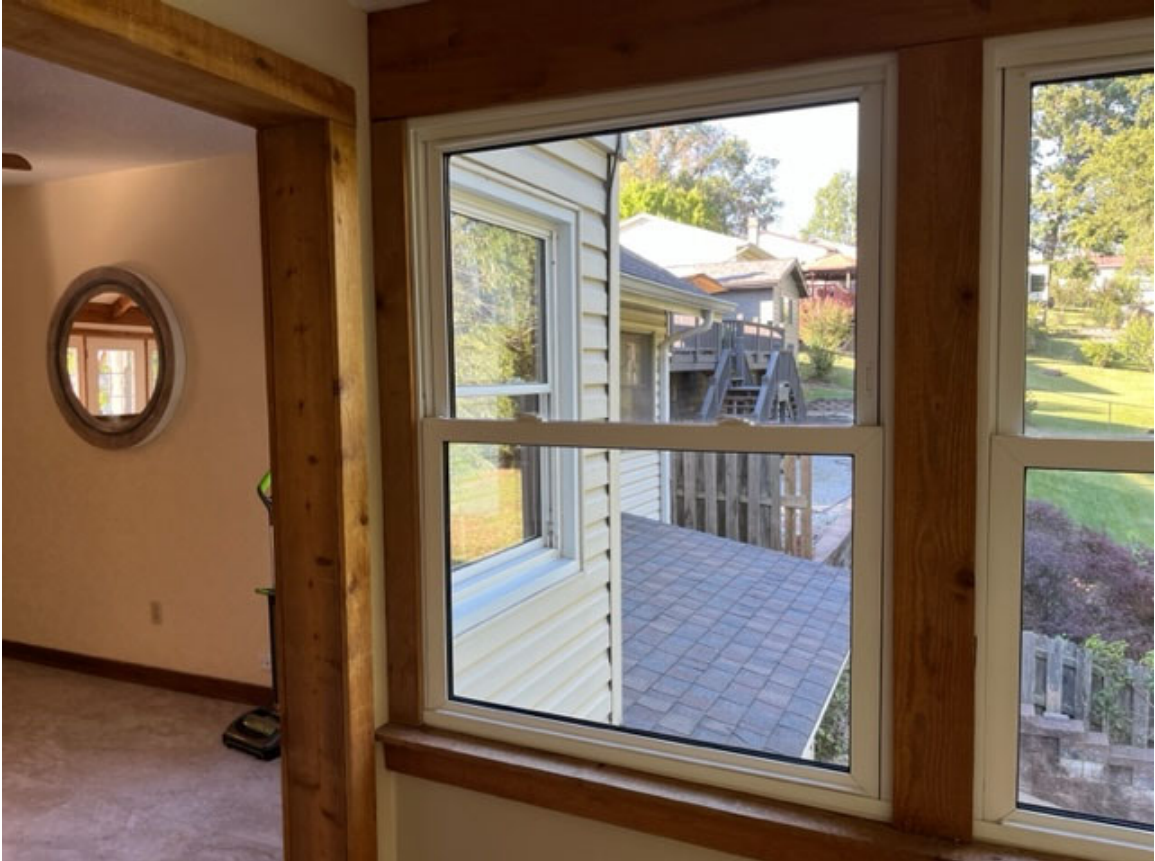
##### **WINDOW/SCREENS:**

Broken or worn spring/rope control noted at the window(s) front left and right rear. The spring/rope balances the window so that it operates properly and stays up when opened. The windows are stuck shut at the right rear. Recommend review/repair as needed.

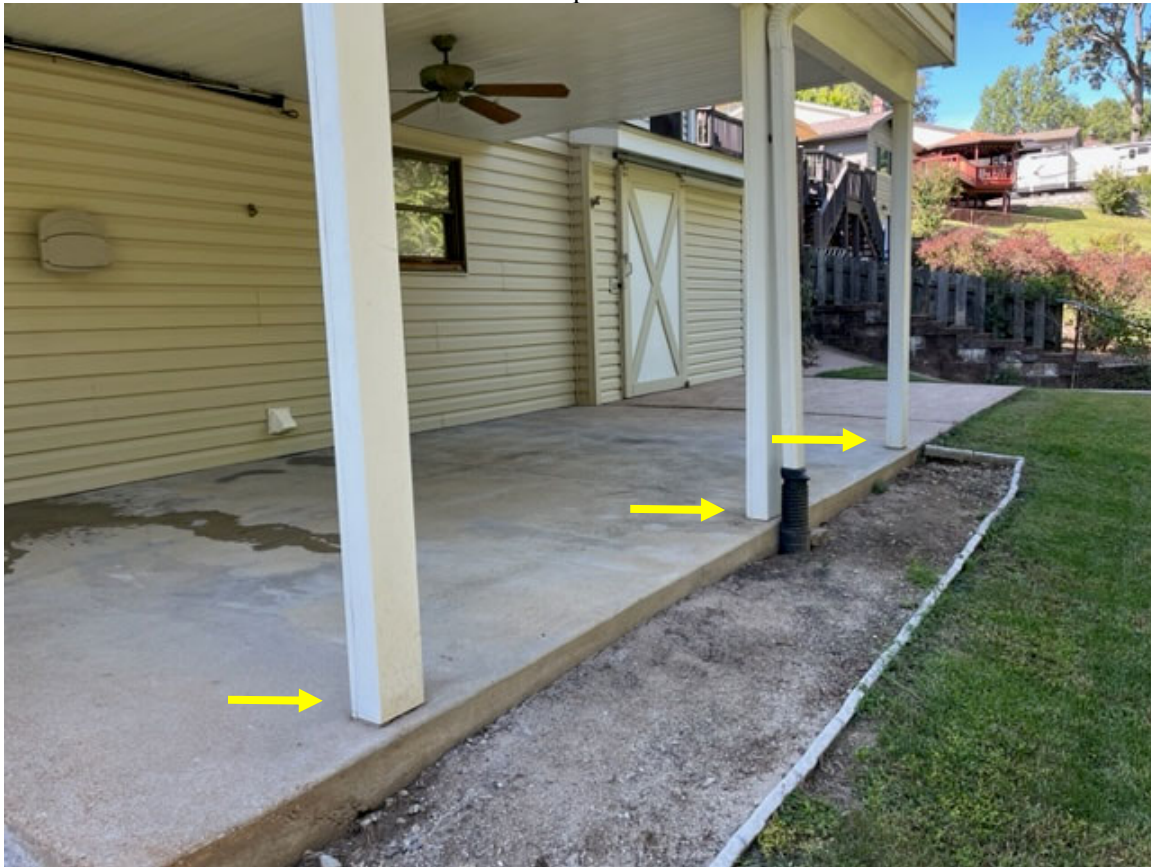
#### SUPPORT POSTS:

The posts are mounted on top of the patio; no notable piers present to support the addition. Recommend review/repair as needed.

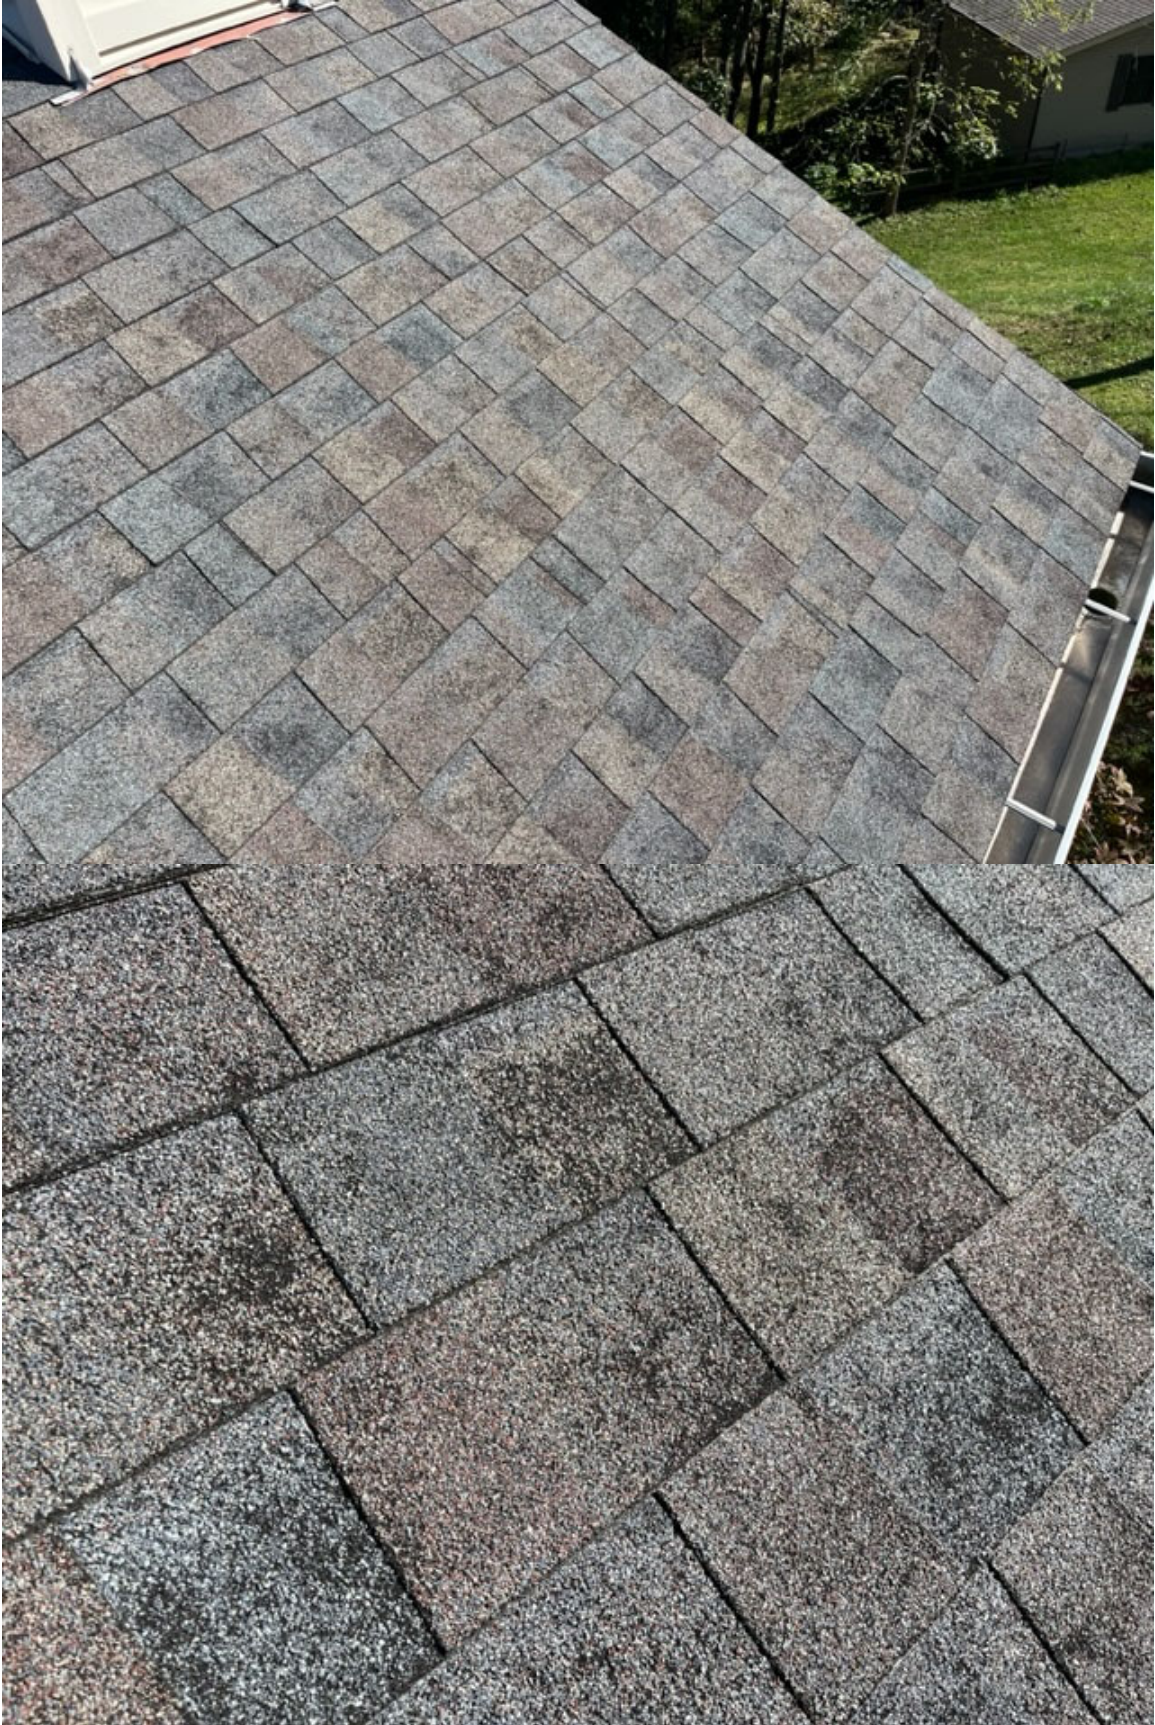
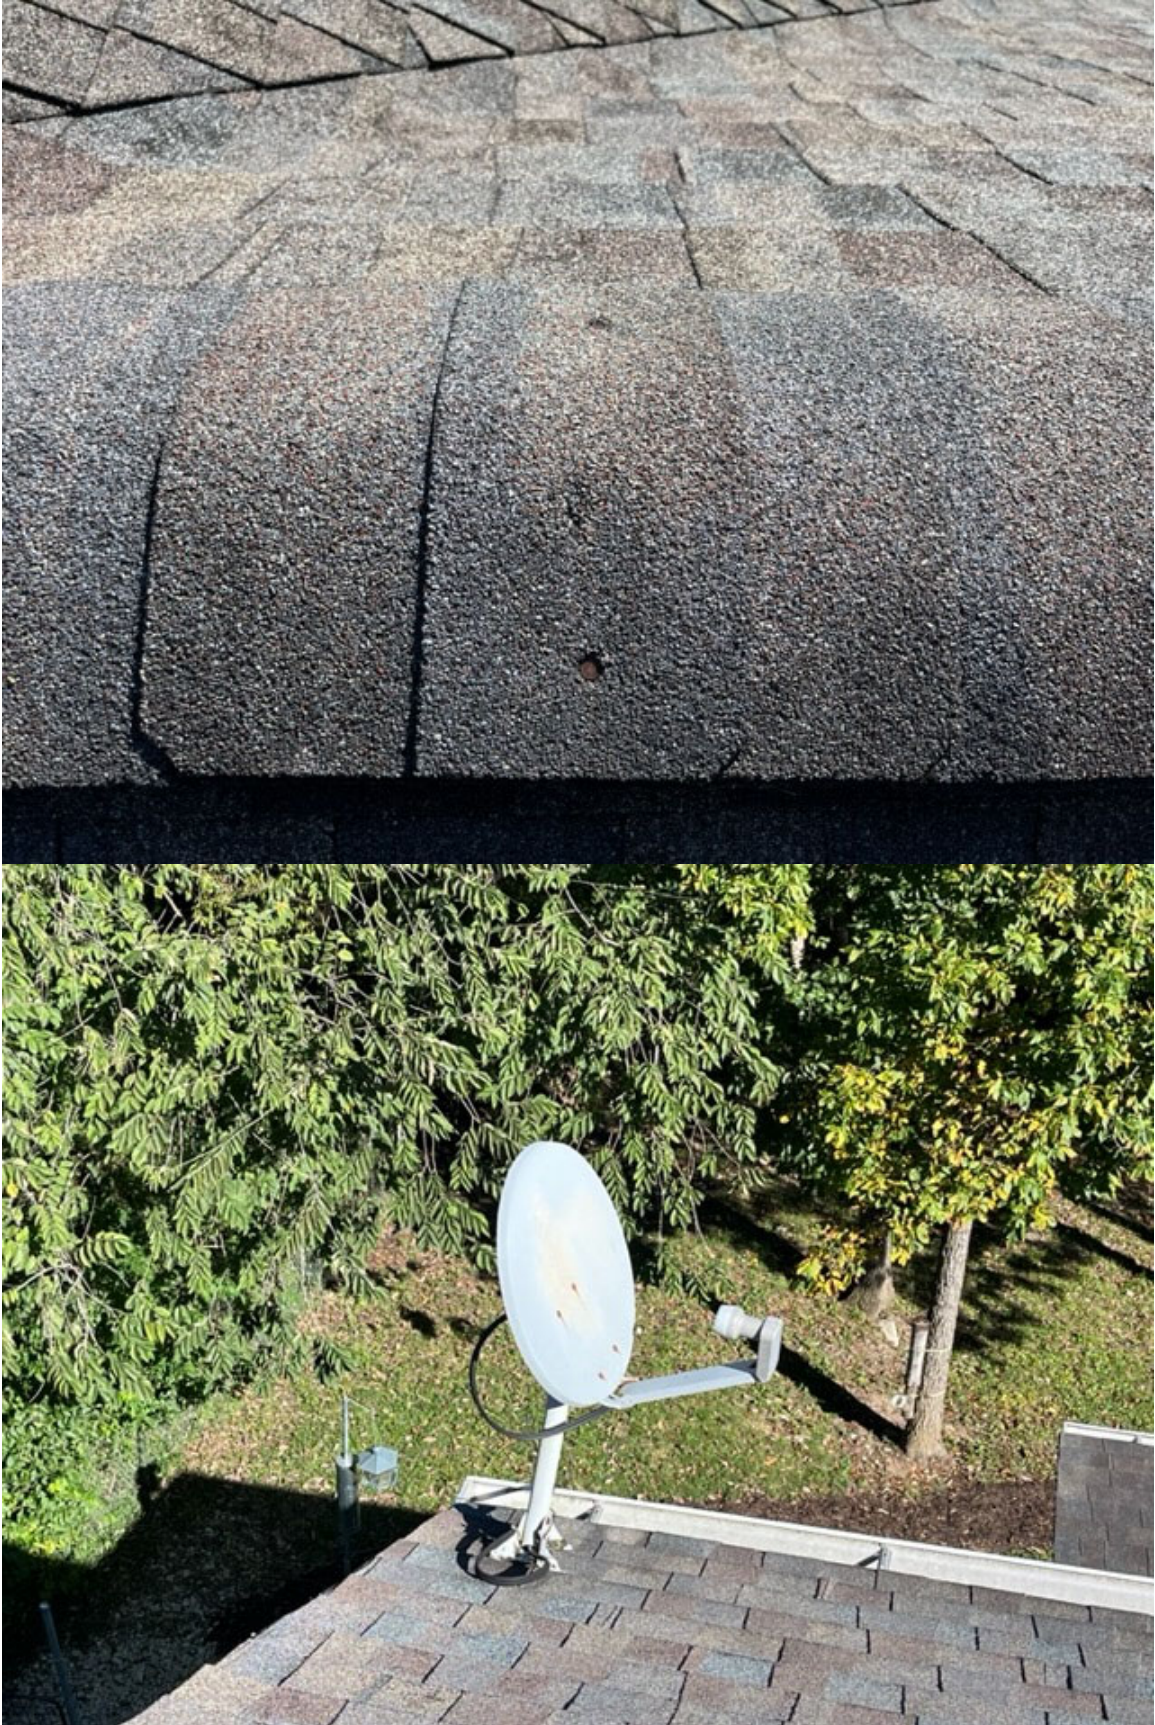
##### CONDITION:

The roof was visually inspected from all accessible areas. The roof appears to be a single layer covering. The average life span for a roof of this type is 15-25 years. The roof does show signs of wear (cupping, curling, cracking and loss of granule material) indicating that the roof covering is in the later stages of its serviceable life. The estimated remaining life is less than 5-7 years.

Some high/exposed nails were noted on the roof. The satellite is mounted to the roof. This area may require additional maintenance.

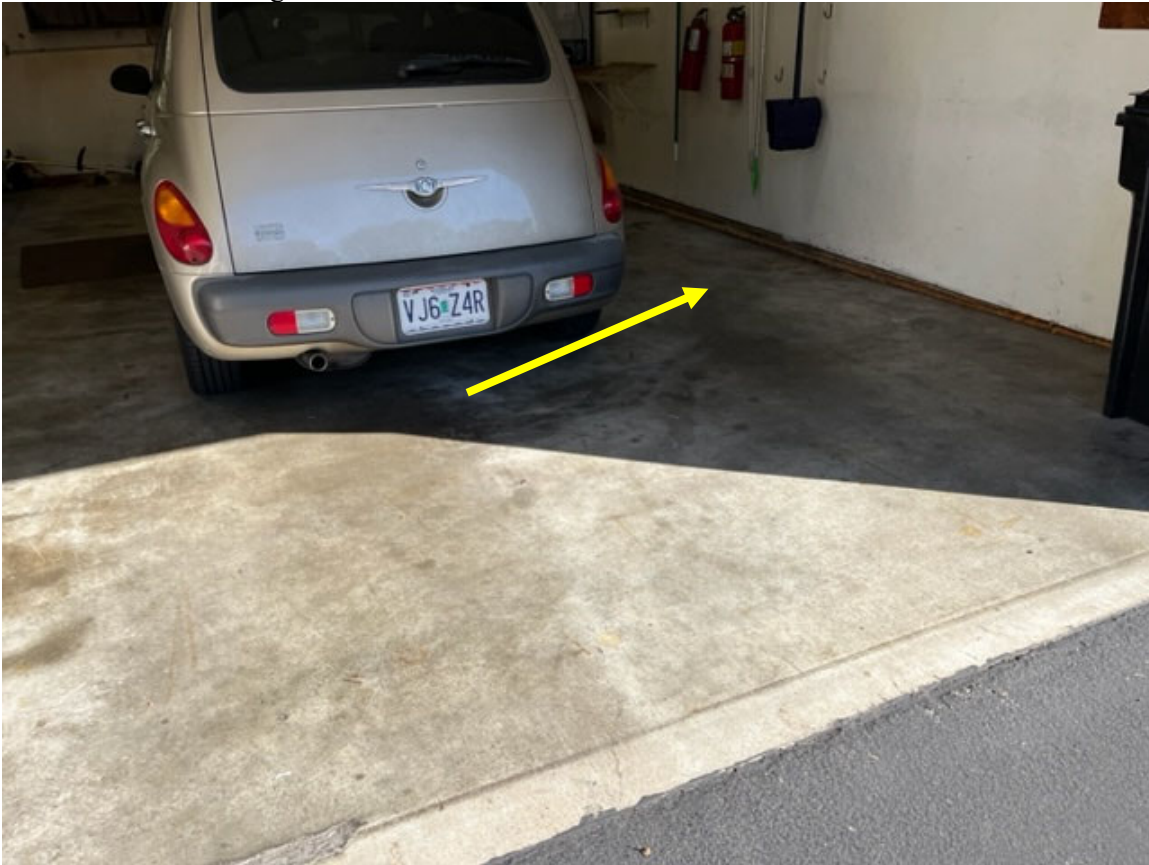
### FLOOR SLAB:

Settling noted.

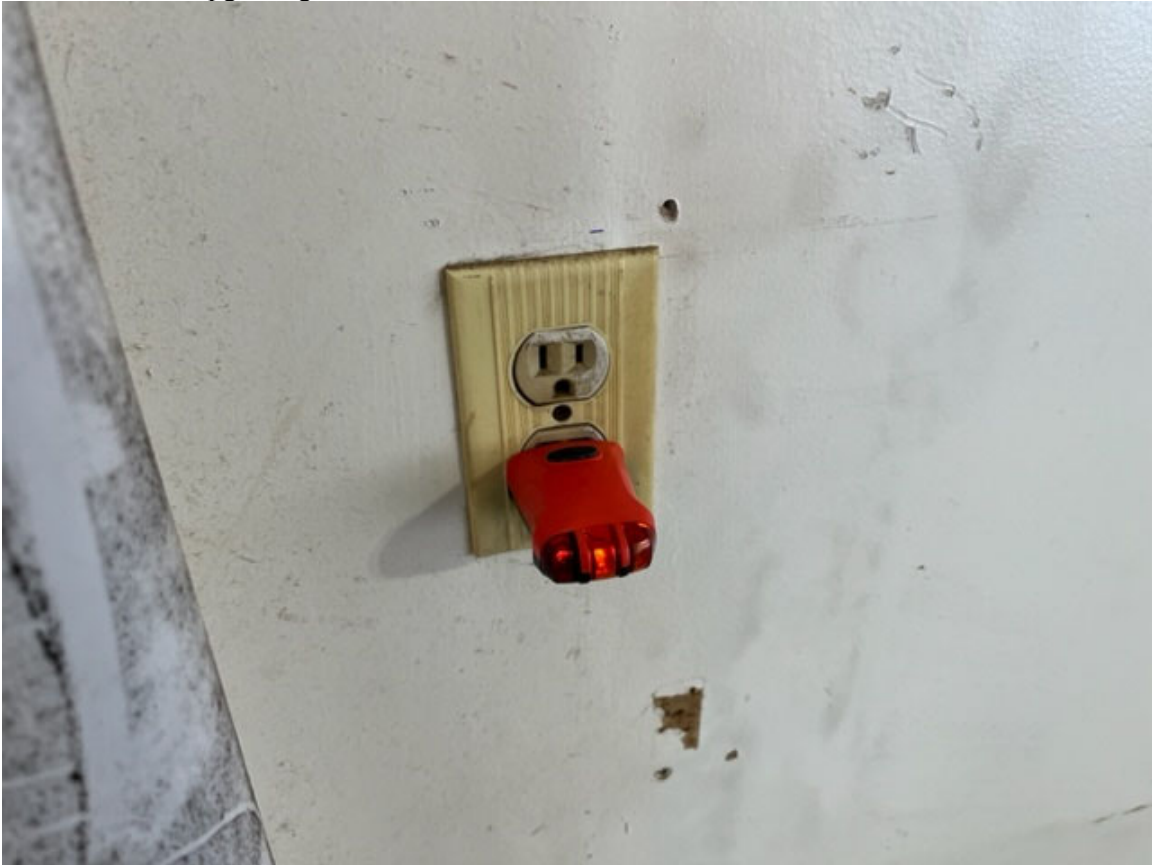
### DOOR OPENER:

This door is an older model and does not appear to be equipped with a safety reverse device. Client may want to consider upgrading to a newer model.  
Recommend review/repair as needed.

**DEFECT:** No GFCI protection noted at the garage outlets right rear, recommend upgrading to GFCI near water sources.

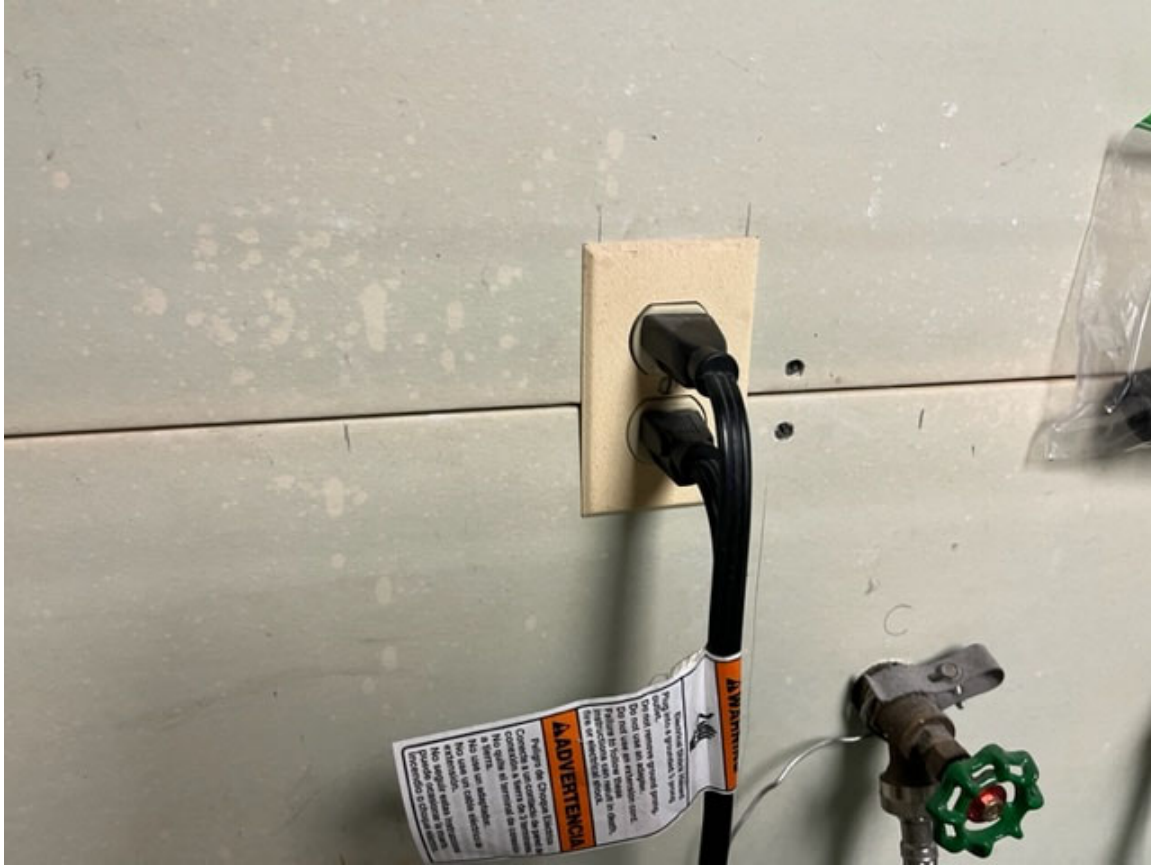
### ELECTRICAL:

**DEFECT:** No GFCI protection noted, recommend upgrading to GFCI near water sources for safety (this may not be a code requirement in some areas). Recommend review/repair as needed.

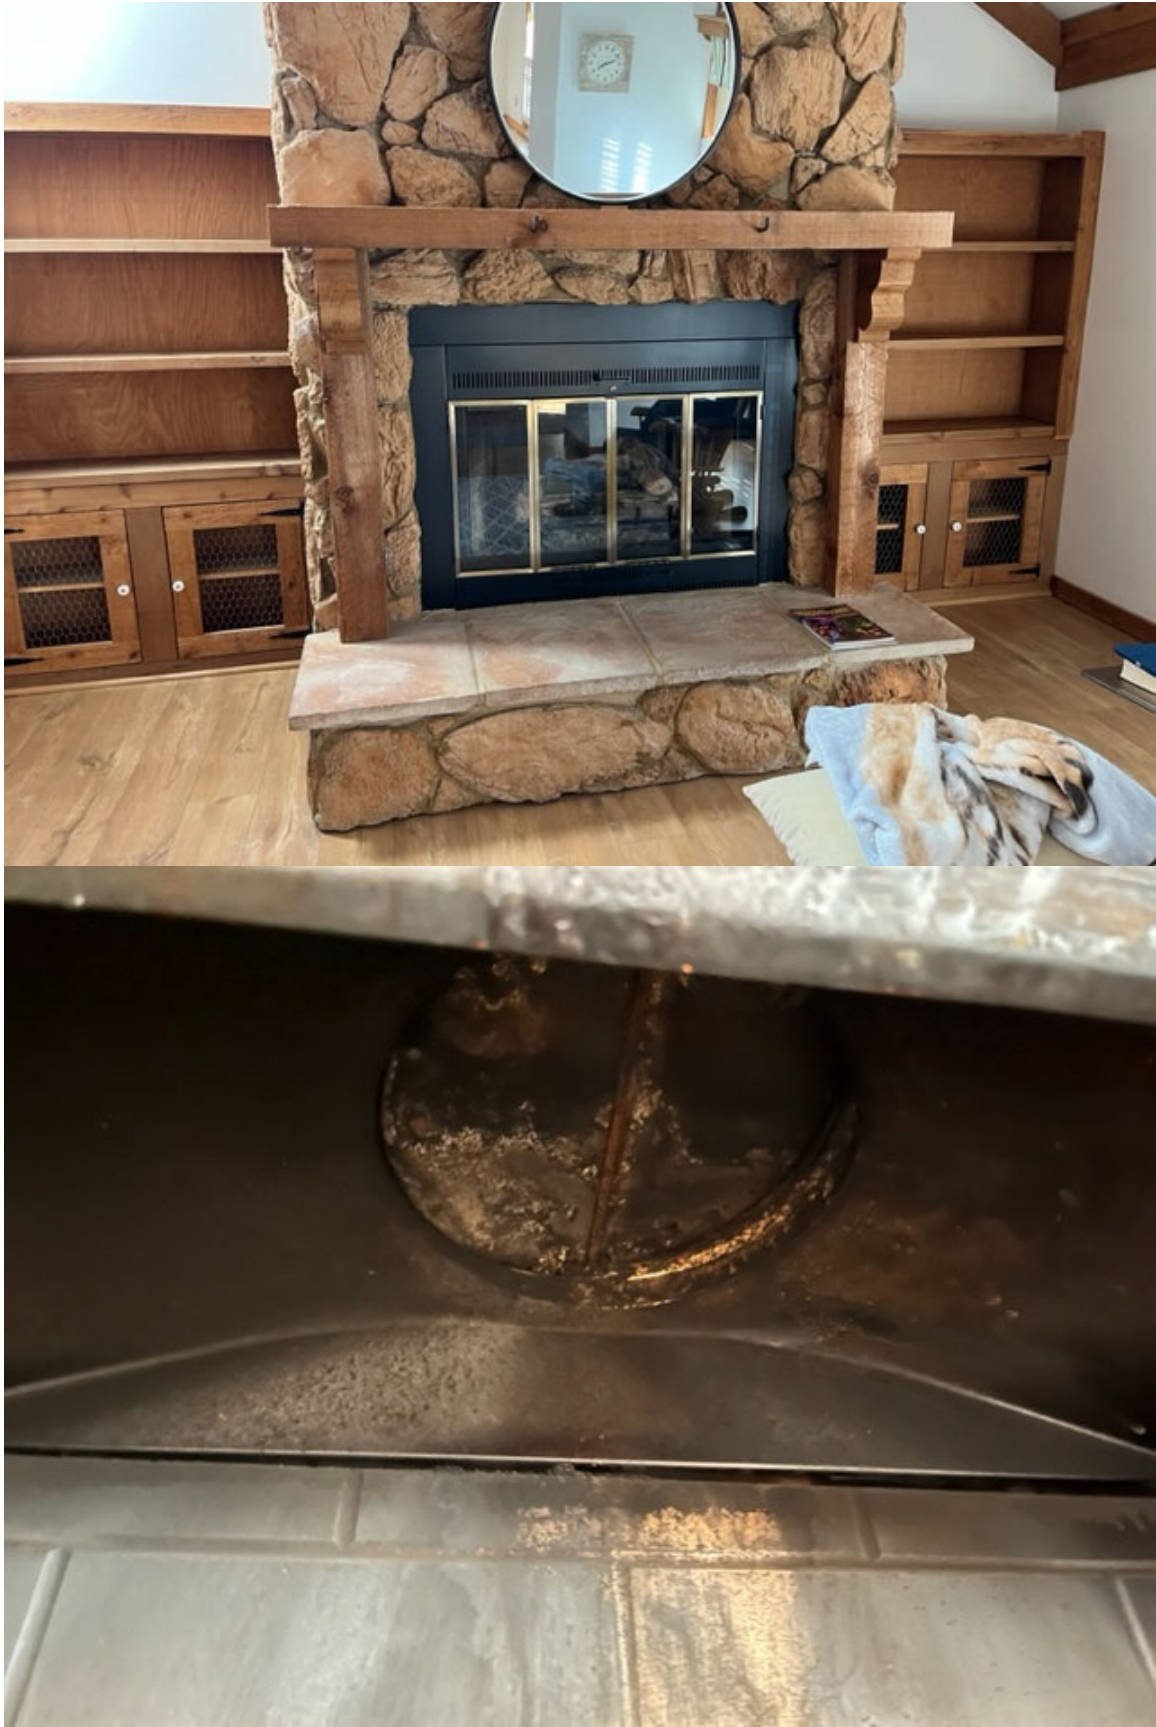
### FIREPLACE:

The fireplaces are serviced with gas logs. Recommend review of the manufacturer recommendations for use and warnings. The damper was inoperable at the time of inspection. Recommend seasonal cleaning. Gas logs should have a gas damper block installed at the damper to allow any seeping gas to vent to the exterior. The pilot was off at the time of the inspection; we do not restore power or light pilots on appliances. Recommend having the unit operational prior to closing. Some minor cracking/deterioration was noted in the stone liner in the fire box. Replacement of the stone is recommended for safety.

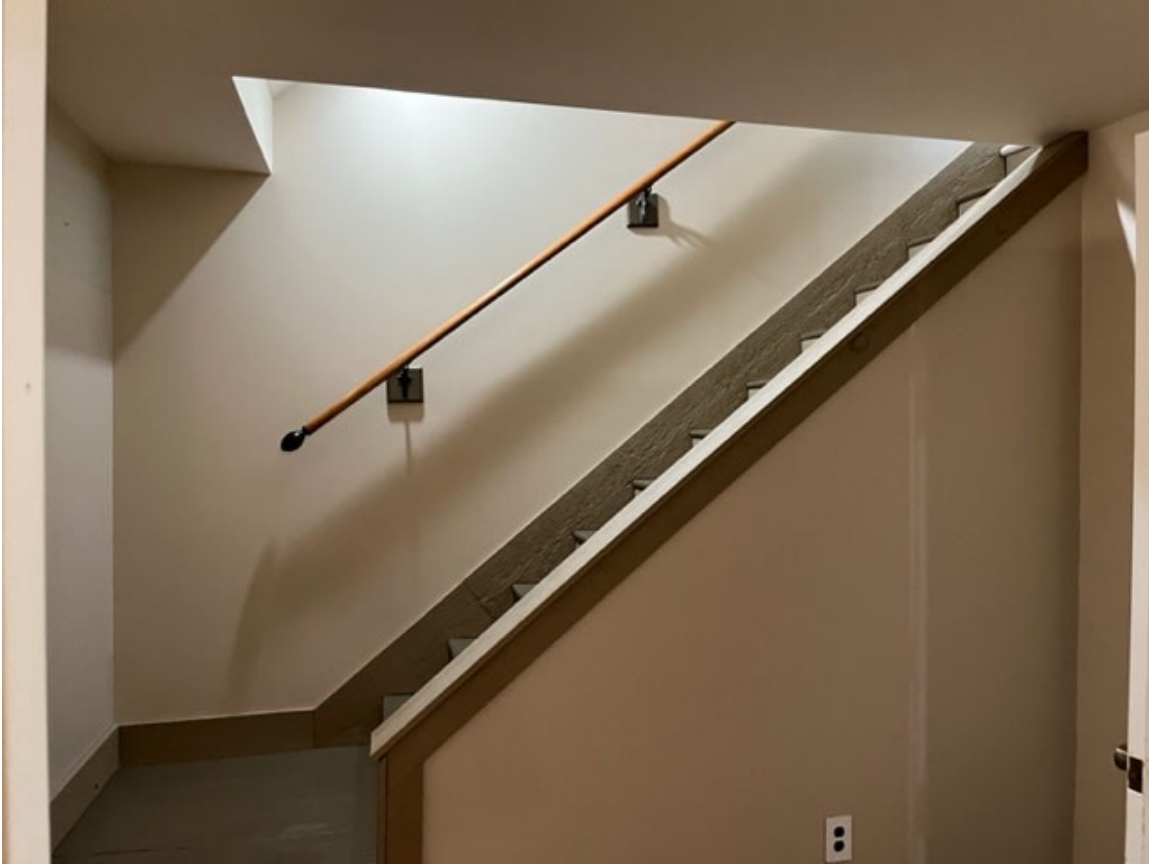
### STAIRS:

Missing guard rail(s), possible safety hazard. Recommend review/repair as needed.
