# ***C. & D. Construction Consultants***

Inspector Name: Bob Reese; ASHI Member 205092  
Inspection No: 24100212  
Inspection Date: 10/2/2024  
Client: Robin Mennel & Sidney Rens  
Address: 5874 Birch Hollow  
St. Louis, MO 63129

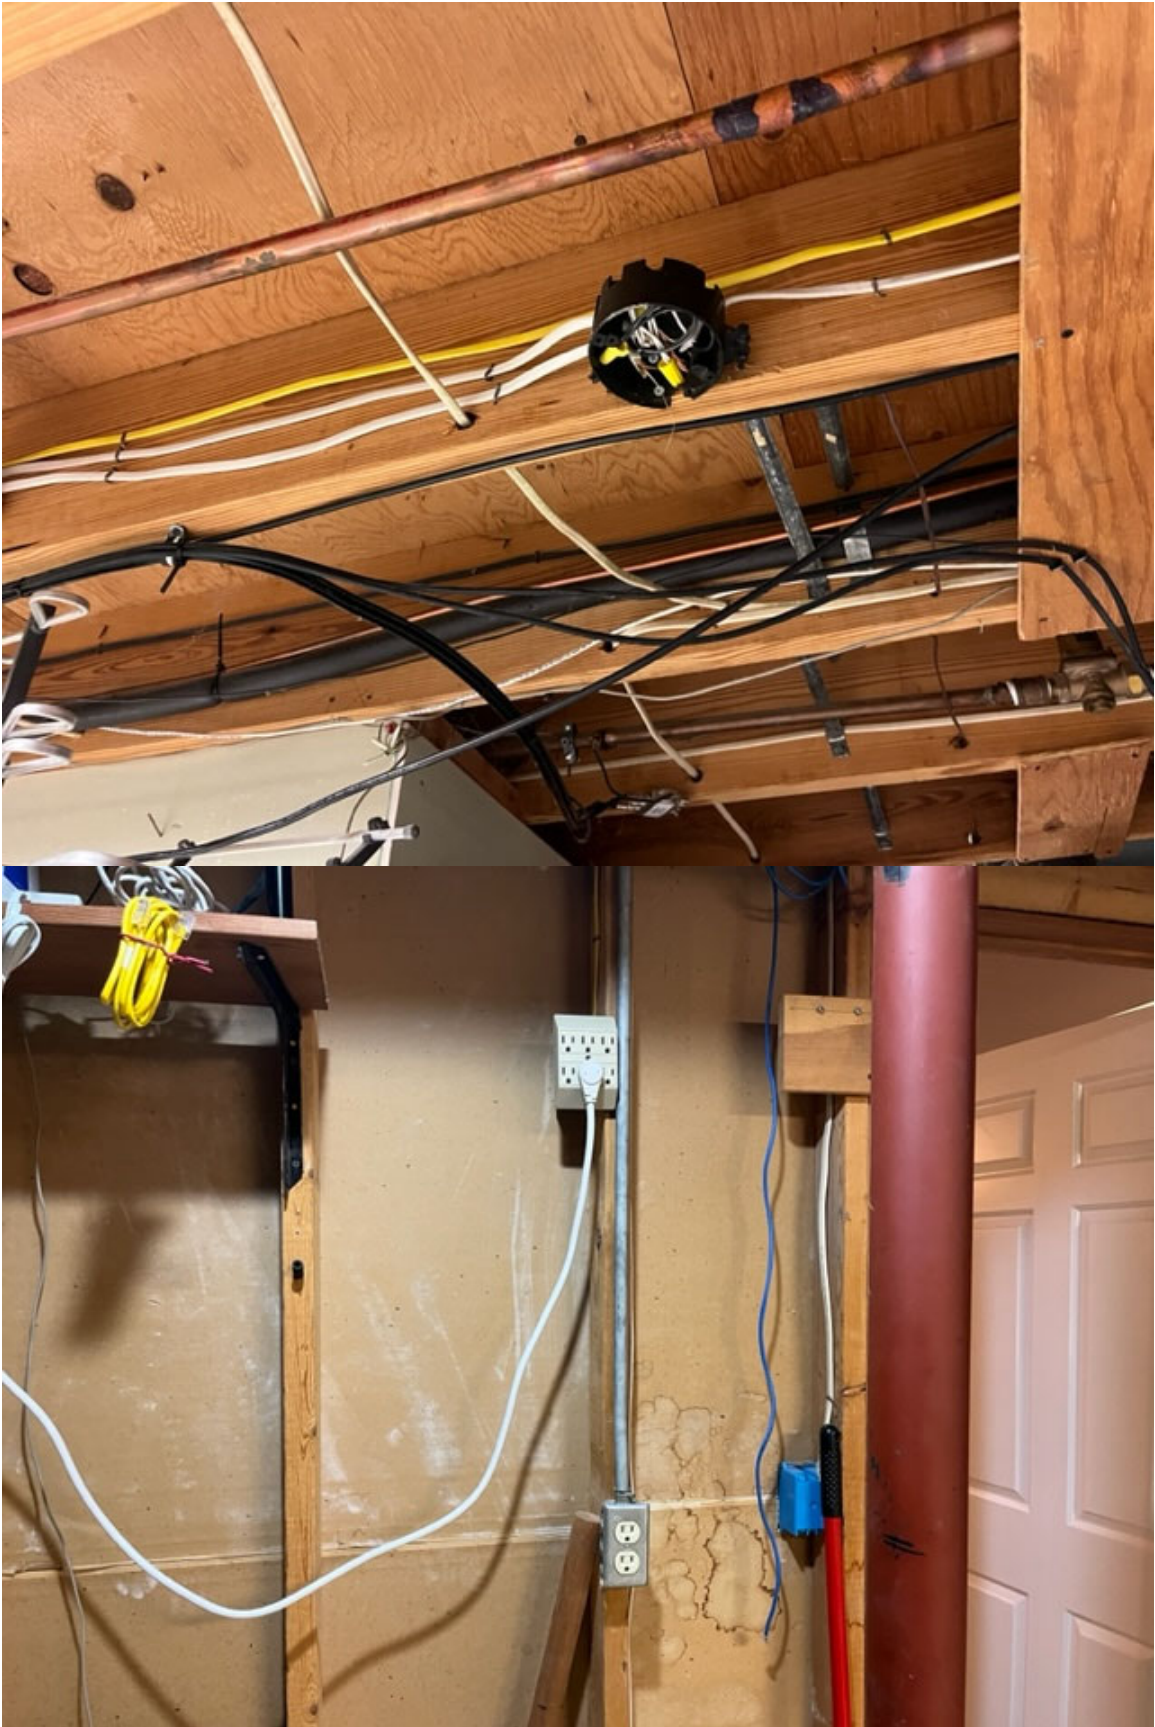
### ELECTRICAL:

**DEFECT:** No GFCI protection noted at the basement outlets at the unfinished area, recommend upgrading to GFCI near water sources. Open junction box(es) noted at the laundry area. Recommend installing a cover plate. Recommend review/repair as needed by a licensed electrical contractor.

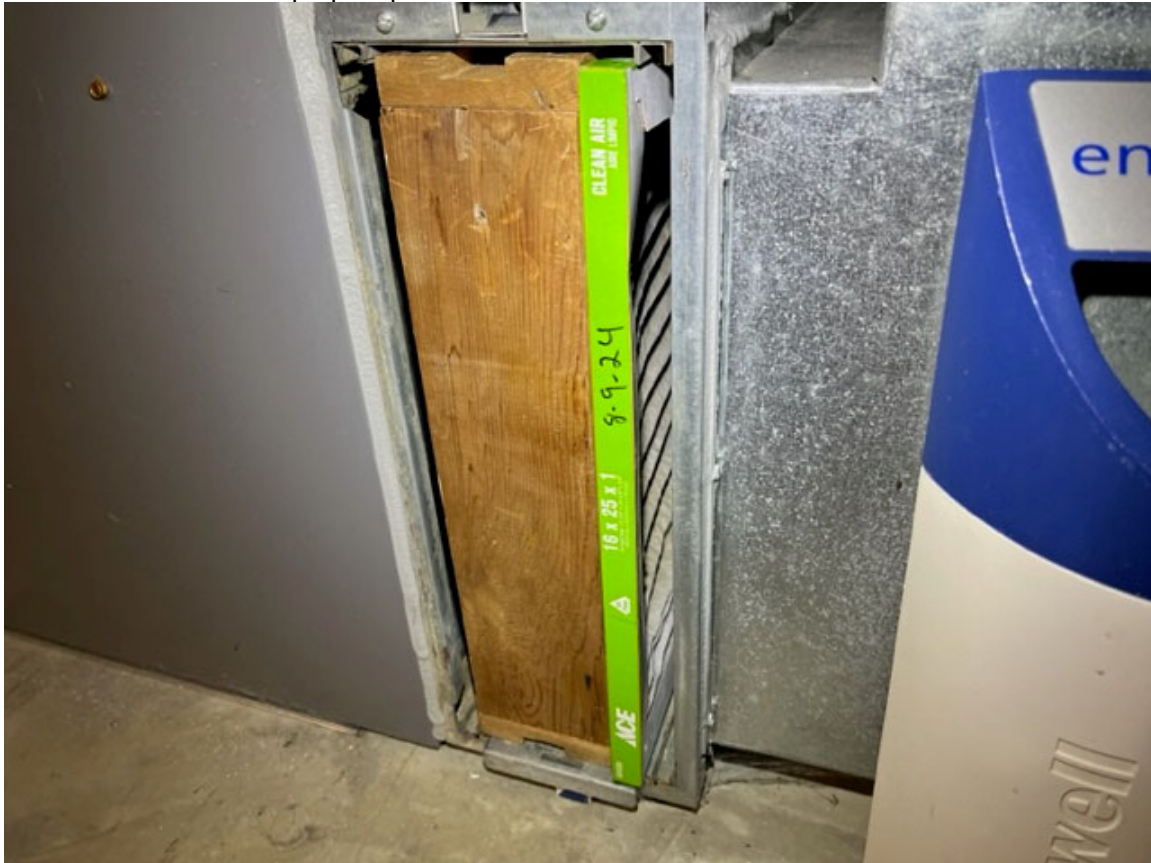
**FILTER:**

Styrofoam was noted on walls as insulation. When styrofoam burns it gives off toxic fumes and is considered a safety hazard.

The filter size is 16x25x4 or electronic filter noted. Recommend replacing ensures proper operation and air flow.

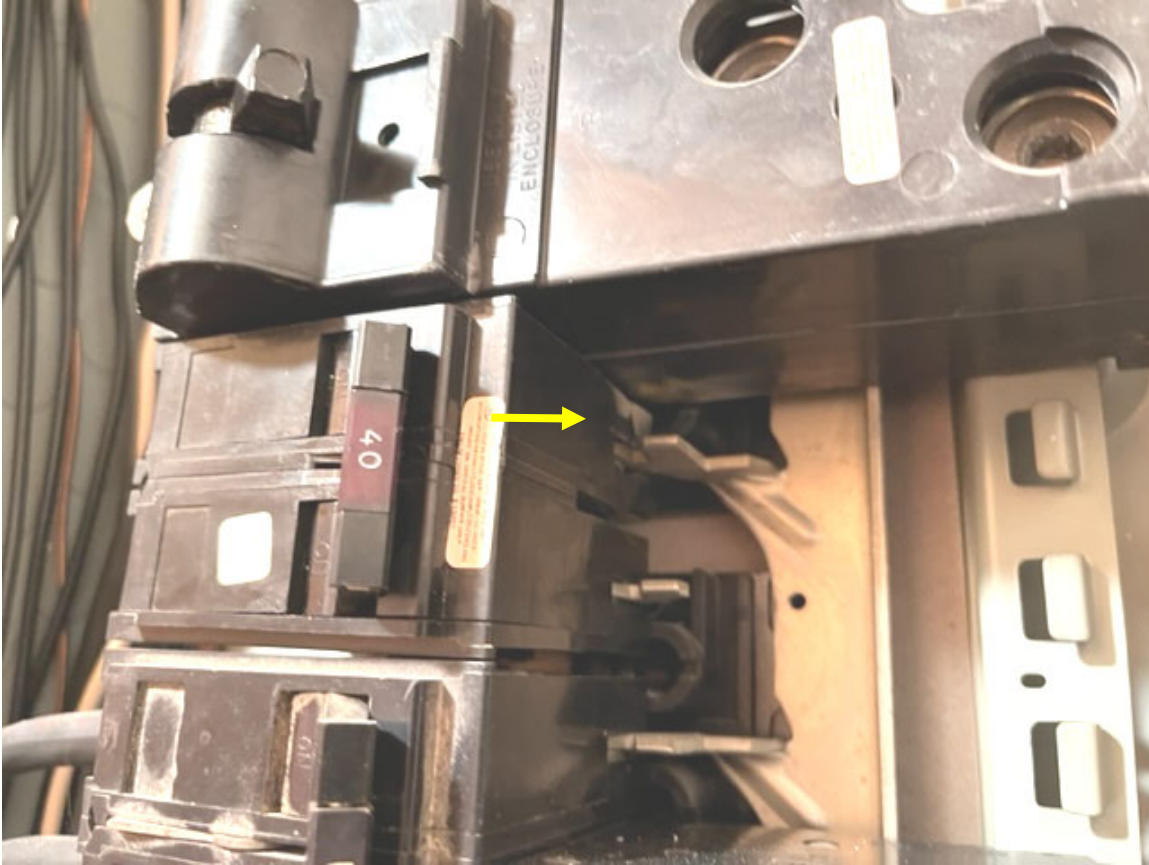
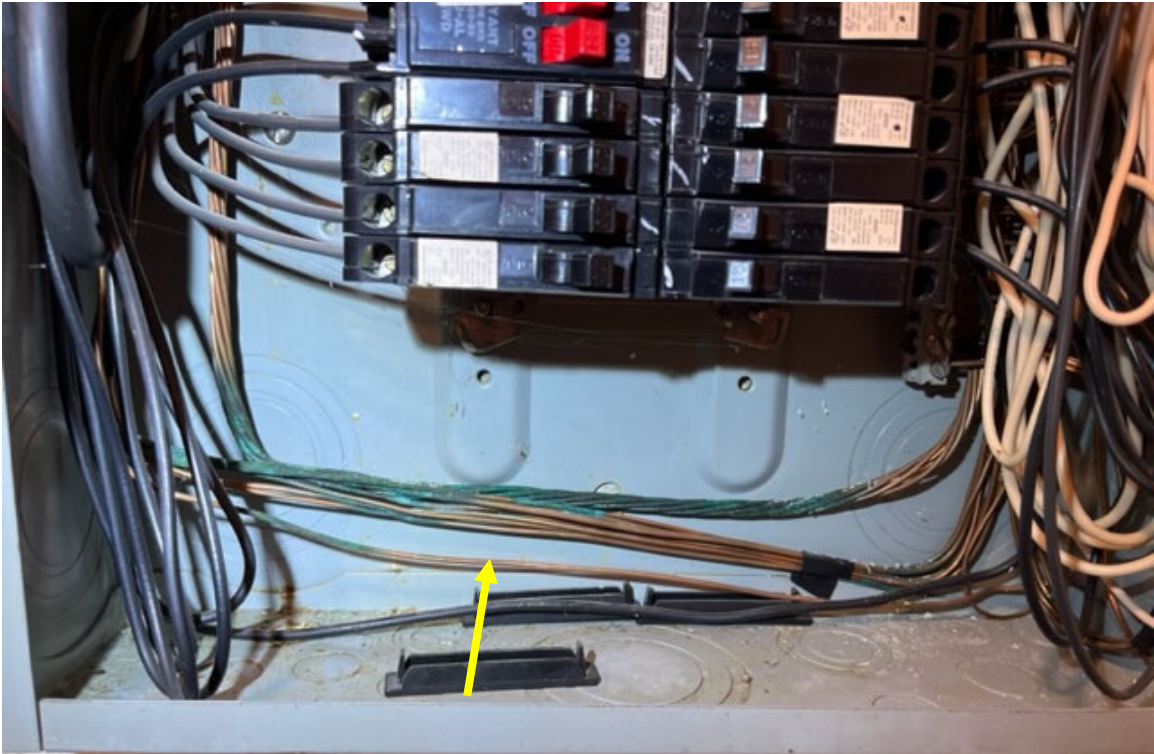
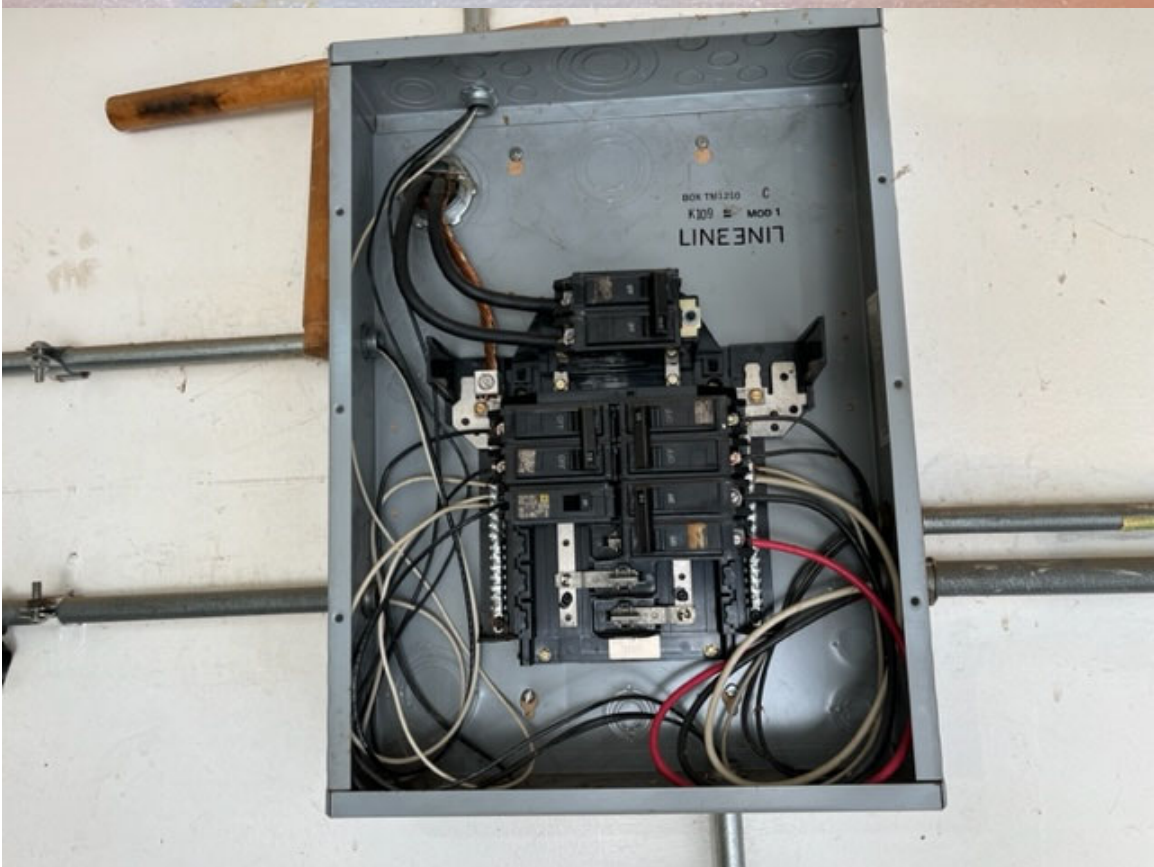
### MAIN PANEL:

**DEFECT:** Damaged burnt wires, breakers or panel components were noted in the panel; arcing was noted at the bottom of the main breaker. Corrosion and deterioration was noted at the ground wires at the bottom of the panel. Some of the breakers in the panel are not the same manufacturer as the panel, unable to determine if they are compatible; this may be a safety hazard. The ground and neutral are not properly separated in the sub panel. The sub panel is mounted higher than allowed by most standards of 6'7" (79"). Recommend review/repair as needed by a licensed electrician.

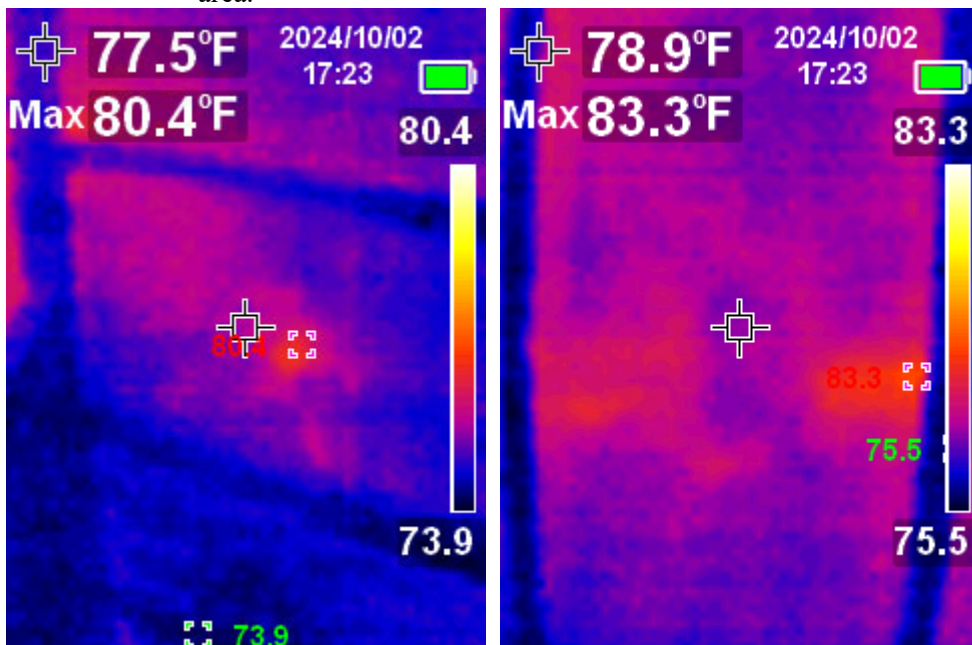
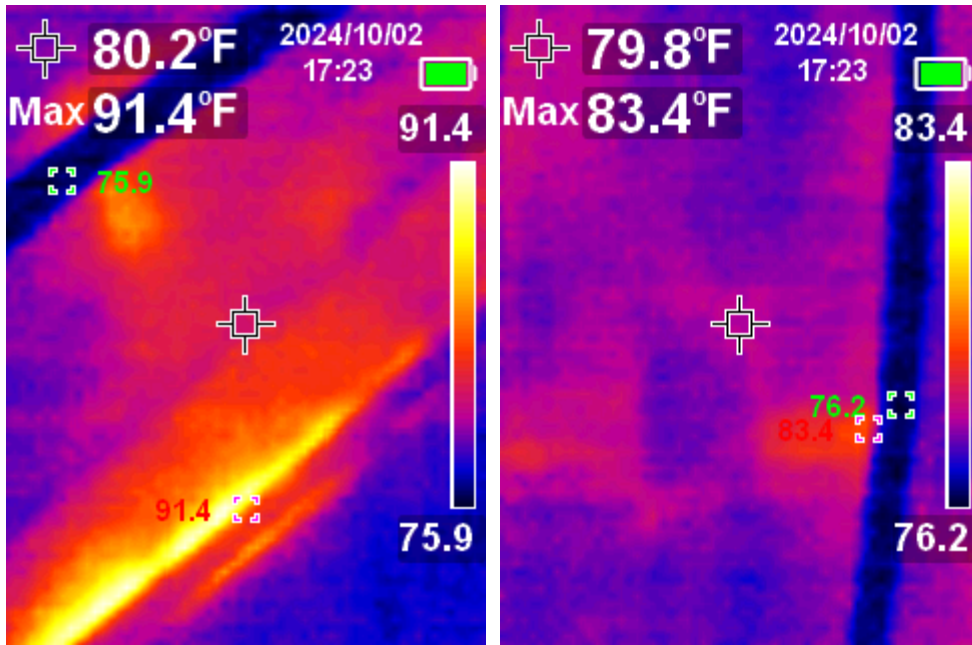
### CEILING:

Hot/cold areas were noted with a FLIR camera on the interior walls and/or ceiling at the living/dining room area. Recommend additional insulation in this area.

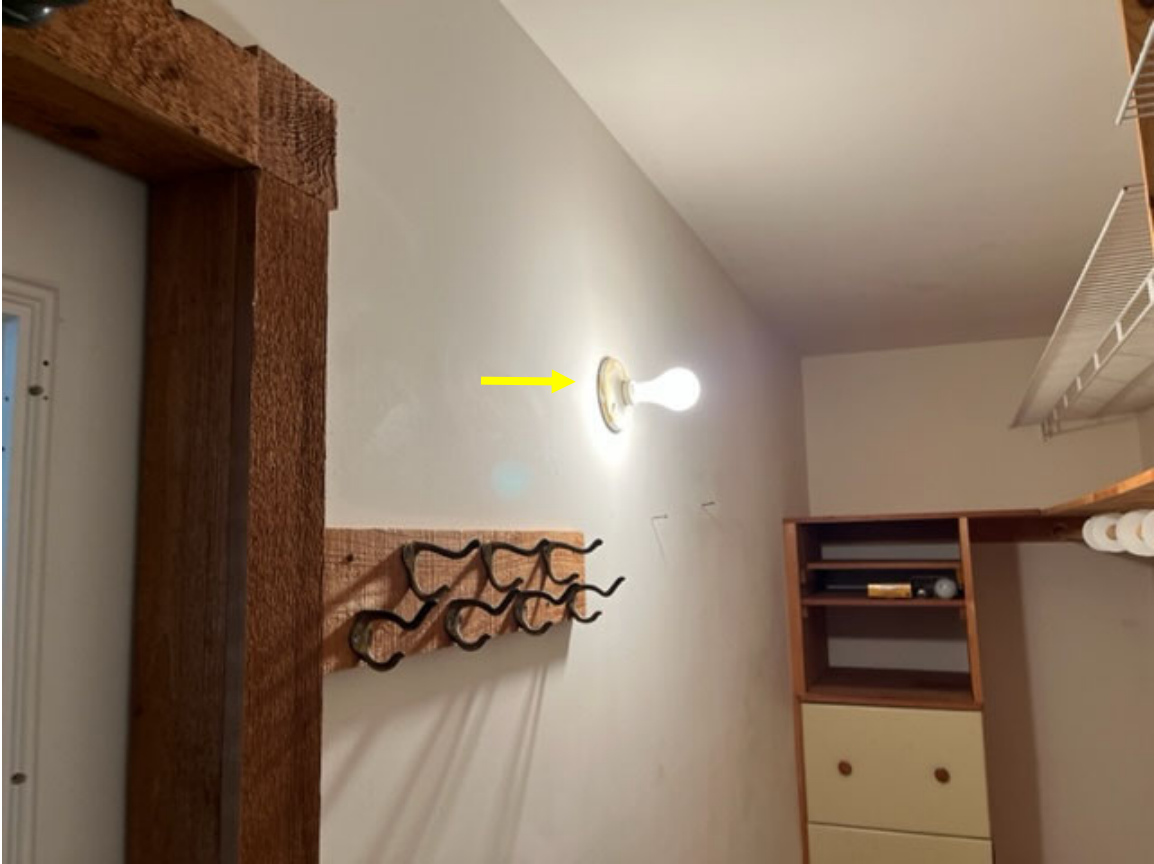
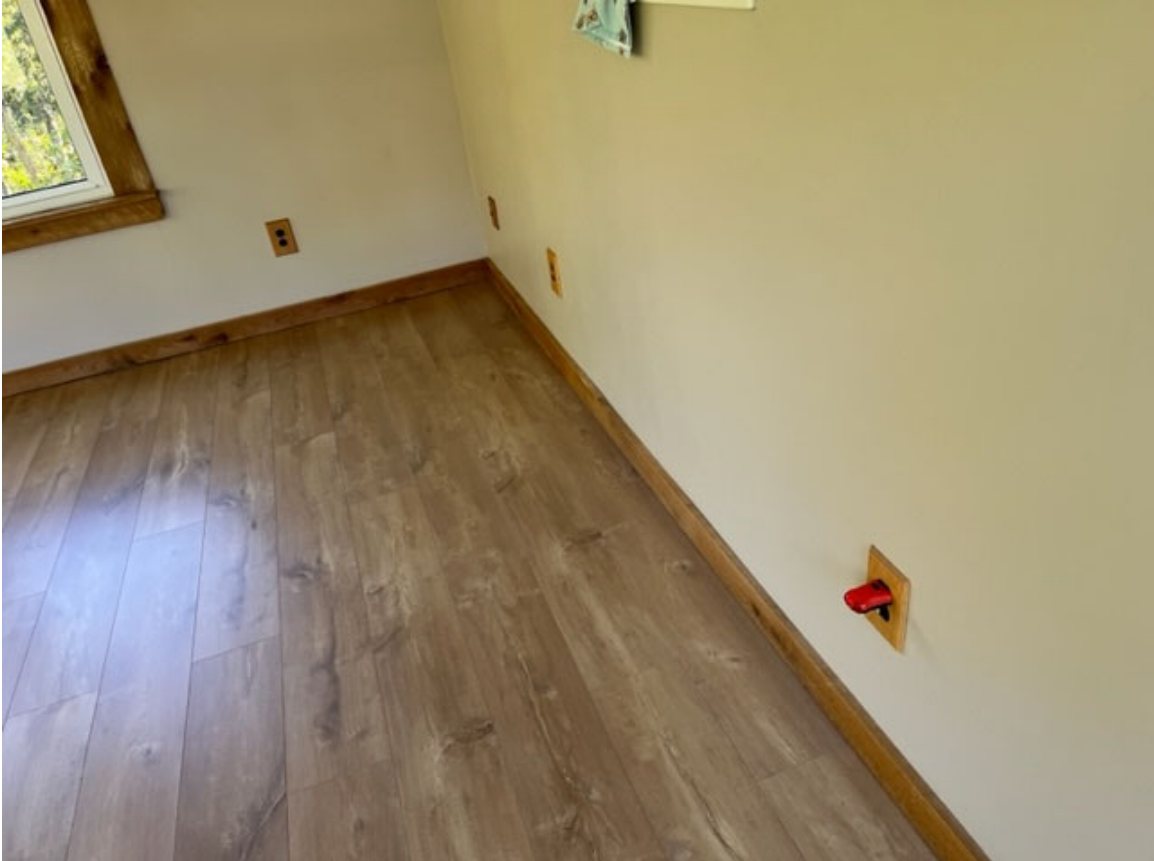
**ELECTRICAL:**

**DEFECT:** Reverse polarity noted at various outlets throughout the house; (hot and neutral wires reversed). No globes were noted on the closet light fixtures; this does not comply with some standards. Recommend review/repair as needed by a licensed electrician.

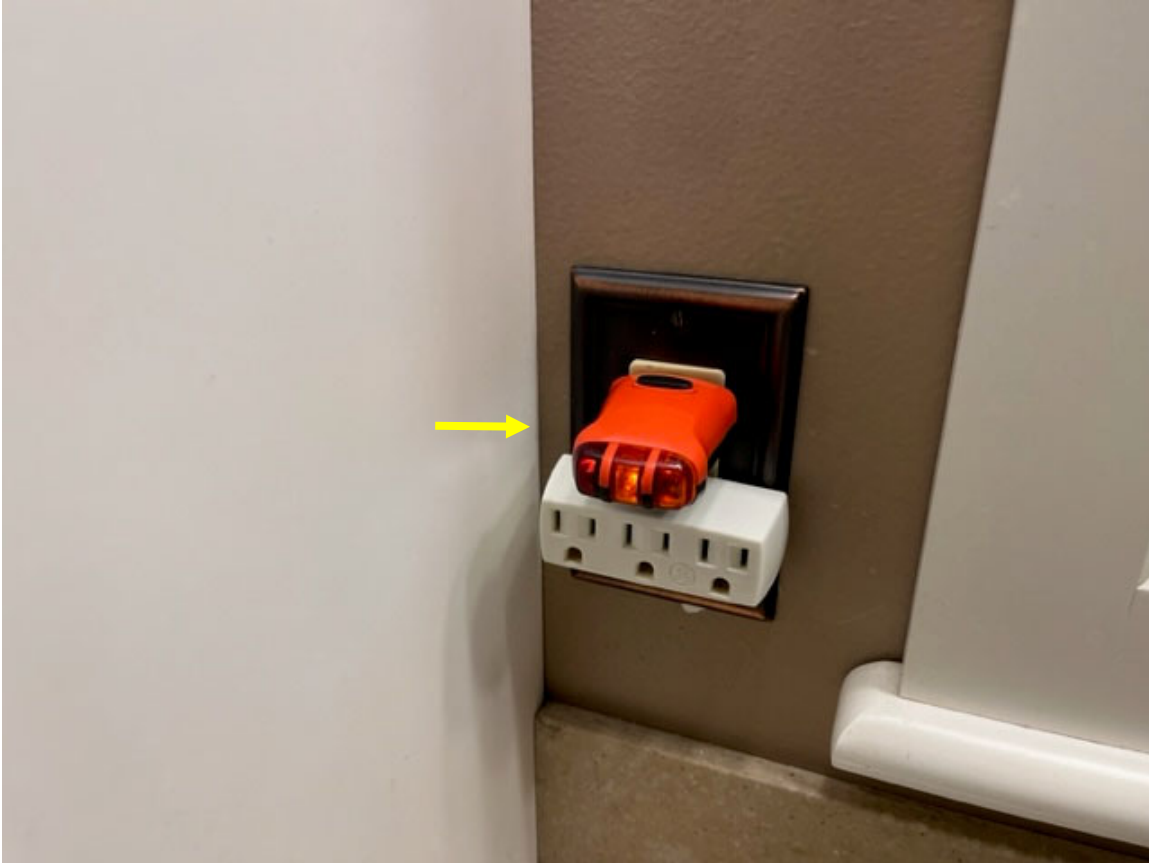
ELECTRICAL:

**DEFECT:** The GFCI protection was not operational at the basement bathroom; reverse polarity noted. Recommend review and replacement as needed.

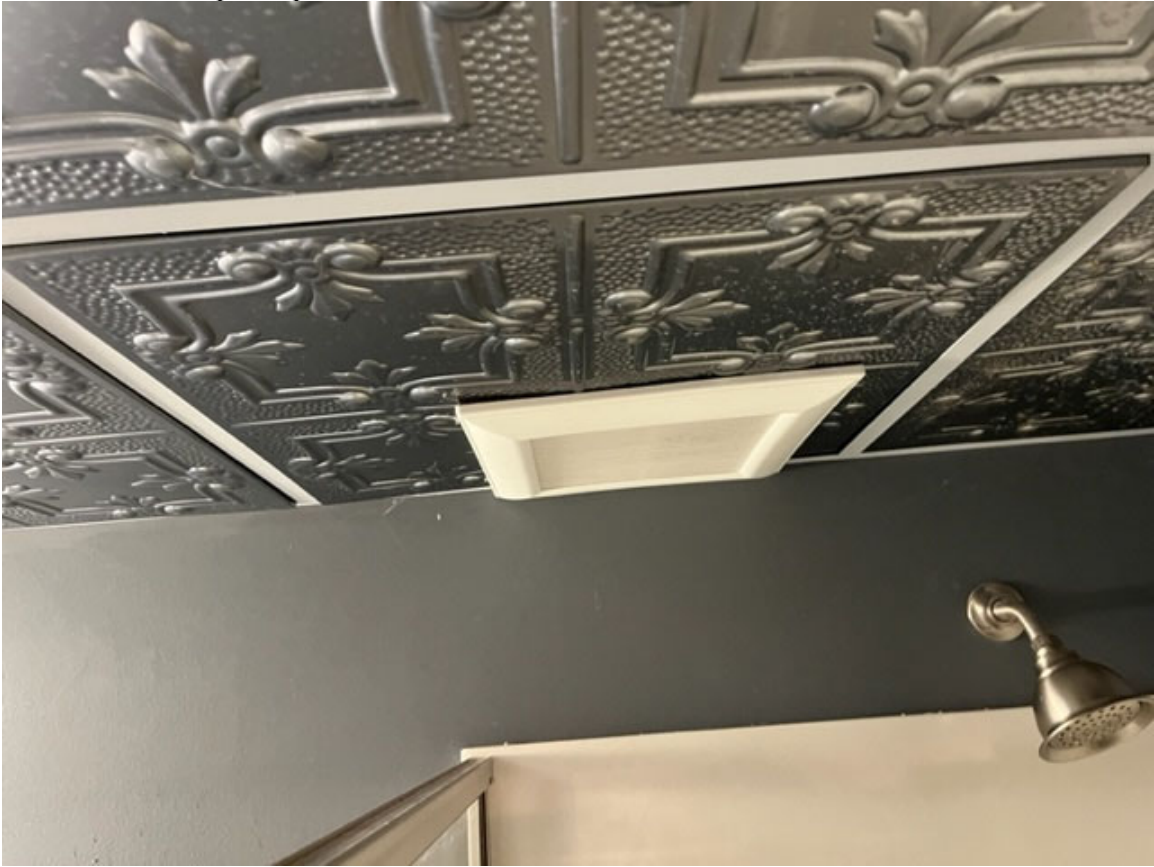
EXHAUST FAN:

Inoperable at the time of inspection at the basement bathroom. Recommend repair/replace as needed.
