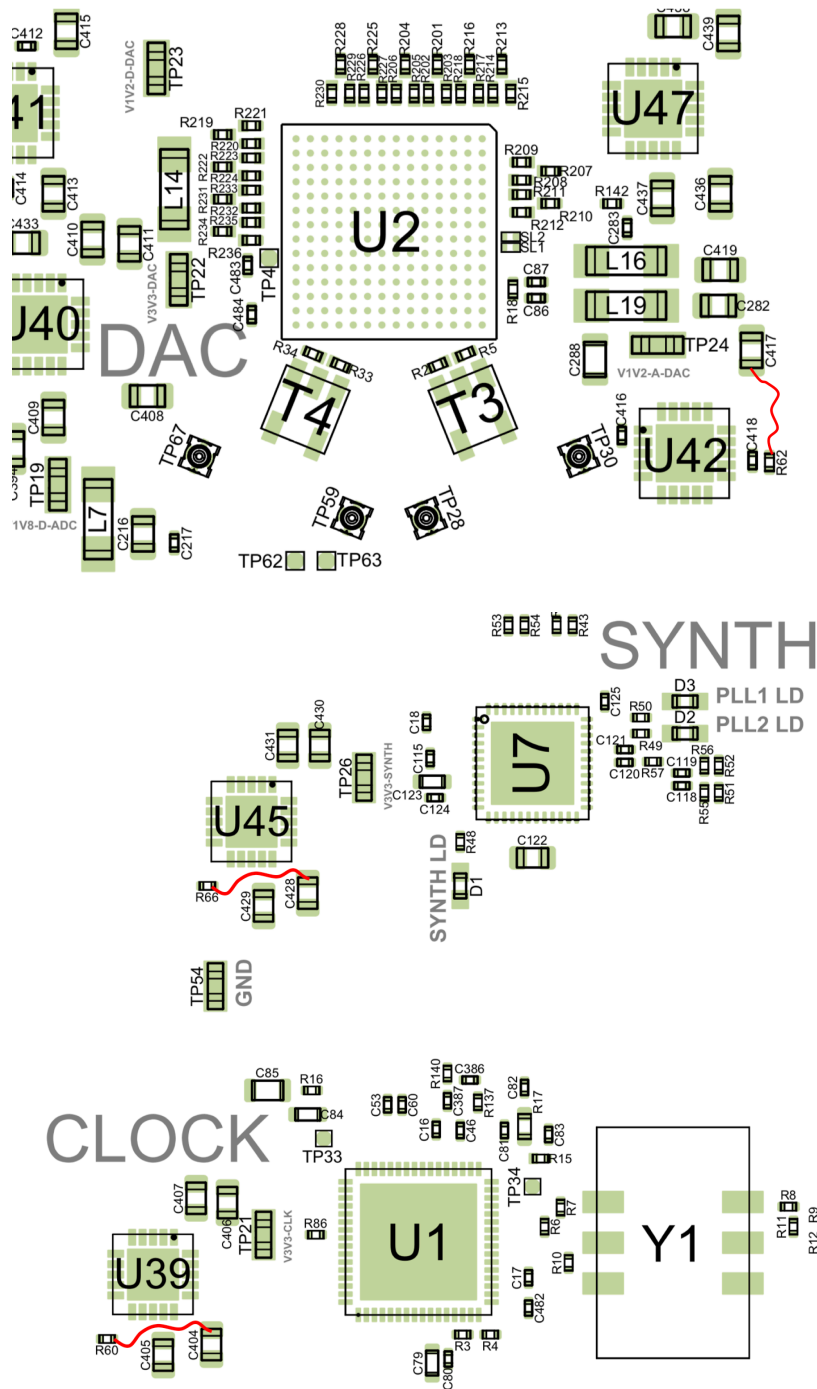
#2. "SPI bus being held low"

Solution: DAC, SYNTH, and CLOCK power supplies need to be jumpered ON (i.e. on by default).

Instructions: Jumper **R62 to C417** (as shown below). Jumper **R66 to C428** (as shown below). Jumper **R60 to C404** (as shown below).

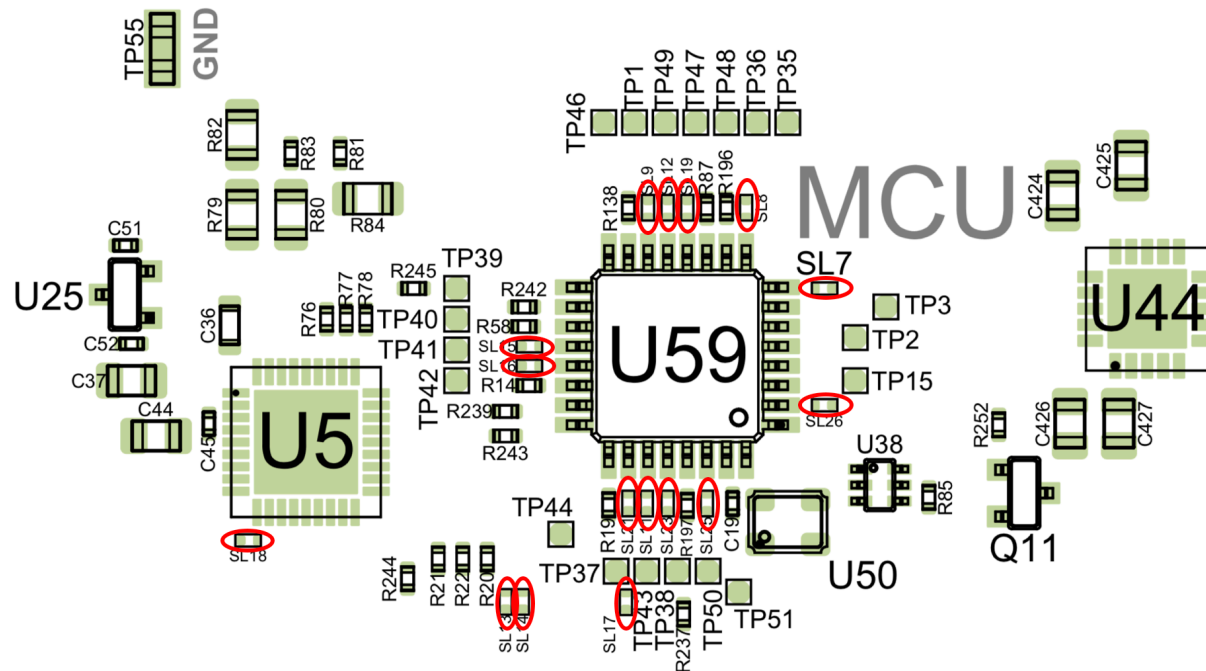
3. "Not enough solder on Solder-Link pads"

Solution: Verify all solder-links are bridged. If not, bridge them. All solder links are highlighted below.

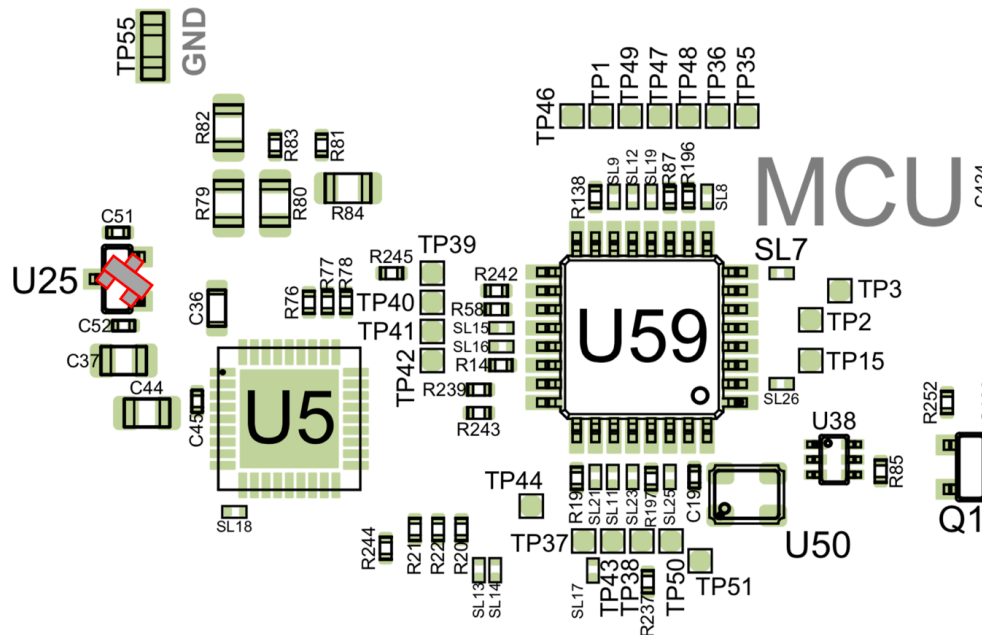
4. "U25 is wrong"

Solution: substitute P/N MCP1700T-5002E/TT and rotate 120 degrees (as shown below).

Note: MCP1700T-5002E/TT is already in BOM. It just needs rotating.

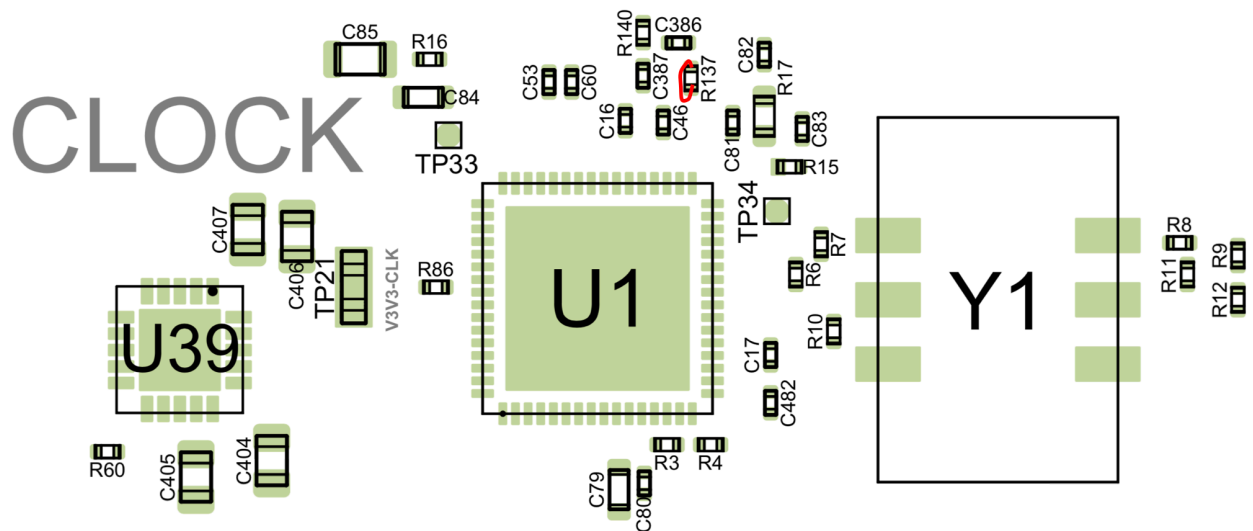
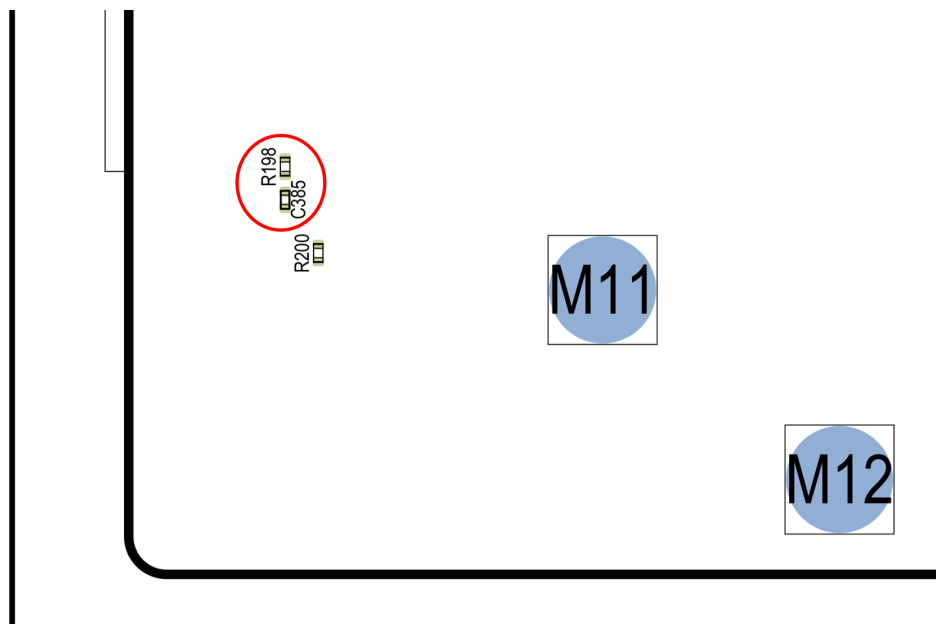
5. "5MHZ Oscillator Quality Issue"

Solution: terminate at drive side instead of receive side

Instructions: Short R137 (as shown below). Make R198 22-Ohms. Make C385 100nF.
