Graviton Rev. 2B change requests

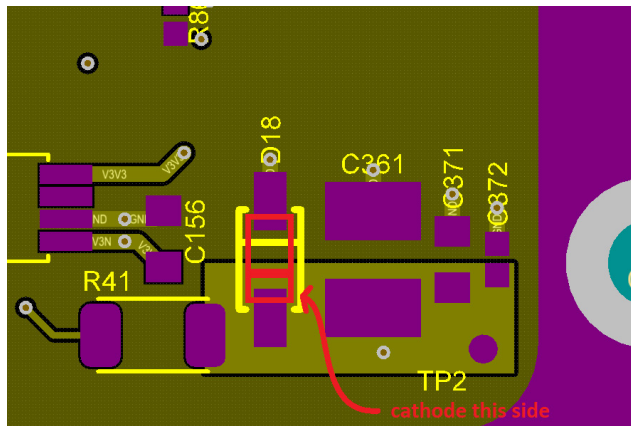
1. Change connector J10 from right angle (P/N S8B-ZR) to thru-hole (P/N **B8B-ZR**). *This part needs to be ordered.*
2. C361 is too tall. Change C361 (P/N GRM32EC81C476KE15L) to P/N **EMK325BJ226MD-T**. *This part needs to be ordered.*
3. R195 was loaded with the wrong part. Should be P/N CSR1206-OR007F1. See Tina for more details.
4. Zener diode D18 is backwards. Please rotate.

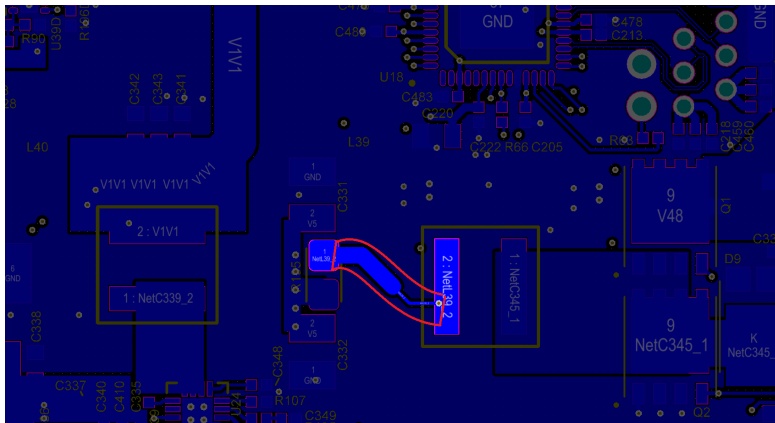
5. 5V trace too thin yielding incorrect current measurements. As a result, this is causing instability in the 5V supply. Please use a piece of wick (copper braided wire), copper film, wire, or other thick conductor to bridge L39 to R195. The connection needs to be less than 1mOhm. As a suggestion I recommend removing L39, adding the conductor, and then re-installing L39.

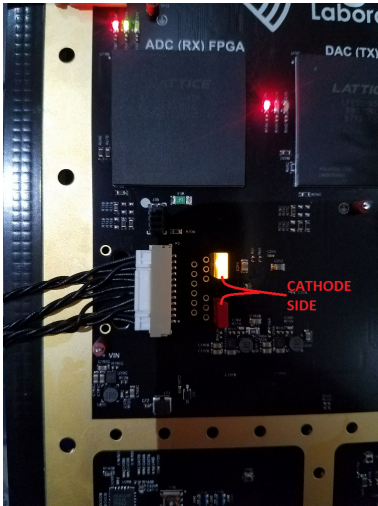
6. Add two thru-hole LEDs as shown below

orange and red LEDs to be provide to SEM by Signal Laboratories.

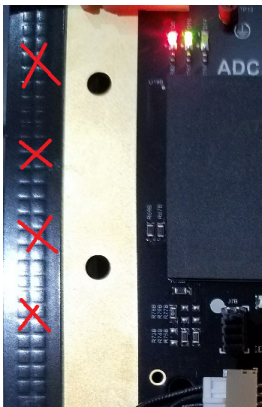
7. Remove the tabs before delivery to Signal Laboratories.
