Home Inspection Report

1832 Astor Way NE, Salem, Oregon 97302

Date: 01 November 2021

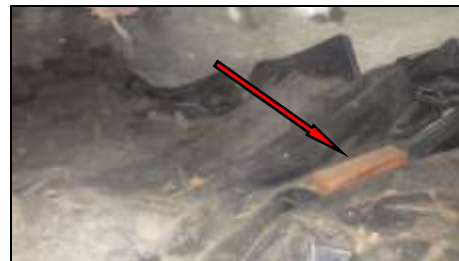
Photo 2

- **Monitor:** There is evidence of rodent droppings in the crawl space.
- **Improve:** The few pieces of wood could be removed from the crawl space (South, SW). Organic debris around a property increases risk of insect or rot damage. [Photo2STR](#)

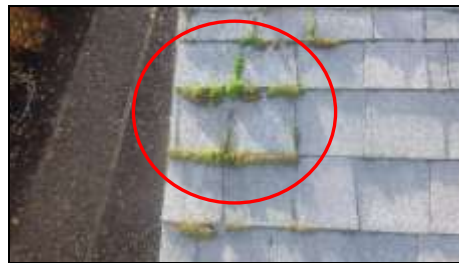
Photo 1

3. **Monitor:** There is evidence of rodent droppings in the crawl space.
4. **Monitor, Repair:** The roofing has areas of moss that is starting to grow. Roof moss should be treated/removed regularly. Moss can quickly grow resulting in diminishing life on the roofing shingles. [Photo1RF](#)

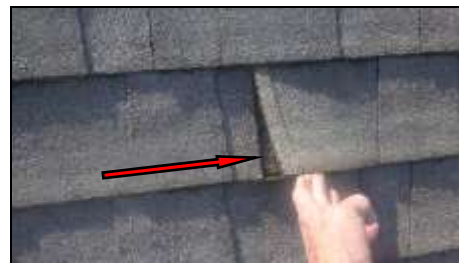
Photo 2

5. **Monitor:** The bottom edge on some of the roof shingles can be lifted up. Do not know if the shingles will blow back during high wind conditions. [Photo2RF](#)

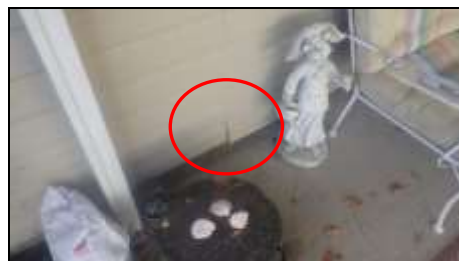
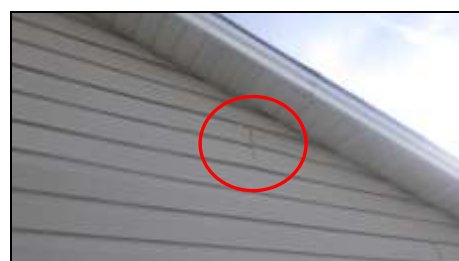
6. **Monitor:** The gutter (East patio) has some water in it. It may not have sufficient slope to drain properly.
7. **Monitor, Repair:** The loose siding (patio) should be re-secured. There is a section of siding (SW) that has a small gap. There is a small section of vinyl siding in the attic. [Photo1,2EXT](#)

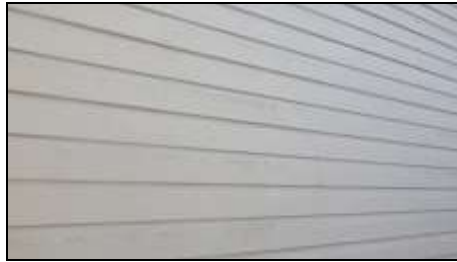
Photo 3

1. **Improve:** The few pieces of wood could be removed from the crawl space (South, SW). Organic debris around a property increases risk of insect or rot damage. [Photo2STR](#)
2. **Improve:** Some areas of the siding/fascia (North) have mildew growing on it that could be treated/cleaned. [Photo3EXT](#)

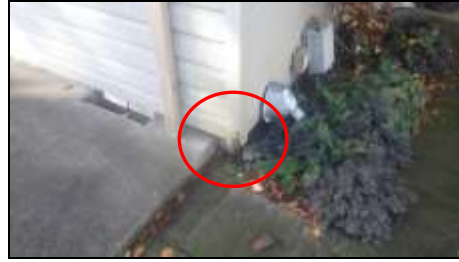
Photo 4

1. **Repair:** There is a damaged corner trim at the east. [Photo4EXT](#)
2. **Repair:** The loose fascia at the front entry should be re-secured. [Photo5EXT](#)

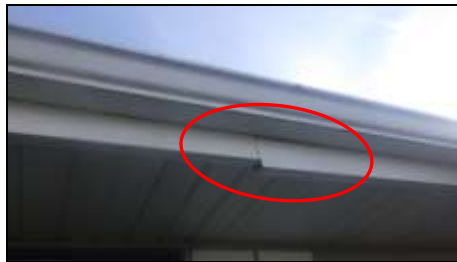
Photo 5

- **Repair:** The loose fascia at the front entry should be re-secured. [Photo5EXT](#)

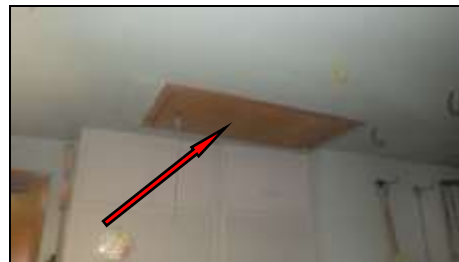
Photo 6

3. **Repair:** The overhead garage door did not open. Could not test the safety features (pressure reverse and optical sensor reverse).
4. **Repair:** The attic hatch material between the garage and the interior of the house should be rated to resist fire. [Photo6EXT](#)

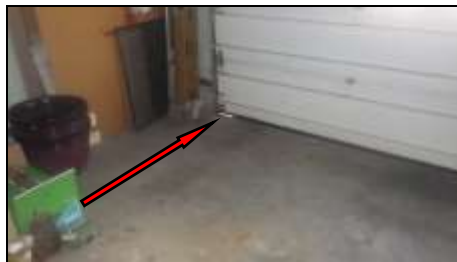
Photo 7

- **Repair:** The overhead garage door did not open. Could not test the safety features (pressure reverse and optical sensor reverse).
- **Repair:** The attic hatch material between the garage and the interior of the house should be rated to resist fire. [Photo6EXT](#)
- **Monitor:** The small gaps at the bottom of the overhead garage door weather strip should be sealed. These small openings can let rodents/blowing water enter the garage. [Photo7EXT](#)

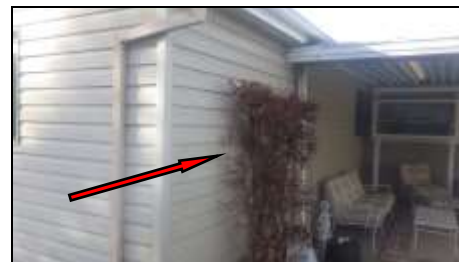
Photo 8

- **Improve:** Vegetation growing on/close exterior walls should be kept trimmed away from siding, window trims, and the eaves to reduce risk of insect and water damage. [Photo8EXT](#)

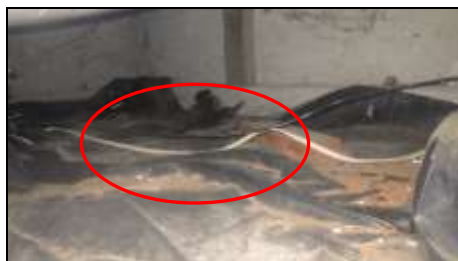
Photo 1

- **Monitor:** Loose wiring should be secured off the crawlspace ground (West). [Photo1ELE](#)

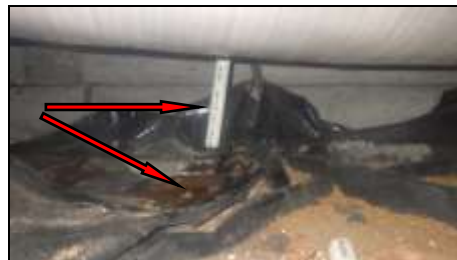
Photo 1

7. **Repair:** The condensate line leading from the furnace should not discharge to the crawlspace (SW). [Photo1HT](#)
8. **Repair:** There is a section of ductwork in the crawlspace (East) that is sagging close to the ground. Ductwork in the crawlspace should be secured 6-8 inches off the ground (West). [Photo2,3HT](#)

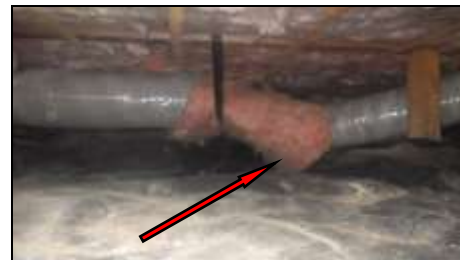
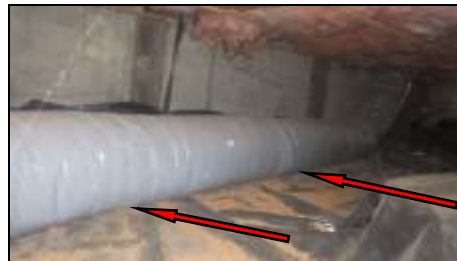
- **Repair:** There is a section of ductwork in the crawlspace (East) that is sagging close to the ground. Ductwork in the crawlspace should be secured 6-8 inches off the ground (West). [Photo2,3HT](#)
- **Monitor, Repair:** No heat supply was found in the kitchen. If this area proves to be cool, a heat supply or some form of supplemental heat could be provided. Rooms that have an exterior wall should have a source of heat.
- **Improve:** Duct cleaning is recommended.

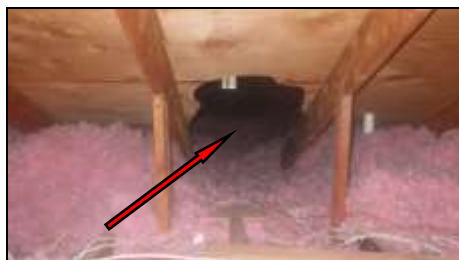
Photo 3

- **Monitor, Repair:** Could not enter the North attic. The small opening in the attic framing makes it difficult to enter the North attic. Do not know if the microwave exhaust pipe fully exits the attic. [Photo3INS](#)

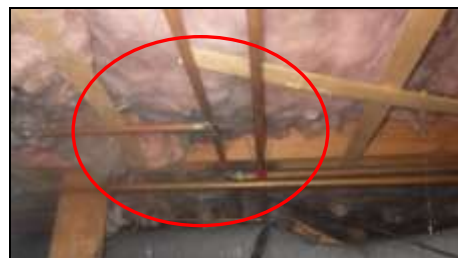
Photo 4

- **Monitor:** Plumbing pipes within the crawl space should be insulated to protect them from freezing. [Photo4INS](#)
- **Monitor:** The crawl space wall vents close to the ground (South) could have a well guard to prevent water blowing into the crawlspace. [Photo5INS](#)
- **Repair:** Small section of ductwork within the crawl space (West) should be better insulated. [Photo6INS](#)

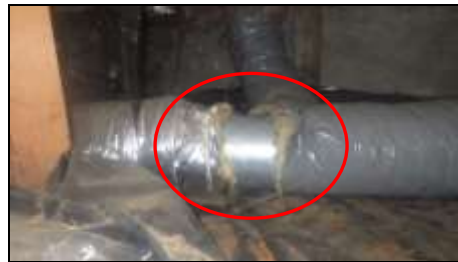
Photo 6

10. **Repair:** Small section of ductwork within the crawl space (West) should be better insulated. [Photo6INS](#)
11. **Repair:** The water heater in the garage does not have a post in front of it to protect it from vehicle damage. [Photo1PLU](#)

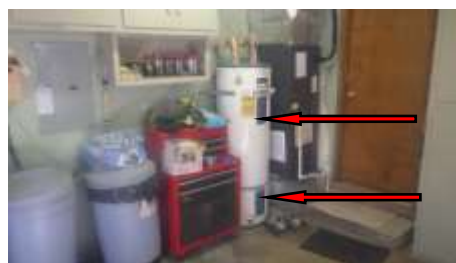
Photo 1

- **Deferred Cost Item:** The water heater is 40 years old. Water heaters have a typical life expectancy of 7 to 12 years. The existing unit is beyond this age range. One cannot predict with certainty when repairs/replacement will become necessary.
- **Repair:** The water heater in the garage does not have a post in front of it to protect it from vehicle damage. [Photo1PLU](#)

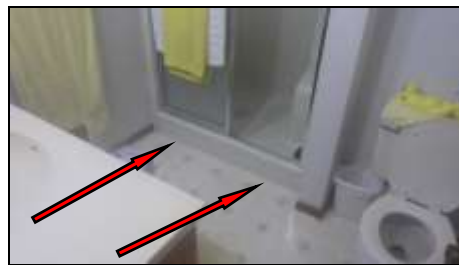
Photo 1

- **Monitor:** Areas of the carpet are showing signs of wear. Some areas of the carpet could be stretched.
- **Monitor:** The flooring at the shower stall/bathtub should be well sealed. [Photo1INT](#)

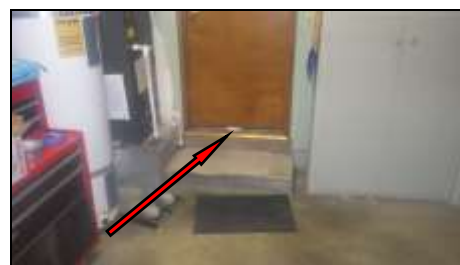
Photo 2

- **Repair:** The door between the garage and the interior of the house should be well sealed to prevent automobile fumes from entering the house. [Photo2INT](#)
- **Improve:** The front door weather stripping does not appear to be thick enough to seal the door.

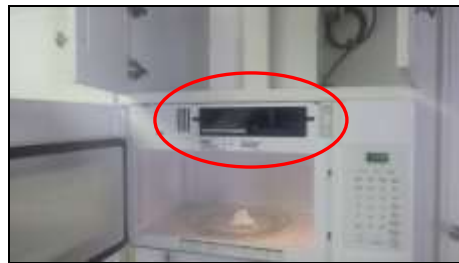
Photo 1

15. **Repair:** The faceplate for the microwave is missing. [Photo1APPP](#)

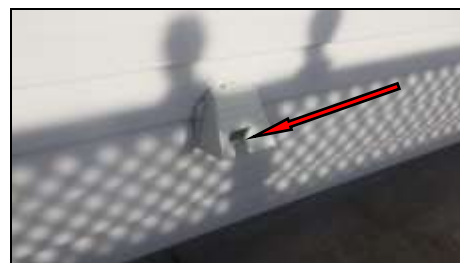
Photo 2

3. **Improve:** Vegetation growing on/close exterior walls should be kept trimmed away from siding, window trims, and the eaves to reduce risk of insect and water damage. [Photo8EXT](#)
4. **Improve:** The Ground Fault Circuit Interrupters (GFCI) are original (1994). They could be replaced with newer ones.
5. **Improve:** Duct cleaning is recommended.
6. **Improve:** The front door weather stripping does not appear to be thick enough to seal the door.
7. **Improve:** The clothes dryer exhaust vent pipe could be cleaned. The cover for the clothes dryer exhaust vent pipe is cracked. [Photo2APP](#)

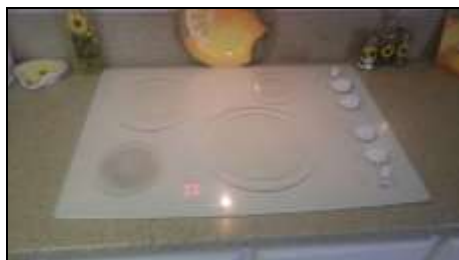
Photo 3

- **FYI:** The glass top to the electric range is showing signs of wear. [Photo3APP](#)
