# Solar AI Platform — Project Report (Starter)

Project: Solar Installation - 123 Main Street (ID: 2)  
Address: 123 Main Street, San Francisco, CA 94102

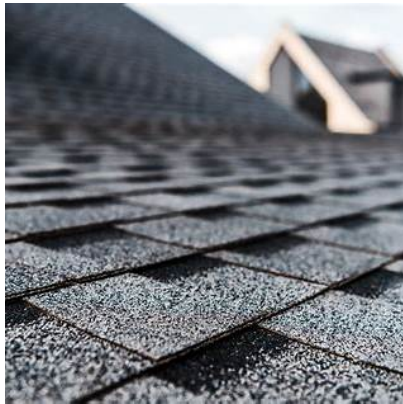
[photo]  
roof\_20251227\_211306\_639732\_good.jpg  
[View Full Size](#)

**Roof Risk: HIGH RISK**

- Weak structural areas detected

**Action:** CRITICAL - Strengthen weak roof structures  
**Reason:** Current structure may collapse under solar panel weight  
**Next step:** Structural engineer assessment, reinforce/repair roof, then

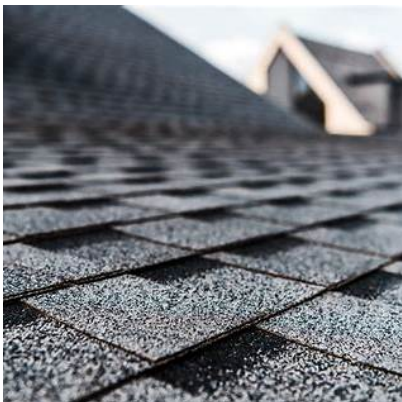
Image 1 — Findings

The roof is constructed with asphalt shingles.  
Visible granular loss is present on the surface of the shingles, indicating normal wear and aging.

No obvious major cracks, holes, or missing shingles are observed in the visible areas.  
No significant signs of water leakage, staining, or discoloration are apparent on the visible shingles.  
No rust or corrosion is visible on the shingle surfaces (no metal components are clearly in focus).  
Edges of some shingles show minor wear/abrasion.
