# Solar AI Platform — Project Report (Starter)

Project: test (ID: 11)  
Address: ghjjh

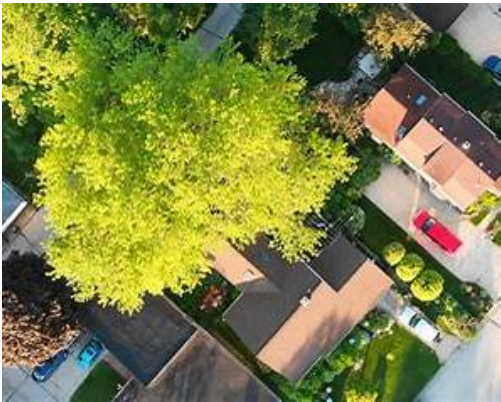
#### Image 1 — Findings

From this aerial perspective, no visible cracks, sagging, holes, or major structural damage are apparent on the main visible roof sections.

No obvious signs of water leakage, prominent staining, or significant discoloration are discernible on the roof surfaces.  
The roof appears to be primarily an asphalt shingle type, common for residential structures.  
Due to the aerial view and image resolution, minor defects such as small hairline cracks, localized rust on flashing (which is not clearly visible), or subtle signs of wear cannot be definitively assessed.  
A very large, dense tree significantly shades a substantial portion of the roof, which would severely impact solar panel efficiency and would likely necessitate significant tree trimming or removal for optimal solar production.  
Roof type identified: Asphalt Shingle

- Action:** Proceed with solar installation
- Reason:** Roof is in good condition with no significant issues detected
- Next step:** Schedule installation at your convenience
