Solar AI Platform — Project Report (Starter)

Project: Solar Installation - 123 Main Street (ID: 2)
Address: 123 Main Street, San Francisco, CA 94102

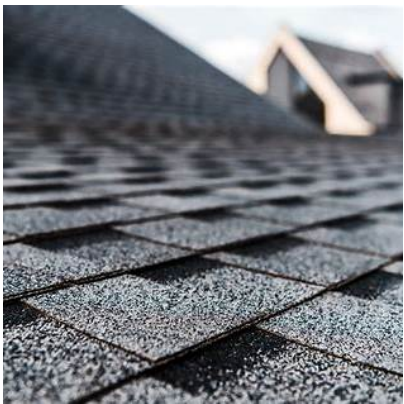
Image 1 — Findings

The roof is constructed with asphalt shingles.
Visible granular loss is present on the surface of the shingles, indicating normal wear and aging.

No obvious major cracks, holes, or missing shingles are observed in the visible areas.
No significant signs of water leakage, staining, or discoloration are apparent on the visible shingles.
No rust or corrosion is visible on the shingle surfaces (no metal components are clearly in focus).
Edges of some shingles show minor wear/abrasion.
