Solar AI Platform — Project Report (Starter)

Project: Solar Installation - 123 Main Street (ID: 2)

Address: 123 Main Street, San Francisco, CA 94102

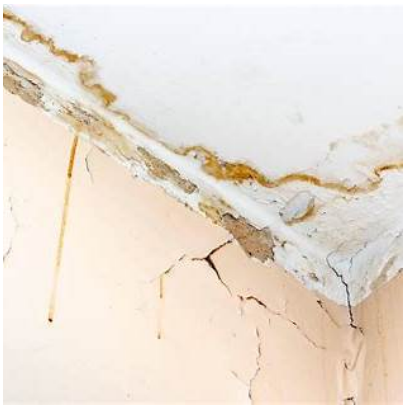
Image 1 — Findings

Extensive water stains and discoloration (brown/yellow) are visible on both the ceiling and the wall, indicative of prolonged water ingress. Significant crumbling and detachment of plaster/finishing material is evident along the edge of the ceiling, consistent with severe water damage. Widespread deep cracks are present on the wall surface, suggesting structural movement or material degradation.

Clear drip marks and active/recent water leakage are visible on the wall, confirming an ongoing or recent water issue. The severe interior damage strongly implies a compromised roof structure and waterproofing above.
Roof type identified: Cannot determine from interior image

Action: CRITICAL - Repair roof leakage immediately
Reason: Active water intrusion poses severe risk to solar equipment and s
Next step: Stop installation, repair all leaks, waterproof roof, then r

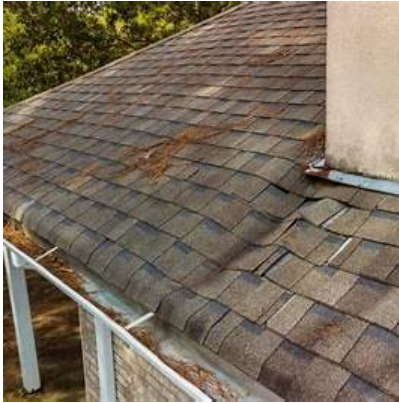
Image 2 — Findings

A very pronounced and significant horizontal sag/undulation is visible across the roof slope, indicating potential structural issues with the roof decking, rafters, or underlying supports.

Widespread and severe deterioration of asphalt shingles is evident, including significant granule loss, curling, lifting, and brittleness. Many shingles appear to be at the end of their lifespan, with several exhibiting creasing and potential breakage points.

Accumulation of pine needles and other debris is present on the roof surface and heavily collected within the gutter, which can trap moisture and accelerate material degradation.

Discoloration and potential surface rust or corrosion are visible on the metal flashing around the chimney, suggesting a potential area for water intrusion.

The overall degradation of the shingles and the pronounced sag strongly imply past or ongoing water damage to the roof structure or decking beneath the shingles.

Roof type identified: asphalt shingles

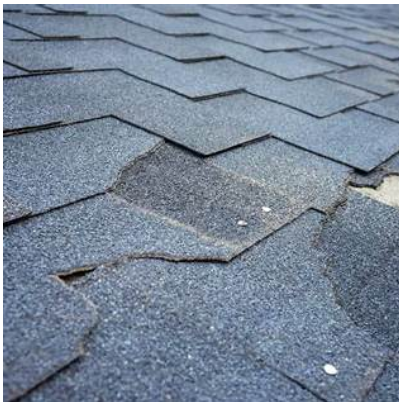
Image 3 — Findings

Extensive cracking, splitting, and tearing of asphalt shingles across the visible surface.

Significant granule loss is evident, indicating advanced wear and deterioration of the shingles.

Multiple shingles are broken or have pieces missing, directly exposing the underlying roof felt/underlayment and potentially the decking.

The exposed underlying material shows signs of discoloration, suggesting past or ongoing water intrusion.

Fasteners (likely nails with caps) are visible and exposed in damaged areas, indicating loss of shingle integrity and potential points of leakage.

The roof covering has completely failed in multiple areas, making it highly susceptible to water leakage.

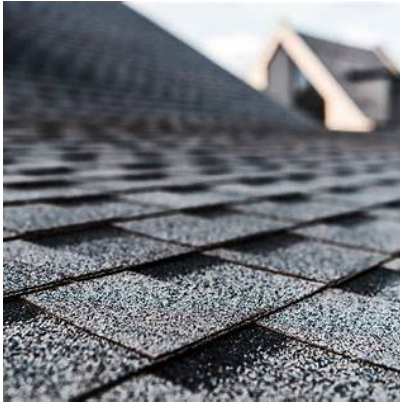
Image 4 — Findings

The visible asphalt shingles appear largely intact with no obvious cracks, lifting, or curling.

The granular surface of the shingles shows some normal variation consistent with exposure, but no widespread or severe granule loss is apparent.

No visible signs of water leakage, staining, discoloration, moss, or significant algae growth are present in the depicted area.

No rust or corrosion is visible on any metal components, as none are clearly visible within the focused image.

The roof section in the foreground appears structurally sound with no visible sagging, holes, or major damage.

While the visible section looks acceptable, the image focuses on a small area, limiting the full assessment of the entire roof's condition and potential age-related wear.
