Westlake Pointe HOA

Level 2 Reserve Study

Report Period - 1/1/2018 to 12/31/2018

Report prepared on – November 20, 2017

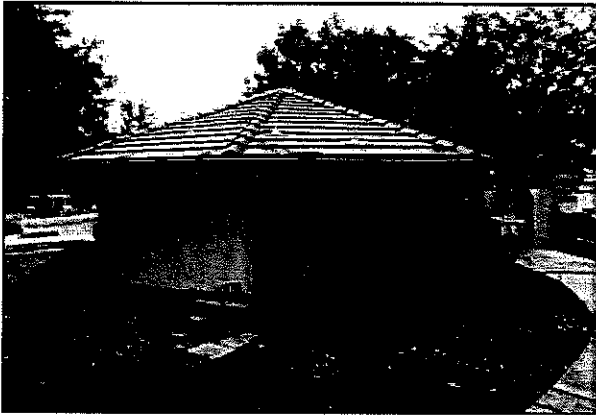
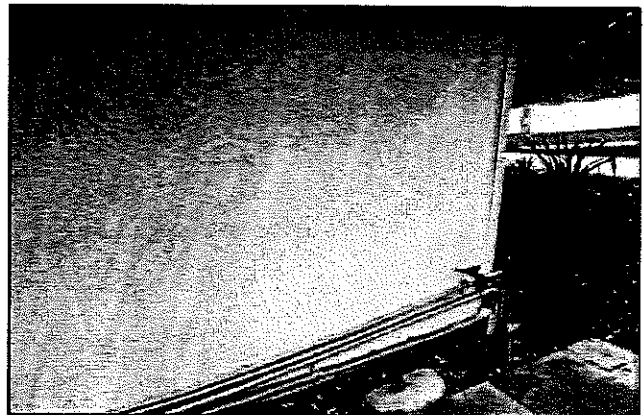
Comp # 201 Pool Building - Repaint

Noted local staining and discoloration at the time of the site visit. These surfaces should typically be repainted approximately every 6 to 8 years to maintain appearance and protect the wood and stucco material. Expect to repaint these surfaces in the near future based on current age and condition.

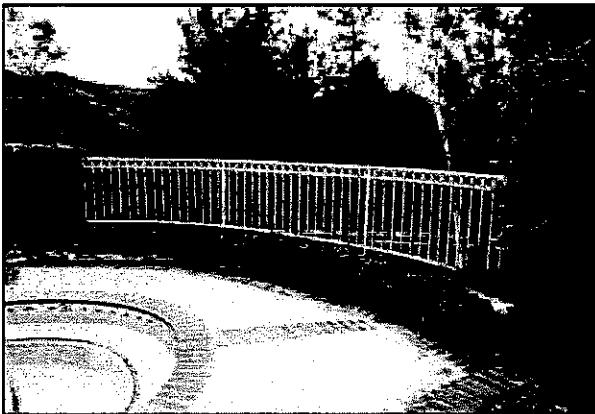
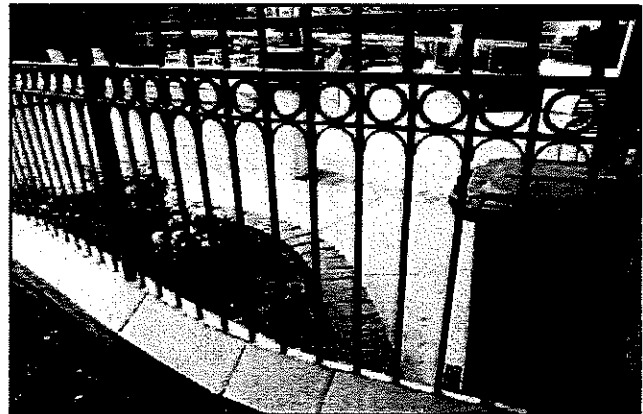
Comp # 207 Pool Fence - Repaint

Noted local rusting at the time of the site visit. We recommend repainting these surfaces approximately every 4 years to maintain appearance and protect the metal material. Repaint these surfaces in the near future based on current condition.

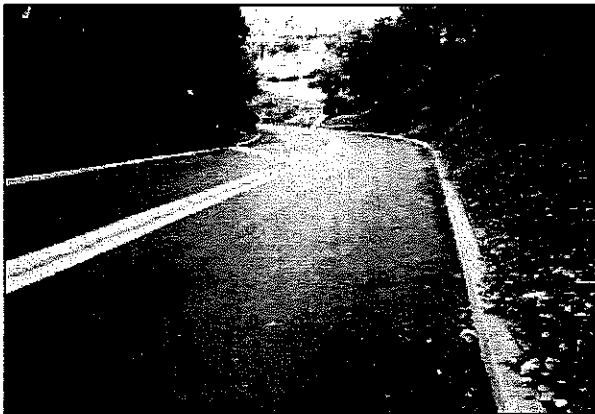
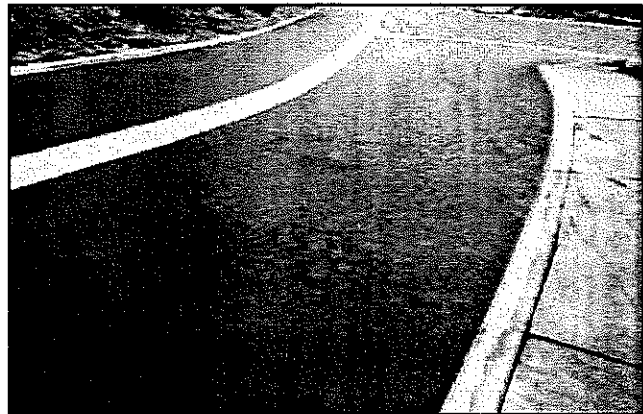
Comp # 401 Asphalt - Remove/Replace

It was reported that these surfaces received an overlay surface in 2003. No significant cracking or structural issues observed during the site visit. Because these streets have already been overlayed performing an additional overlay is not possible. We therefore recommend funding to completely remove and replace the asphalt material. Remaining life based on current condition.

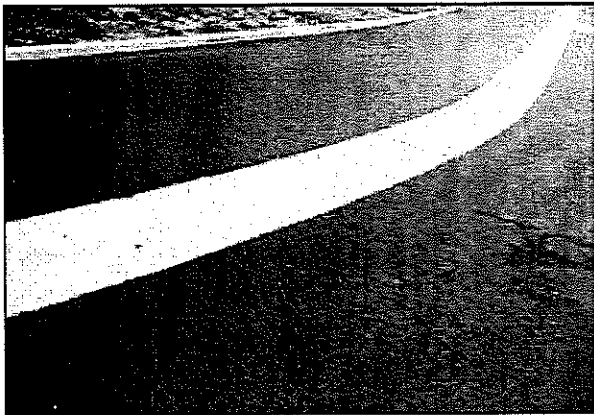
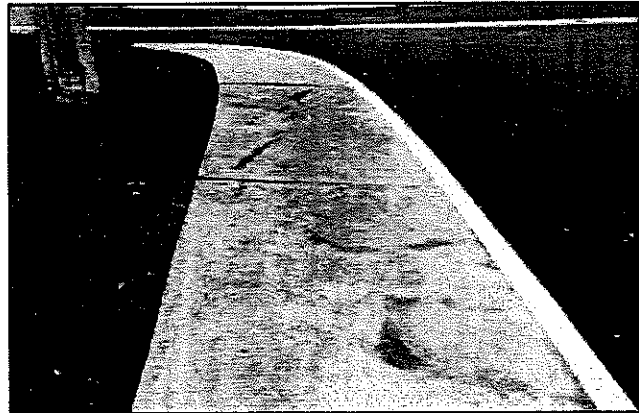
Comp # 403 Concrete - Repair/Replace

No significant cracking noted with the concrete surfaces. Although these surfaces may experience an extended useful life periodic repairs will need to be made to repair significantly cracked or uneven areas. We recommend funding to repair these surfaces approximately every 10 years.

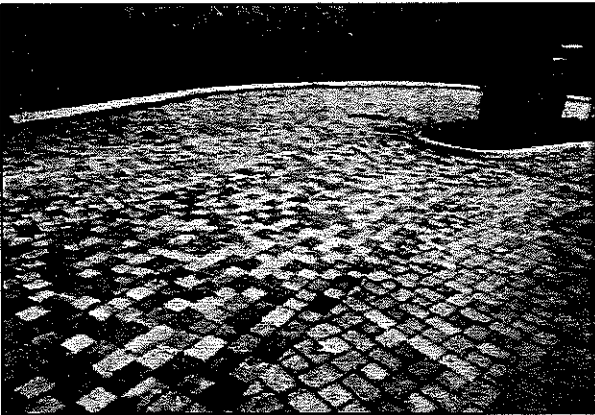
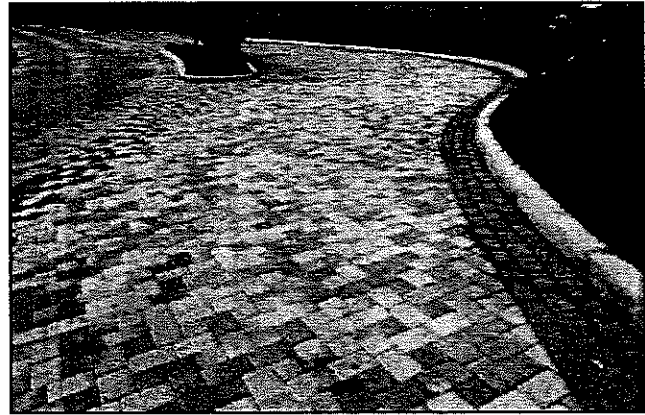
Comp # 405 Concrete Pavers - Repair/Replace

Pavers are in good condition. Although these pavers may experience an extended useful life with local repairs we recommend funding for their complete replacement approximately every 25 to 30 years

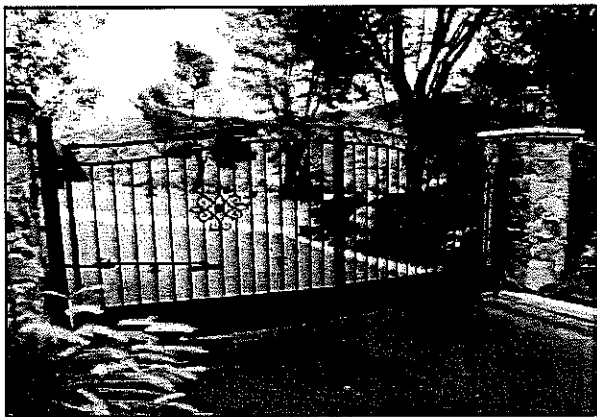
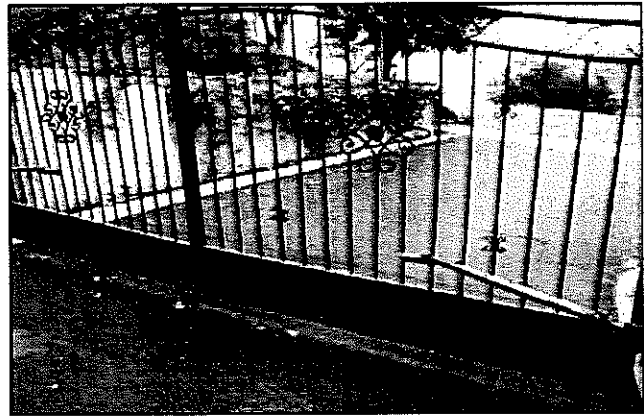
Comp # 504 Vehicle Gates - Replace (Rear Gate)

These vehicle gates are older although generally in fair condition. No significant rust or deterioration observed during the site visit. Although these gates may experience an extended useful life we recommend funding for the their replacement approximately every 25 years to ensure proper function and keep up with current decorative tastes.

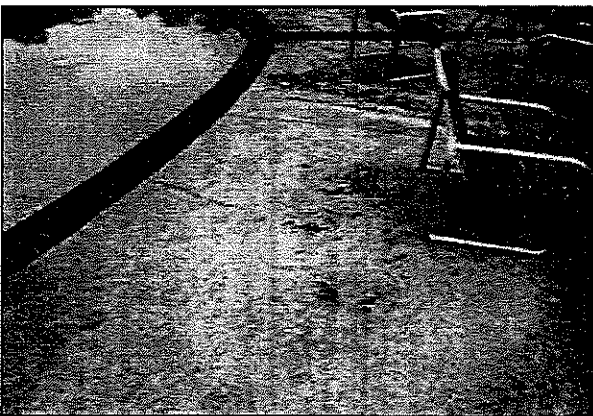
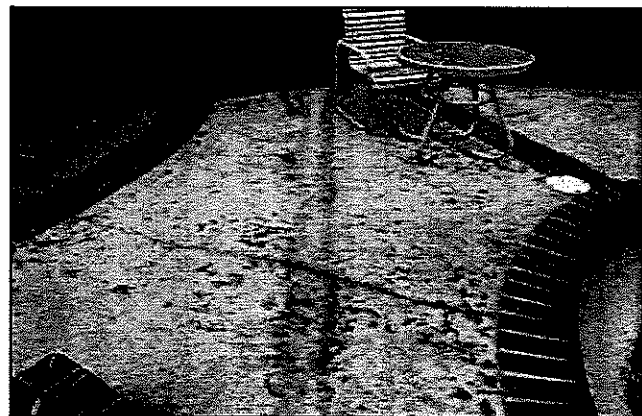
Comp # 608 Pool Deck - Replace

Noted local area of cracking to the pool area decking. Although this deck may experience an extended useful life we recommend funding for its replacement approximately every 30 years.

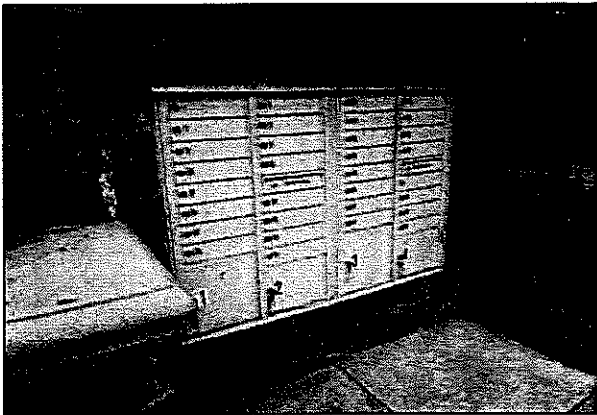
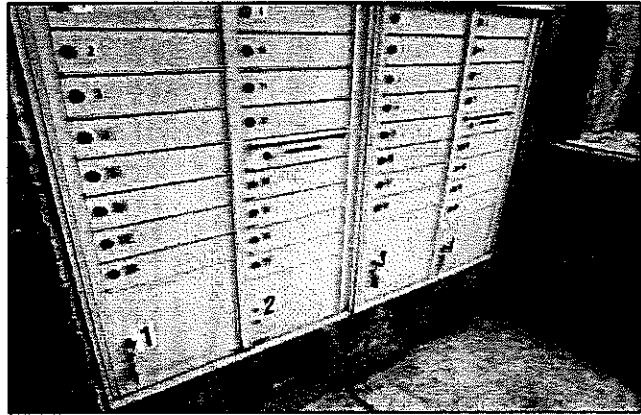
Comp # 803 Mailboxes - Replace

Boxes are in good condition. No significant marking or discoloration noted at the time of the site visit. Expect to replace this component approximately every 15 to 20 years assuming normal use and wear. Remaining life based on current condition.

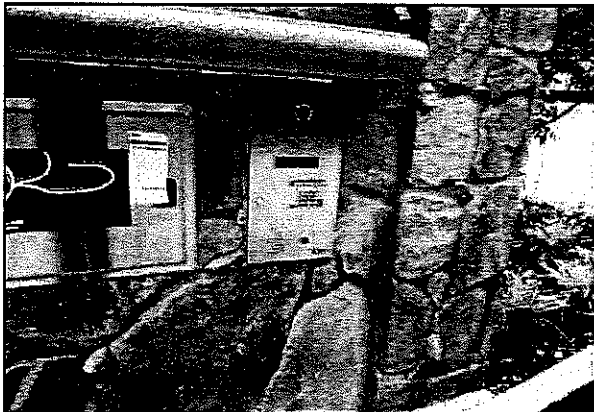
Comp # 905 Phone Entry System - Replace

The client reported that this system will be replaced prior to this reporting period. For purposes of this report we have assumed this system was replaced and is in good condition. Expect a useful life of approximately 10 years from this component.

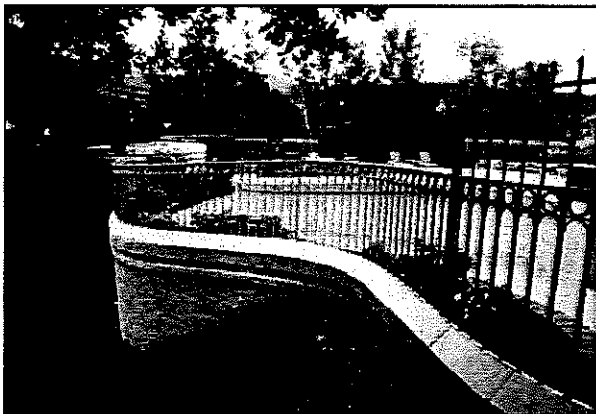
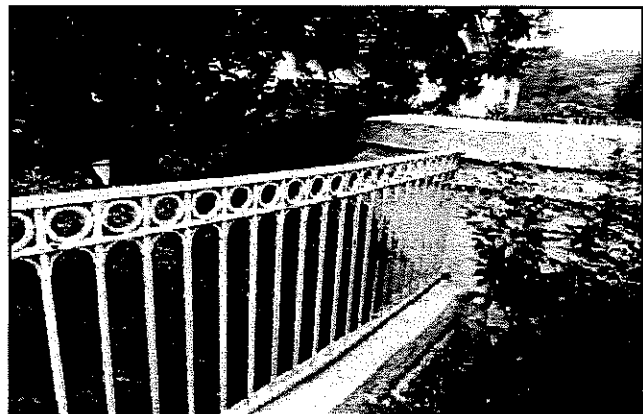
Comp # 1002 Pool Fence - Replace

Noted local rusting although no structural issues or broken welds observed during the site visit. With regular painting and periodic maintenance this fencing should experience a useful life of approximately 20 to 25 years. Remaining life based on current condition.

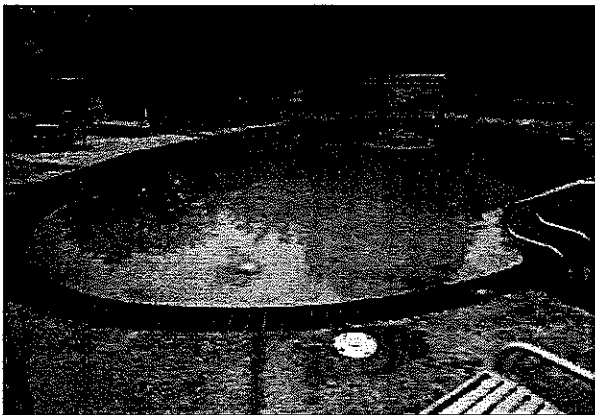
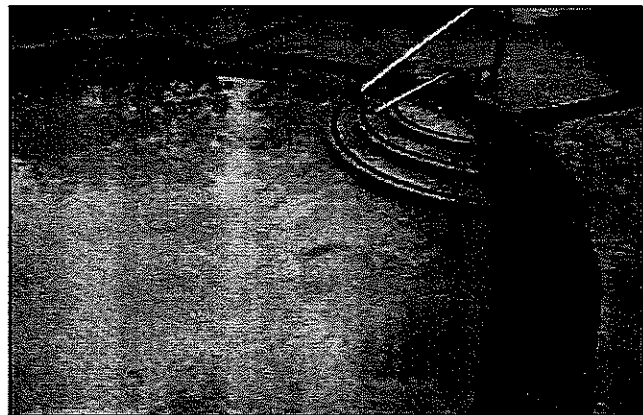
Comp # 1101 Pool - Resurface

Noted moderate discoloration to the pool surface. This surface should typically experience a useful life of approximately 12 years. Expect to resurface this pool in the near future based on current condition.

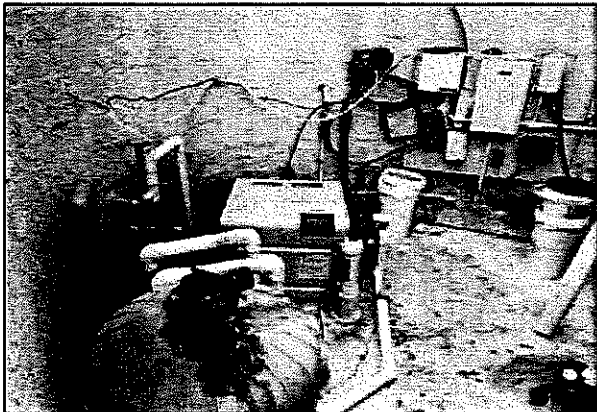
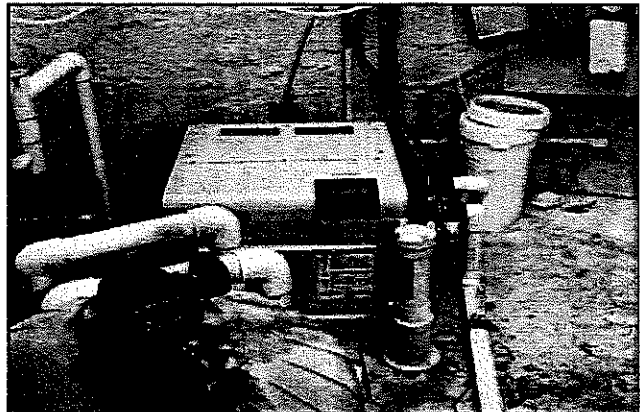
Comp # 1104 Pool Heater - Replace

Unable to access the pool equipment at the time of the site visit. This heater appears to be newer and in good condition. We recommend funding to replace this heater approximately every 10 to 12 years to ensure proper function.

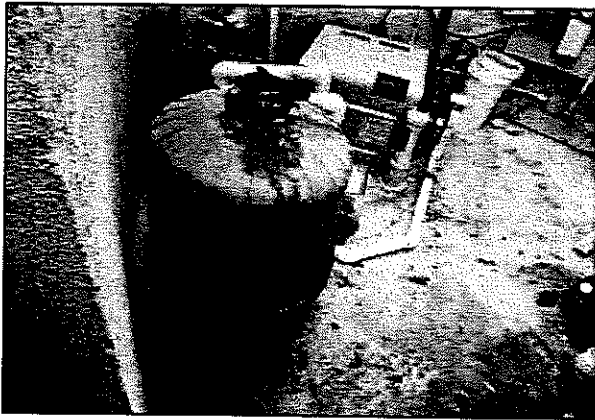
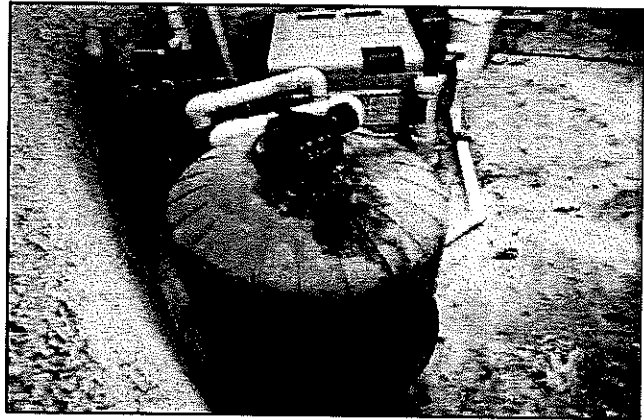
Comp # 1107 Pool Filter - Replace

Unable to access the pool equipment at the time of the site visit. Noted evidence of leaks to this filter. We recommend funding to replace this filter in the near future based on current age and condition.

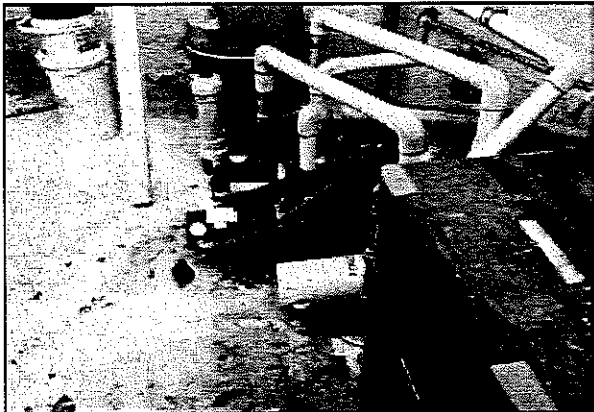
Comp # 1110 Pool/Spa Pumps - Partial Replace

Unable to access the pool equipment at the time of the site visit. No problems reported with the pool/spa pumps. No expectation to replace all the pumps at the same time. We recommend funding to replace one pump approximately every three years. Expect to make replacements to the individual motors when necessary as an operating expense.

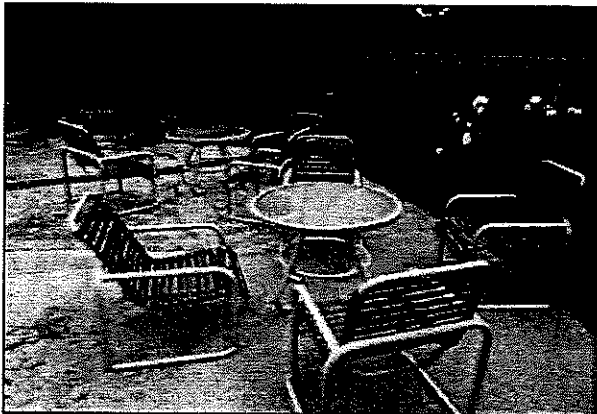
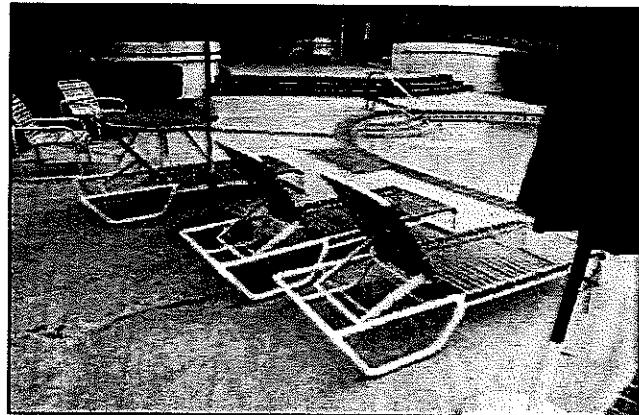
Comp # 1121 Pool Furniture - Re-Strap

The age and condition of the pool furniture generally varies. It was reported that this furniture is periodically re-straped. We recommend funding to re-strap this furniture approximately every 2 years and funding for complete replacement approximately every 12 years (see Comp#1120 Pool Furniture - Replace).

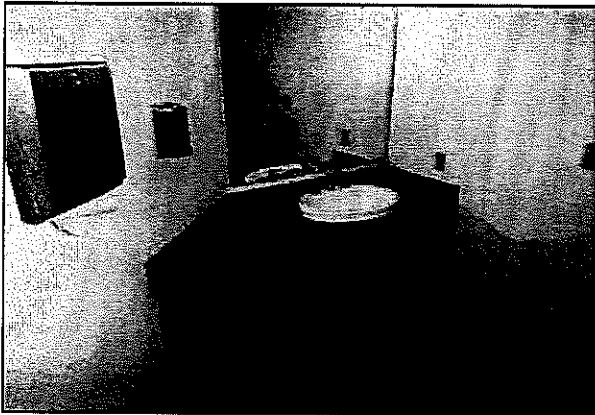
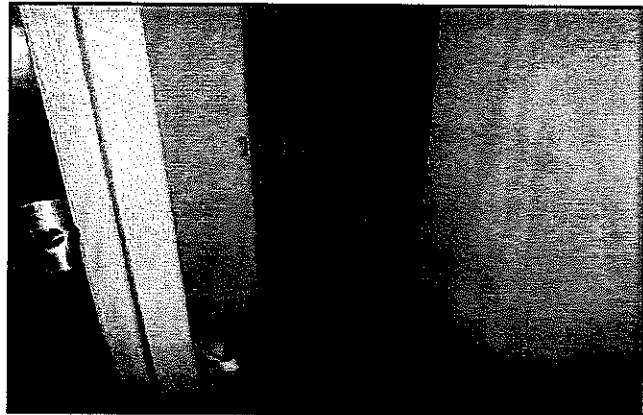
Comp # 1413 Restrooms - Remodel

The restroom interiors are typically in fair condition. Noted local tile damage although generally these restrooms are in fair condition. We recommend funding to refurbish these restrooms approximately every 15 to 20 years to maintain appearance and keep up with current decorative tastes.

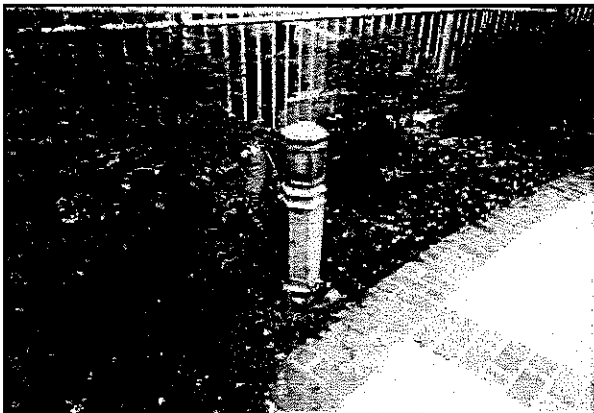
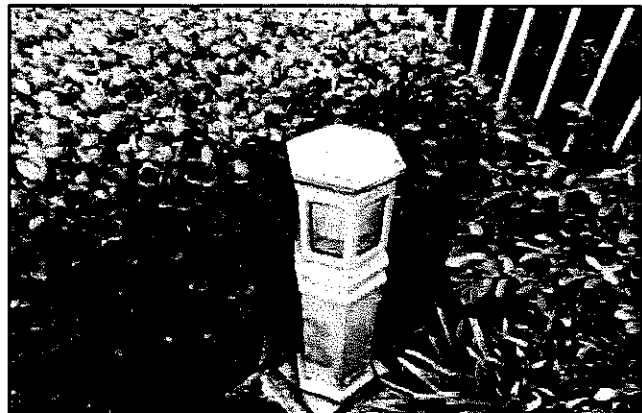
Comp # 1605 Bollard Lights - Replace

The bollard lights are typically in fair condition. Noted fading although no damaged or broken fixtures observed during the site visit. We recommend funding to replace these lights approximately every 15 to 20 years. Repaint these fixtures when necessary as an operating expense.

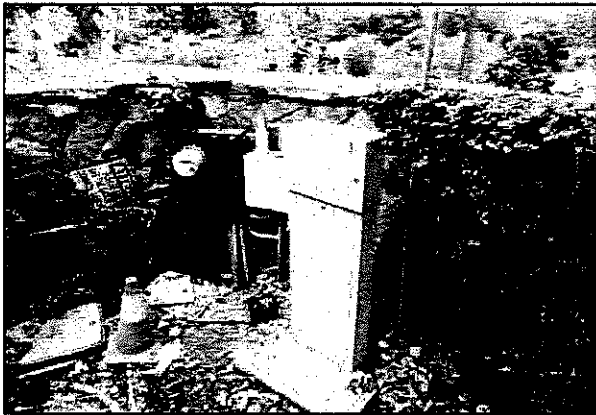
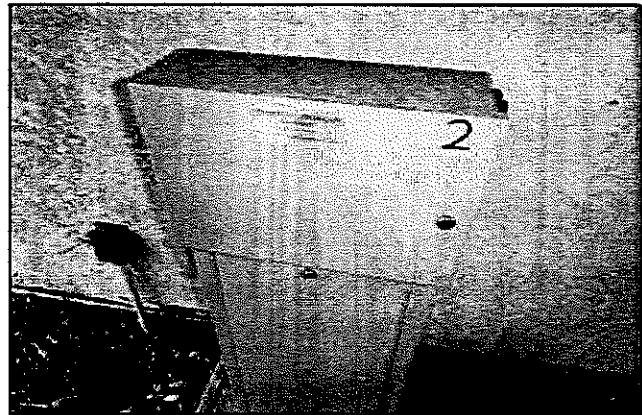
Comp # 1703 Irrigation Time Clocks - Replace

The time clocks are newer and generally in good condition. No problems noted during the site visit. This type of clock has a typical useful life of approximately 10 to 12 years. Remaining life based on current age and condition.

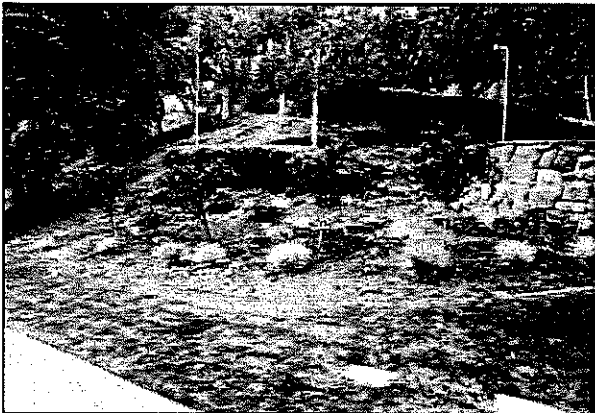
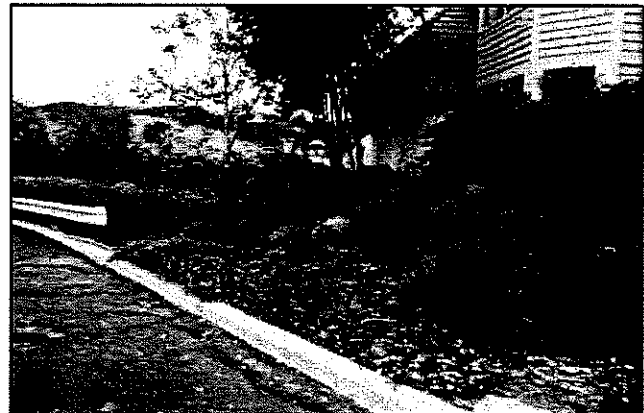
Comp # 1812 Landscaping - Renovate

The client reports the association plans on making landscaping improvements in the near future. No expectation to completely replace the landscaping. We recommend funding for an allowance to generally refurbish the landscaping, make local tree replacements, and make upgrades to the irrigation system and landscape lighting approximately every 10 years.

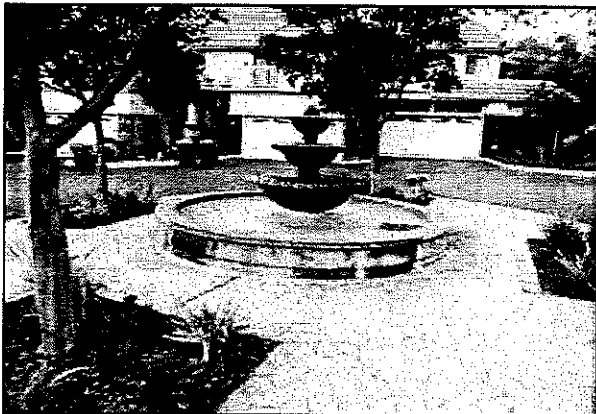
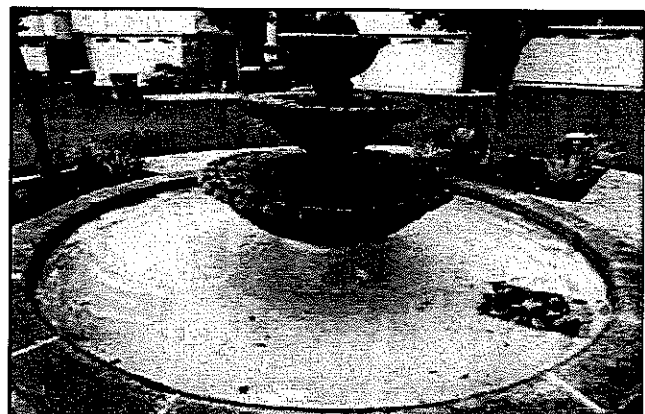
Comp # 2201 Fountains - Refurbish

Although these fountains may experience reach an extended useful life we recommend funding to refurbish the fountains and resurface the pond areas approximately every 15 years. Replace pumps components when necessary as an operating expense.
