Article No.: TASC Tip-02-07

TAAT reverse issues

Should you replace the valve body?

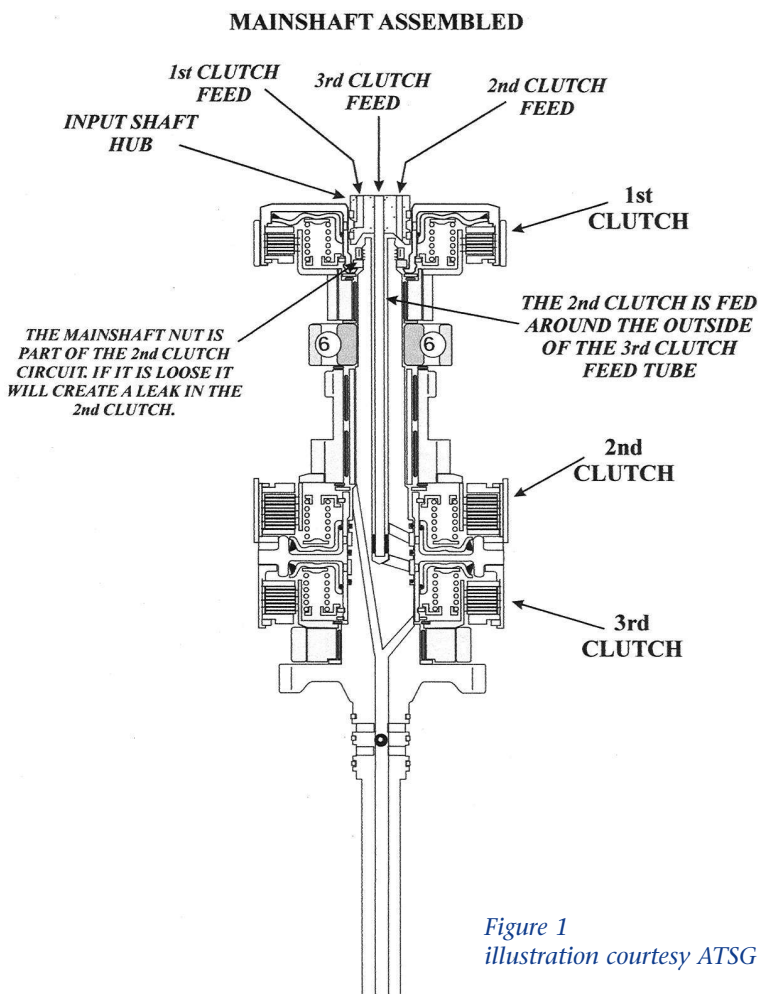
Figure 1
illustration courtesy ATSG

The most common cause of delay or no reverse, other than the valve body, is a loose mainshaft nut (see Figure 1). The symptoms will most likely occur when the vehicle is hot, and may also exhibit a soft or flared 2nd gear upshift. According to ATSG's 2003 Seminar information, a loose mainshaft nut can cause a leak in the 2nd clutch circuit. When the nut is loose, the mainshaft walks back and forth in the middle of the case. This causes a small gap between the 1st clutch and the nut, which is where the leak in the 2nd clutch circuit appears. A new mainshaft nut should be replaced with every repair, since it has a factory thread locker. The nut can be accessed by removing the side cover, which

means the unit does not have to be removed to replace it. The nut, and this is very important, should be torqued to 111 ft. lbs. The Saturn part number for the mainshaft nut is 21001680.

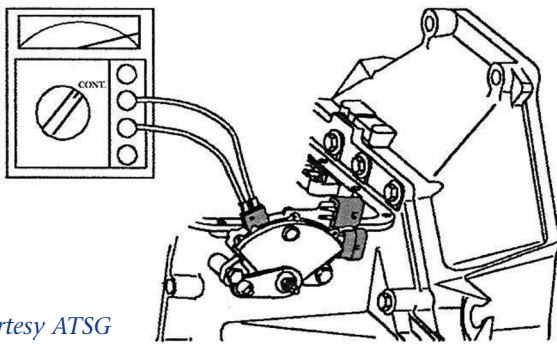
Figure 2
illustration courtesy ATSG

Another problem that occurs, especially when the unit has been removed, is an incorrectly adjusted pattern select switch, which we all commonly know as the manual lever positioning switch. If the pattern select switch is not adjusted properly, a no reverse condition, as well as loss of drive and/or erratic or harsh shifting can occur. To adjust the pattern select switch, according to the ATSG Service Information, put the selector in the D4 position. DO NOT start the vehicle. Connect an ohm meter to the switch (see Figure 2). Rotate the switch until the ohm meter reads continuity. Once a reading is obtained, tighten the pattern select switch. Once again, the valve body is still the main cause for reverse as well as forward issues with the TAAT. But as you can see, there can be other areas that may also need to be addressed.
